May 18, 2012

Reference: NVS-rw214  
PE12-008

This letter is in response to your letter of April 20, 2012, received in this office on April 23, 2012, concerning the request for information for a Preliminary Evaluation of an alleged inadvertent partial/total parking brake application on a International 3200IM chassis while the vehicle is in motion with the potential for inadequate warning of the braking event to the driver.

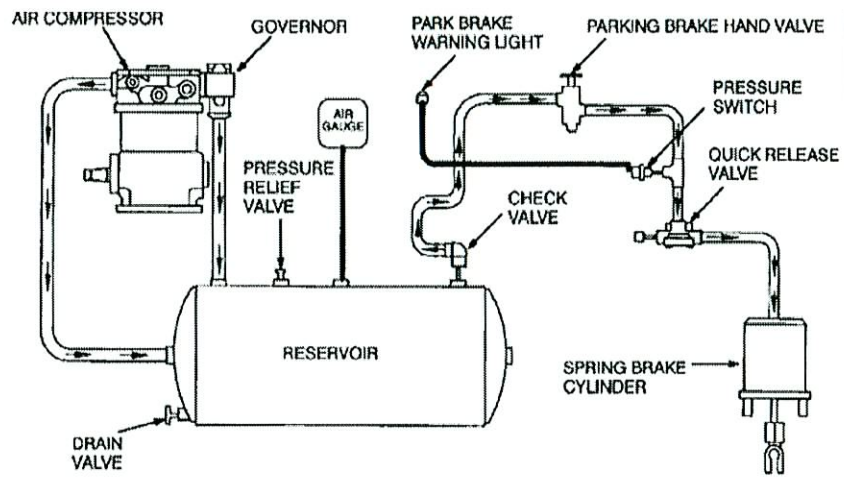
**Response 10** Navistar's current information indicates that the SAAR parking brake as designed for the 3200IM commercial bus chassis does provide adequate warning to the driver in the event that there is a leak in the air system. The parking brake system for the 3200IM chassis does have a standard low air warning audible alarm, as well as the dash mounted air gauge and the warning light. The system is designed to operate normally at 125 psi air pressure. The low air warning buzzer is programmed to come on at approx. 70 psi. In the event of a slow to moderate leak this would give adequate warning to the driver as the air system decays. The parking spring brake does not begin to apply until the pressure gets below 58 psi. A diagram of the park brake system is given below:

- b. In order for the spring brake on the SAAR transmission mounted parking brake to apply, there has to be an air loss at the brake chamber down to pressure levels below 58 psi. Since the low air audible alarm activates at around 70 psi, the alarm, light, and the dash mounted pressure gage would have given warning to the driver long before the air level decreased to the point of lever actuation.
