August 31, 2012

Reference: NVS-rw214
PE12-011

This letter is in response to your letter of August 2, 2012, received in this office on August 9, 2012, concerning the request for information for a Preliminary Evaluation of an alleged high pressure oil line failing on the MY 2008 Navistar International CE School Buses.

MDT MY08 CE Bus (PB105) - High PSI Supply Hose Replacements

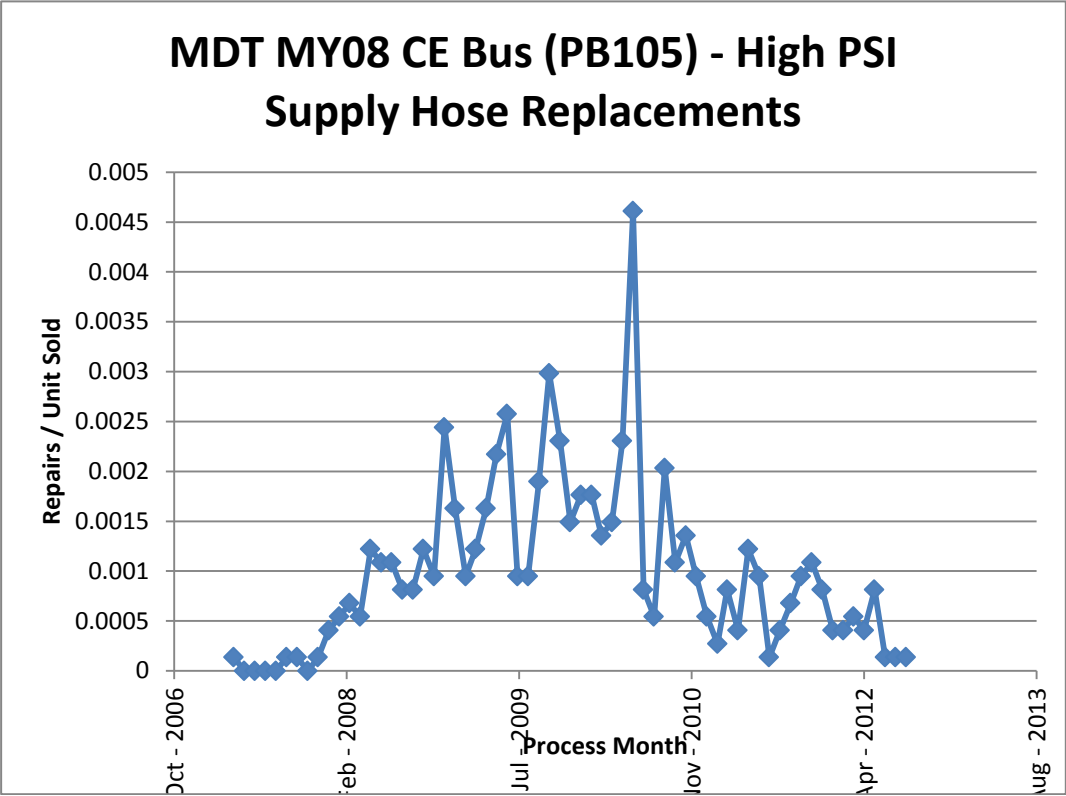
Note that while the data may suggest some early reliability issues with the high pressure oil line, the chart below indicates a significant improvement in the reliability of high pressure oil line on model year 2008 bus claims since the November of 2010 claim process date.

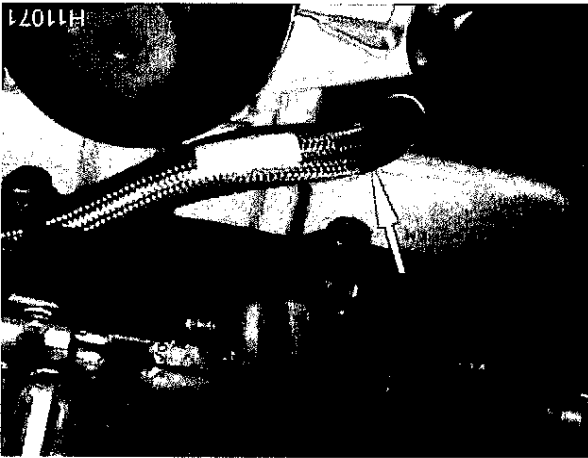
Figure 569 Bad alignment of high-pressure oil hose (hose twisted)

- b. The hose design was not robust enough for the pressure and duty cycles required. Installation practices are also critical for the long term reliability of the hose to ensure no twisting occurs, which introduces a pre-stress condition.

- CAUTION:** To prevent engine damage, the high-pressure oil hose must be positioned and aligned in a smooth arc, not twisted, under excess tension or touching engine components.
8. Position and align the high-pressure oil hose, so the hose is not under excess tension or twisted. Tighten each swivel nut on the high-pressure hose, using one wrench to hold the hose nut, while using another wrench to tighten the swivel nut to special torque value (Table 47).
 9. Position and align the high-pressure oil hose, so the hose is not under excess tension and the hose bends in a smooth arc. Use one wrench to hold

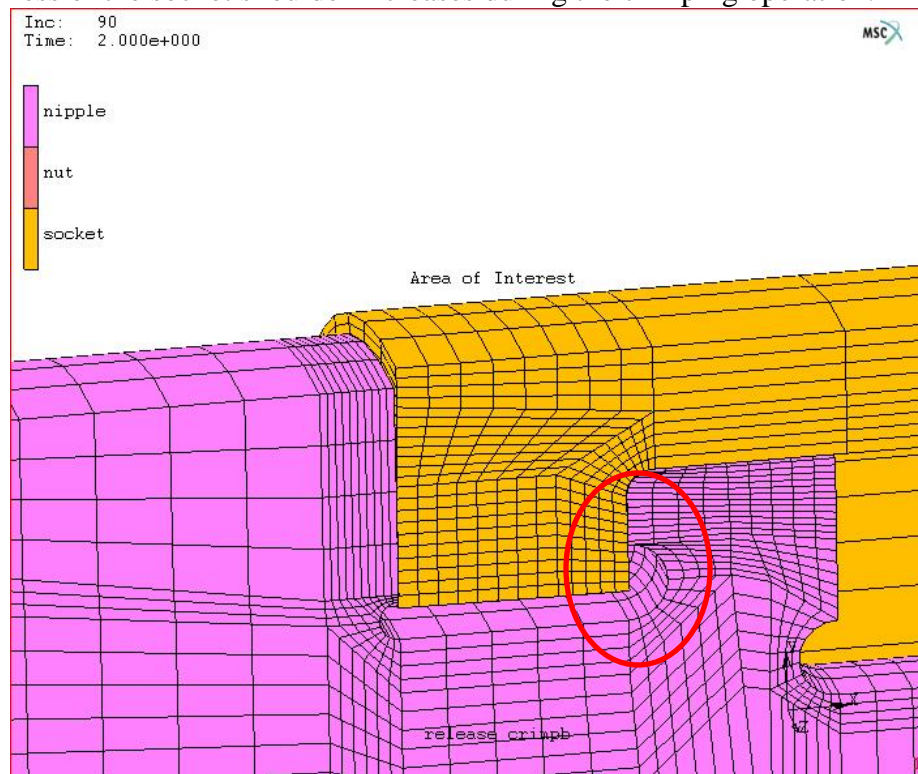
Figure 1 Location of Interest on the nipple

If the gap on the nipple is within specification but below the nominal value of .120 inches the socket could interfere with the nipple. This interference means that a positive stress will occur on the undercut. In terms of the fatigue, this stress is a residual mean stress, which will affect the expected fatigue life at this location. If the residual stress is compressive, it will help the fatigue life and if it is tensile it will diminish the fatigue life.

The shoulder thickness of the socket grows approximately .016 inches when the socket is crimped to .830 inches. Depending on the width of the nipple, the socket can interfere with the nipple groove. This interference causes residual mean stresses in the nipple. These mean stresses can potentially significantly reduce the fatigue life of the part with fracture occurring at the undercut shown in Figure 1.

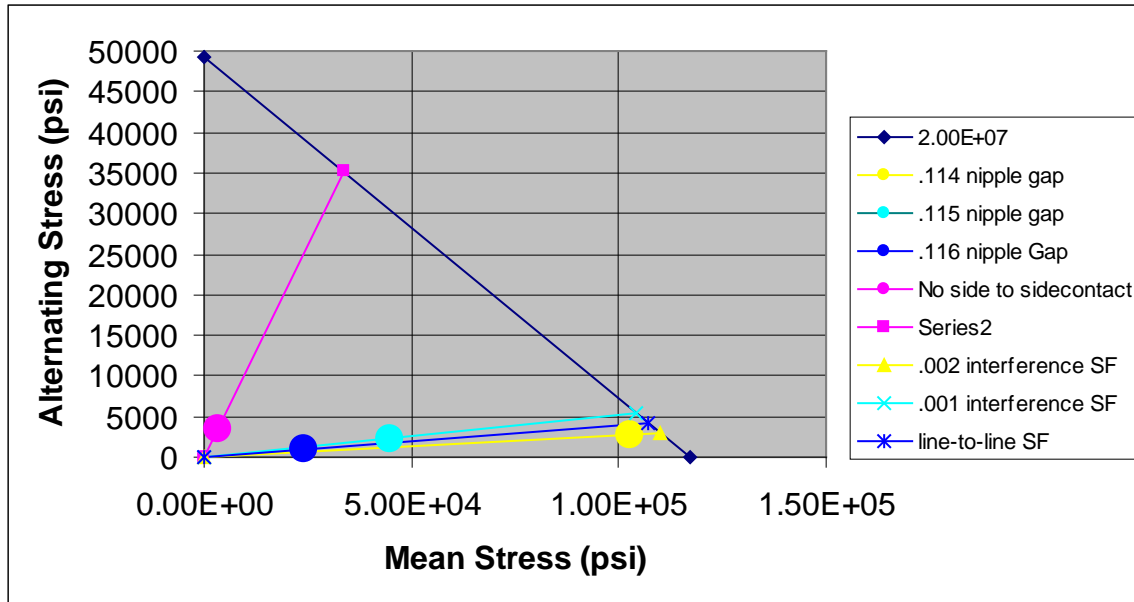
Figure 2 Haigh Diagram of Various Fatigue Conditions

A graphical representation of the safety factor is shown in Figure 2. The line from the origin to the mean and alternating stress condition is extended to the Goodman line. The difference between the stress point and the point of interference with the Goodman line is the safety factor. It should be noted that the

Goodman line represents a probability of 50% of failure, so that the closer the stress condition is to the Goodman line the more likely fatigue failure is to occur.
