July 19, 2012

RE: NVS-212mjl, PE12-012

MY 2011-2013 Hyundai Elantra manufactured in Hyundai's Ulsan, Korea factory.

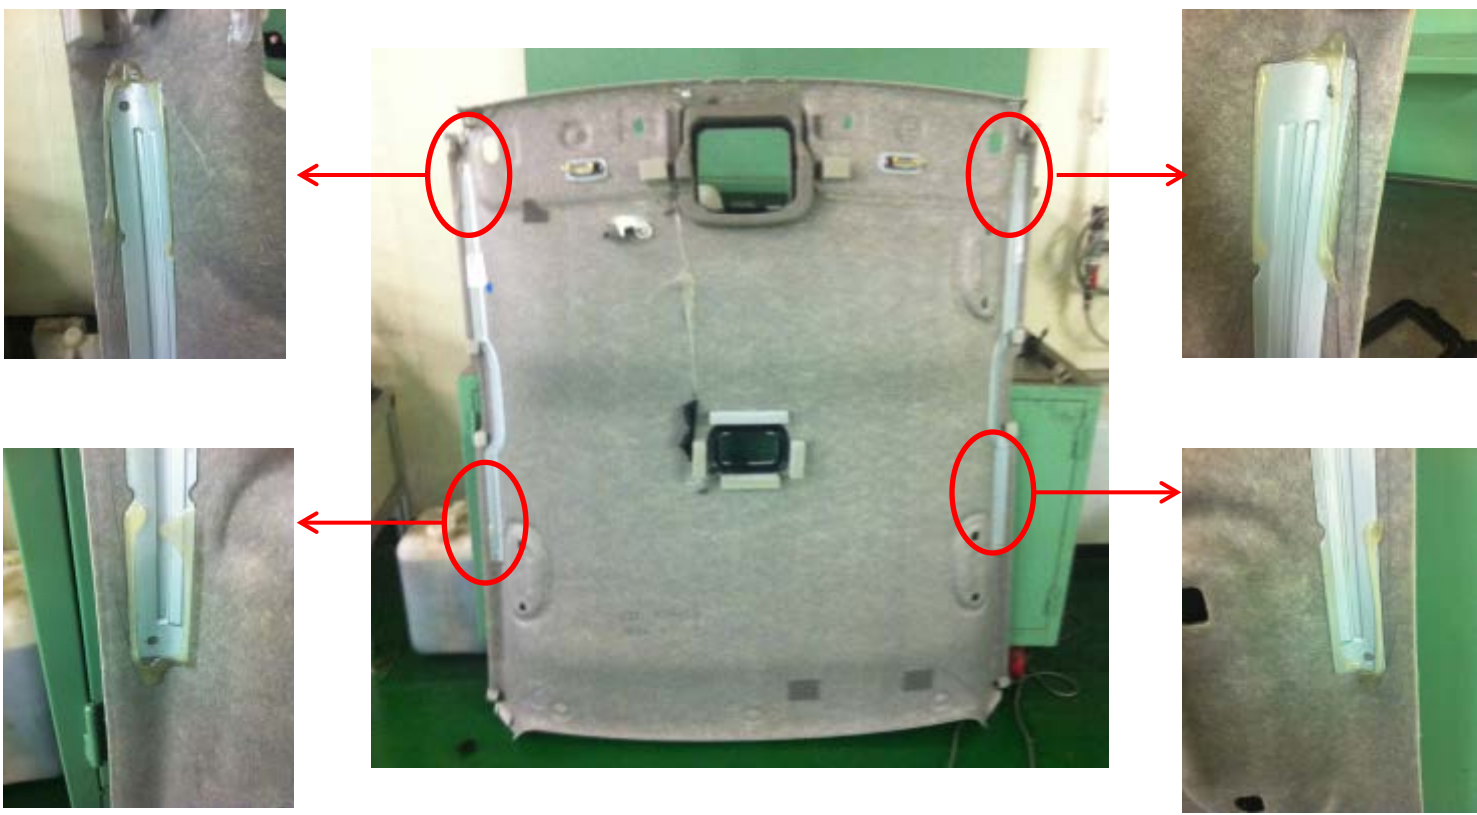
Part No.	853133X150TX	Inspection date	'12.06.01
License No.	██████████	Production date	'12.01.11
Photo

MD headlining BRKT inspection results
