PE12-019

MADZA

APPENDIX 11

2002-2004 Tribute Accelerator
Cable Recall 2704L

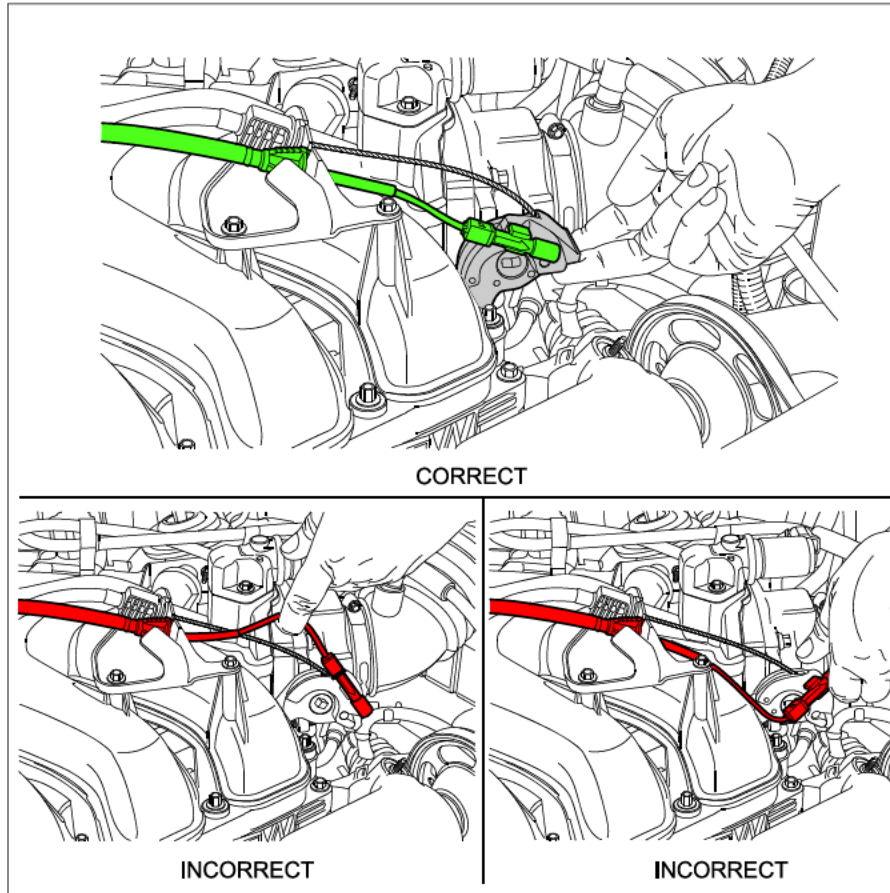
CAUTION: Damage to the speed control cable may result if the throttle body cam is rotated by lifting up on the speed control cable or the speed control cable connector end. When disconnecting the accelerator cable from the throttle body, rotate the throttle body cam only by lifting up on the cam itself. See Figure below.

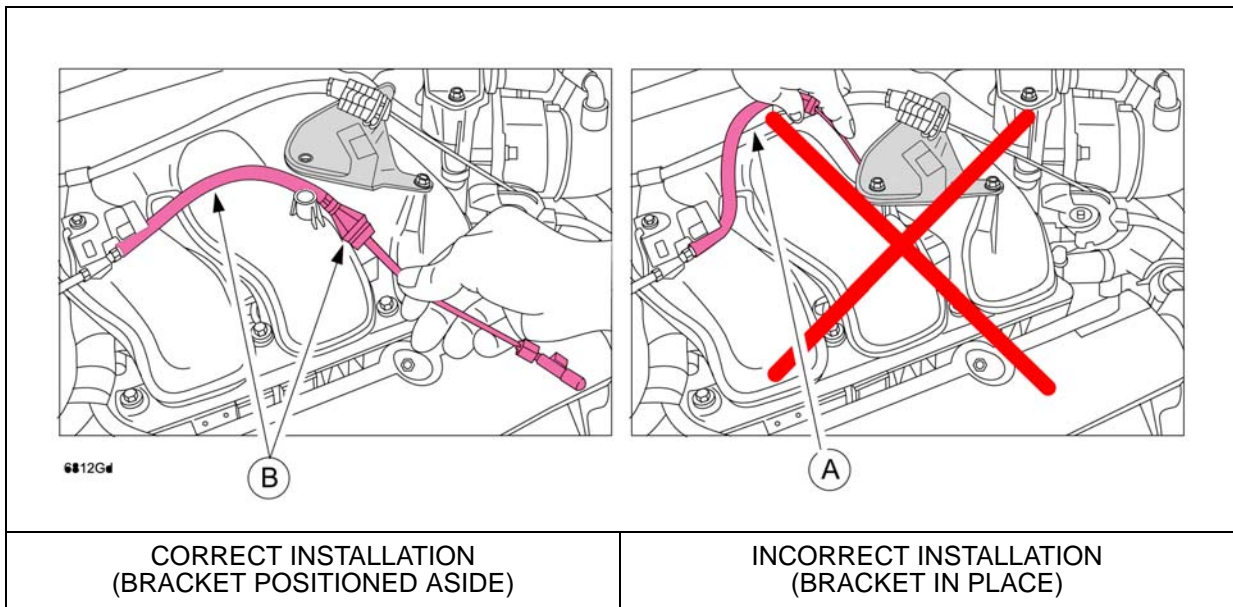
NOTE: Do not bend the speed control cable (A) in order to route it under the throttle cable bracket. The throttle cable bracket must be positioned aside or damage to the speed control cable may occur.

- Route the speed control cable (B) under the bracket as shown in "correct installation" below.

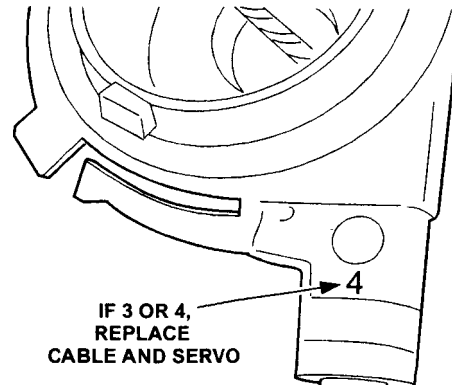
2001 TRIBUTE [RECALL 93008] CRUISE CONTROL CABLE CAP DAMAGE

4. Separate the cruise control cap from the actuator and inspect number at the cable to cap connection as shown in the following illustration.

- If the cavity is #3 or #4, proceed to "C. Repair Procedure."
- If not, reassemble cruise control cable cap and place a yellow paint mark on top of the servo to indicate completion of repair. Reconnect the battery ground cable and set radio presets. Proceed to "**D. AUTHORIZED MODIFICATION LABEL INSTALLATION.**"
