PE12-019

APPENDIX 17

July 6, 2012 - Internal Mazda
communication regarding
NHTSA question of Mazda
update.

SUBJECT: Safety Recall 04S25: *Update*
All 2002 through 2004 Model Year Left Hand Drive (LHD) Escape Vehicles Equipped
with 3.0L Engines
Accelerator Cable Replacement

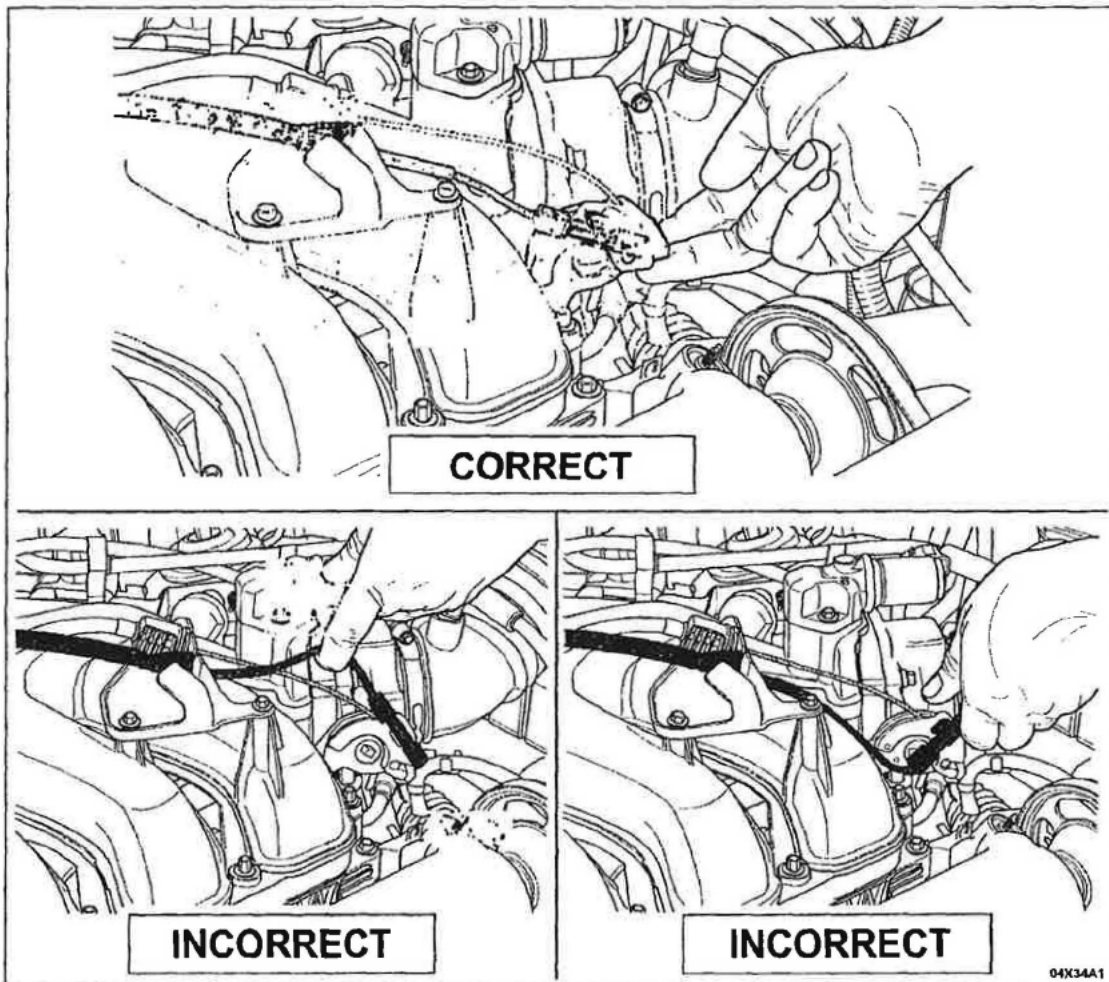
FIGURE 1

CAUTION: Damage to the speed control cable may result if the throttle body cam is rotated by lifting up on the speed control cable or the speed control cable connector end. When disconnecting the accelerator cable from the throttle body, rotate the throttle body cam only by lifting up on the cam itself. See Figure 1.

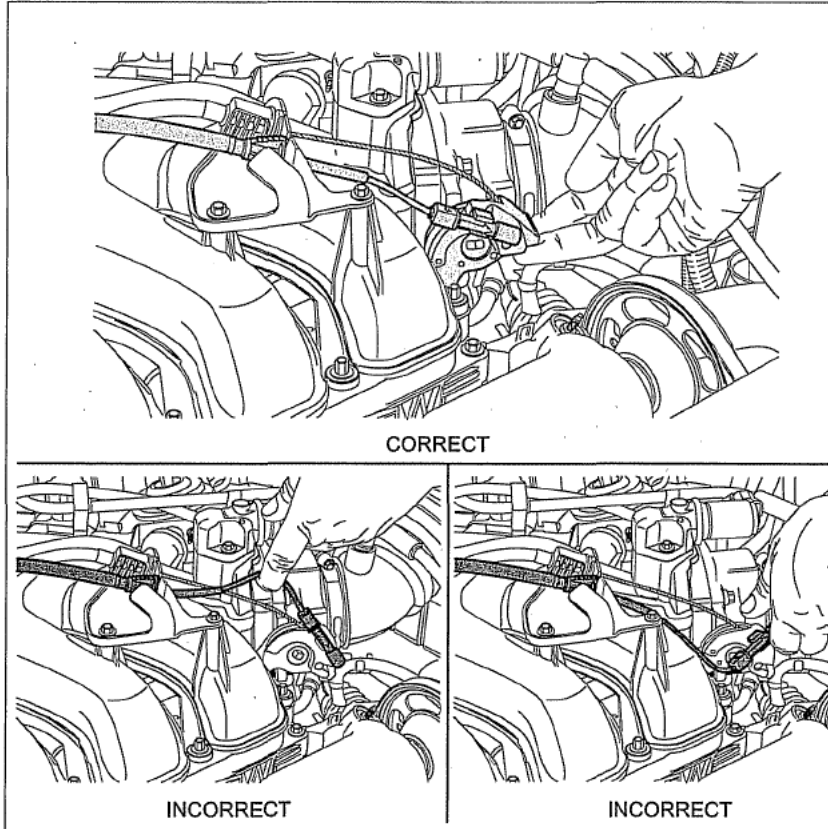
CAUTION: Damage to the speed control cable may result if the throttle body cam is rotated by lifting up on the speed control cable or the speed control cable connector end. When disconnecting the accelerator cable from the throttle body, rotate the throttle body cam only by lifting up on the cam itself. See Figure below.

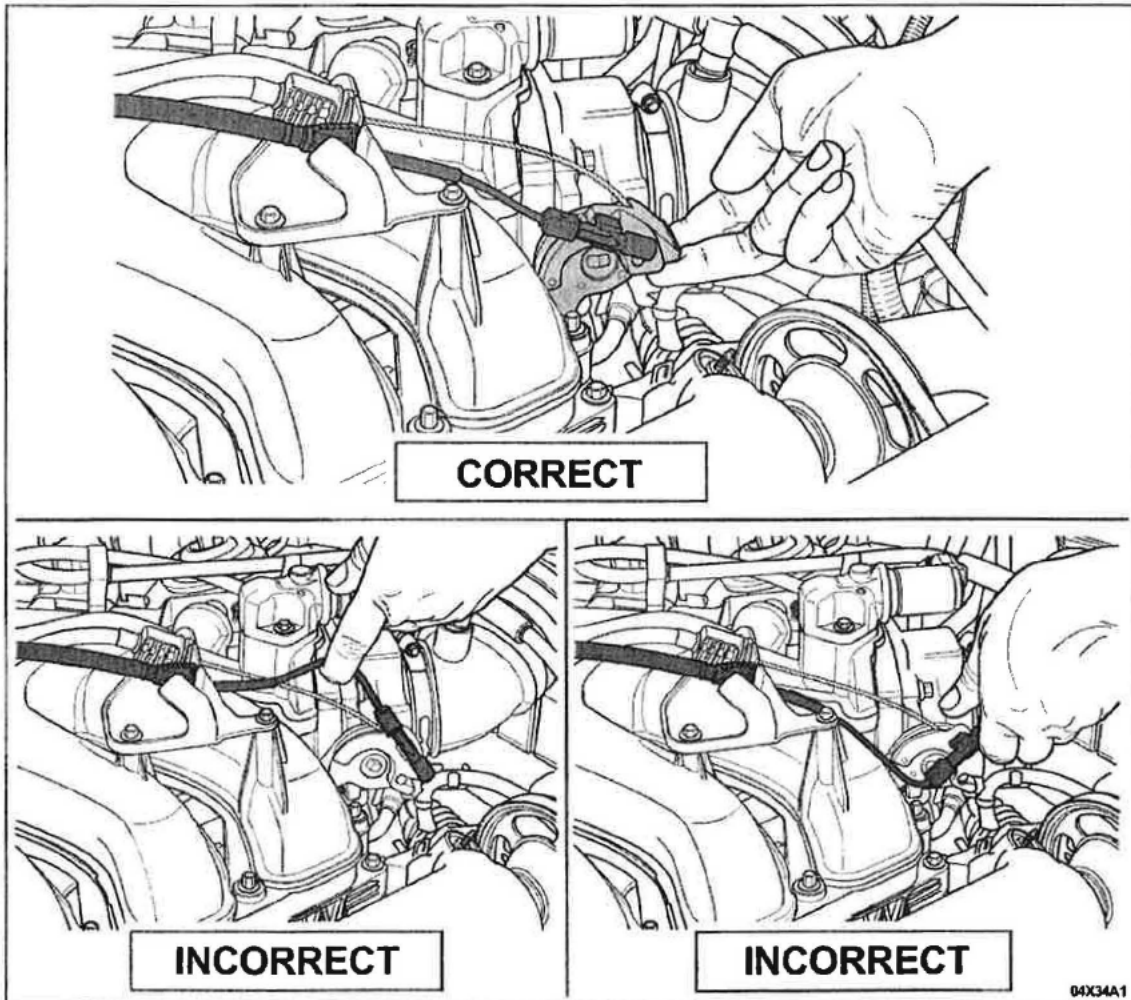
FIGURE 1

CAUTION: Damage to the speed control cable may result if the throttle body cam is rotated by lifting up on the speed control cable or the speed control cable connector end. When disconnecting the accelerator cable from the throttle body, rotate the throttle body cam only by lifting up on the cam itself. See Figure 1.
