National Highway Traffic Safety Administration (NHTSA)  
Office of Defects Investigation (ODI)  
Room W48-312  
1200 New Jersey Avenue SE  
Washington, D.C. 20590

Reference: NVS-213krh; PE12-032

**Note: This attachment contains Chrysler Group LLC's response to Questions 8 and 9 as well as an amended response to Question 5.**

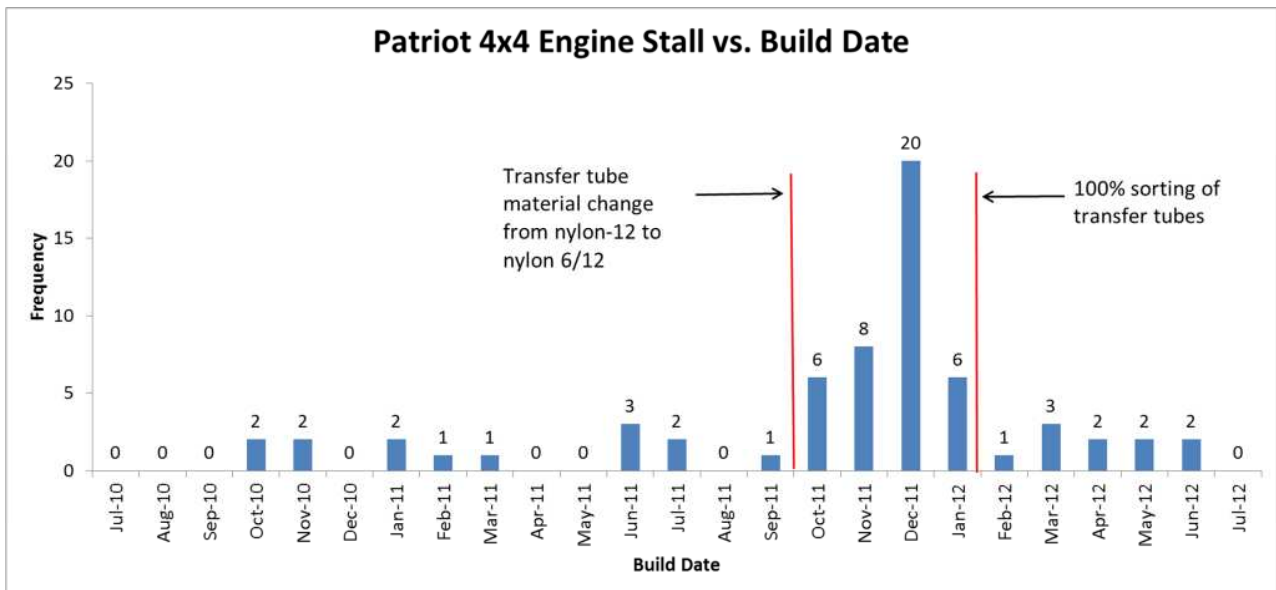
Fig 1

When looking at the customer complaints and field data, along with the tube material change and clean date from sorting at the fuel tank assembly supplier, it is apparent that the material change could correlate to the elevated level of complaints between October 2011, and January 2012. This is illustrated below in Figure 1.

The 2012 MY VOQ data provided by NHTSA during the course of the investigation reveals a very similar pattern of complaint rate both by build data (Fig 1) and report date (Assessment 3).

Some of the assessments may indicate the 5/8 inch tube to be more susceptible to creating a low rate of siphoning in the fuel tank. However, it should be noted it took a combination of several extreme operating conditions (high ambient temperature, high RVP fuel, low fuel pump voltage, maximum engine fuel demand for an extended period, and high altitude) to create the low rate of siphoning during the assessment. The properly formed 5/8 inch tube, prior to and after the material change, showed a far lower rate of engine stalling as can be seen in Figure 1.

The assessments suggest that some of these conditions reported in the field could create a low rate of siphoning in the fuel tank. These conditions in and of themselves may not lead to a lack of siphoning, but when coupled with a malformed transfer tube, it may exacerbate the siphoning process and lead to an engine stall condition. This is evidenced by the elevated customer complaint data during the same period of time when it is believed malformed tubes were installed in vehicles. See Figure 1 above.
