Subject: PE12-033:NVS-213SMcH

The Ford Motor Company (Ford) response to the agency's November 19, 2012 letter concerning reports of alleged speed control cable failures resulting in a stuck throttle condition in 2000 through 2003 model year Ford Taurus and Mercury Sable vehicles equipped with a 4-valve Duratec engine is attached.

FORD MOTOR COMPANY (FORD) RESPONSE TO PE12-033

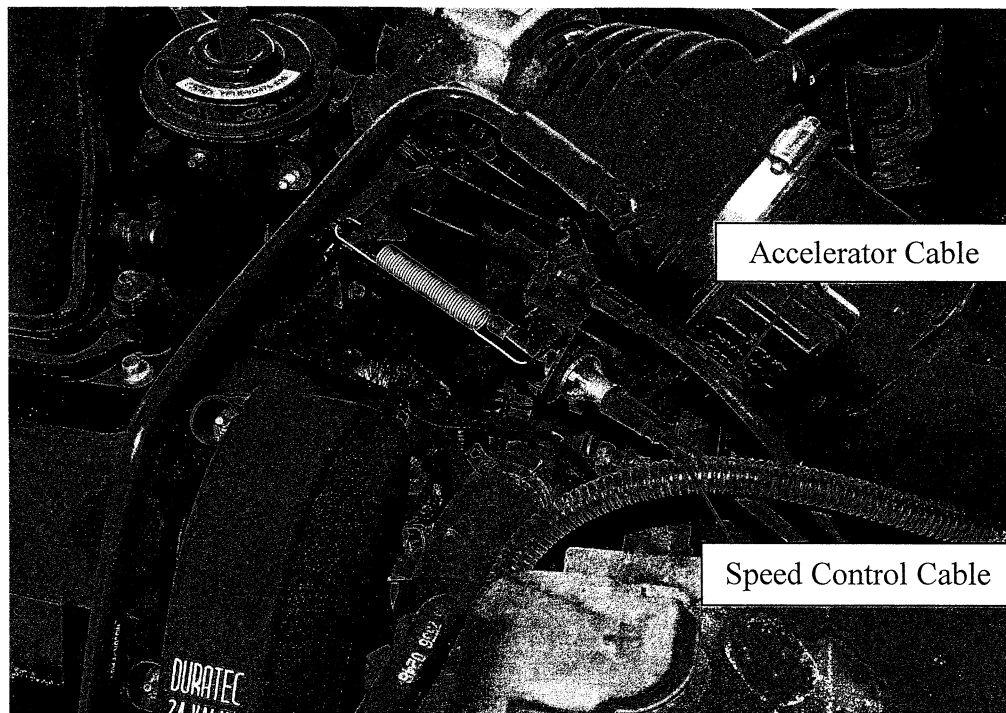
Figure 1 - Bracket and Cable Orientation of a 2003 Model Year 4-Valve Duratec Engine

f-i) The speed control cable collar on the subject vehicles is designed with a locating key that orients the collar, and subsequently the retention tab window, to the bracket. While this key does allow for a minimal amount of rotation (approximately 5 mm), it ensures that the cable collar is consistently oriented relative to the mounting bracket and results in the retention tab windows being positioned somewhat horizontally on the subject vehicles. A similar locating key is present on the 2000 through 2003 model year Ford Taurus and Mercury Sable vehicles equipped with a 2-valve Vulcan engine that also locates the cable relative to the mounting bracket. This unique mounting bracket design locates the retention tab window on the speed control cable vertically.

In addition to having a unique mounting bracket design, 2000 through 2003 model year Ford Taurus and Mercury Sable vehicles equipped with a 2-valve Vulcan engine also have a different throttle body design from the subject vehicles. This combination of both a unique throttle body design and cable mounting bracket design result in a slightly different cable routing which angles the cable down and under the air inlet tube. The different resulting orientations can be seen in Figures 1 and 2 below:

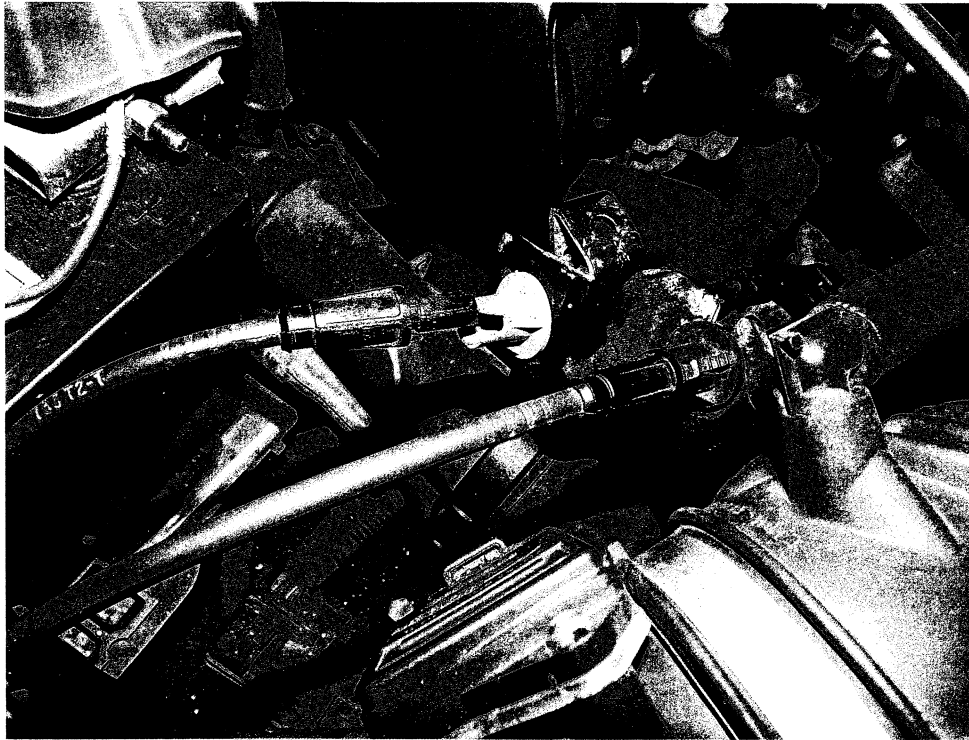
Figure 4 – Potential Maximum Throttle Opening

For vehicle evaluation purposes, Ford installed a speed control cable with a broken collar on a 2002 Taurus and manually positioned the cable ferrule on the edge of the broken collar as shown in Figure 4, below. A throttle opening of approximately 29% was recorded. This process was repeated with a different speed control cable, also with a broken collar, and a similar result was achieved.

Ford then performed vehicle drive evaluations to better understand the effect that a 29% throttle opening had on brake vacuum depletion and on braking ability. During these evaluations, which were conducted at vehicle speeds of up to 70 mph, the vehicle was easily controllable and was braked to a complete stop with a single brake apply. The vehicle stopping distance was normal and required only a slight increase in braking effort. Similarly, after multiple brake applications (applied both rapidly and slowly) to diminish vacuum assist, the vehicle was again controllable and safely brought to a complete stop using the vehicle brakes.
