**National Highway
Traffic Safety
Administration**

Subject: FINAL REPORT: EA12-003 "Ford Freestar Third Seat Anchor
Corrosion"

Memorandum Report
DCD-2190 EA12-003
Ford Freestar Third Seat Anchor Corrosion

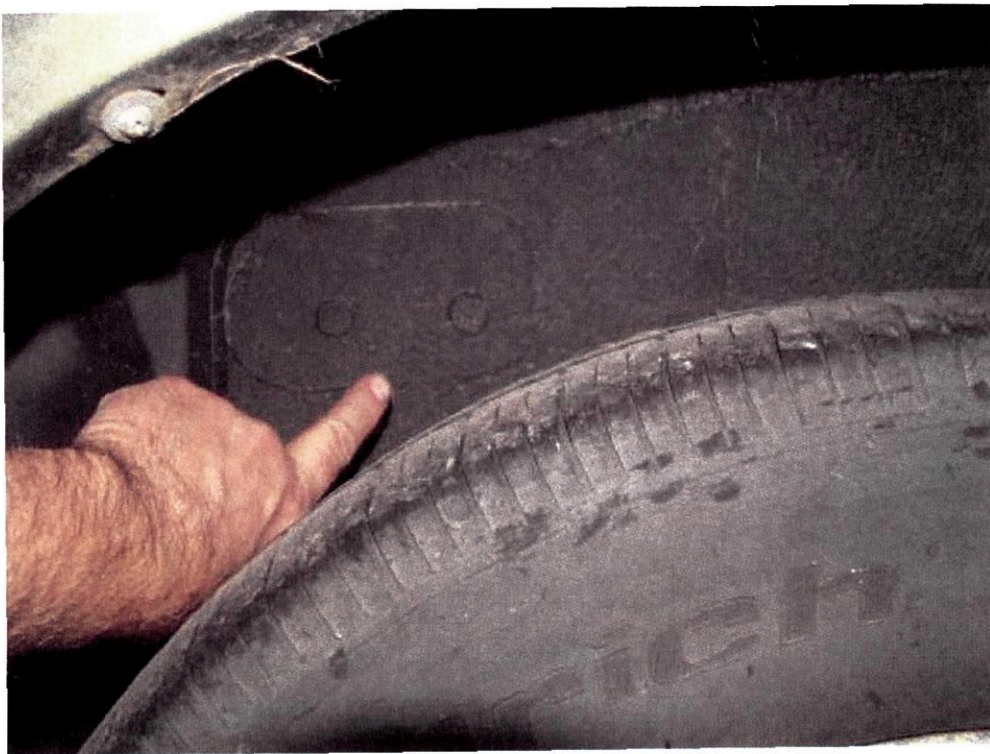
Figure 6 – Mounting Plate in Rear Wheel Well

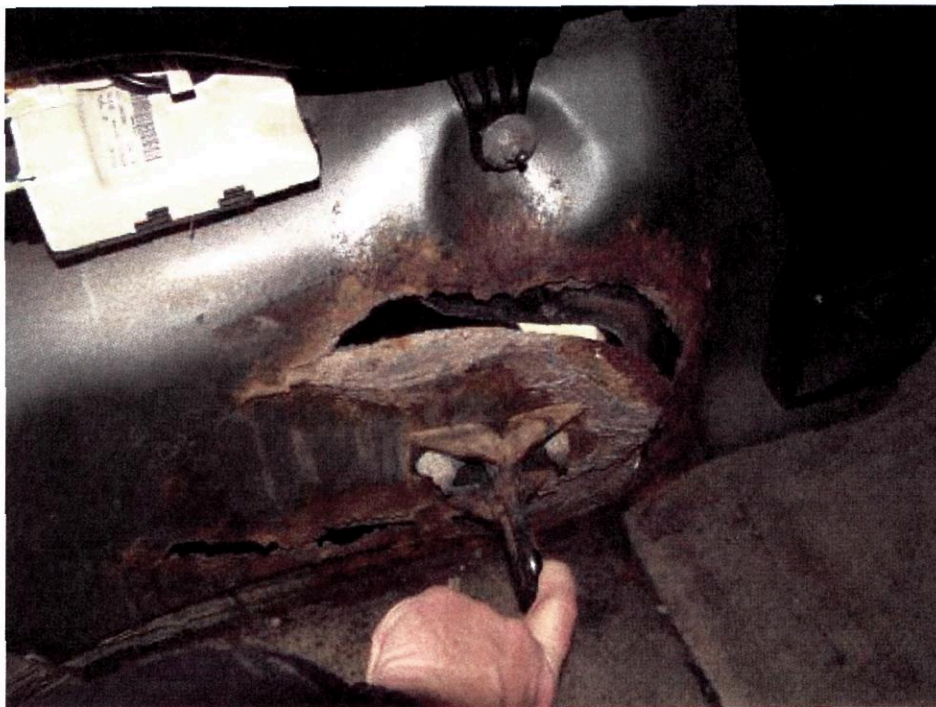
Several vehicles were inspected for which a VOQ had been submitted alleging a complete loss of the left seat anchor. In each case, the claim was verified. Figures 7 -9 show the typical condition of these vehicles.

Figure 7 – Severe Corrosion on VOQ Vehicle

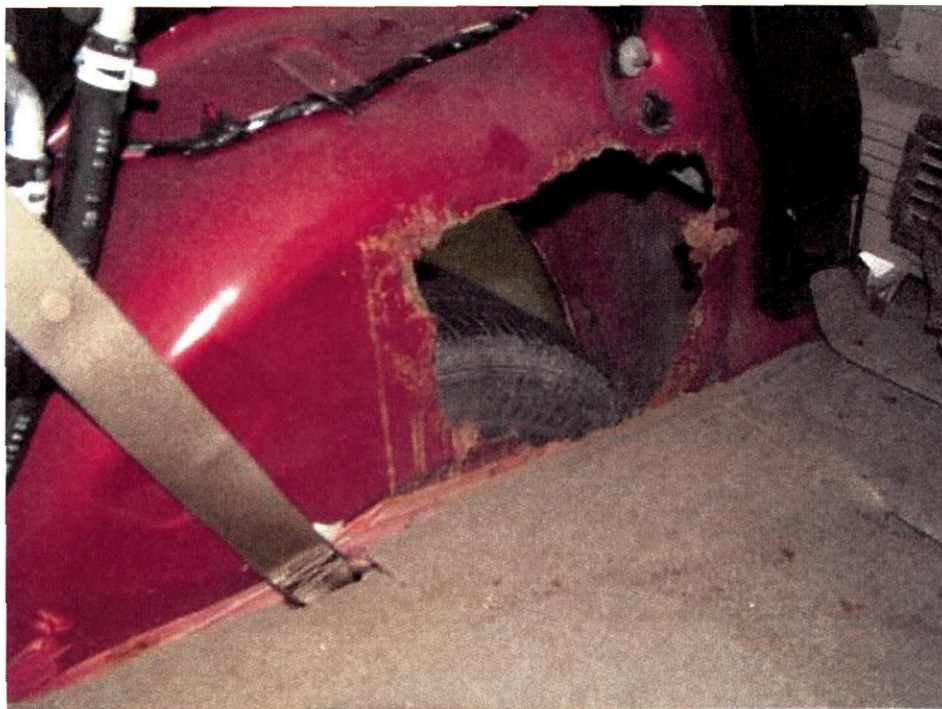
Figure 8 – Fully Corroded and Lost Seat Anchor

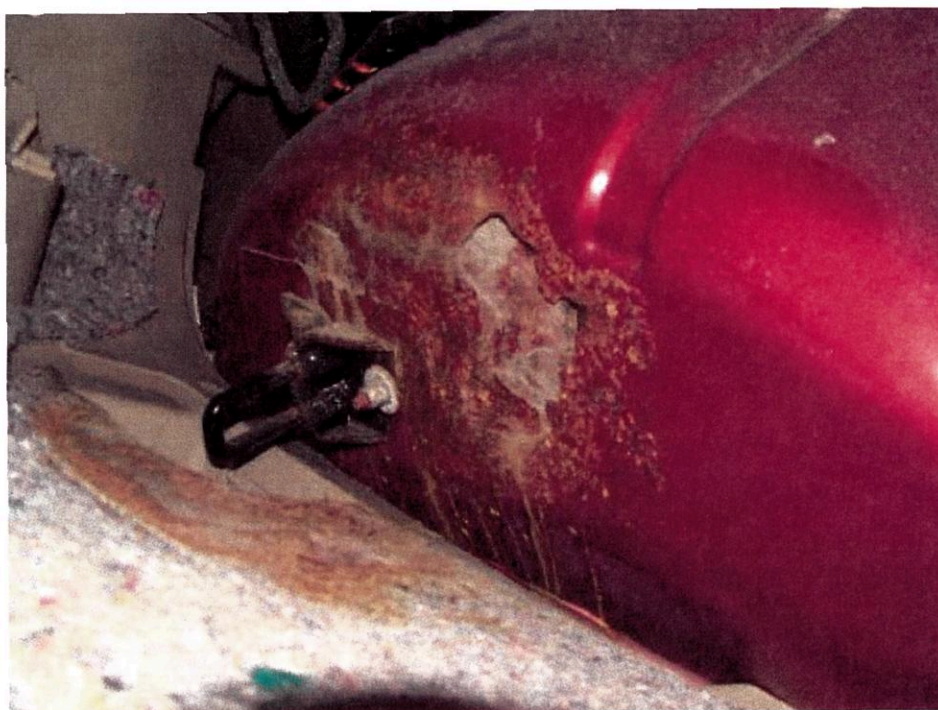
Figure 9 – Partially Corroded Seat Anchor

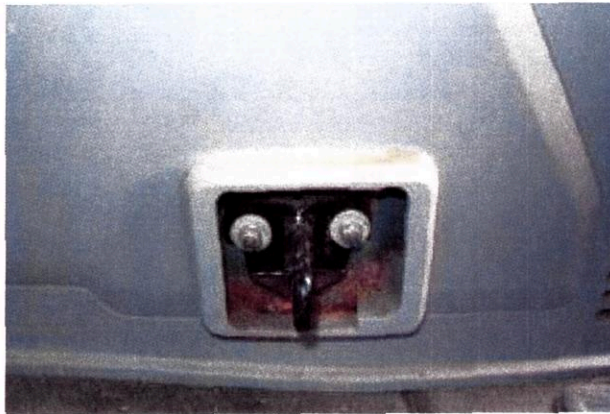
Figure 1
Anchor Loop with Trim Panel

This vehicle was owned by VRTC and was inspected twice. The condition of this vehicle in the initial inspection is shown in Figures 1 and 2. The condition of this vehicle in the second inspection, which occurred approximately nine months later, is shown in Figures 3 and 4. Note the increased deterioration between the two inspections.

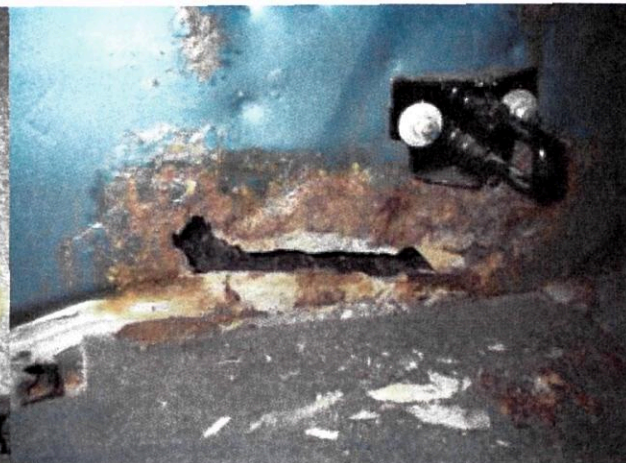
Figure 4
Increased Corrosion of Anchor Loop

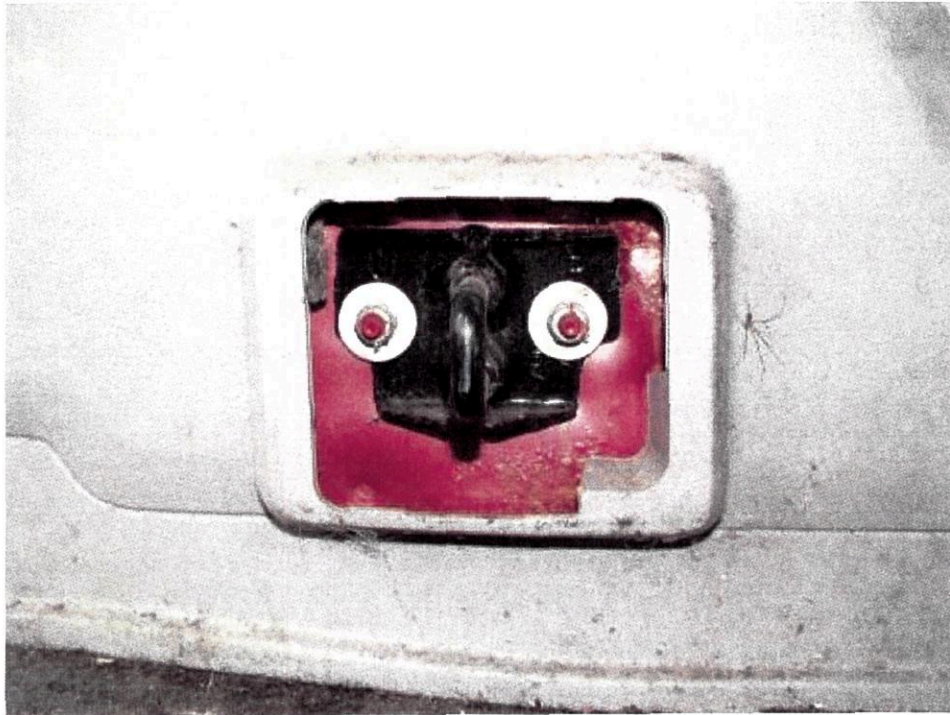
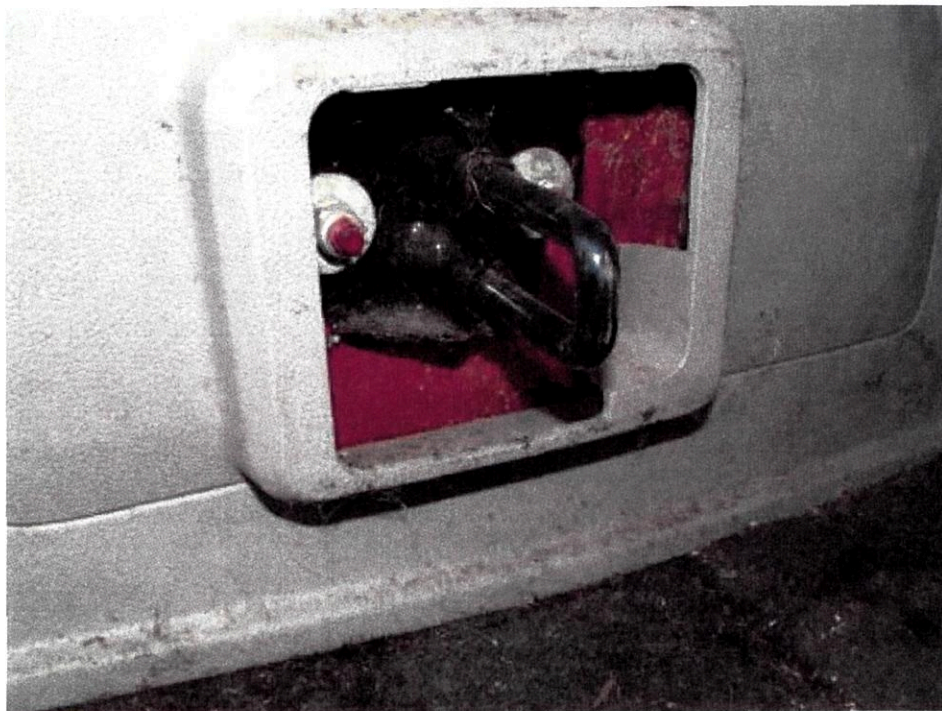
Vehicle #5 VIN: 2FMZA52254BAXXXXX

This vehicle was found in a salvage yard and removing the trim panel was not permitted. Corrosion was readily visible through the hole in the trim panel.

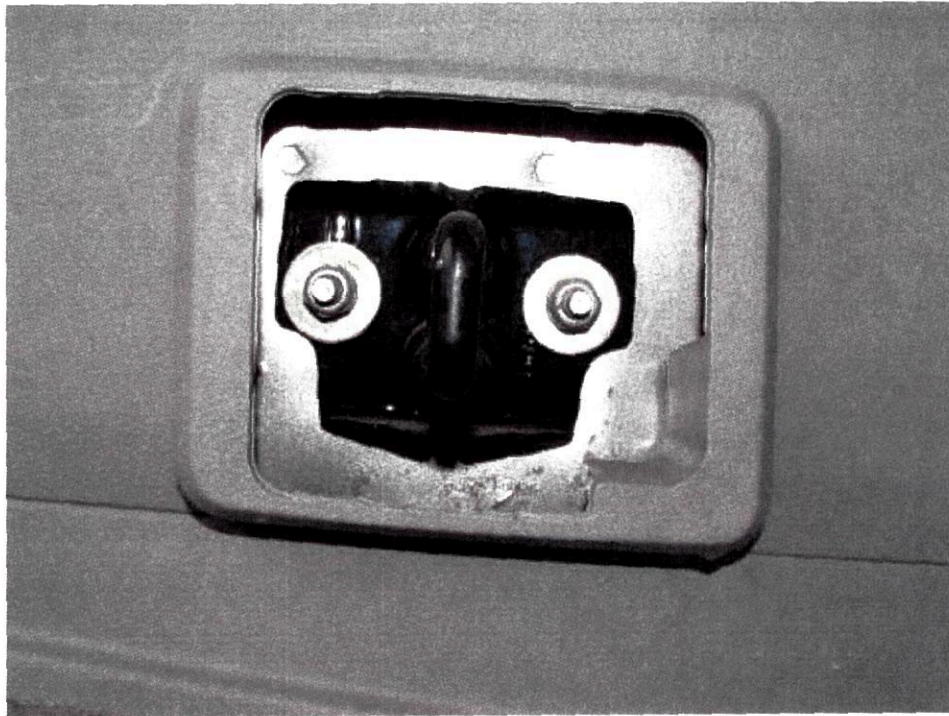
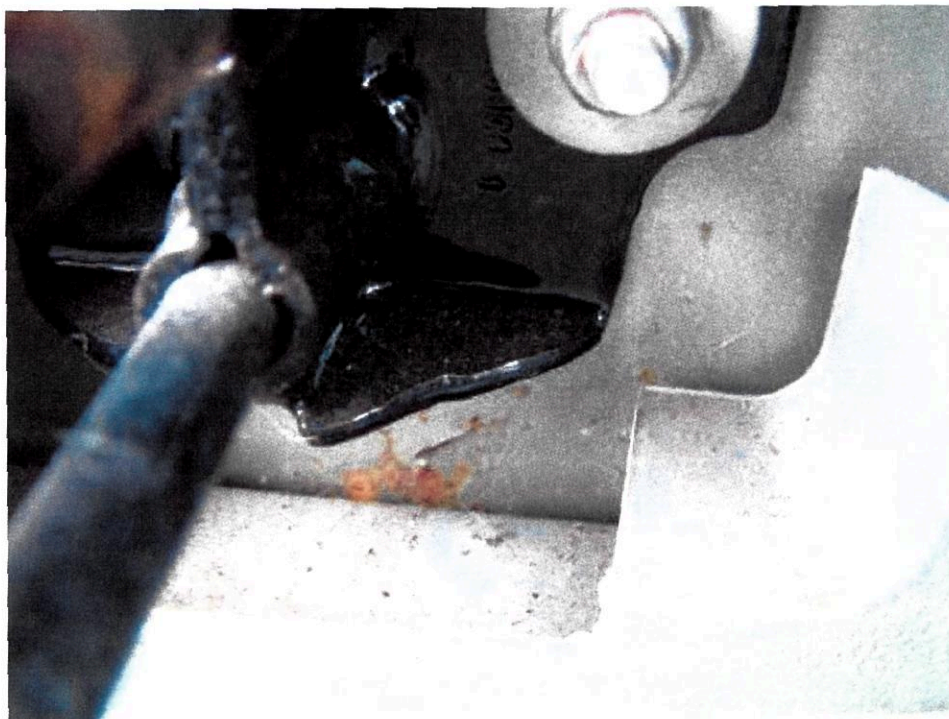
Vehicle #6 VIN: 2MRDA22205BJXXXXX

This vehicle was found in a salvage yard and removing the trim panel was not permitted. The trim panel could be pulled away enough to reveal minor corrosion around the anchor.

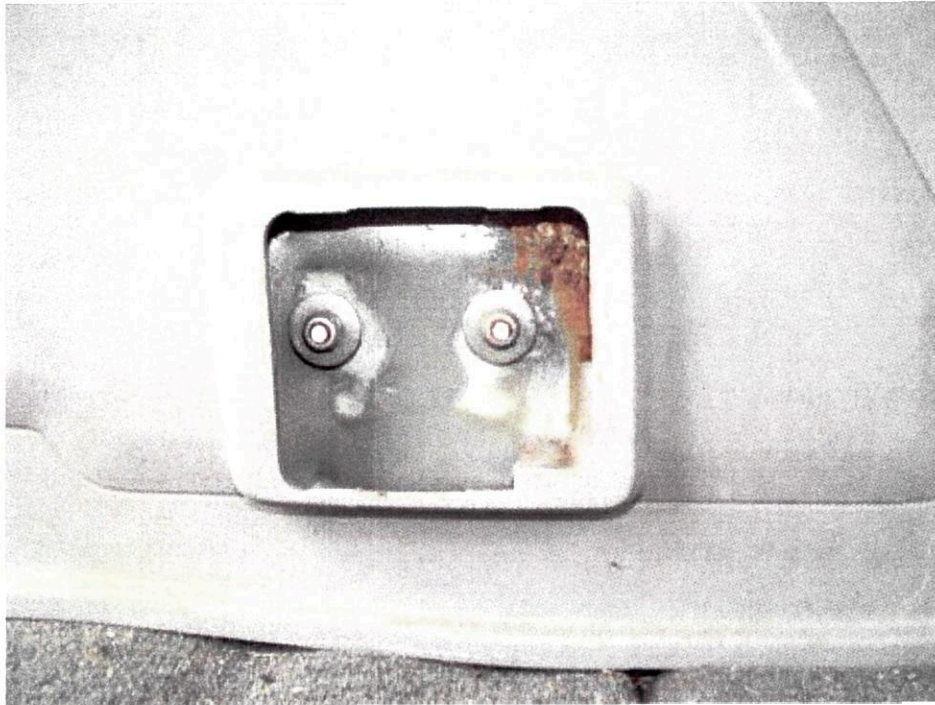
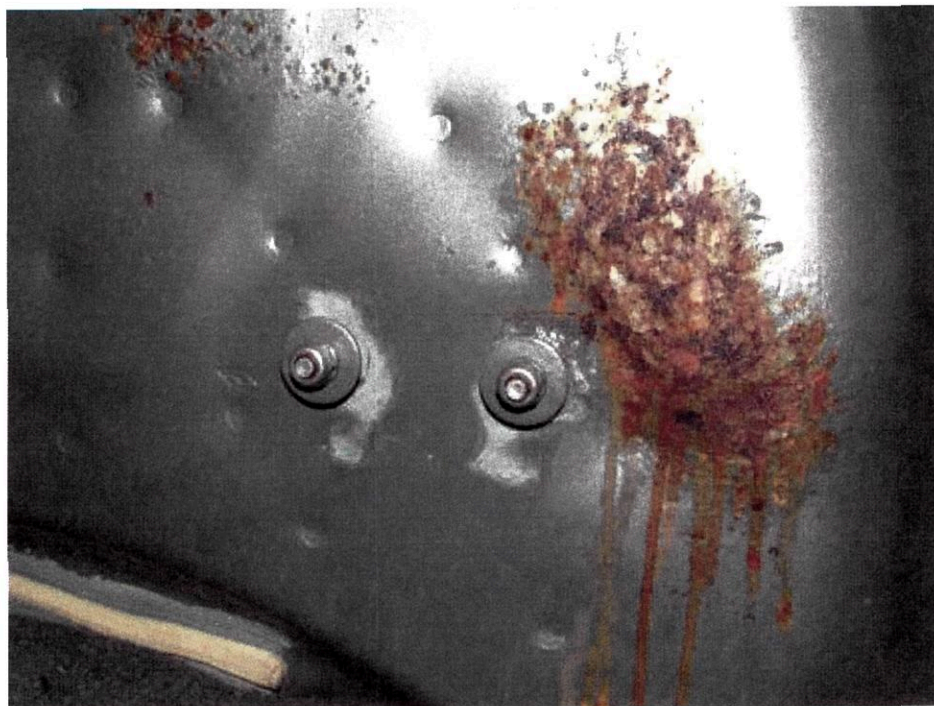
Vehicle #7 VIN: 2FMZA51686BAXXXXX

This vehicle exhibited some visible corrosion with the trim panel in place and more when the trim panel was removed.

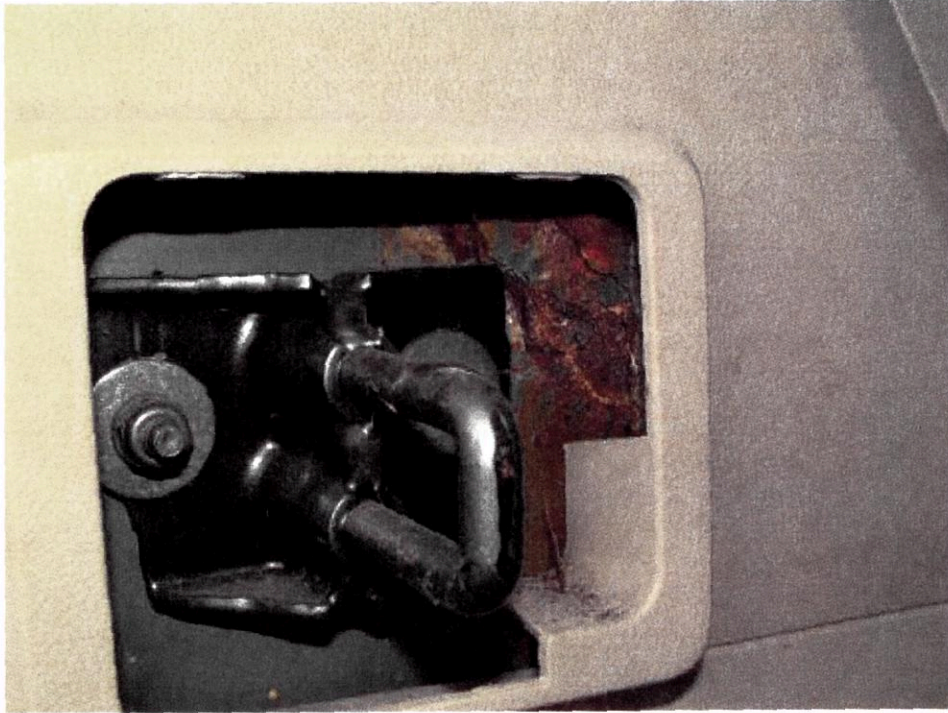
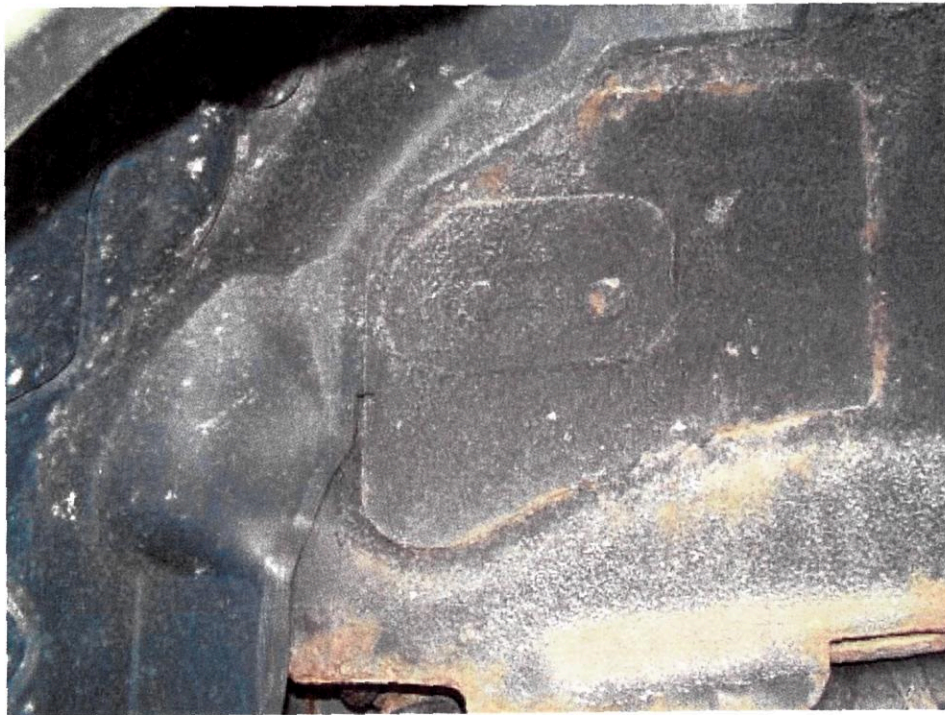
Vehicle #9 VIN: 2FMDA51654BAXXXXX

This vehicle was in a salvage yard and removing the trim panel was not permitted. It exhibited some visible corrosion with the trim panel in place.

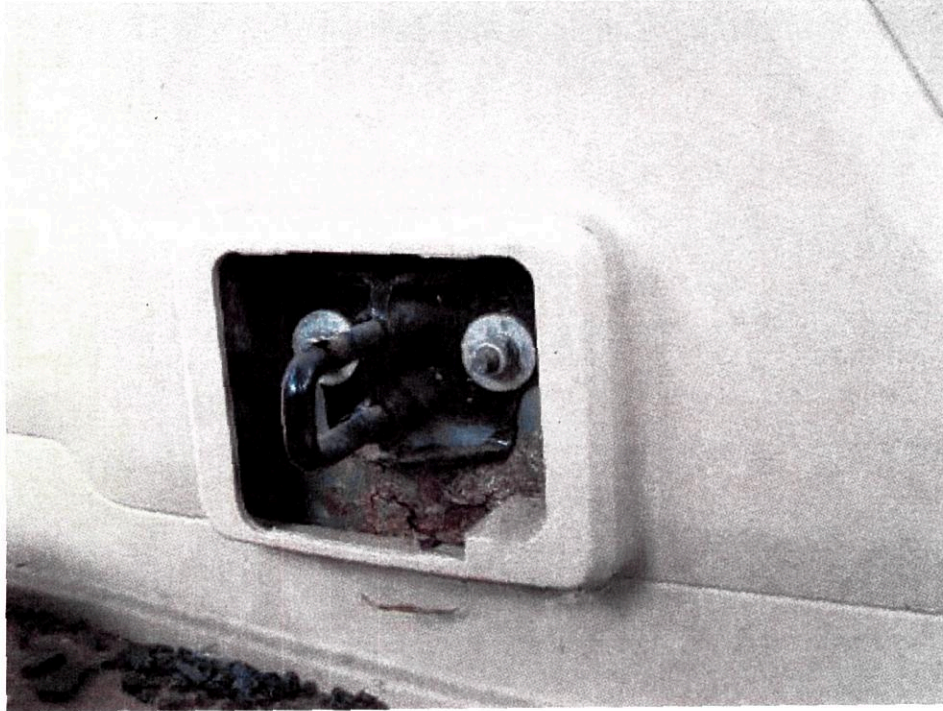
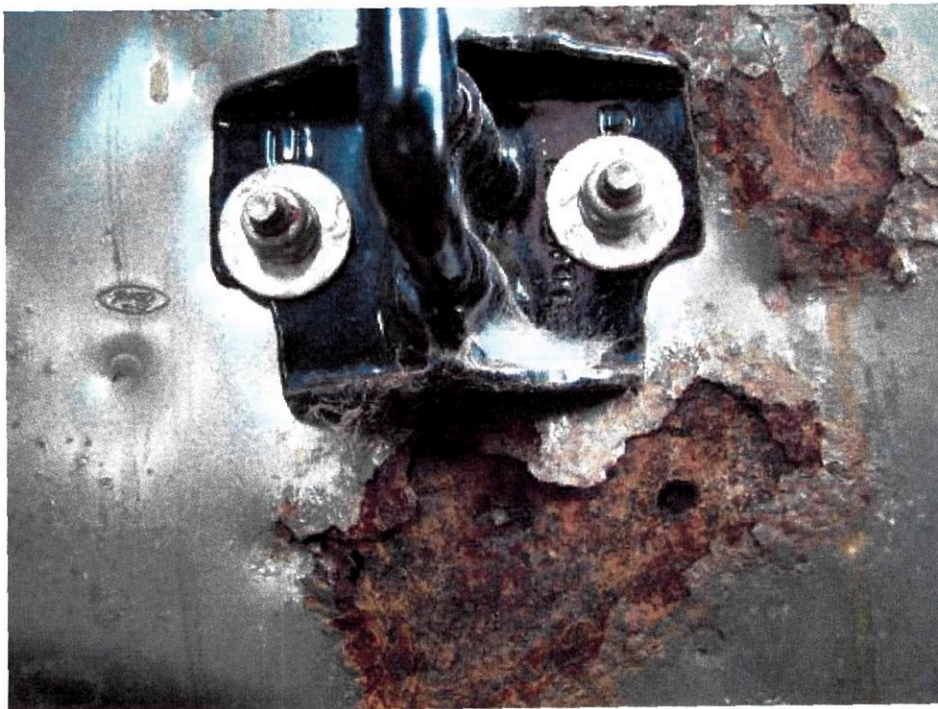
Vehicle 12 VIN: 2FMZA51674BAXXXXX

This vehicle exhibited corrosion with the trim panel in place and more so with the trim panel removed.

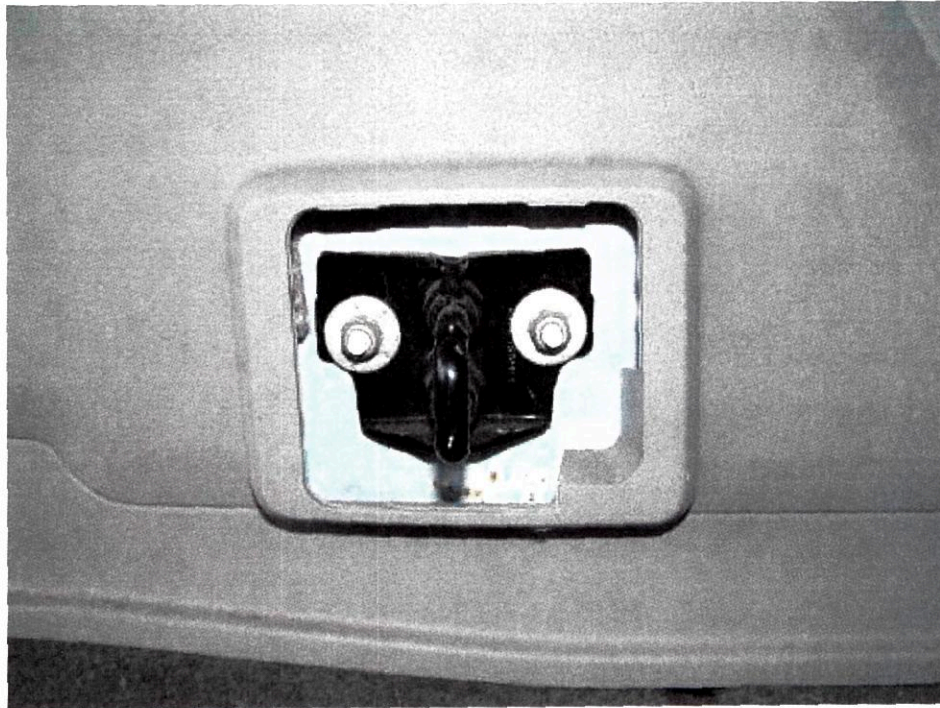
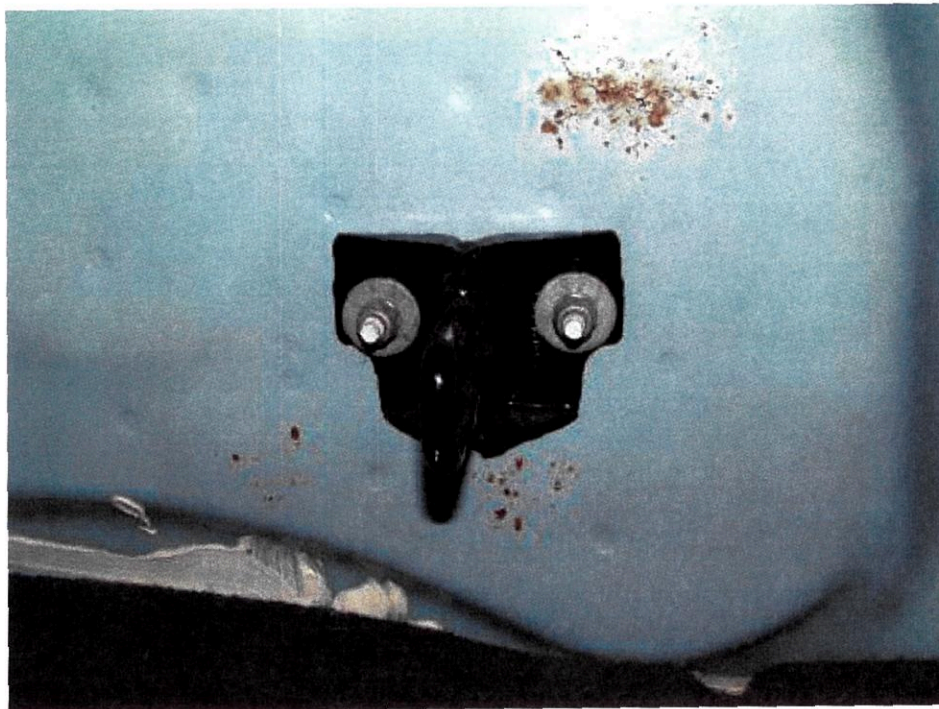
Vehicle #13 VIN: 2FMZA51655BAXXXXX

This vehicle exhibited no corrosion with the trim panel in place and only very minor corrosion with the trim panel removed.

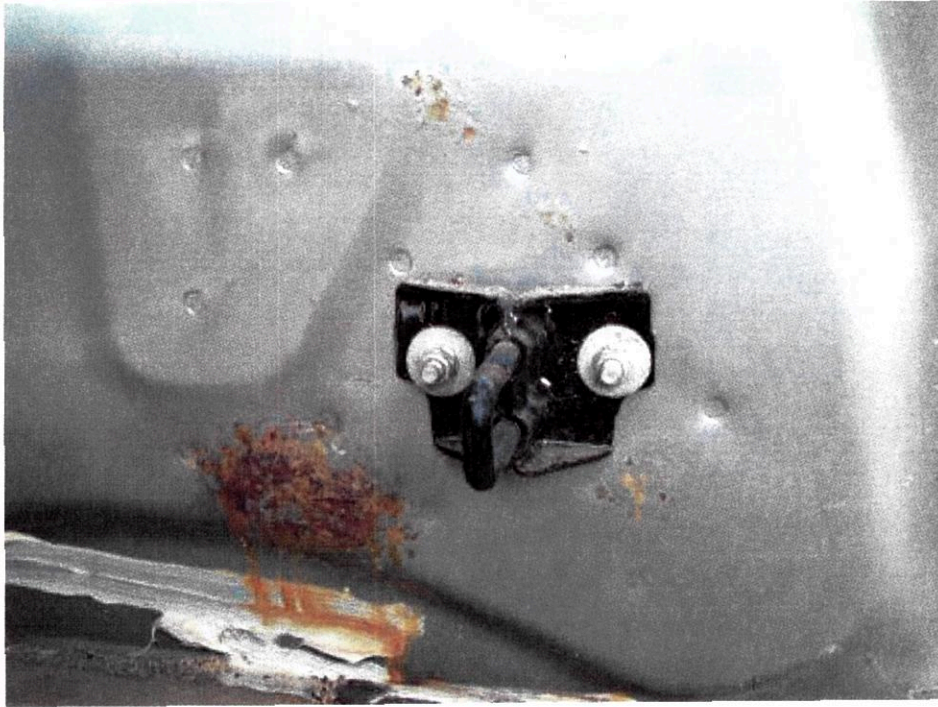
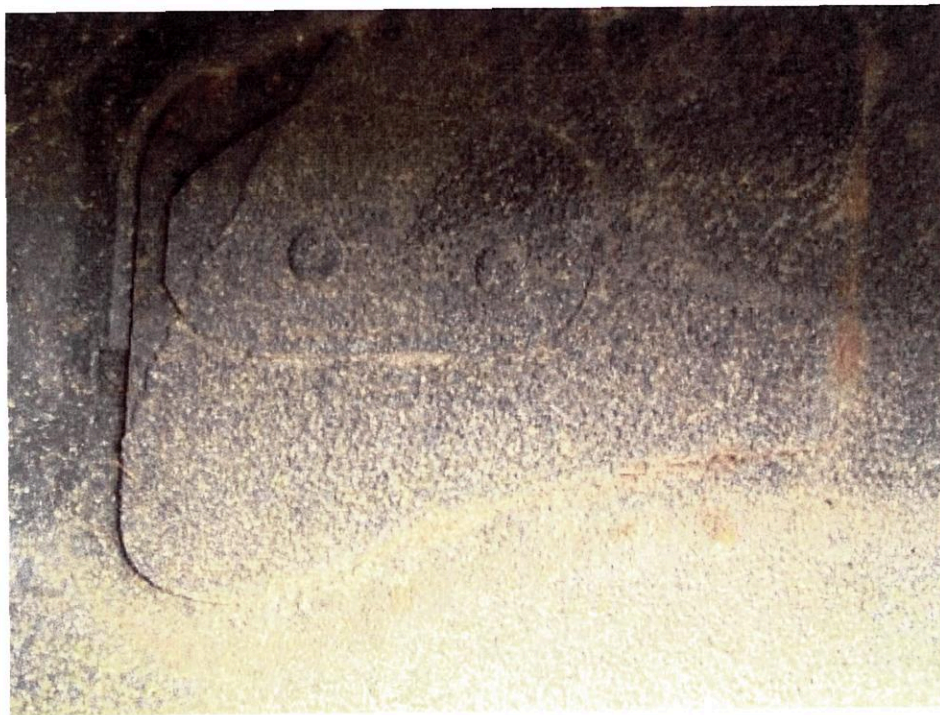
Vehicle #14 VIN: 2FMZA57694BAXXXXX

This vehicle exhibited some corrosion on the interior of the occupant compartment and also exhibited a lack of integrity of the undercoating inside the left rear wheel well.

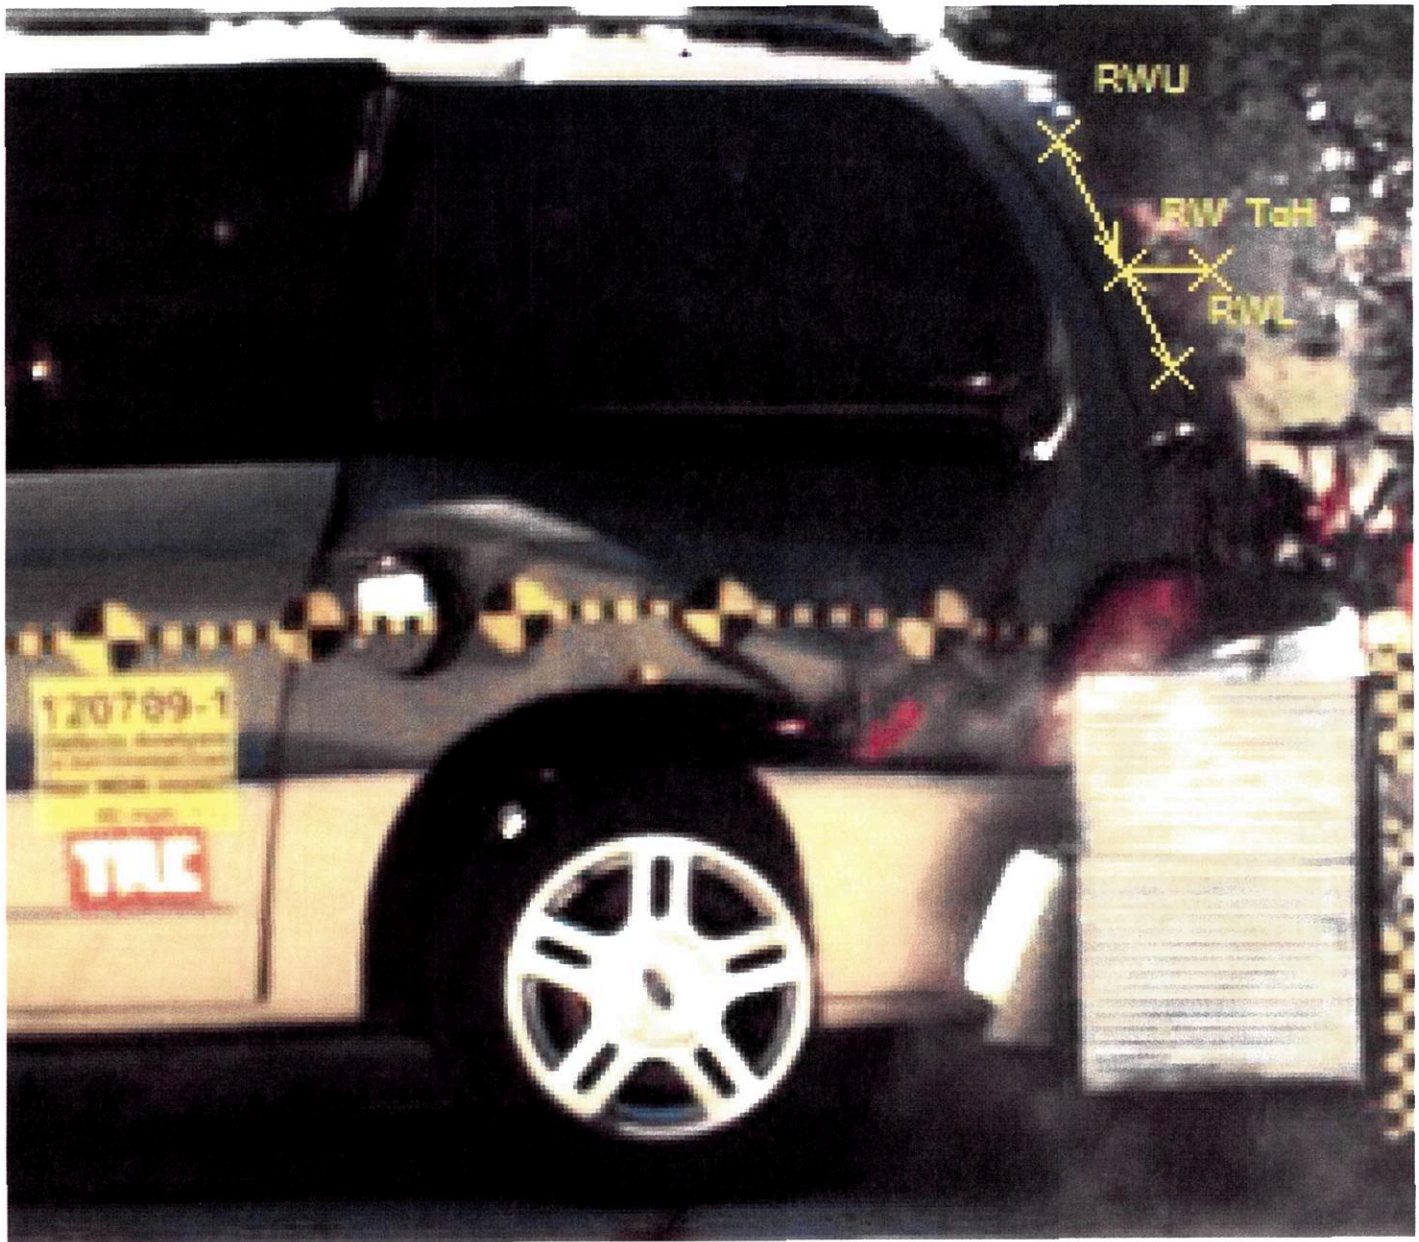
Test 120709-1: **Intact seat with head restraints down**

Time of maximum head excursion = 0.167s / 167ms.

RW to ToH at maximum head excursion = 154.94mm / 6.1in.

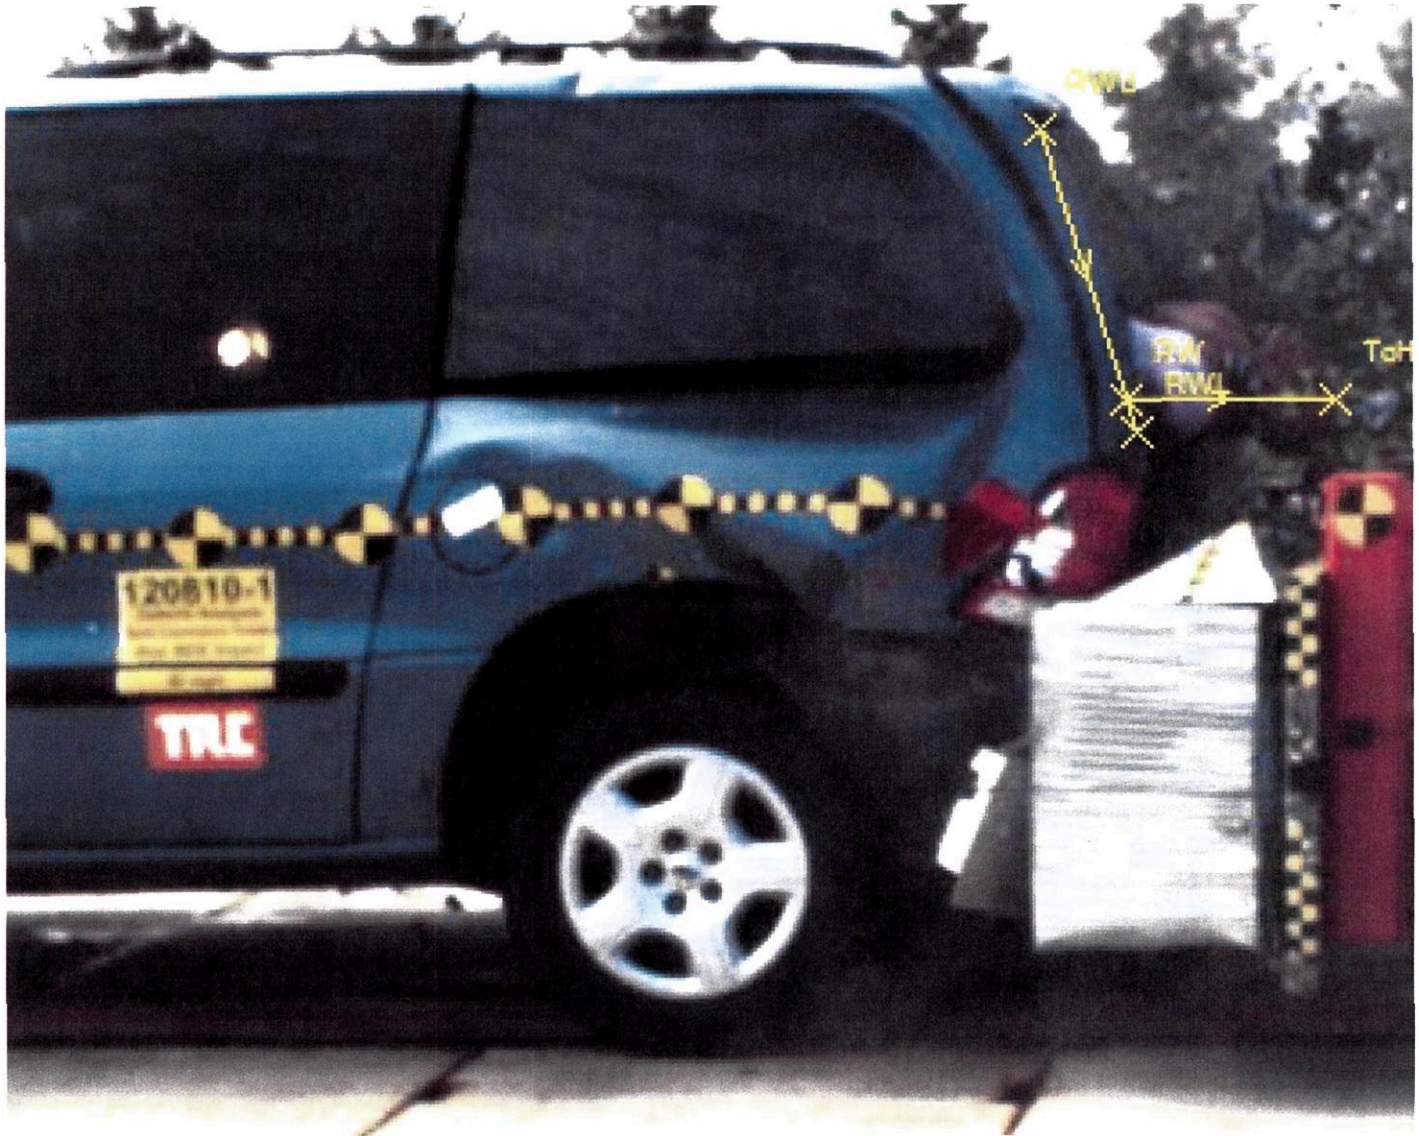
Test 120810-1: **Corroded seat with head restraints down**

Time of maximum head excursion = 0.191s / 191ms.

RW to ToH at maximum head excursion = 401.782mm / 15.8in.

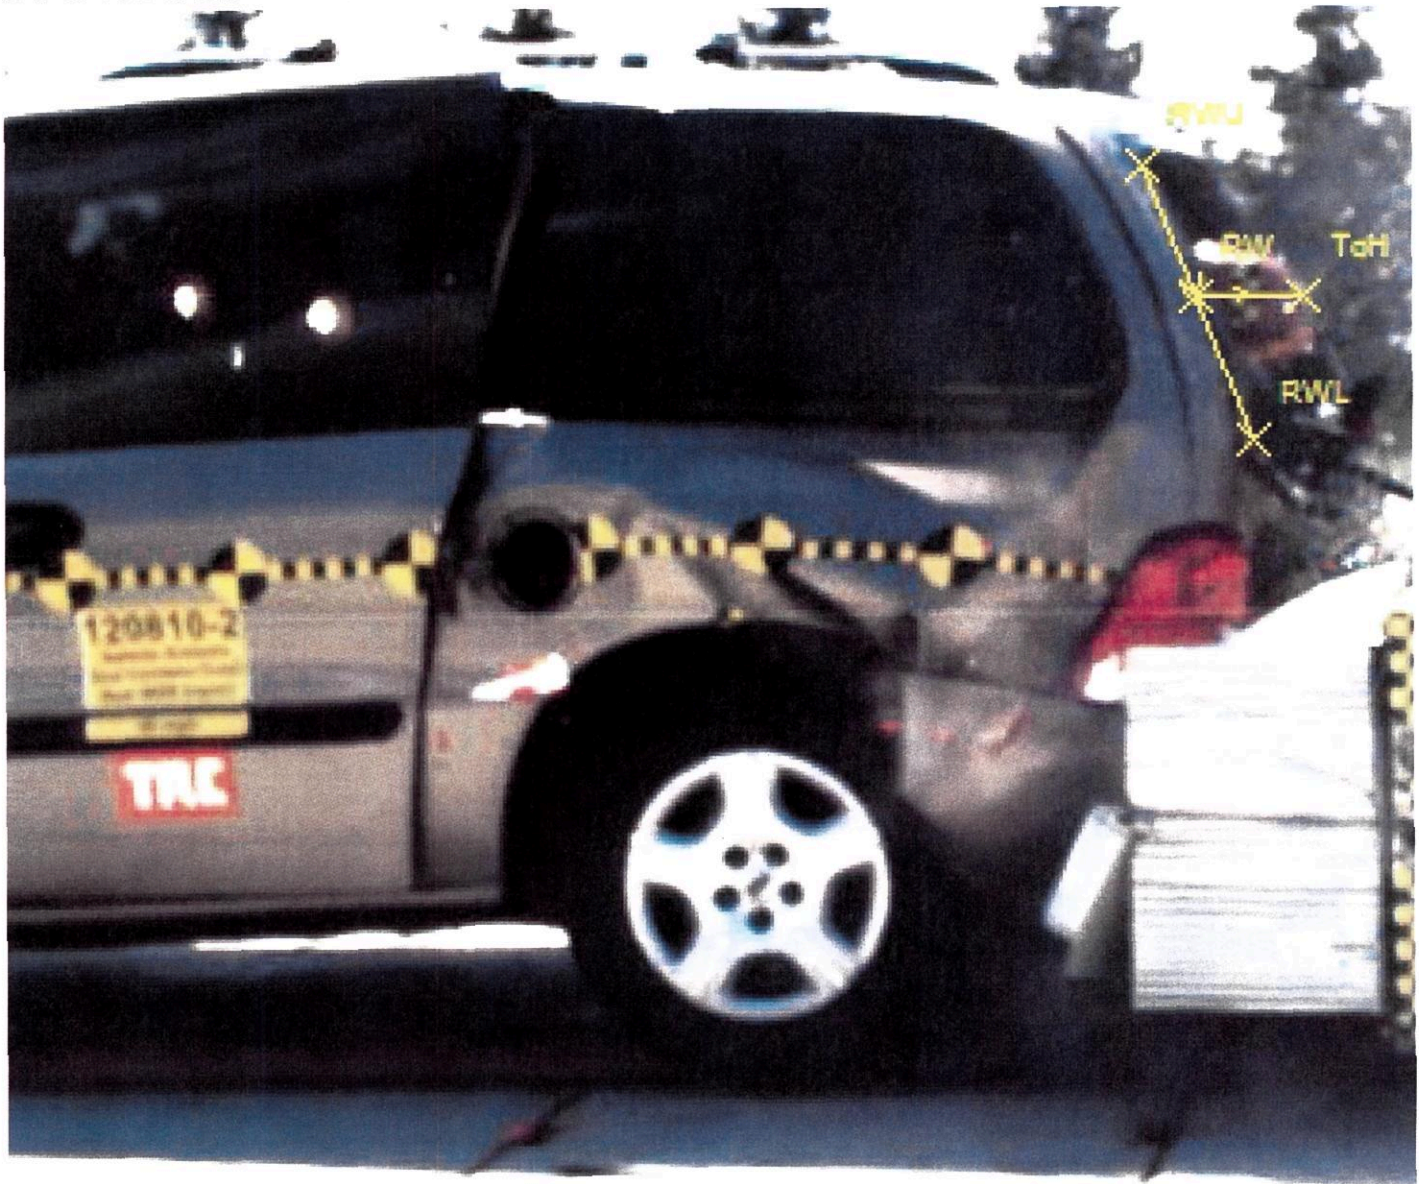
Test 120810-2: **Intact seat with head restraints up**

Time of maximum head excursion = 0.192s / 192ms.

RW to ToH at maximum head excursion = 180.975mm / 7.1in.

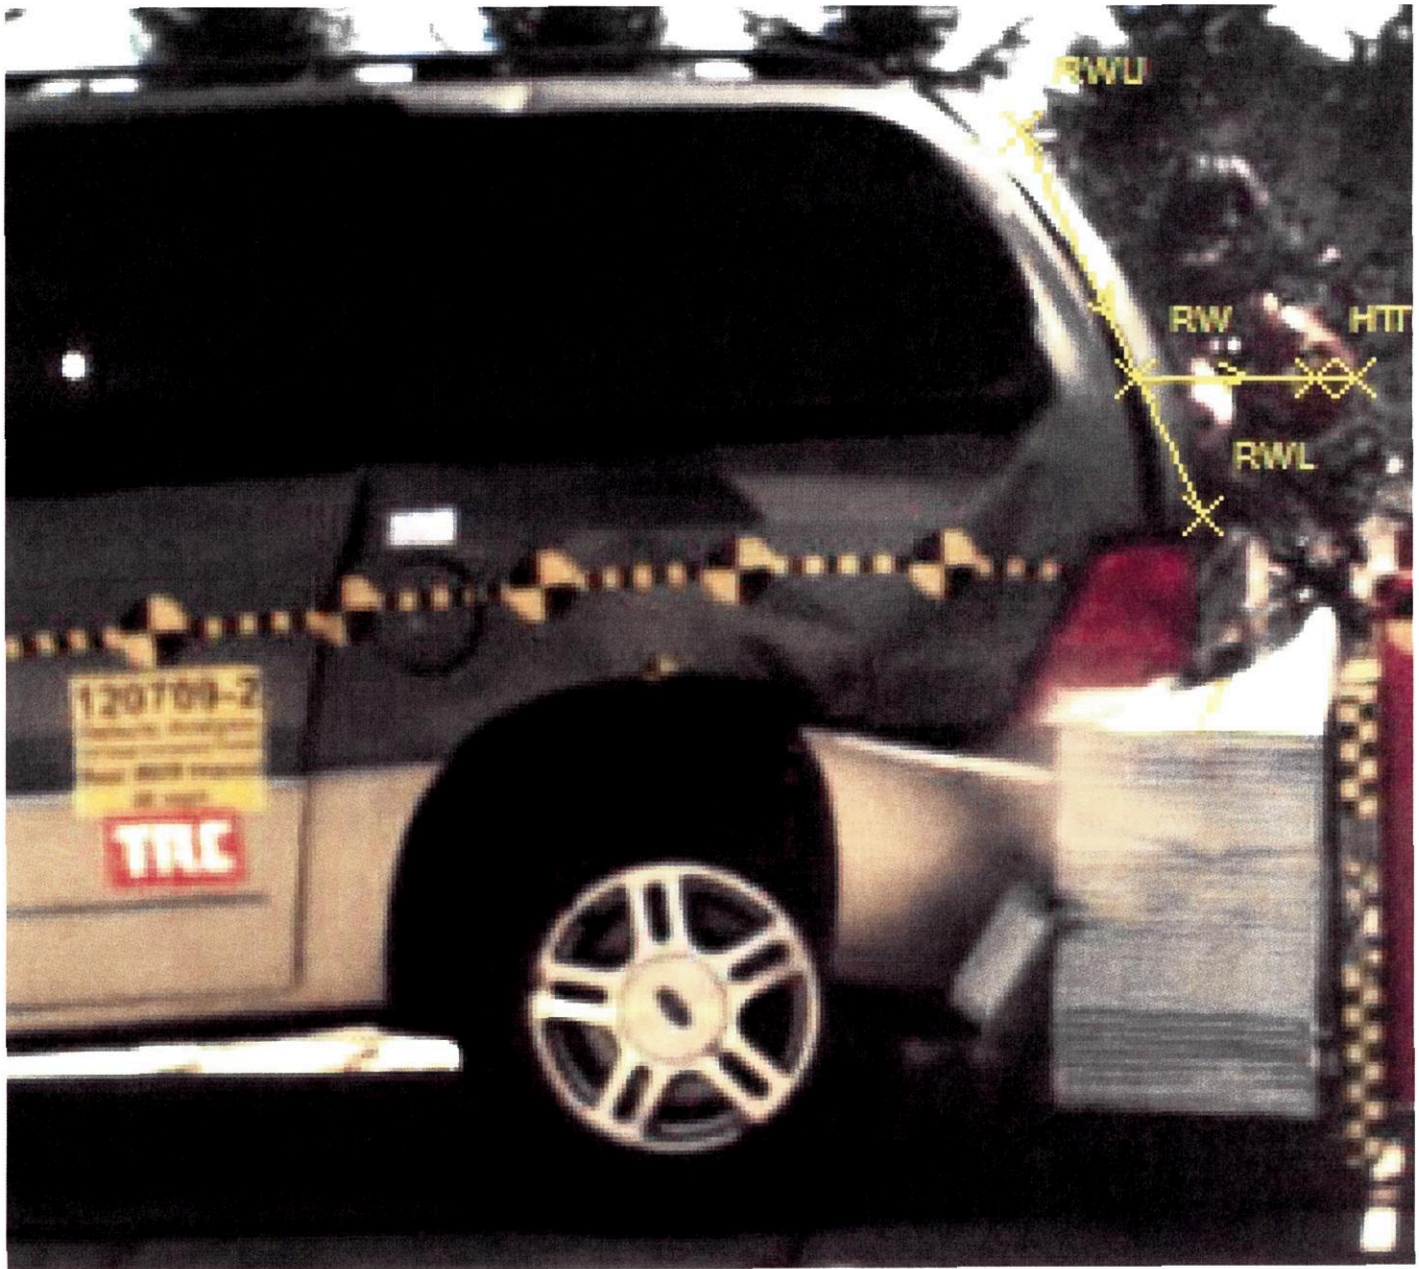
Test 120709-2: **Corroded seat with head restraints up**

Time of maximum head excursion = 0.172s / 172ms.

RW to ToH at maximum head excursion = 339.436mm / 13.4in.
