EA12-005 Reconstruction Testing for KJ Jeep Liberty and ZJ Grand Cherokee

July 2014

U.S Department of Transportation
National Highway Traffic Safety Administration

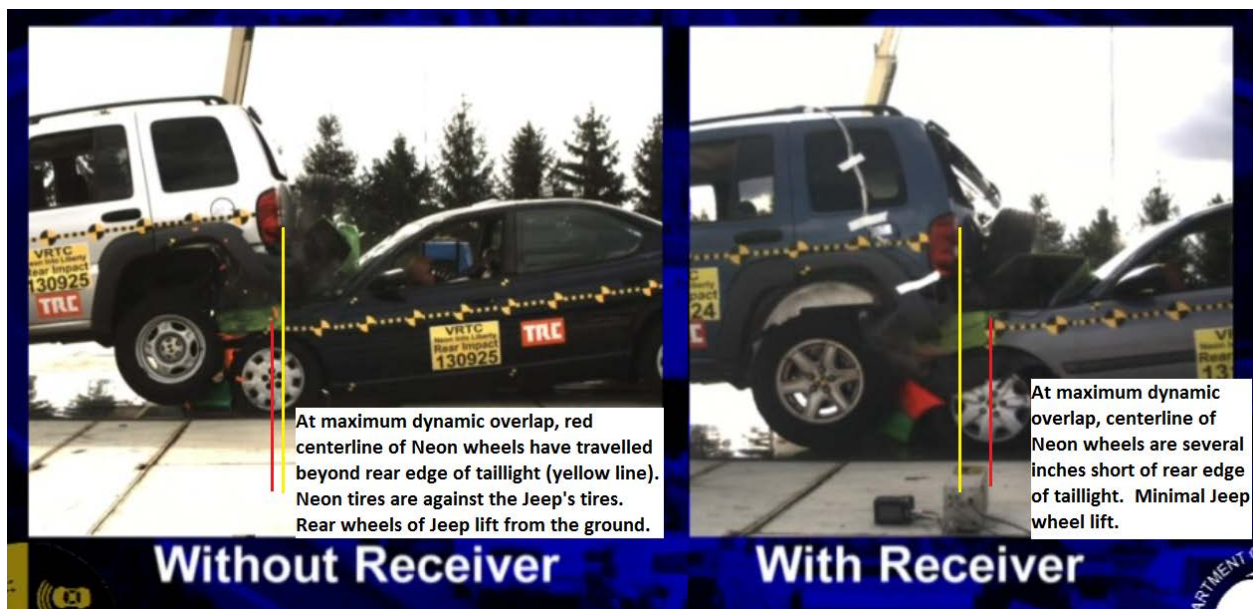
Figure 6 - Difference in dynamic overlap of Neon and Jeep Liberty

This test used a 1997 Plymouth Neon as the bullet vehicle and a 2004 Jeep Liberty without a hitch-receiver as the target vehicle. Post-test observation of the impact damage to the target vehicle was compared to and found to be consistent with the damage of the vehicle in the real-world crash. The fuel tank was directly contacted by the Neon, and most of the 68.5 liters of Stoddard in the tank spilled by the end of 30 minutes. Review of the high-speed video footage revealed the Neon passed under the Jeep and significantly lifted the back end until the front wheels of the Neon contacted the back wheels of the Jeep to move it forward, indicating significant under-ride as shown in Figure 6.

This test used a 1997 Plymouth Neon as the bullet vehicle and a 2004 Jeep Liberty equipped with an OE hitch-receiver as the target vehicle. Model years of both the bullet and target vehicles were the same as the original crash. Post-test observation of the impact damage to the target vehicle showed no rupture of the fuel tank. Review of the high speed video footage revealed the Neon directly impacted the hitch-receiver and reduced upward motion of the Jeep from the baseline test due to reduced under-ride, also shown in Figure 6. Additionally, the front wheels of the Neon did not contact the back wheels of the Liberty. Post-test observations from the baseline and comparative test, as compared to the real-world crash are shown in Figure 6. A comparison between the two front bumper reinforcements of each Neon test vehicle is shown in Figure 7. Pre and post-test photos of the target vehicle fuel tanks are shown in Figure 8, Figure 9, and Figure 10, respectively. Test #1 shows significant scraping of the tank from the under-ride of the bullet vehicle (see Figure 9). Also the orange paint from Region 2 (17 to 24 inches above the ground) can be seen on the vehicle exhaust pipe and rear differential indicating significant interaction between the bullet vehicle, the Jeep fuel tank, and other adjacent components. Figure 10 shows the post-test photo of the comparative test (Test #2) with the hitch-receiver installed. The fuel tank and exhaust pipe do not show signs of under-ride or interaction with the bullet vehicle.

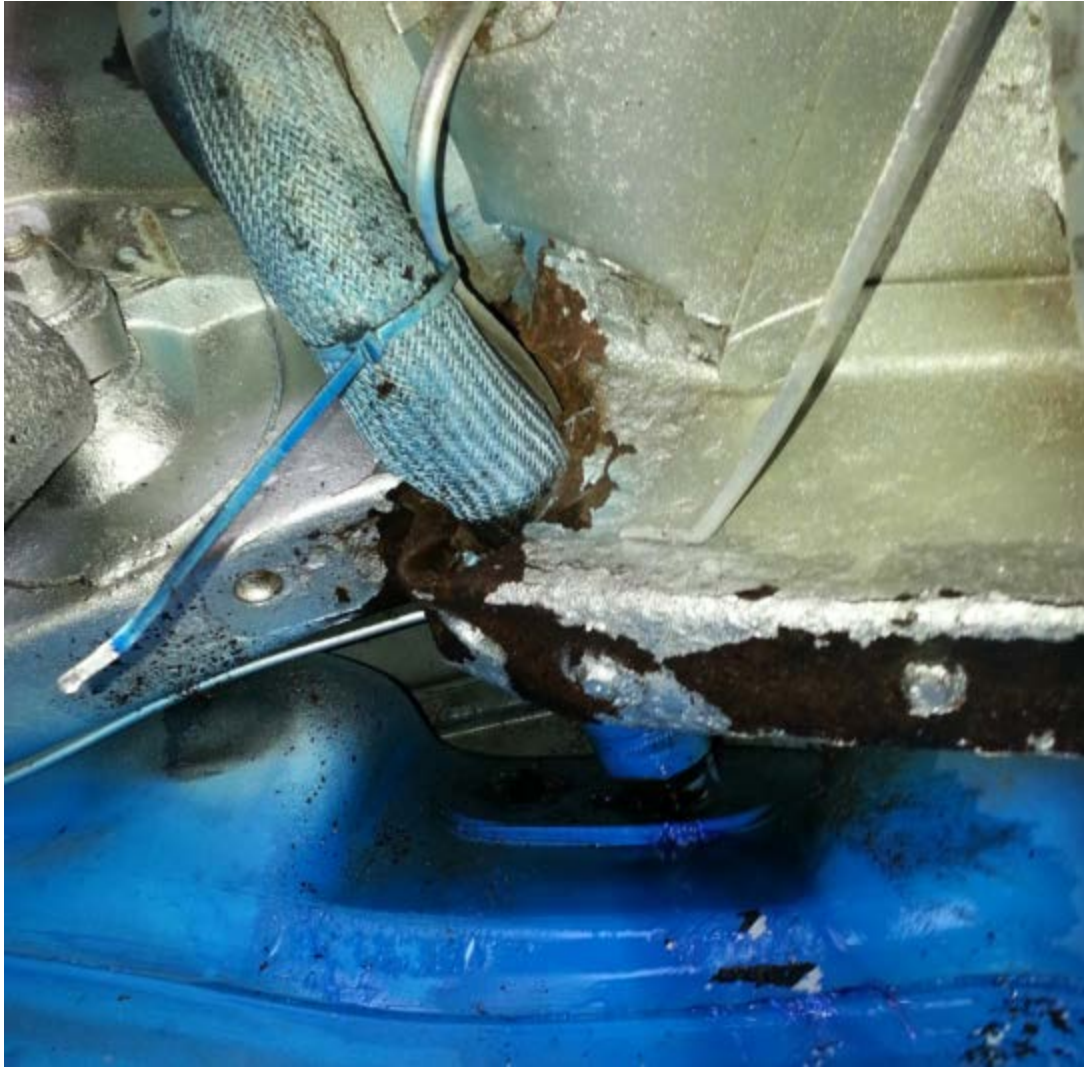
Figure 12 - Test #3 Significant rust causes collapse at relief tunnel in rail where fuel hoses pass through

Both of the Jeep Grand Cherokees tested to this point had unseen corrosion (rust) inside of the frame rails that wasn't revealed until after the tests. While this was not surprising given the number of exposure years in salt-belt states, it was reasoned that this could potentially be a variable in crash performance and may reduce the ability of the frame rail relief tunnel to resist crushing. A Jeep Grand Cherokee with limited salt exposure was procured for baseline Test #5. Although height had not been a significant factor in producing the crushed frame rail, the cut on the bottom side of tank in the real-world crash had still not been produced, so a final attempt was made to further lower the front ride height of the Cadillac, but the progressive springs limited static compression to between two and three inches, making the striking height essentially only marginally lower than in Test #4. At the conclusion of this test, there was no fuel leak. The left frame rail had bent outward, but the filler hose relief tunnel was not crushed and allowed the hoses to slide through the tunnel as it was bent by the force of the crash. Despite significant scraping between the Cadillac and the Jeep tank being produced, the cut in the bottom of the tank was not produced. It became apparent that it would be improbable to be able to control the formation and motion of sharp features from the deforming Cadillac, while also predicting whether the metal reinforcement on the Jeep would break away or just deform.

The reconstruction of the Cadillac Deville into the ZJ Jeep Grand Cherokee revealed a repeatable failure mode with the crushed and rusted frame rail pulling on the fuel filler hoses until they broke the connections from the plastic tank. It was confirmed that a vehicle with little to no rust could withstand the crash. The hitch-receiver bracket and mounting bolts provided a structural reinforcement that prevented the collapse of the moderately rusted frame rail relief tunnel in testing.

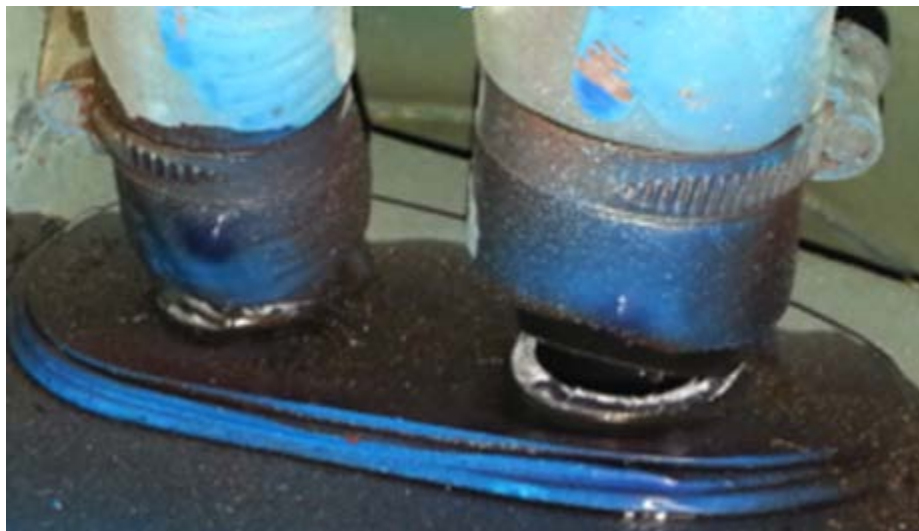
facts to support pre-impact braking. At the conclusion of the first test, it was evident that the Cadillac struck the Jeep with an impact point at least two inches higher than in the real-world crash based on intrusion patterns into the rear gate of the Jeep. At least one known source of the fuel leak in the real-world crash was a several inch long cut along the bottom of the tank. It is possible that other leak sources existed, but no other sources were documented. In the baseline crash, a fuel leak was produced; however it originated at the fuel filler hose connections. There is a relief tunnel (hole) through the left frame rail that routes the fuel filler hose along the path to the filler cap shown in Figure 11. The tunnel in the frame rail was crushed due to the force of the crash, combined with significant rust originating from the hollow, inside of the rail, and this resulted in the hoses being captured in the frame rail, shown in Figure 12. As the frame rail bent, it pulled upward on the fuel tank hose connections and broke them at their bases on the plastic tank, resulting in a significant leak, as shown in Figure 13.

Figure 13 - Test #3 Broken fuel connections on plastic fuel tank

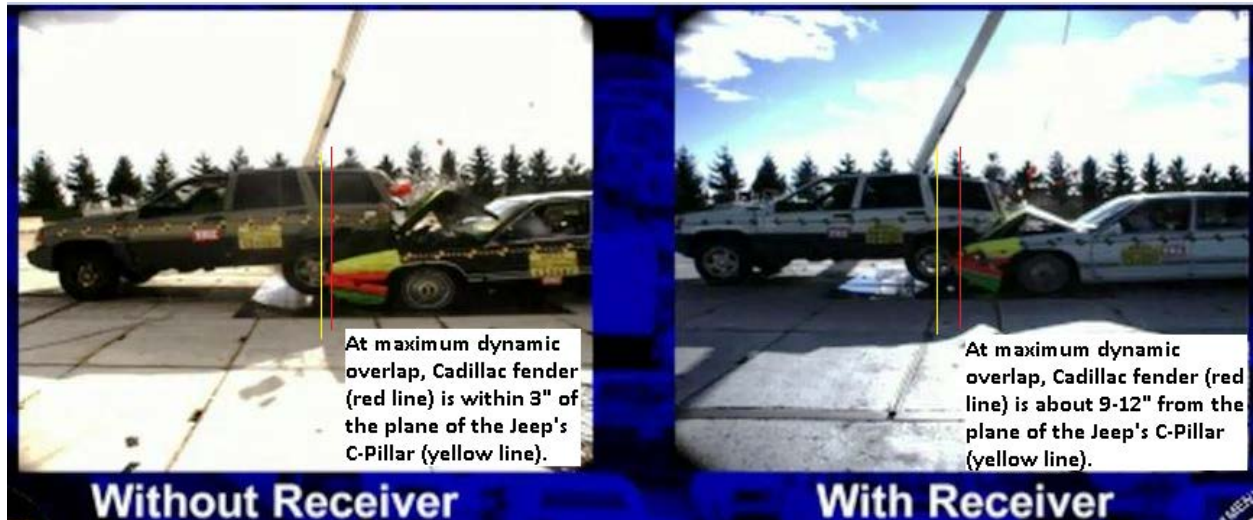
Figure 14- Dynamic overlap between Cadillac and Jeep Grand Cherokee without and with a hitch-receiver

from the high speed video showed the difference in dynamic overlap, where the Cadillac did not encroach as far into the Grand Cherokee when it was equipped with the hitch-receiver (Figure 14).

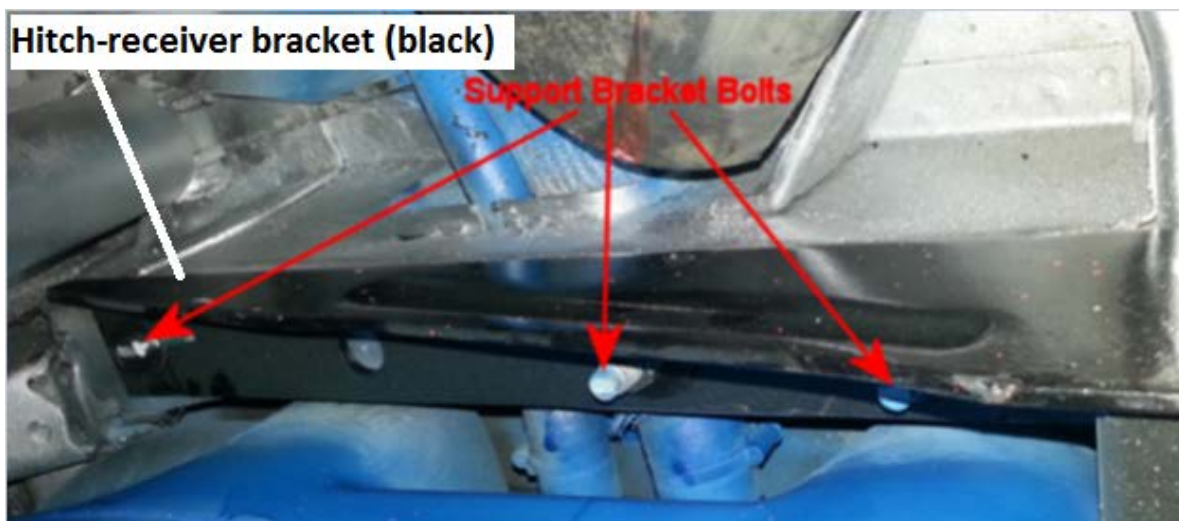
The Cadillac bumper engaged directly with the Jeep's hitch-receiver and prevented the frame rails from bending near the tank. The support brackets that attach the hitch-receiver to the body of the Jeep with three bolts on each side provided significant structural support (Figure 15). This also resulted in greatly reduced scraping between the Jeep's tank and the Cadillac.

Figure 15 - Test #6 - Hitch-receiver bracket reinforces tunnel, hose not captured - Minimal rust vehicle

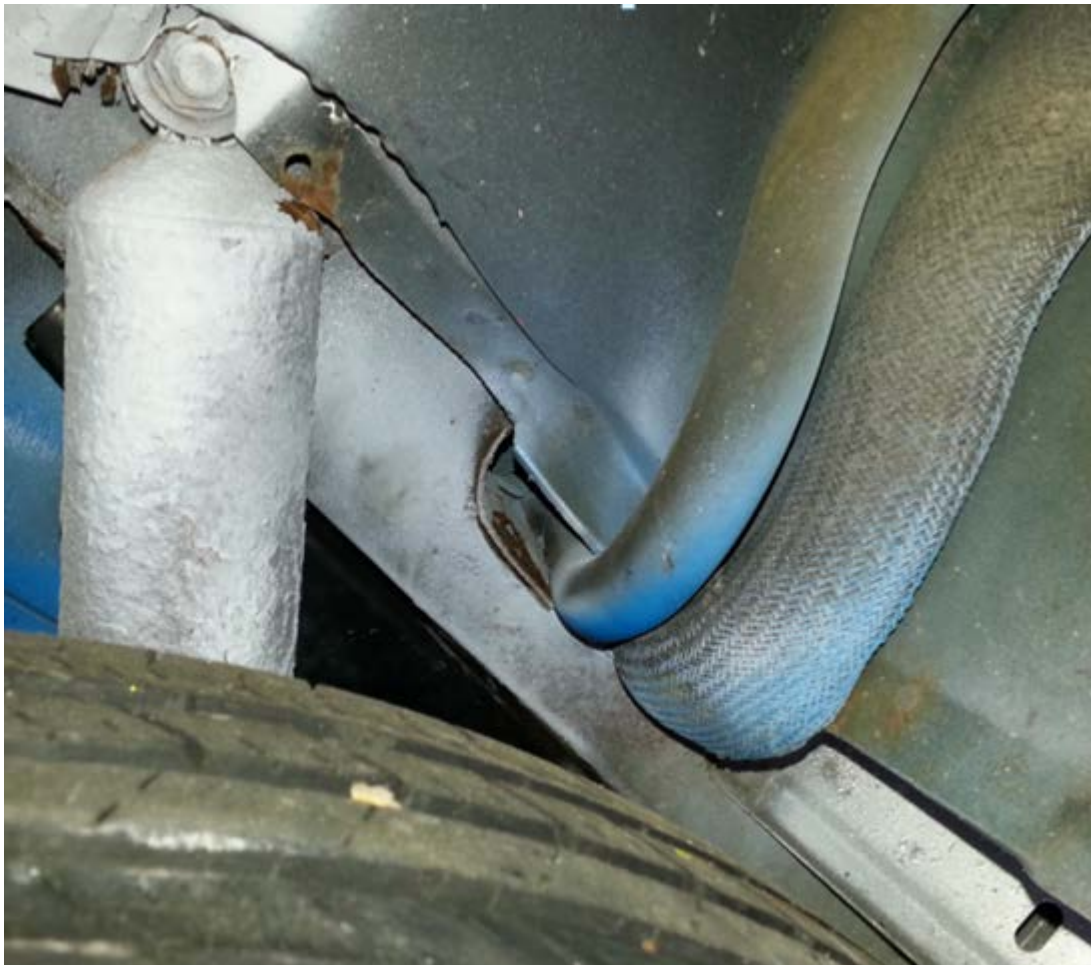
The last ZJ Grand Cherokee test was Test #7. This test was conducted to determine whether the frame rail reinforcement properties demonstrated in Test #6 would also sufficiently benefit a rusted frame rail relief tunnel. The Jeep used for Test #7 had up to 18 years of road salt exposure. The Cadillac was set to normal ride height, similar to baseline Test #3. At the conclusion of the crash, there was no fuel leak. The Cadillac again directly struck the hitch-receiver and the frame rails did not bend near the tank. The hitch support bracket bridged the frame rail relief tunnel and transferred the impact force to a forward point on the frame rail away from the tank (Figure 16). Scraping between the Cadillac and fuel tank was minimal.

Figure 16 Test#7 Rail with rust reinforced by hitch-receiver bracket, hose not captured – moderately rusted vehicle

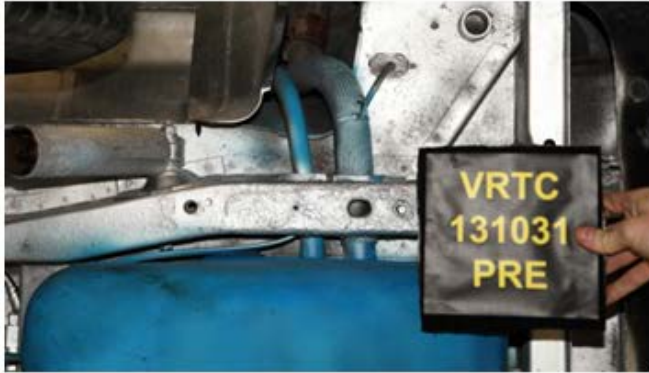
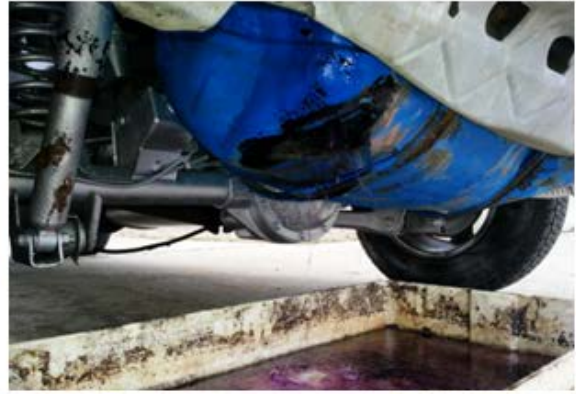
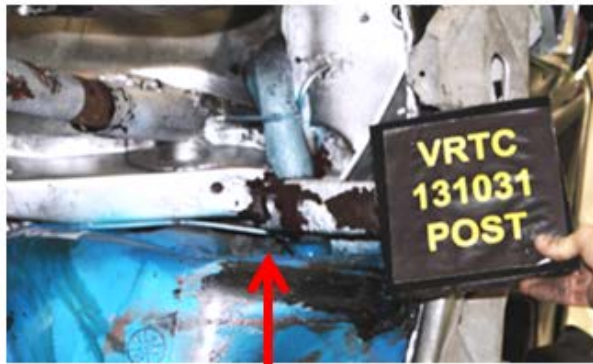
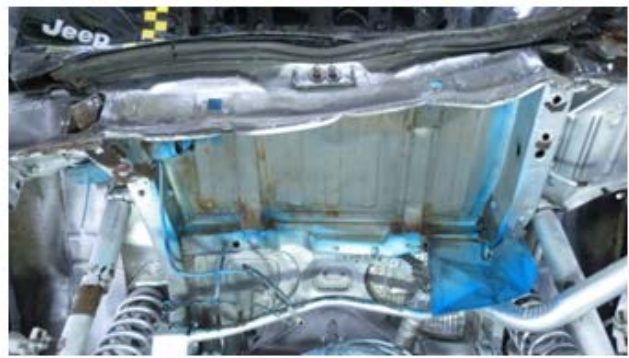
Fuel filler frame pass-through collapsed and pulled away from tank – Known source of leak from testing, Unknown if this occurred in the real-world crash

Significant sliding interaction between tank & bullet vehicle – Known source of leakage from real-world crash

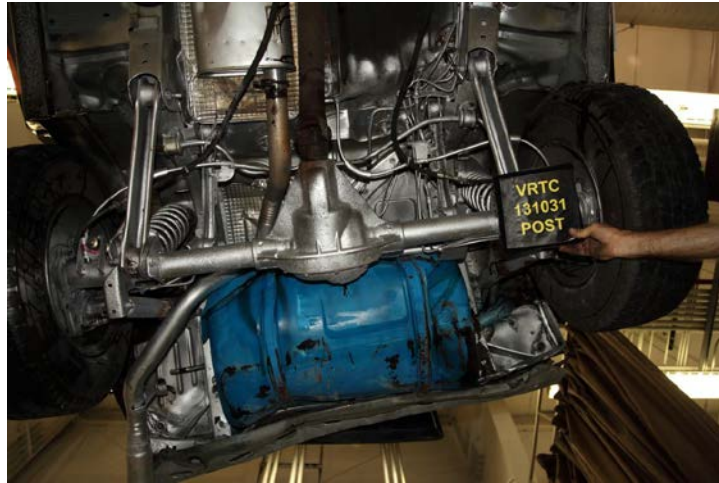
Figure 24 - Test #3 Post-test target vehicle fuel tank close-up without hitch-receiver

Pre-test and post-test photos of the target vehicle fuel tank from the baseline test (Test#3) are shown in Figure 23 and Figure 24, respectively. The post-test photo shows the scraping caused by the under-ride. Figure 25 shows the post-test photo of the comparative test (Test #7) with hitch-receiver installed. The fuel tank did not show signs of under-ride, but did show signs of impacting the rear differential of the Jeep.

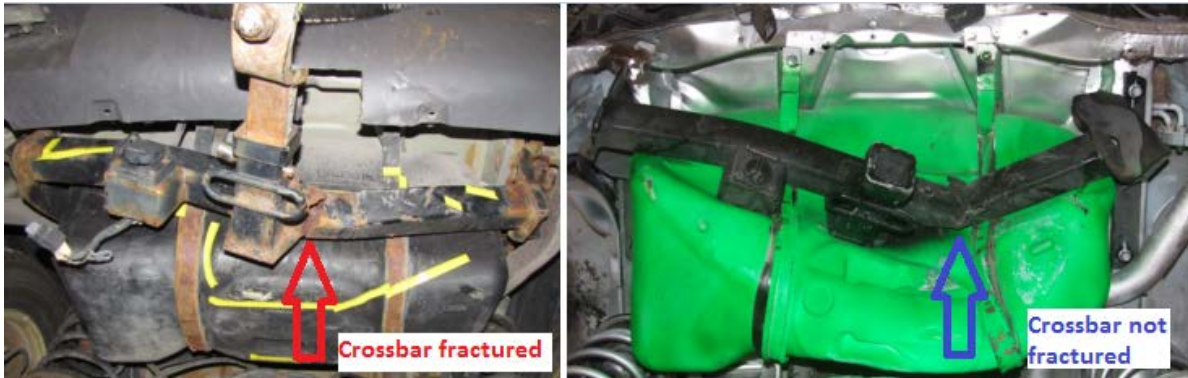
Figure 26 - Left: Real-world crash cross-member fracture, Right: Reconstruction deformation, no cross-member fracture

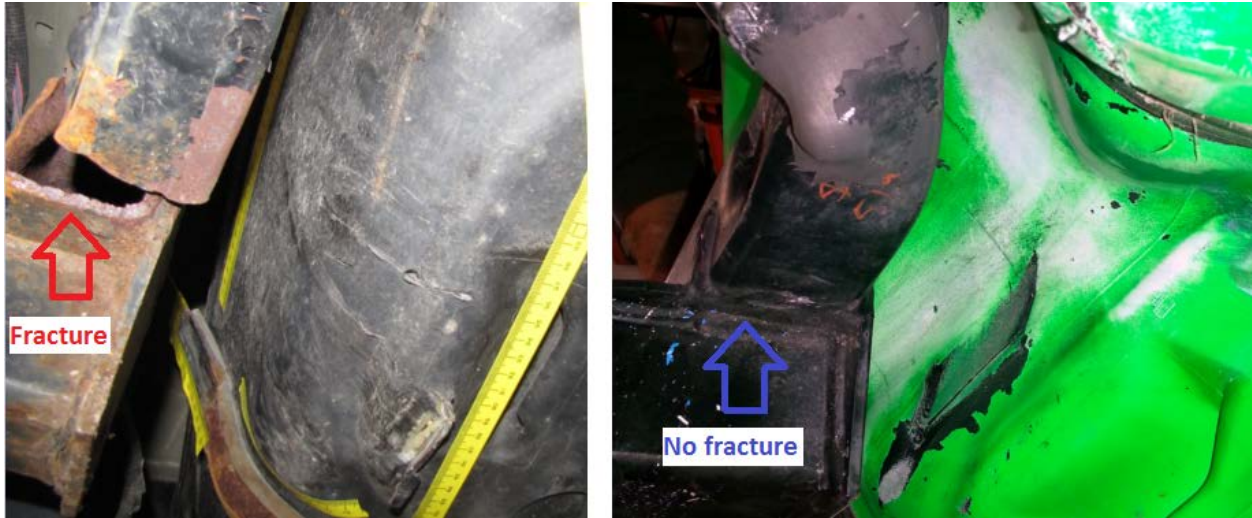
Figure 27 - Left: Real-world crash cross-member fracture (picture taken several months after crash), Right: Reconstruction deformation, no cross-member fracture

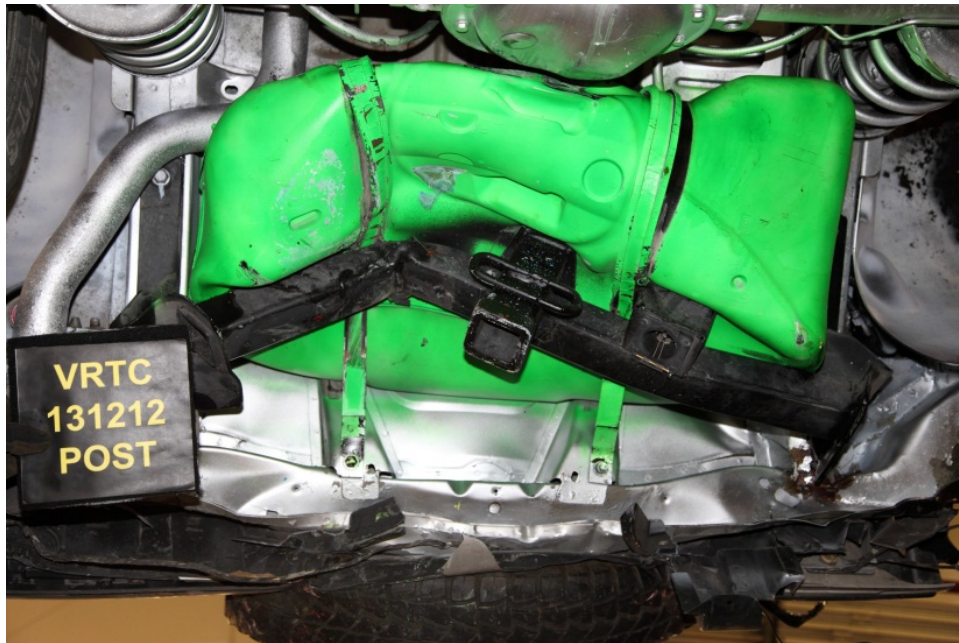
Figure 29 - Test #8 Post-test target vehicle fuel tank close-up view

Pre-test and post-test photos of the target vehicle fuel tank from the baseline test (Test#8) are shown in Figure 28 and Figure 29, respectively. The post-test photo shows no signs of under-ride from the bullet vehicle. Post-test observations are compared to the real-world crash and shown in Table 11. Damage to the tested Jeep Liberty indicated that the energy levels were consistent with, if not in excess of that achieved in the real-world crash. In post-test observation and during the procedural longitudinal rollover test, leakage occurred when the vehicle was rolled in the rollover fixture. Upon disassembly, the source of the droplets was discovered to be the overfill vent connector and the charcoal vapor connector, which had broken off at the top of the fuel pump assembly (Figure 30). These connectors were made from a nylon material and were formed into the top of the housing. They do not carry fuel during normal operation because they function to vent vapors and prevent overfilling. A third connector of the same material, the high pressure supply connection, which does carry fuel during normal operation, remained intact. Further investigation of the fuel pump inside of the tank revealed that the bottom of the plastic pump housing assembly had been displaced forward, had shattered inside of the fuel tank, and had broken the internal supply tube to the fuel pump. This rendered the pump incapable of pressurizing the external fuel tube.

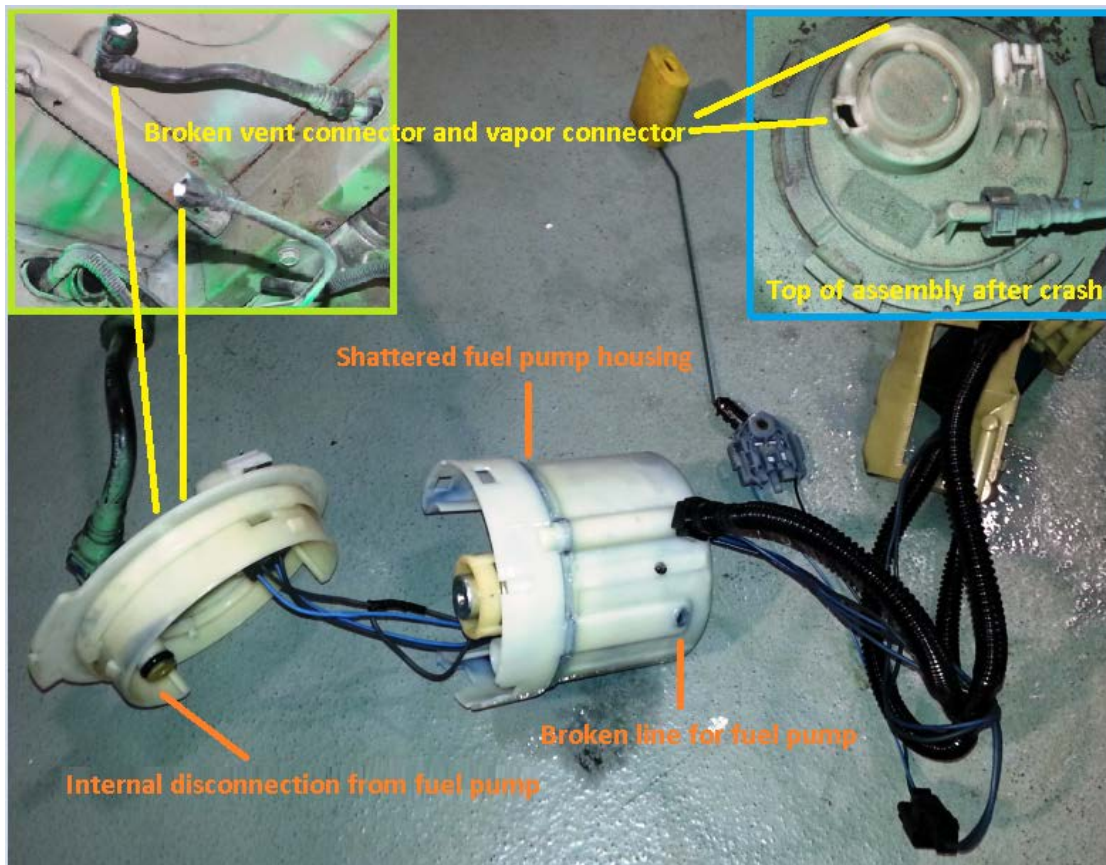
Figure 30 - Additional observation: Fuel pump assembly contained in tank rendered internally non-functional by crash. Vent and vapor tubes broken externally.
