Subject: PETITION FOR AN INVESTIGATION INTO DEFECT CONDITIONS IN UPPER IMMEDIATE
STEERING EXTENSION SHAFT #2 MANUFACTURING DEFECT IN THE 2004-2009 TOYOTA PRIUS
VEHICLES W/RESPECT TO RECALL 12V-537

PETITION, Toyota Prius Steering, Upper Intermediate Extension Shaft #2, Manufacturing Defect w/resp/to Recall 12V-537 (Lower Intermediate Extension Shaft #1, Manufacturing Defect)

Vehicle: Richwine Subject Vehicle 2005 Toyota Prius
VIN: JTDKB20U95 [REDACTED] MfgDt 10/04
Issue: Alleged Steering Malfunction

George Richwine, 05Prius
Data & Analysis, Steering Failure

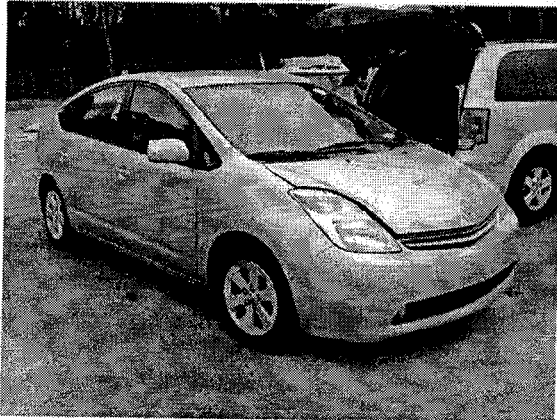
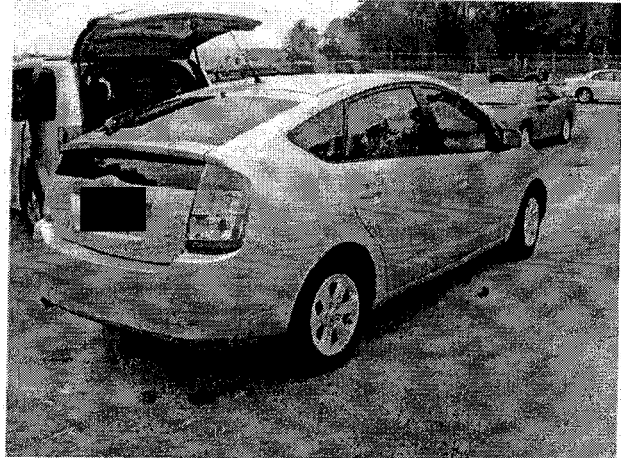
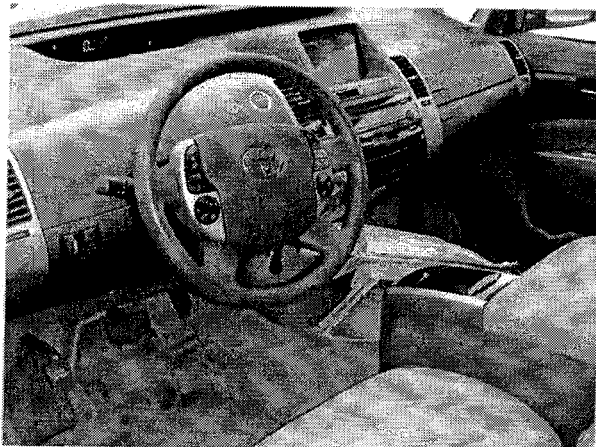
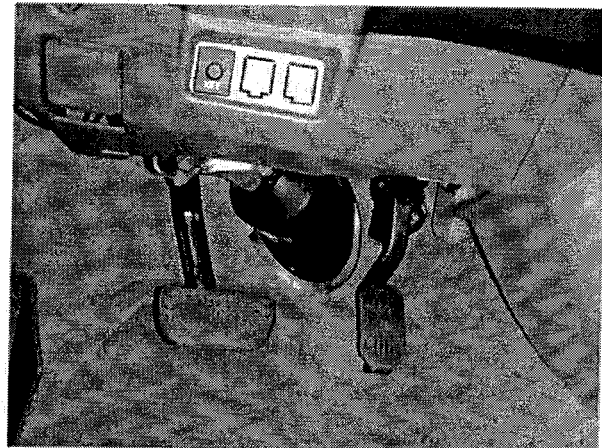
Exhibit C.1 The SV as found.

1. On 4Jan13, I flew to Jacksonville FL Naval Air Station (JAX, NAS), and inspected the subject vehicle (SV) in the base impound lot. My activities included retrieval of ECM and SRS data and an inspection of the occupant compartment steering column components [no lift was available to allow for inspection of the lower components]. On immediate vehicle viewing, the subject vehicle steering wheel was shown by Mr. Richwine to rotate multiple turns, in both directions, with no resistance and no response of the front wheels. I made a video of that demonstration. Exhibit C.1 shows the SV as found. Note the upper intermediate steering shaft #2 seen hanging over brake pedal.

Note the upper intermediate steering shaft #2
hanging over brake pedal

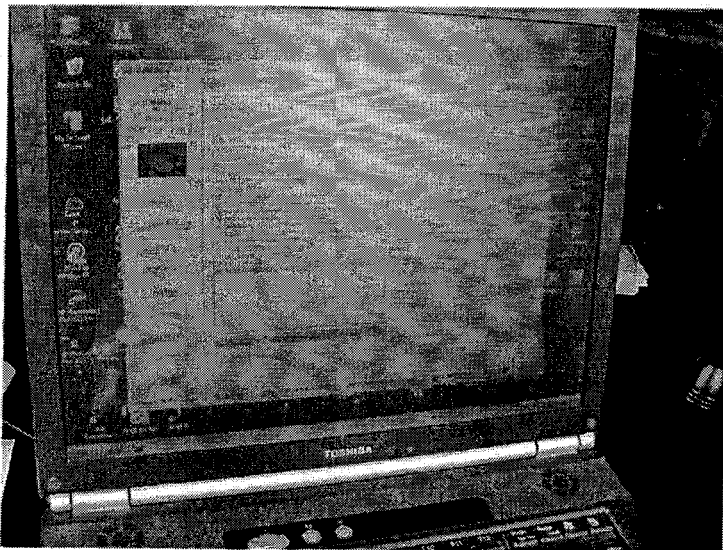
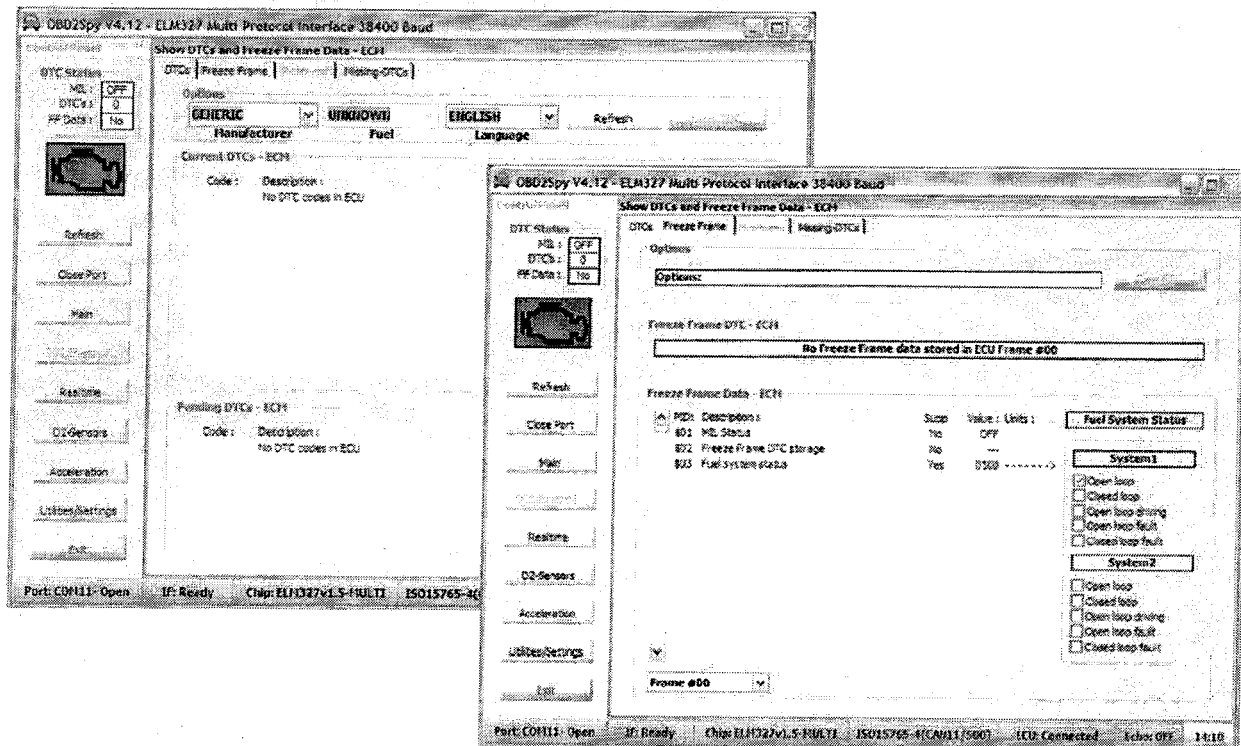
Exhibit C.2. Interrogation of ECM [engine control computer] with OBD2Spy v4.12 and AutoEnginuity V11.0 scanners. The ECM evidenced no DTCs and no Freeze Frame data on either scanner.

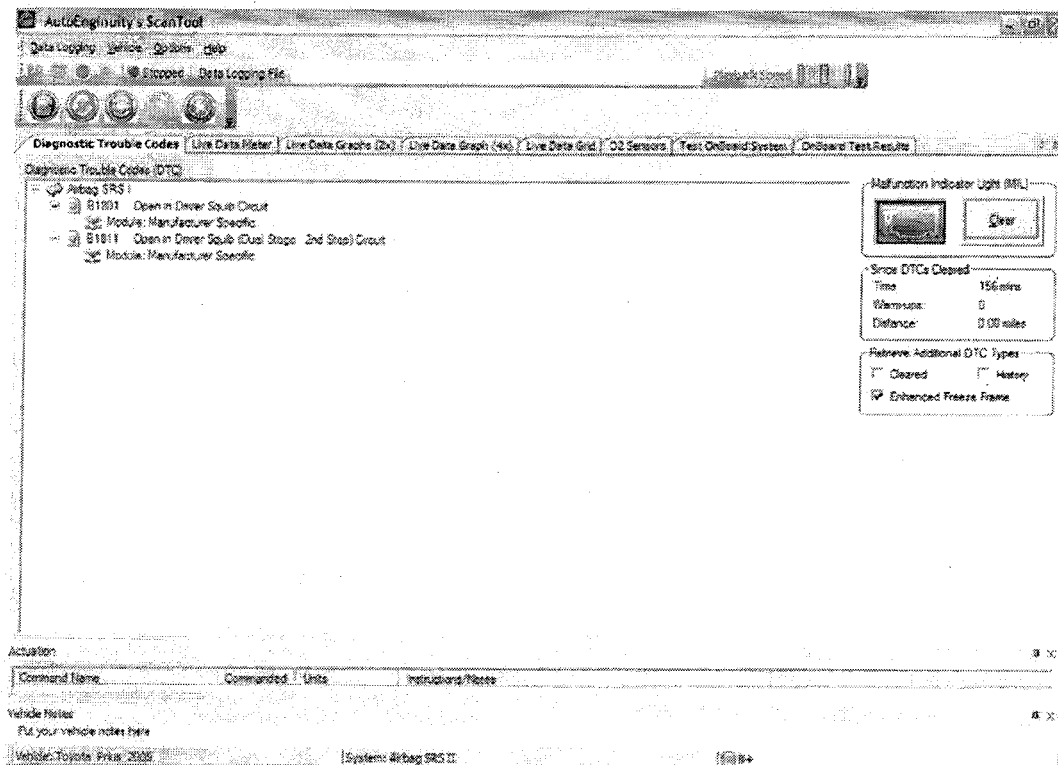
3. Next, the SRS ECU [EDR] was interrogated with AutoEnginuity V11.0 scanner and a Bosch CDR v 8.10. No event data was saved in the EDR. DTCs B1801 [Driver Squib Stage 1 = open] and DTC B1811 [Driver Squib Stage 2 = open] were retrieved from the SRS ECU. These are entirely consistent with the unrestricted steering wheel which clearly ruptured the clockspring [used to connect to driver airbag squib 1 and squib 2]. See Exhibit C.3.

See Exhibit C.3. The SRS ECU [EDR] was interrogated with AutoEnginuity V11.0 scanner and a Bosch CDR v 8.10. No event data was saved in the EDR. DTCs B1801 [Driver Squib Stage 1 = open] and DTC B1811 [Driver Squib Stage 2 = open] were retrieved from the SRS ECU. These are entirely consistent with the unrestricted steering wheel which clearly ruptured the clockspring [used to connect to driver airbag squib 1 and squib 2].

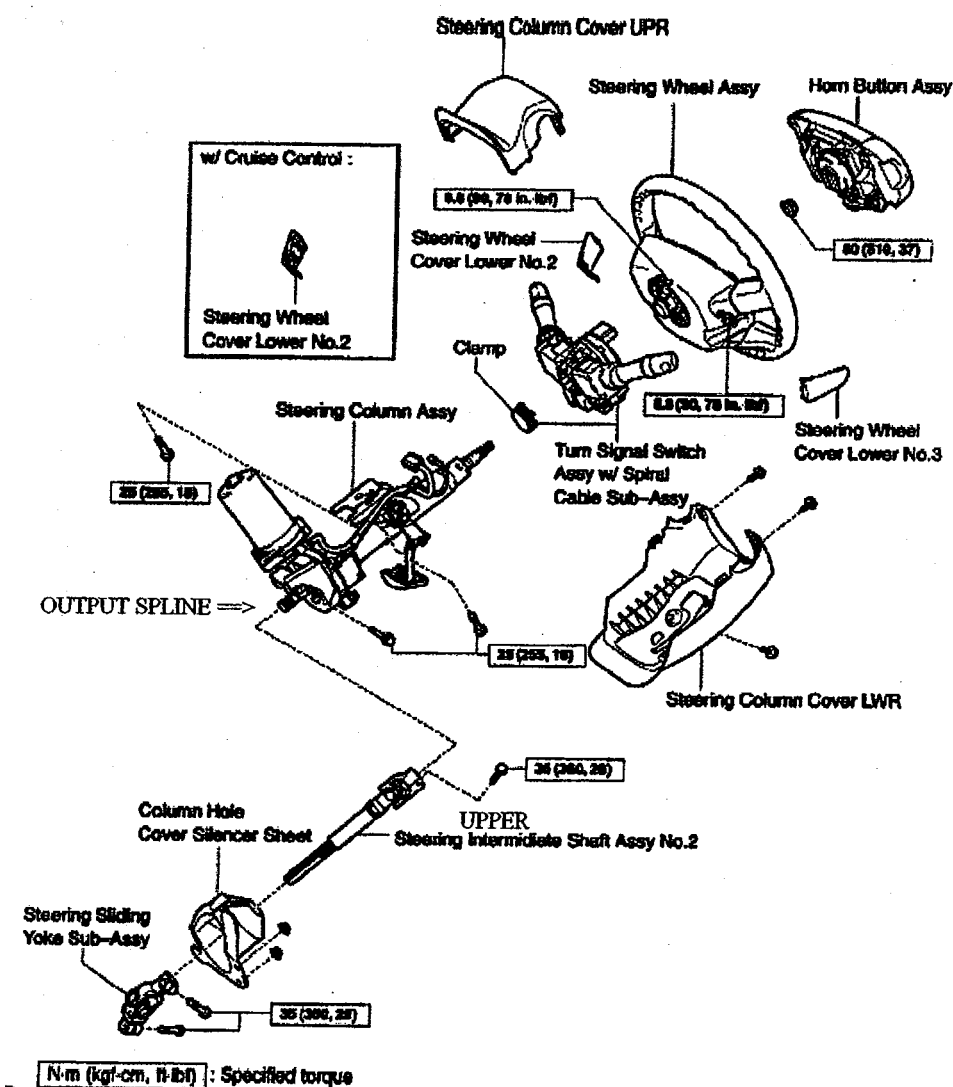
2005 Toyota Prius
Fig. 8: Identifying Steering Column Assy Components And Torque Specifications (1 Of 2)
Courtesy of TOYOTA MOTOR SALES, U.S.A., INC.

Exhibit C.4.1 Upper half of the steering column linkage. The steering column linkage in the subject 2005 Prius consists of two intermediate shafts and an electric power assist top column. Note annotated power assist output spline and upper intermediate shaft #2.

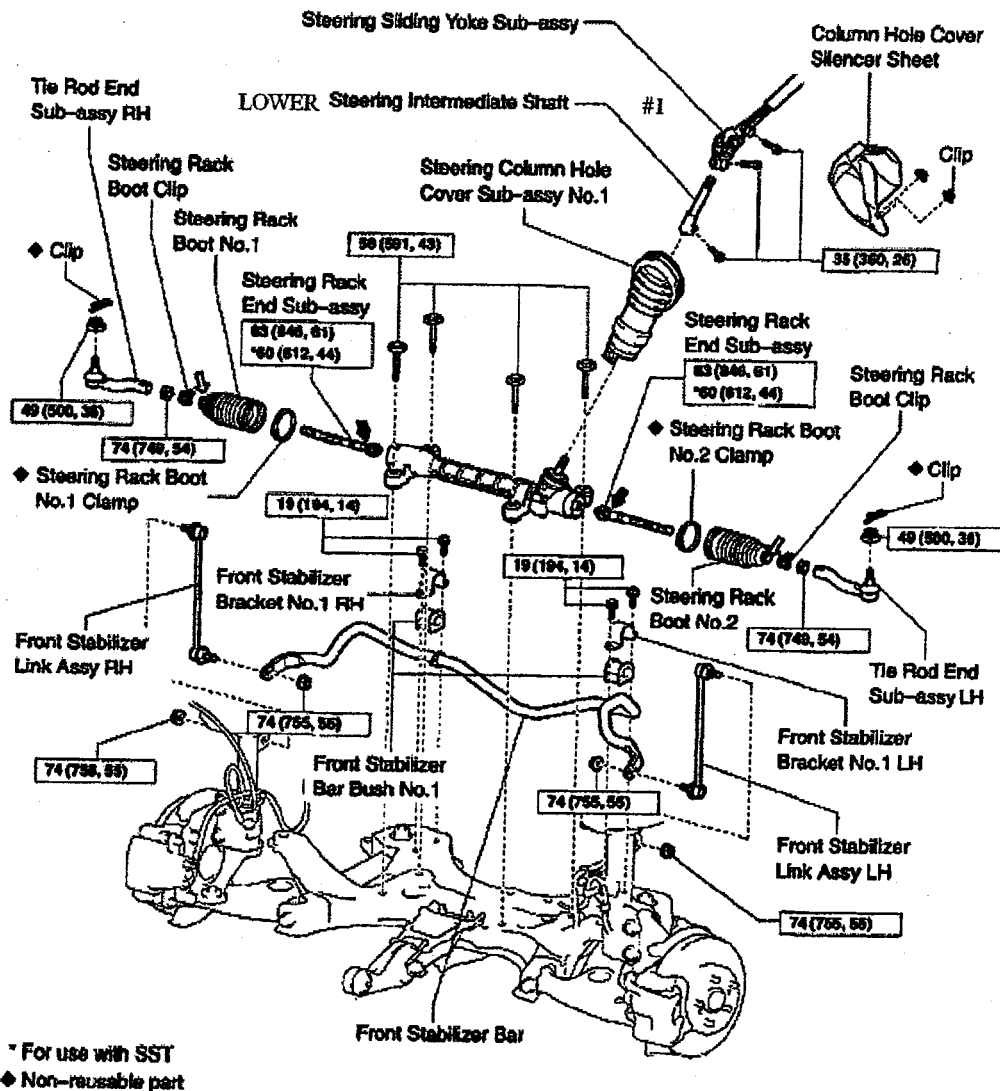
Fig. 4: Identifying Steering Gear Assy Components And Torque Specifications
Courtesy of TOYOTA MOTOR SALES, U.S.A., INC.

Exhibit C.4.2 Lower half of the steering column linkage. Note annotated lower intermediate shaft #1.

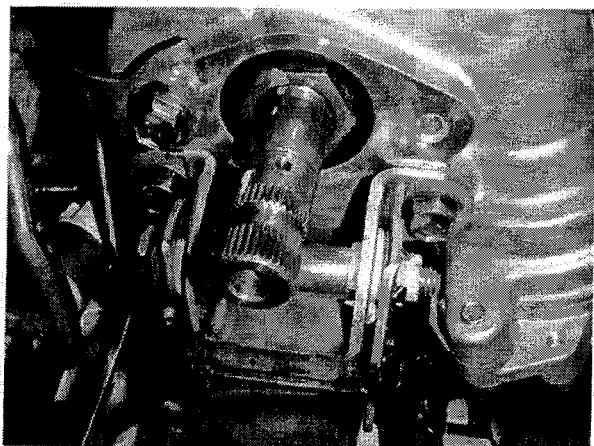
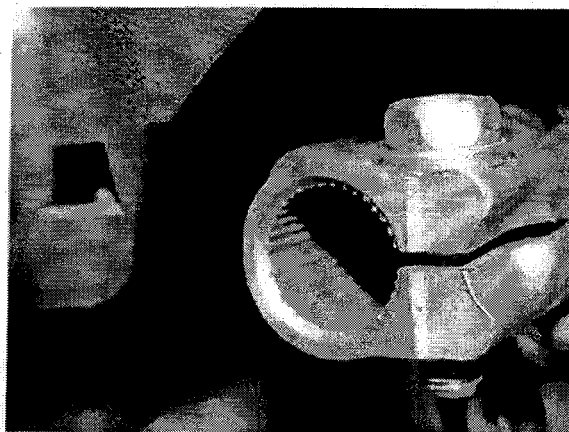
8. Inspecting the upper column for possible causes of this, I found that the upper steering intermediate shaft [#2] had separated from the exit spline of the power assist column output. This separation had no observable or known intervening cause such as a collision or abusive usage. The upper steering column intermediate shaft #2 separation is not part of the Toyota Steering Recall 12V-537 or any of its predecessor versions. See Exhibit C.8.

Exhibit C.8. Showing the upper steering intermediate shaft [#2] as found separated from the exit spline of the power assist column output. This separation had no observable or known intervening cause such as a collision or abusive usage.

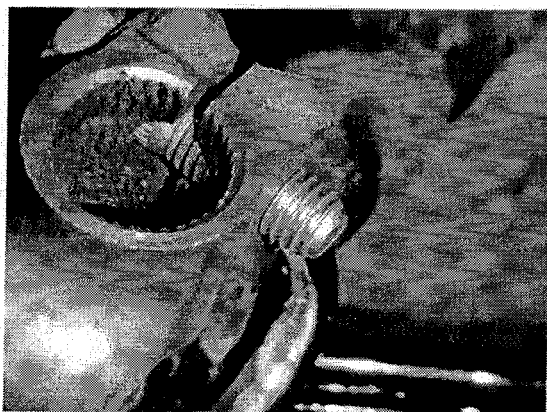
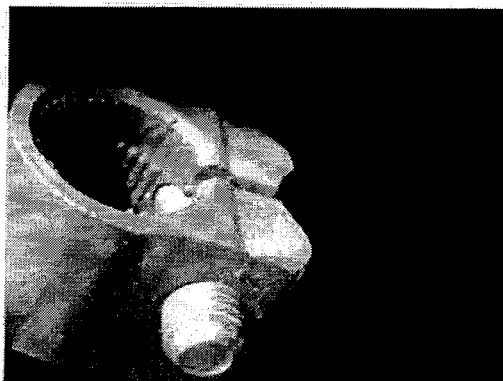
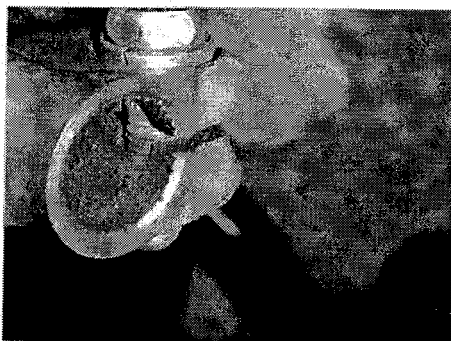
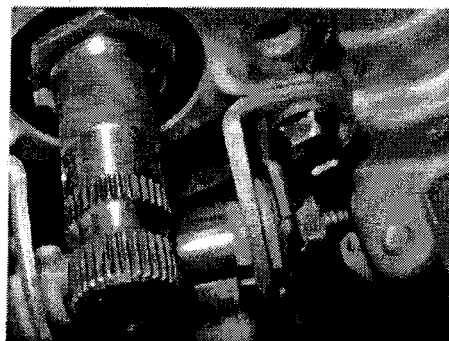
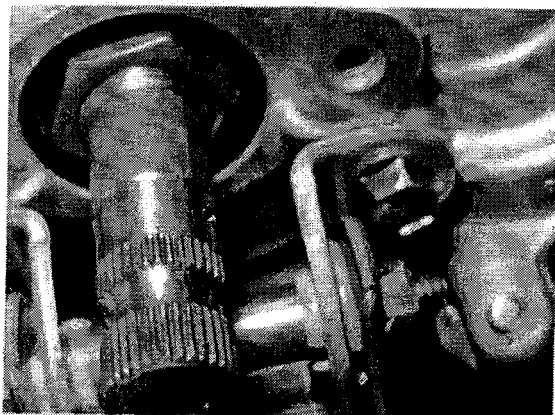
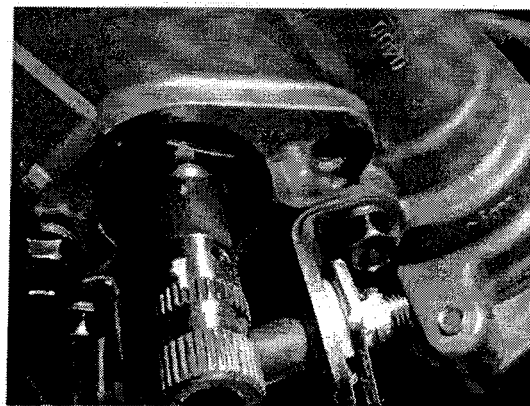
9. Exhibit C.9 shows the upper mating end of the upper end of the upper steering intermediate shaft #2 and the fact that its internal splines are mechanically worn away for approximately 1/4 of the intended mating distance [with the power assist exit spline]. It should be noted that the upper intermediate shaft #2 is actually part of a sliding link, and the malfunction portion was intended by design to have been locked onto the power assist exit spline. This lock function is accomplished by its affixing bolt occupying the machined annulus in the power assist exit spline, as well as 'cinching up' the intermediate shaft #2 internal spline connection [this is a venerable mechanical design, conceptually similar to the manner in which many bicycle pedals are locked onto the bicycle drive gear axle]. There was no deformation of the power assist exit spline indicating a possible drag-over of the locking bolt.

10. Since the locking bolt was found intact in the intermediate shaft, and was no deformation of the power assist exit spline indicating a possible drag-over, the locking bolt could not ever have been properly locked onto the power assist exit spline. Additionally, a careful examination of location of the rust marks on the power assist exit spline show that the upper intermediate shaft #2 was only installed on approximately the first third of the power assist exit spline. Its intended design [based on proper locking bolt position would have been for complete coverage of the upper intermediate shaft #2 spline with the power assist exit spline - with the locking/cinching bolt residing in the power assist exit spline annulus. Exhibit C.9 shows the SV bolt and the power assist exit spline annulus.

11. Exhibit C.9 also shows that the worn section of the upper intermediate shaft #2 spline coincides with the approximate [NON-rust mark delineated, covered] portion of the power assist exit spline.

Exhibit C.9 shows the upper mating end of the upper end of the upper steering intermediate shaft #2 and the fact that its internal splines are mechanically worn away for approximately 1/4 of the intended mating distance [with the power assist exit spline]. It should be noted that the upper intermediate shaft #2 is actually part of a sliding link, and the malfunction portion was intended by design to have been locked onto the power assist exit spline. Note metallurgical debris inside spline cavity.

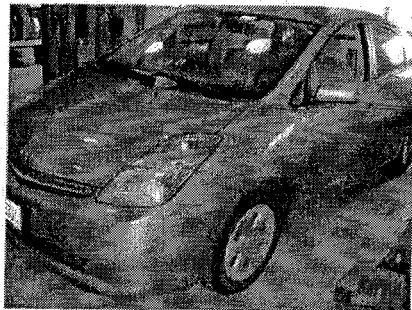
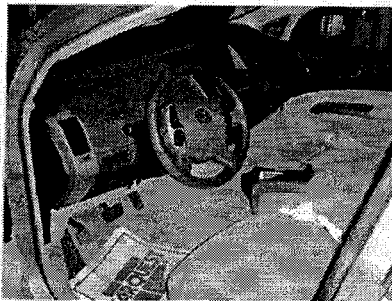
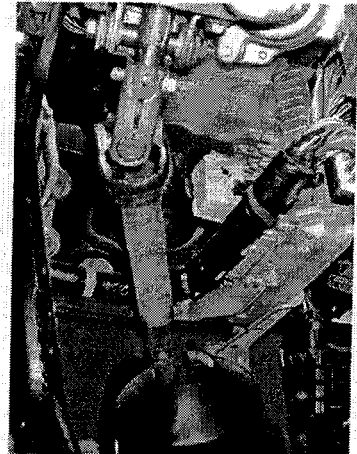
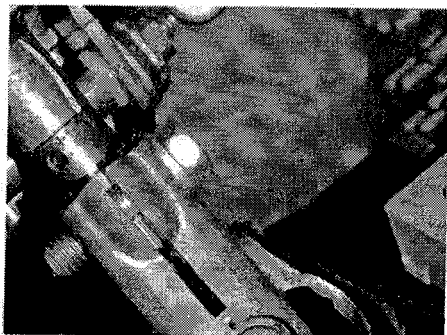
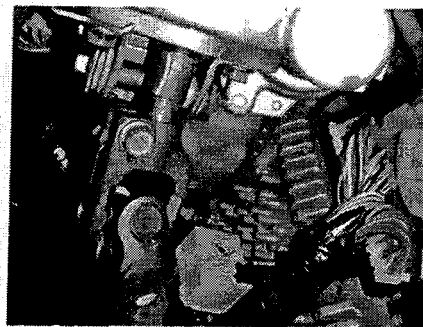
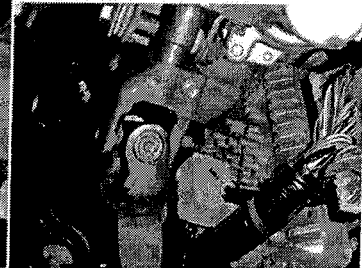
¹ To confirm the applicability of my exemplar, I checked the part #s of the OEM upper steering intermediate shaft #2 for both model years. It turns out that Toyota installed a new P/N 45260-47052 on vehicle production after Nov05 and specified that same P/N as superceding the OEM shaft P/N for any replacements on 2005 MY vehicles. Thus the mechanical design for both model years is by definition, identical.

Exhibit 12 A photo sequence showing that exemplar vehicle and its upper intermediate steering shaft #2 assembly on the exemplar power assist exit spline annulus. These photos clearly show, with no ambiguity, that a proper installation includes the cinching bolt properly residing in the power assist exit spline annulus.
