U.S. Department  
of Transportation

**National Highway  
Traffic Safety  
Administration**

# ODI RESUME

**Investigation:** PE 13-014  
**Date Opened:** 05/07/2013  
**Investigator:** Derek Rinehardt  
**Approver:** Frank Borris  
**Subject:** Alleged Loss of Steering  
**Date Closed:** 01/31/2014  
**Reviewer:** Jeff Quandt

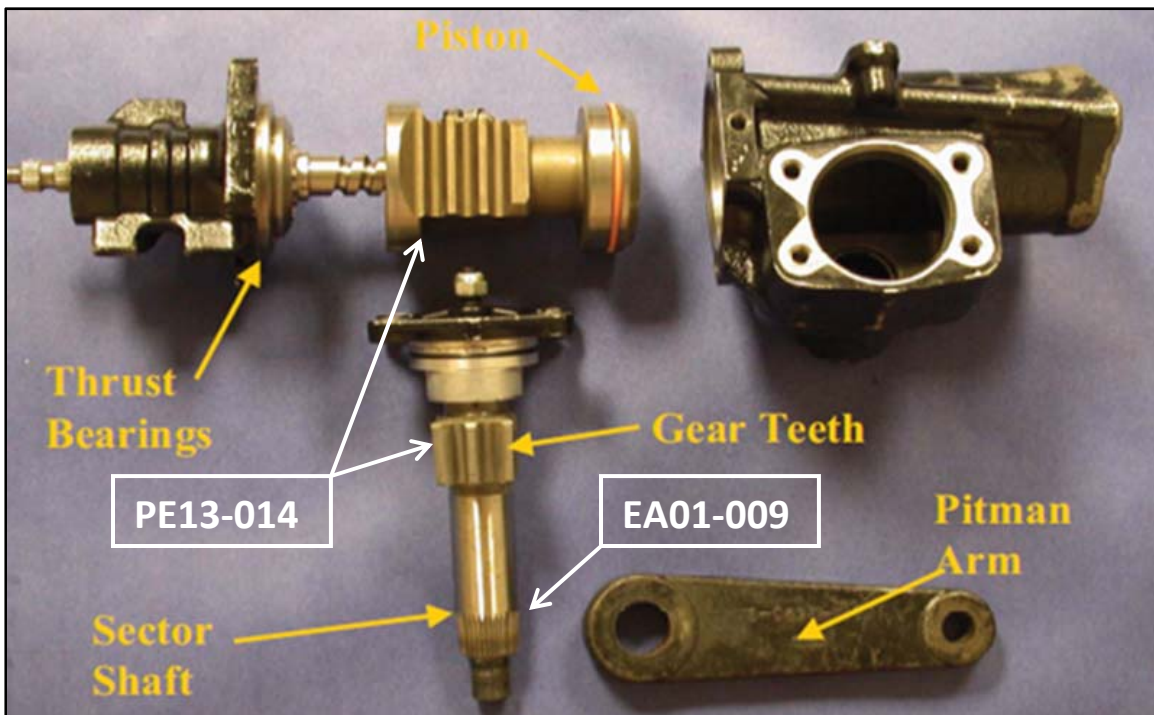
Ford increased the diameter of the sector shaft from 1.375 inches to 1.625 inches at the start of MY 2005 production, increasing the resistance of the steering gear assembly to torsional overload by approximately 48% and changing the failure mode from sector shaft fracture to cracked or broken sector shaft gear teeth. The redesigned steering gear assembly was used in approximately 1.1 million MY 2005 through 2009 Ford Super Duty pick-up trucks, including the subject vehicles. Figure 1 shows the basic steering system design used in Ford Super Duty trucks investigated in EA01-009 and PE13-014. Figure 2 shows the locations of failures resulting from impact related torsional overloading of the sector shaft for the subject vehicles and the prior generation Ford Super Duty trucks investigated in EA01-009. Figure 3 shows an example of a failed sector shaft investigated in EA01-009 and comparisons of fracture surfaces of sector shafts failing from fatigue loading and from torsional overload.

Figure 2. Ford F-Series Super Duty steering gear components and locations of overload failures for EA01-009 and PE13-014.

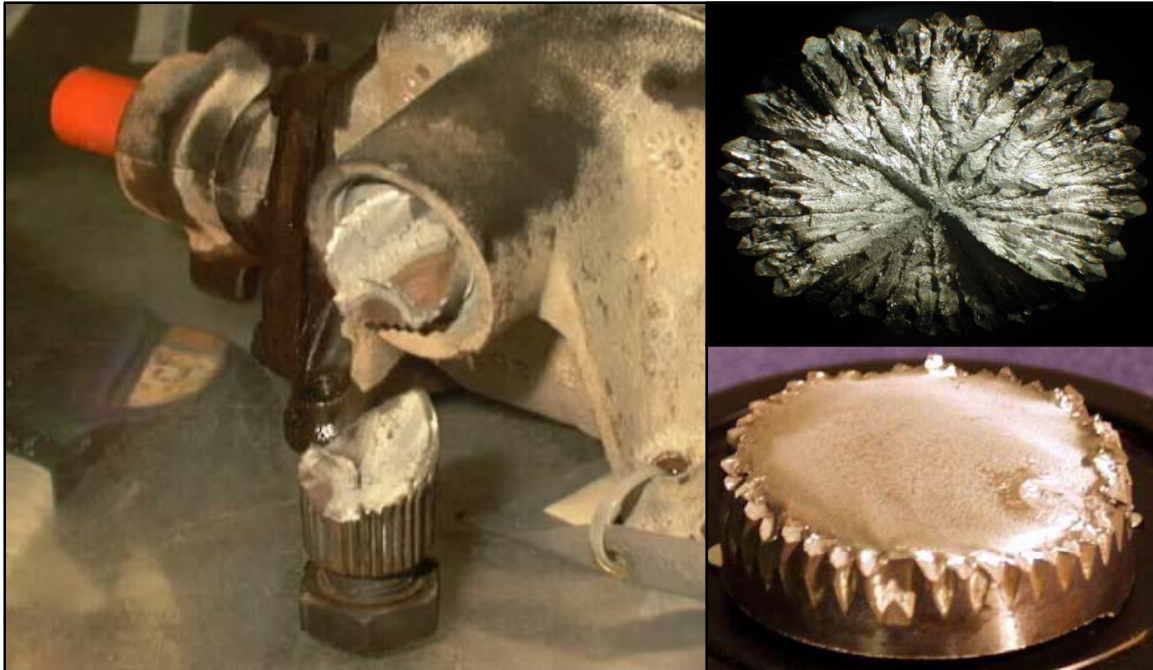
As background, ODI investigated steering gear sector shaft fractures in approximately 1.3 million MY 1999 - 2001 Ford Super Duty pick-up trucks and MY 2000 - 2001 Ford Excursion sport utility vehicles in Engineering Analysis EA01-009. The investigation determined that the sector shaft failures were "the result of extraordinary, possibly multiple, impacts and not the result of fatigue." No defect in design, manufacturing or materials was identified in the sector shaft. EA01-009 was closed August 19, 2003 with 169 complaints, resulting in a rate of 12.9 incidents per 100,000 vehicles after approximately one year of service.

Figure 3. Steering gear sector shaft overload failure (left), MY1999-2001 Ford F-Series Super Duty, EA01-009. Sector shaft fracture surface for fatigue failure (upper right) and overload failure (lower right).

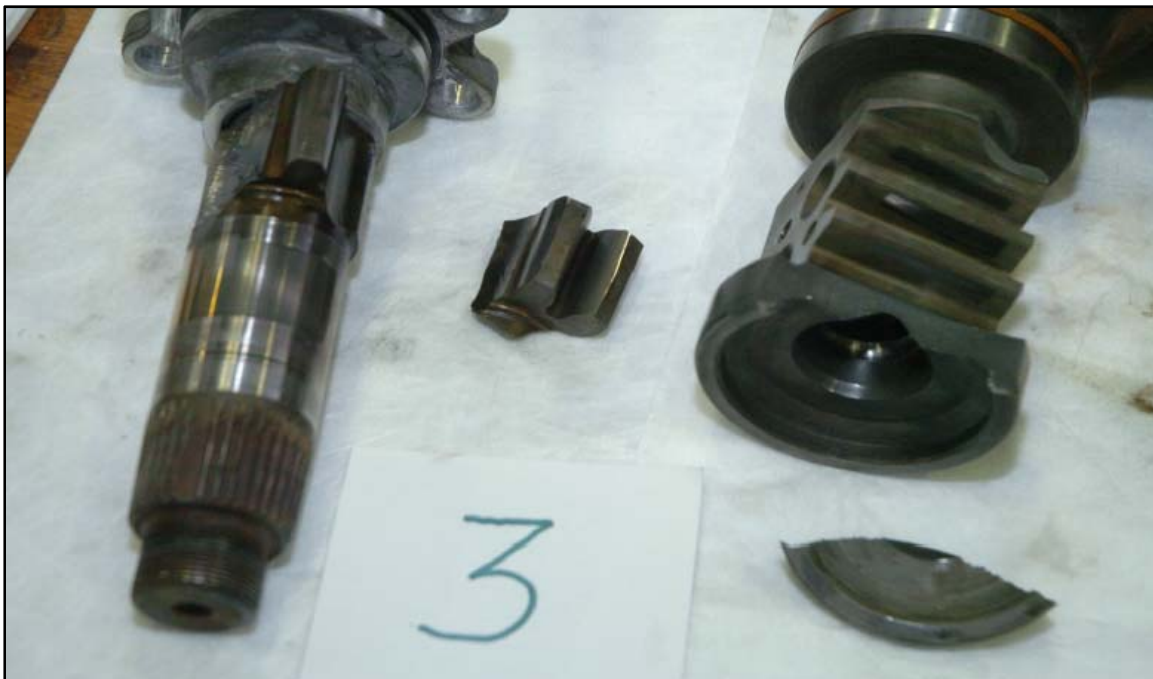
Ford provided field return part analysis of failed steering gears from MY 2005 through 2009 Super Duty trucks found evidence of broken sector shaft gear teeth and piston damage consistent with incidents of single event overload (Figure 4). Laboratory analysis found no evidence of fatigue or material property defects in any of the fractures. Analysis of complaint rates by vehicle build month showed no patterns indicating potential manufacturing quality issues and no difference before and after Ford introduced design changes to the input shaft and sector shaft seals in July 2007 to address potential leak concerns (Figure 5). Analysis of failures by time in service indicates a random failure pattern/distribution, consistent with incidents of impact induced overload (Figure 6).

Figure 4. Steering gear teeth fracture overload failure, MY 2005-09 Ford F-Series Super Duty (PE13-014).

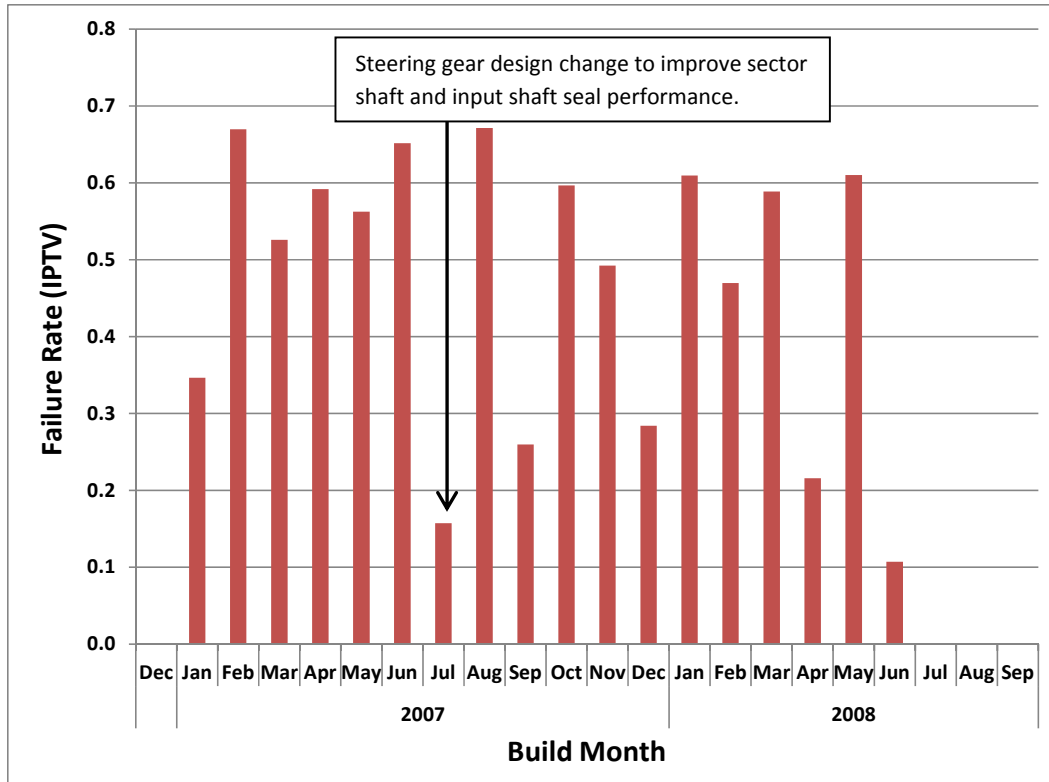
Figure 5. Steering gear failure rate by vehicle build month, MY08 Ford Super Duty.

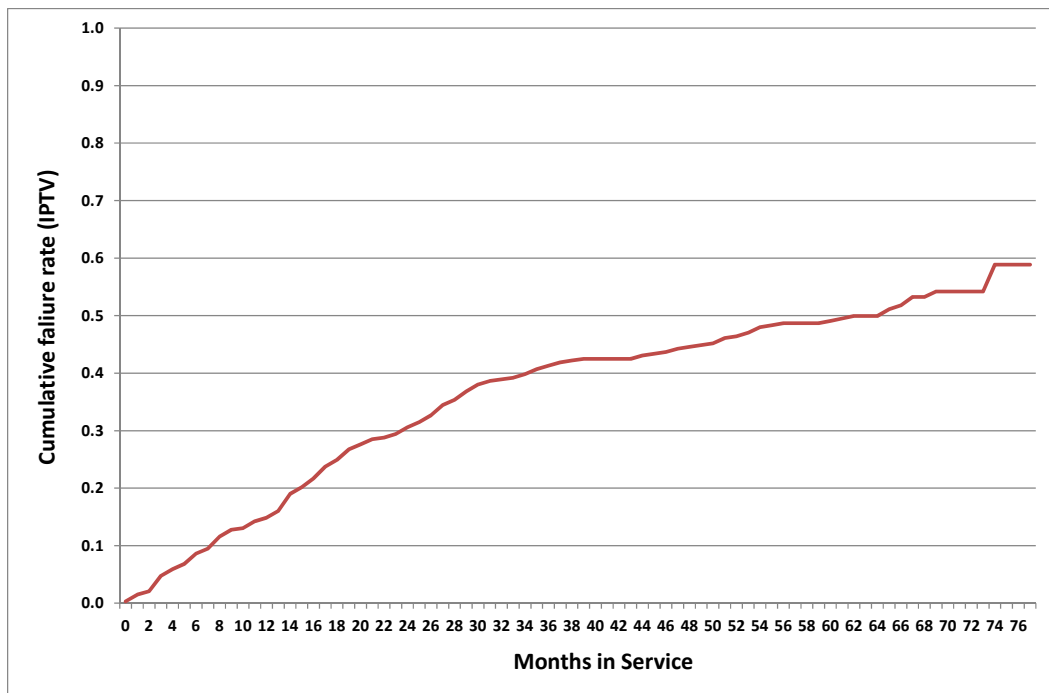
Figure 6. Failure rate by time in service, MY08 Ford F-Series Super Duty steering gear overload failure Using data from all sources, including complaints, field reports and warranty claims.
