# ODI RESUME

**Investigation:** EA 13-004  
**Prompted by:**  
**Date Opened:** 04/26/2013  
**Investigator:** Derek Rinehardt      **Reviewer:** Jeff Quandt  
**Approver:** Frank Borris  
**Subject:** Loss of Steering Control

**Manufacturer:** Ford Motor Company  
**Products:** MY 2005 - 2008 Ford Crown Victoria Police Interceptor Models  
**Population:** 195,000  
**Problem Description:** Separation of the lower steering column shaft from the upper steering column shaft resulting in a loss of steering control.

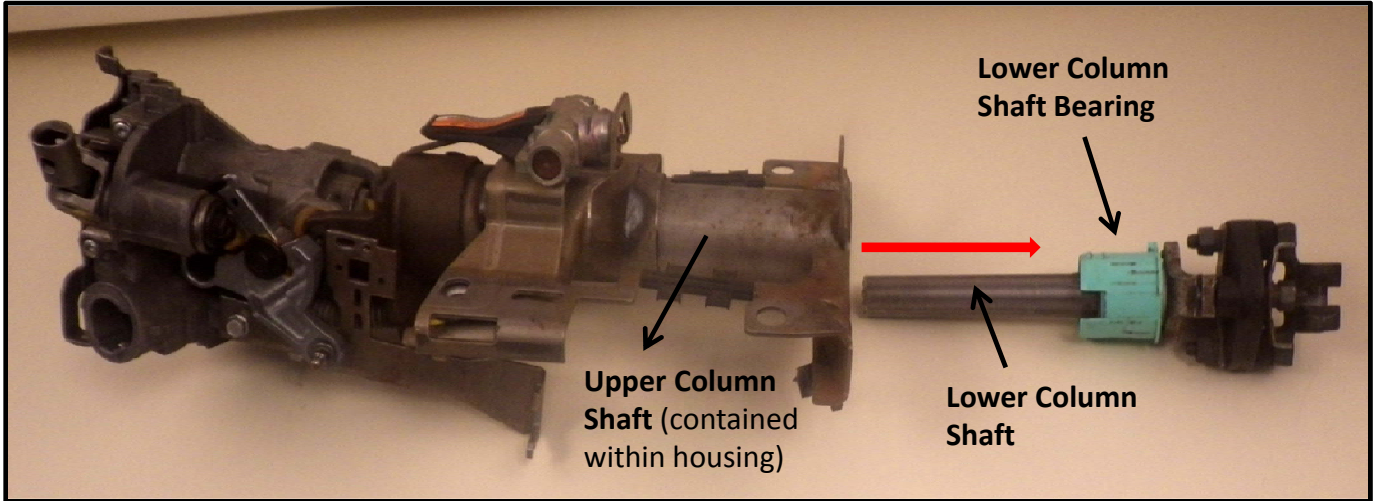
In response to the Office of Defects Investigation's (ODI) Information Request (IR) during PE12-025, Ford provided 2 complaints and 9 warranty claims related to the alleged defect in the subject vehicles (see Figure 1 for an exemplar picture). ODI has received 5 complaints related to the alleged defect, including 1 related to an incident reported in one of the Ford complaints. The incident rate involving subject vehicles is 7.7 per 100,000 vehicles (15 total incidents). Five of the 15 incident vehicles were associated with a prior history report of a frontal impact incident.

### Lower Steering Column Shaft Complete Separation

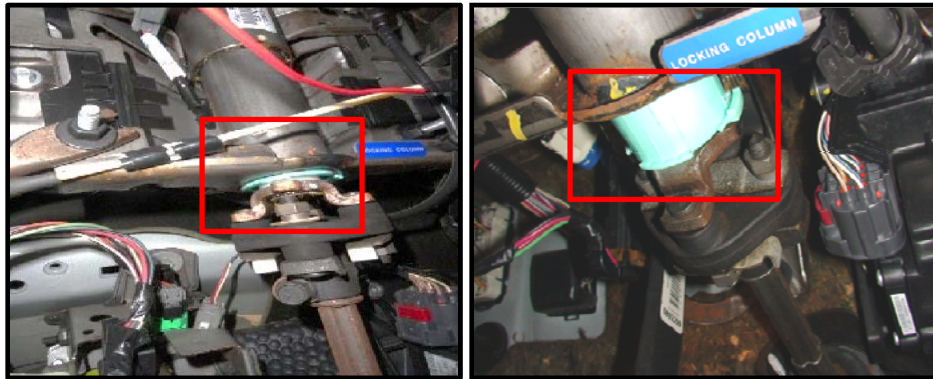
Figure 2

ODI also identified 42 reports (39 reports associated with subject vehicles and 3 reports associated peer vehicles) of

the lower steering column shaft bearing displacement that did not result in complete separations of the upper to lower steering column shafts (see Figure 2). Vehicles with this condition were identified during inspections of police fleets or during vehicle repairs for complaints of looseness, binding or noise in the steering system while turning.

### Lower Column Shaft Bearing Displacement

Displaced Lower Bearing
