DP13-001

TOYOTA

C0T Dealer Letter T-CP-C0T-

Subject: **Safety Recall - C0T Remedy Notification**
2004 to certain 2009 Model Year Prius Vehicles
Steering Intermediate Extension Shaft

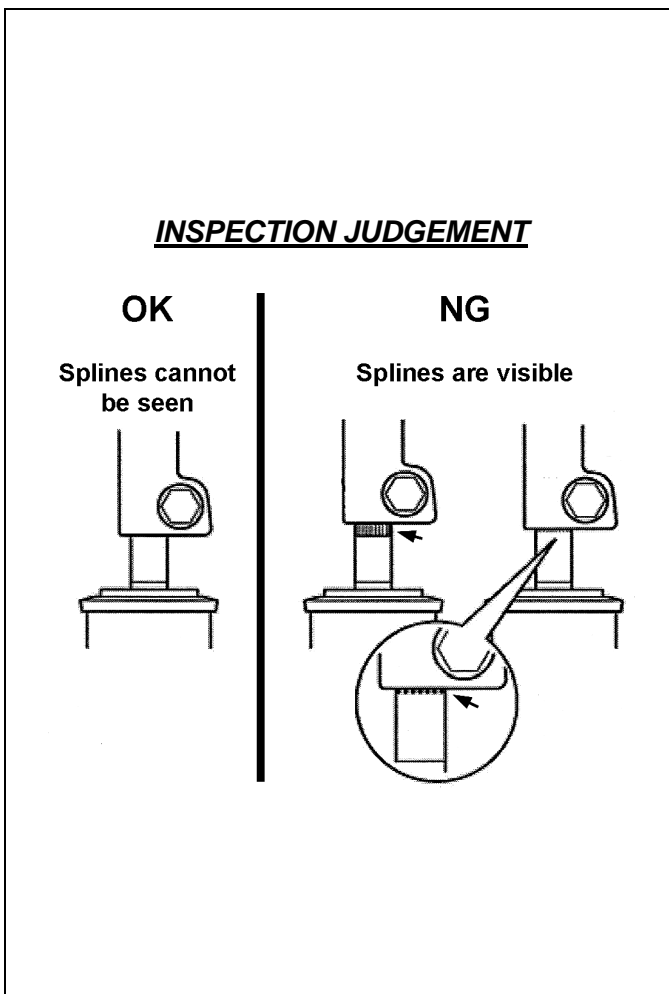
c) Are the splines of the steering gear visible?

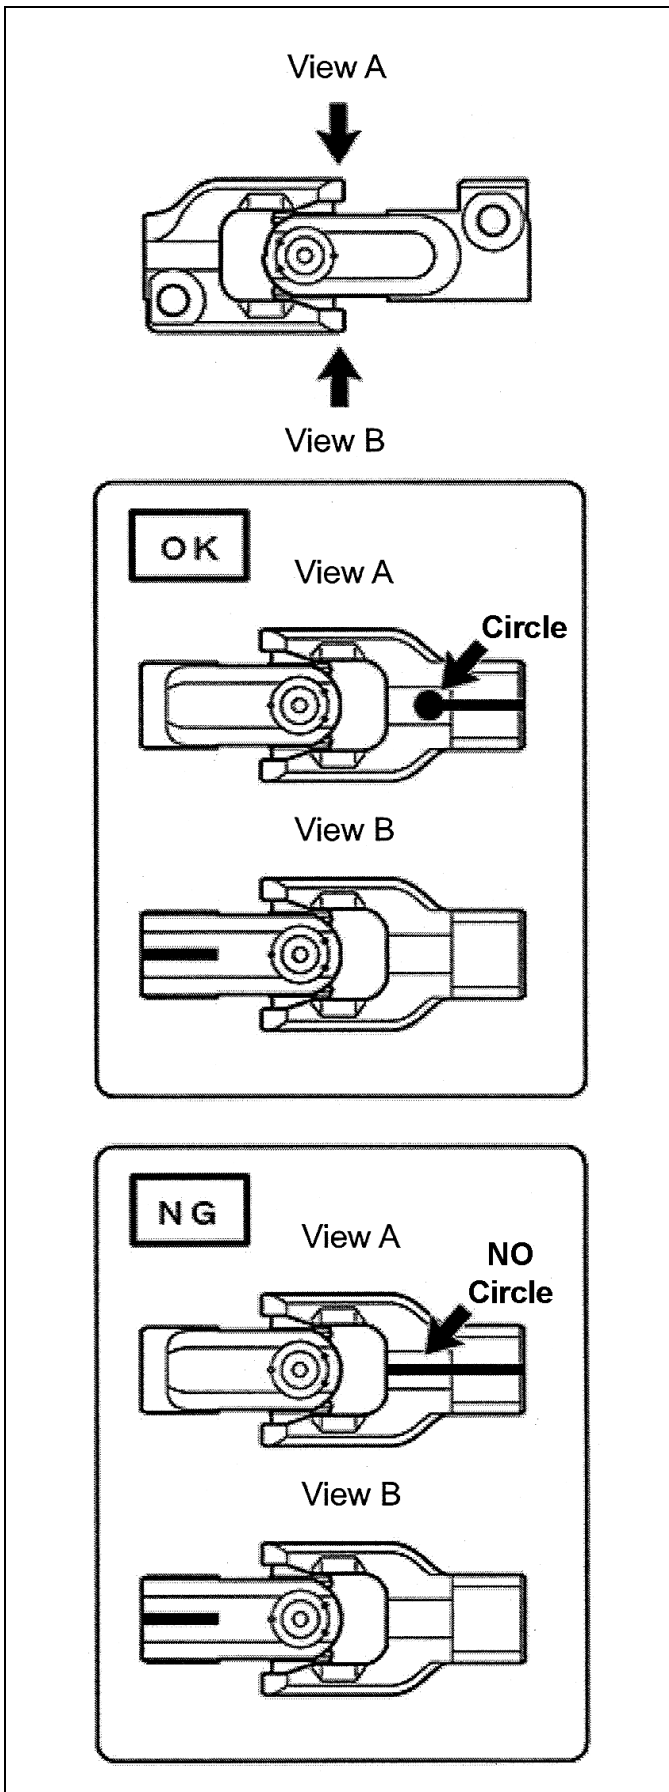
A VIDEO SHOWING AN NG SLIDING YOKE IS AVAILABLE TO VIEW ON TIS.

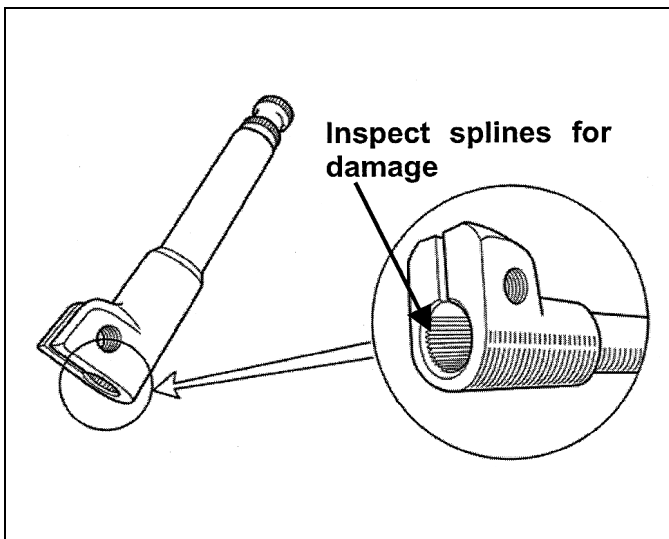
- b) Inspect the internal splines of the intermediate (extension) shaft No. 1 for damage. Is damage present?

- Intermediate (extension) shaft is **NG**. Replace the intermediate (extension) shaft No. 1 and the bolt with a **NEW** one.

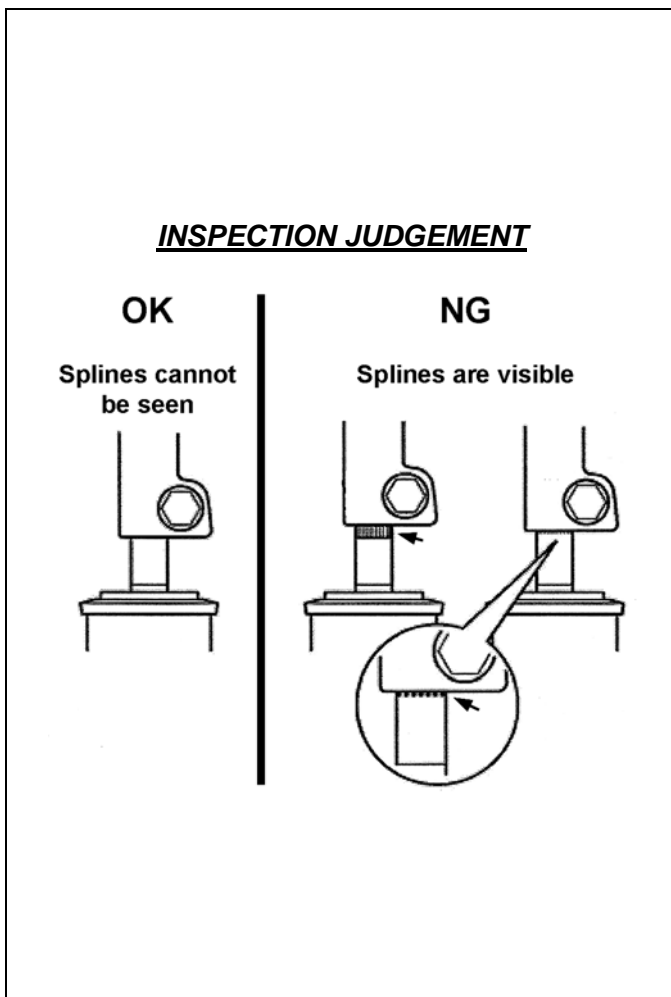
- c) Are the splines of the steering gear visible?

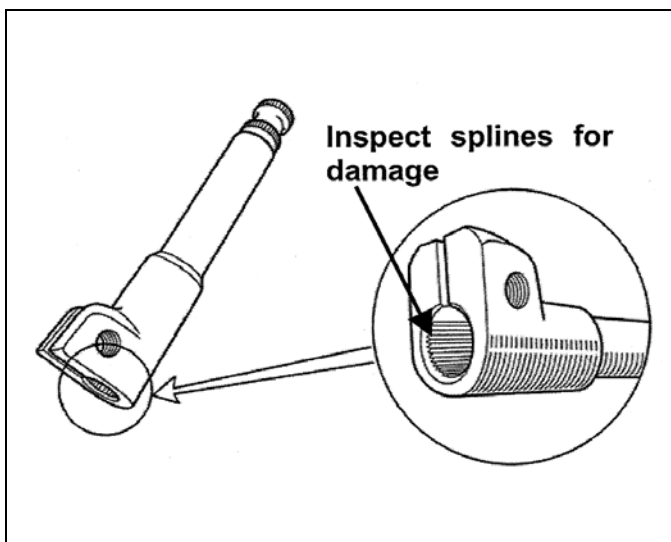
- b) Inspect the internal splines of the intermediate (extension) shaft No. 1 for damage. Is damage present?
