maintenance-site-vpt ▶ Driveline - Active Issues... Question 9 Describe all modifications or changes made All Documents

PE13-002

VOLVO TRUCK

QUESTION 9

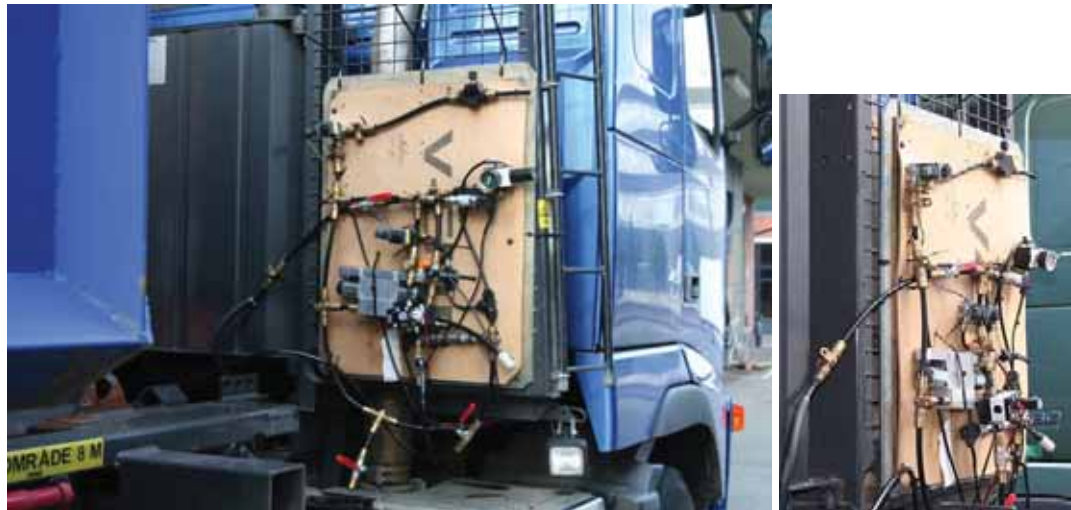
Figure2. Test setup.

The tests were performed in FH-72. A test setup to simulate leakage was mounted on the outside of the truck (see appendix2, figure 2). The setup was partially automatized and hand-operated (see figure 3). Four different sorts of leakages were tested. Medium and large leakage from air supply side and medium and large leakage from the internal clutch system (between CVU and CCA).

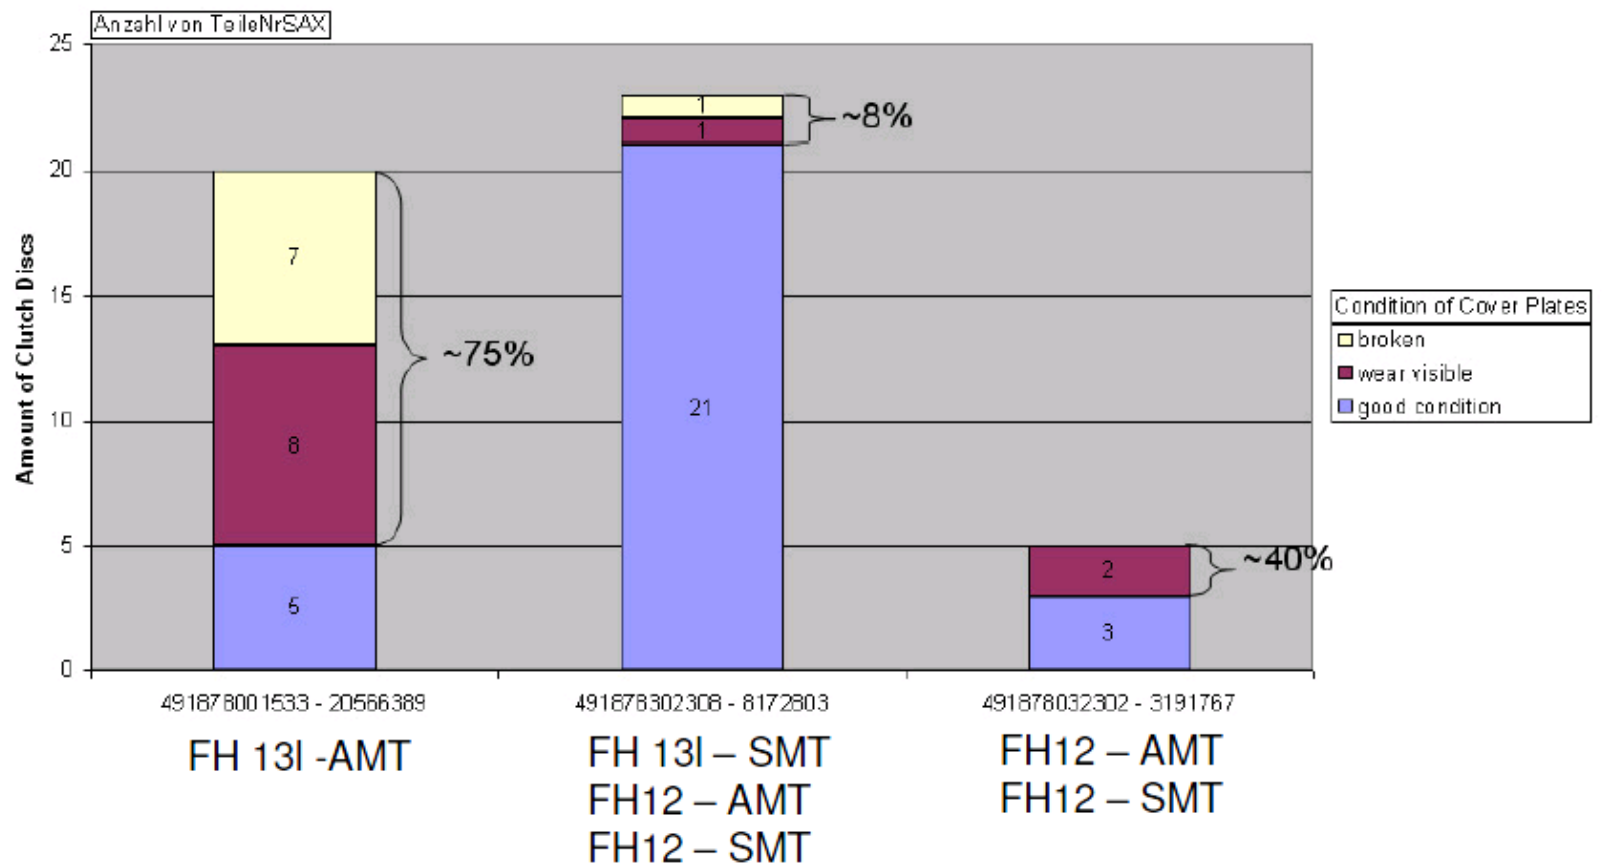
Evaluation - Wear at Cover Plates

B4 – Investigation of 50 clutch discs from Bielefeld

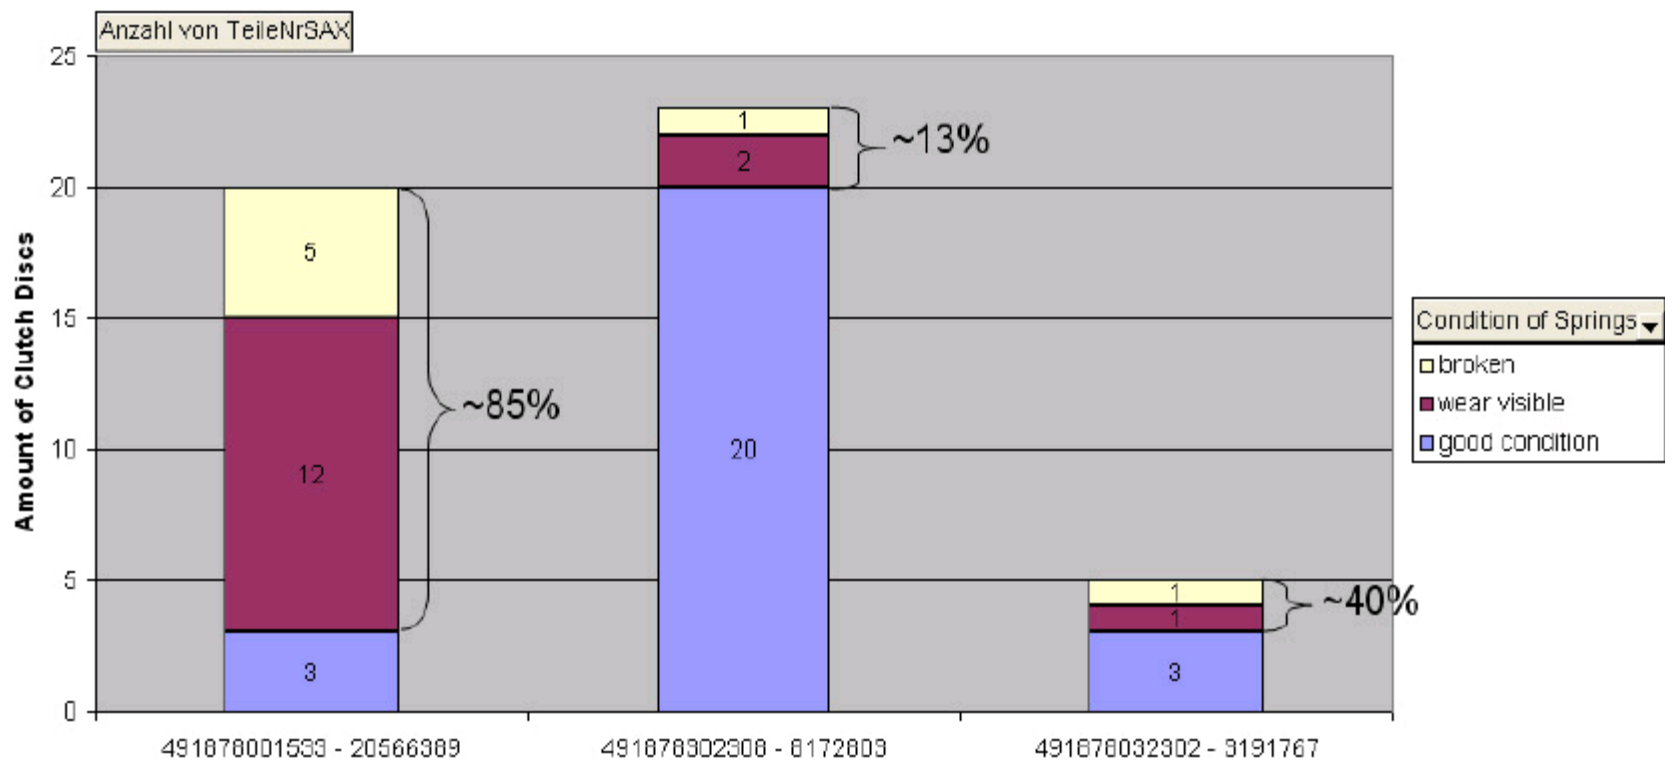
Evaluation - Wear at Springs

B4 – Investigation of 50 clutch discs from Bielefeld

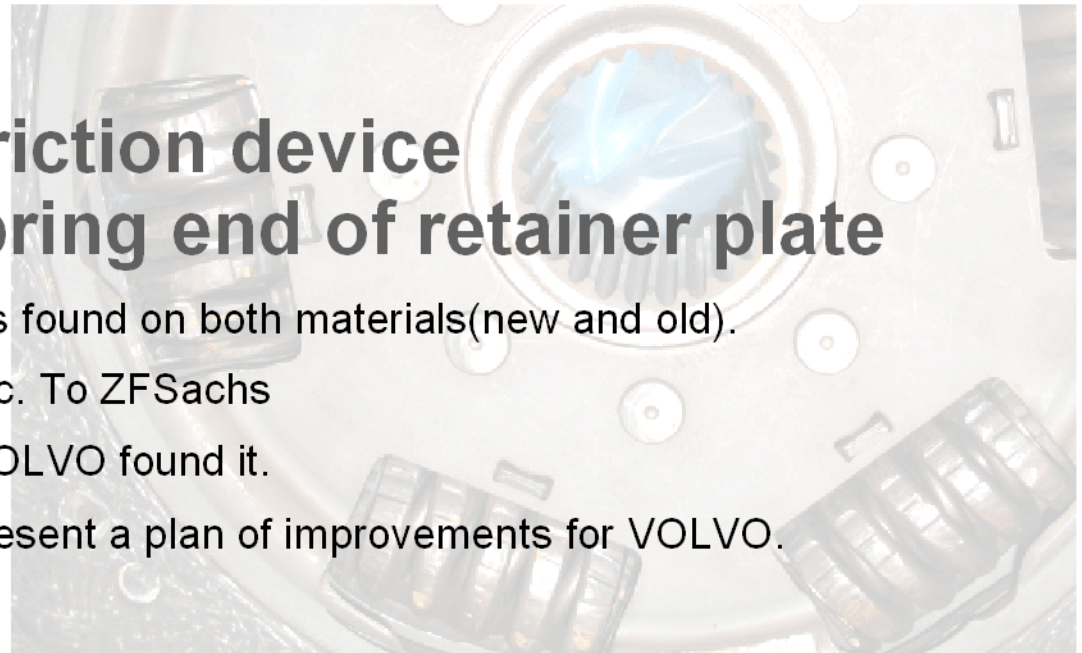
flakings of the Volvo field test clutch

- Flaking is not a new phenomena, it was found on both materials(new and old).
- It is not a VOLVO specific problems acc. To ZFSachs
- ZF Sachs was not aware of this until VOLVO found it.
- ZFSachs are analyzing this and will present a plan of improvements for VOLVO.

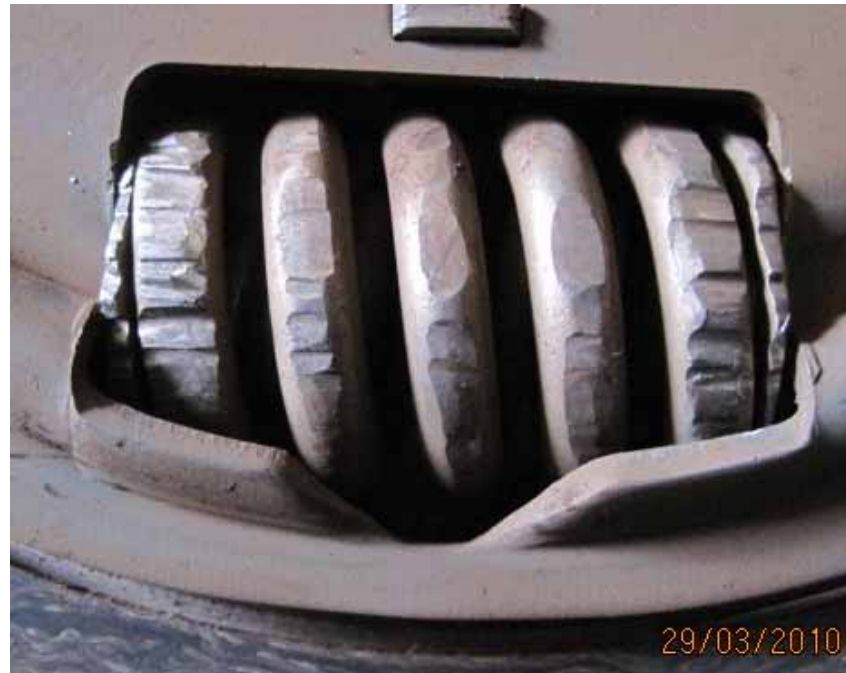
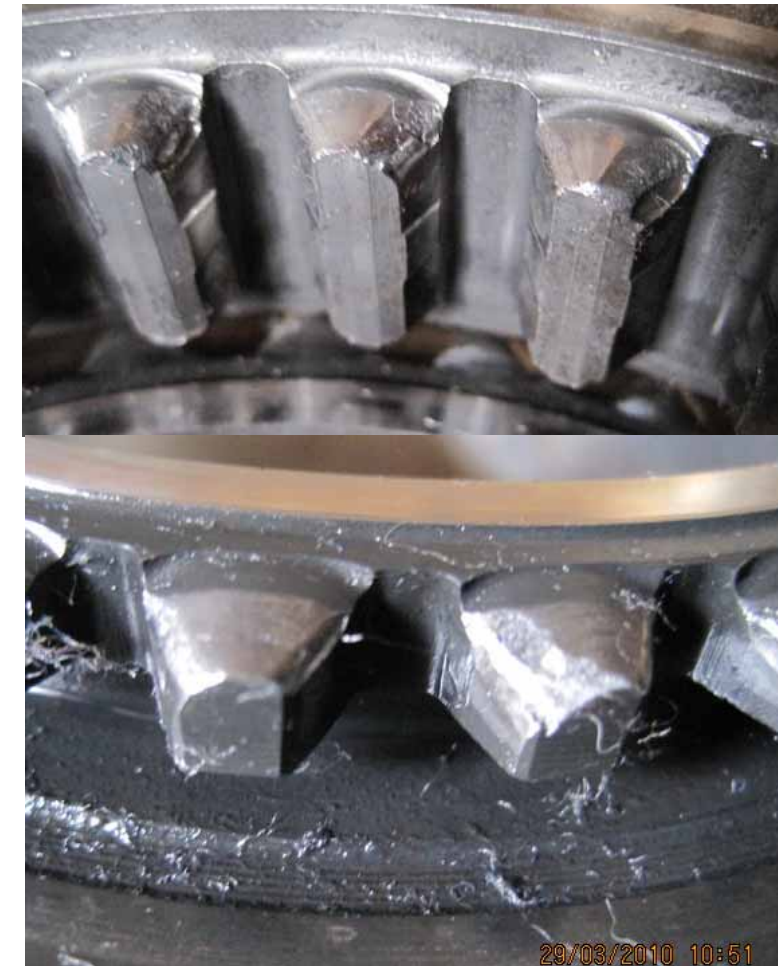
A-656043 - 311970kms
1068 Carlisle Jump Out 2/3/4/5/7/9
Damper, sleeve & gear all damaged

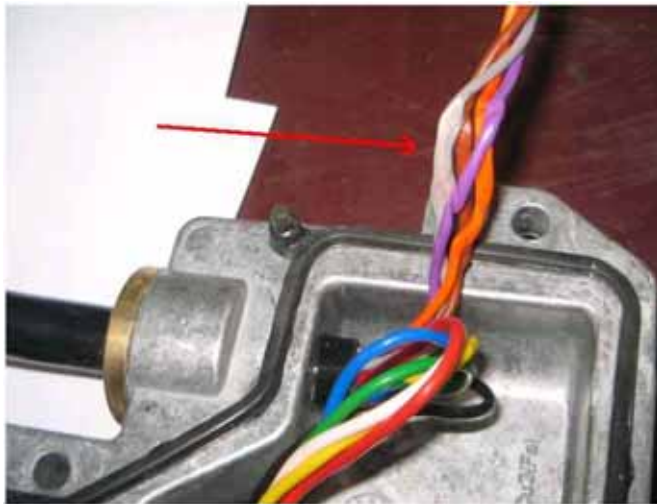
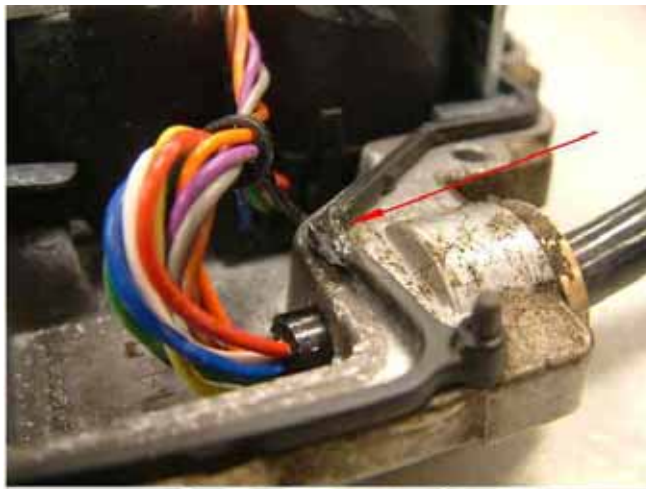
Before S/N 36050:

After S/N 36050 the assembly process has been changed. 3 cable ties are mounted:
