PE13-017

SUTPHEN

7-25-2013

Enclosed is the information that was requested as part of Preliminary Evaluation PE13-017.

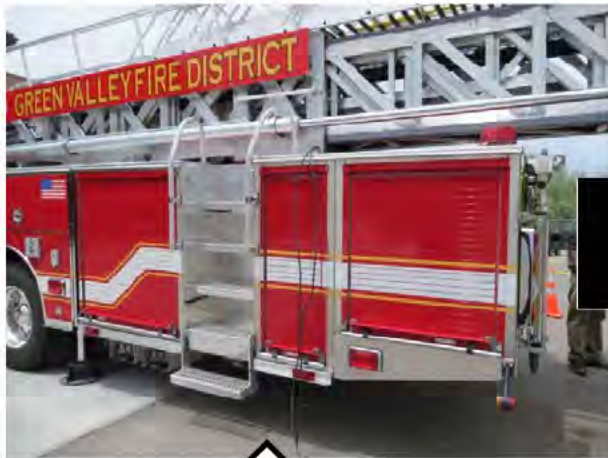
Photo showing the cables lying off the side of the apparatus

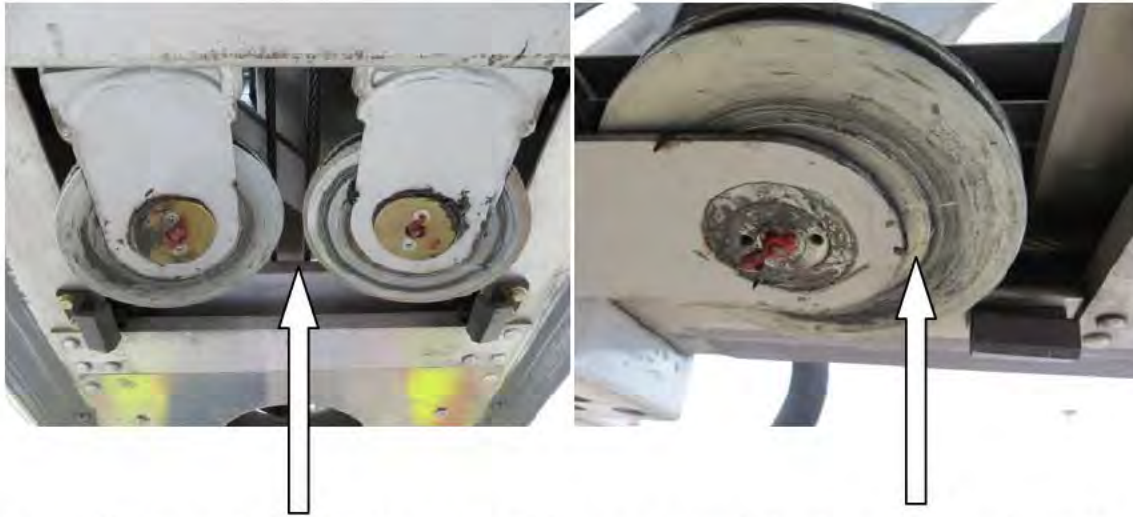
Note in the above photos that there is no visible grease around the sheave wheel and that the wheel is pulled off center approximately 3/8". These two wheels could not be turned by hand.

It is important to note that both extend cables failed.

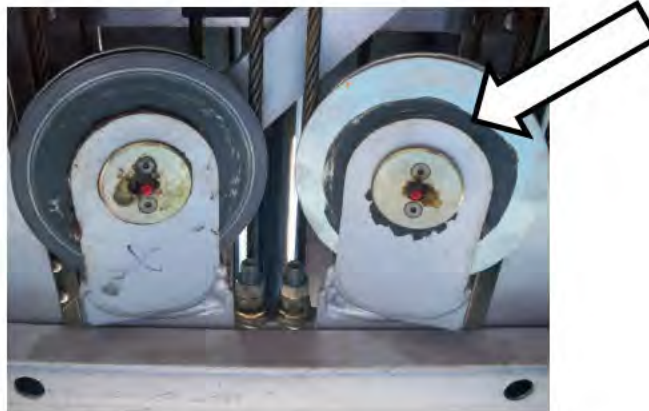
Below are photos of the same components on a truck (Rostraver PA # HS4382) that was manufactured one year prior to the [REDACTED] unit. The grease is plainly visible and the pulley wheels are centered.

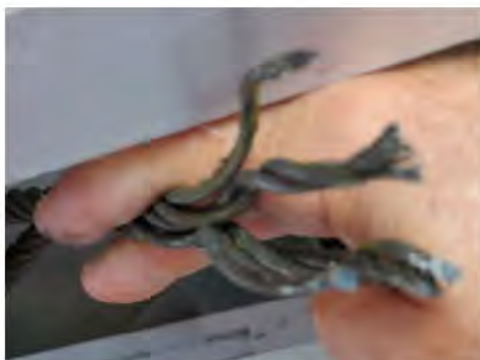
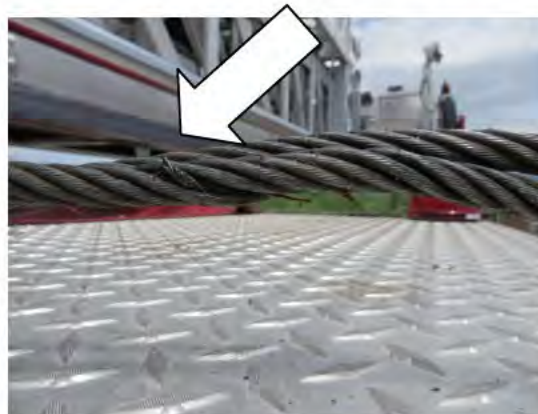
We did find one cable end that was frayed.

Visible broken strands of the extend cables

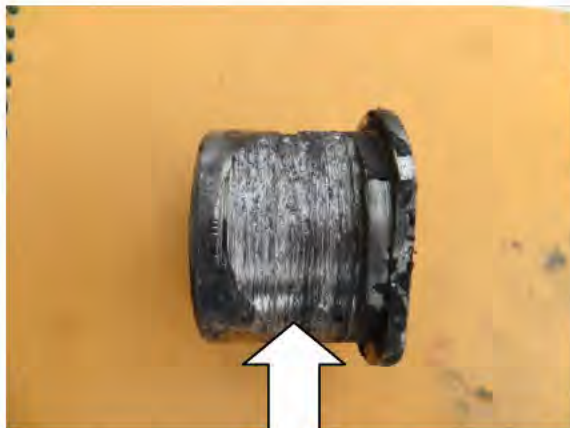
Once the first wheel was removed we found that there was no visible lubricant and the composite bearing was worn completely away on one side. The pin itself was worn flat about 3/16 to 1/4". The wheel is showing signs of abnormal wear on both the top and bottom side where it was rubbing on the bracket.

Worn Pulley Pin

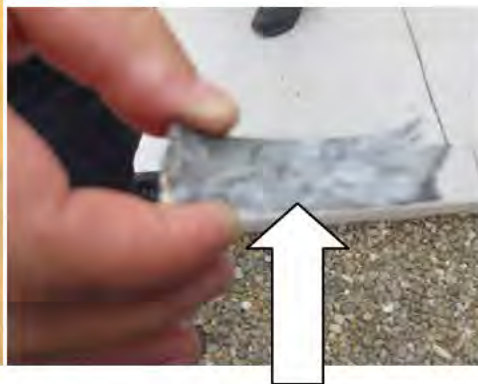
Composite Bearing showing 70% to 80% of the material worn away.

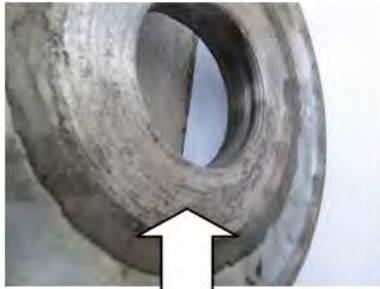
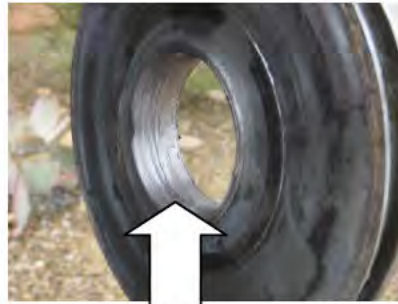
Sheave Wheel showing metal on metal contact and no lubrication. Note that the outside area was also rubbing on the bracket. This would make one assume that no lubrication is the cause of this wear.

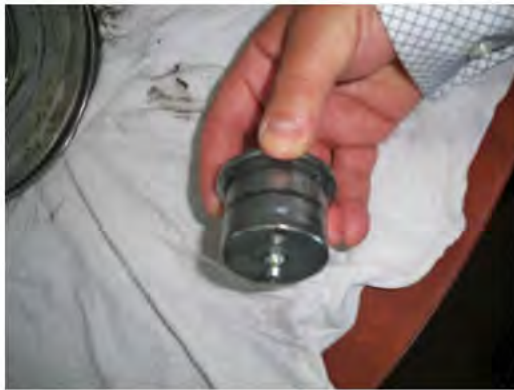
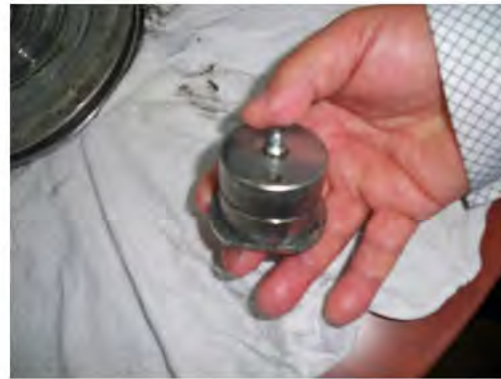
Sheave Wheel Pin with no wear

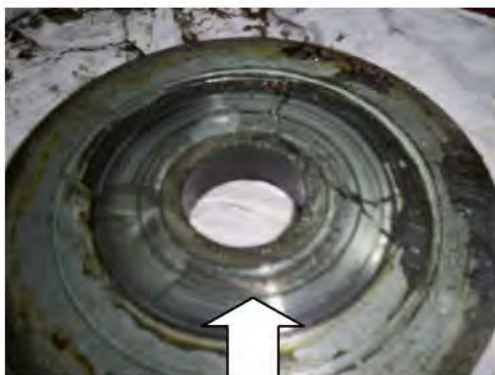
Sheave wheel with no wear, unlike the components on the [REDACTED] unit

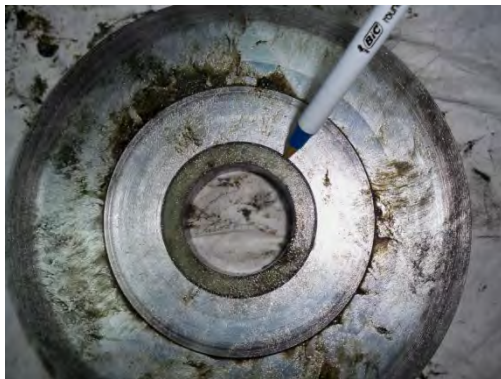
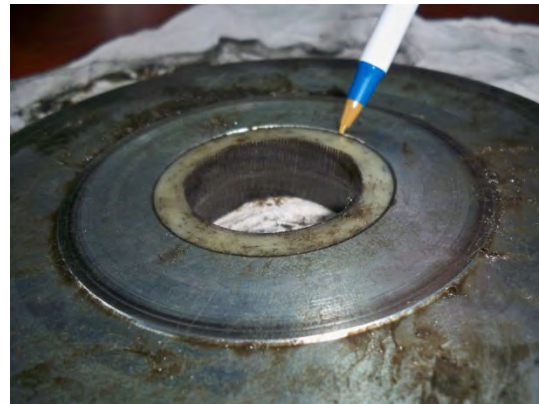
Composite Bearing as installed in the wheel. No signs of wear. This wheel is from the Rostraver unit that is one year older than the [REDACTED] unit.
