PE13-017

Accident Investigation Report -  
8-20-12

Re: Accident Investigation – Production #HS4596 Green Valley AZ, SPH100 Aerial Platform

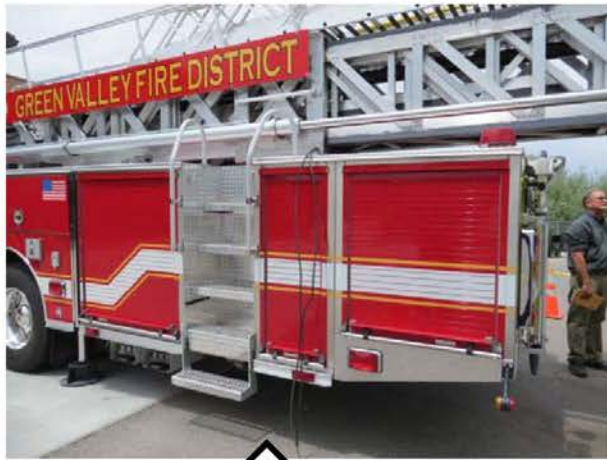
Photo showing the cables lying off the side of the apparatus

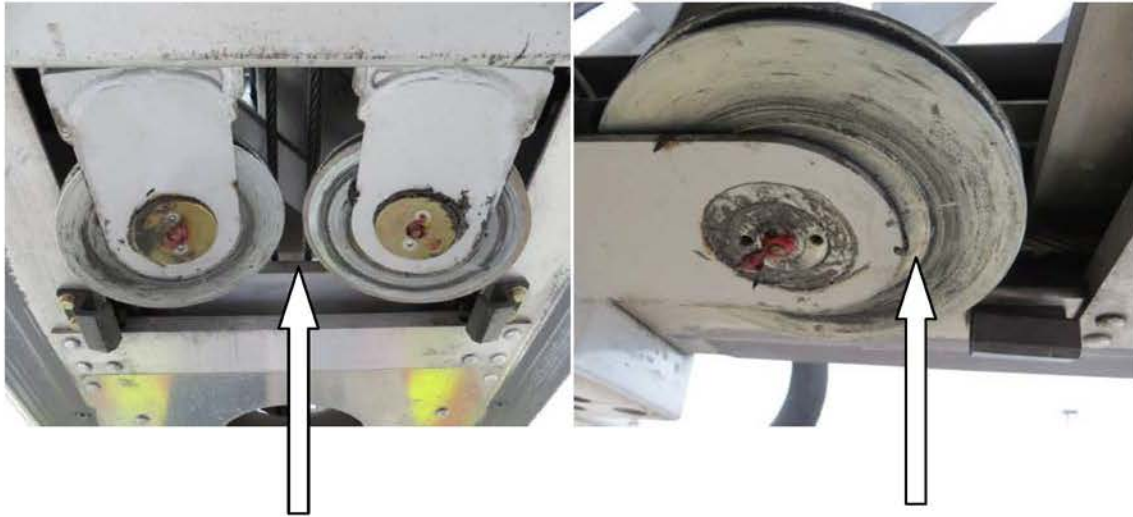
Officer Johnson explained his concern was with two pulley sheaves located at the end of the second boom section. He asked us to look at the two sheave wheels. He wanted to know if it was normal for them to be tight and not turn. The two wheels appeared to be off center by about ½" and locked up tight. We explained that it was not normal.

Note in the above photos that there is no visible grease around the sheave wheel and that the wheel is pulled off center approximately 3/8". These two wheels could not be turned by hand.

**It is important to note that both extend cables failed.**

In our opinion, proper maintenance would have kept the components from prematurely wearing out. Along with this, proper inspection would have caught the abnormal wear on the cables and sheaves. Maintenance could have then been performed to address the problem before the components seized. So with a properly maintained and inspected apparatus, the risk of this type of incident is very minimal.

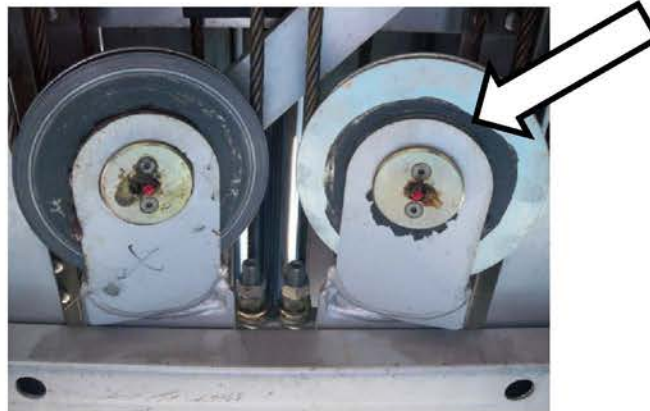
Below are photos of the same components on a truck (Rostraver PA # HS4382) that was manufactured one year prior to the Green Valley unit. The grease is plainly visible and the pulley wheels are centered.

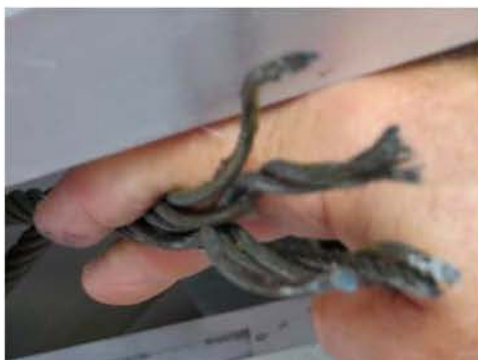
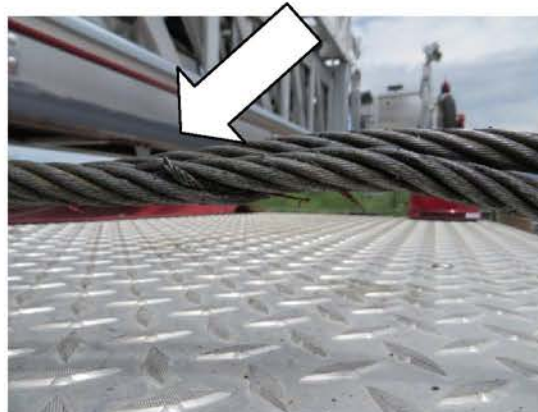
We did find one cable end that was frayed.

Visible broken strands of the extend cables

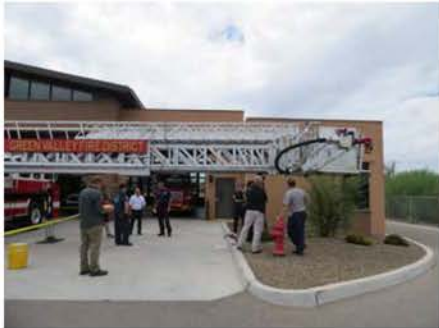
When Joe arrived we had swung the boom to the right sight side of the apparatus to get a better view of the underside of the boom assembly.

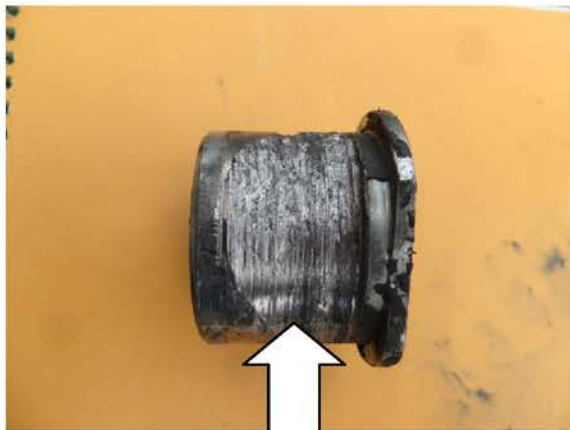
Once the first wheel was removed we found that there was no visible lubricant and the composite bearing was worn completely away on one side. The pin itself was worn flat about 3/16 to 1/4". The wheel is showing signs of abnormal wear on both the top and bottom side where it was rubbing on the bracket.

Worn Pulley Pin

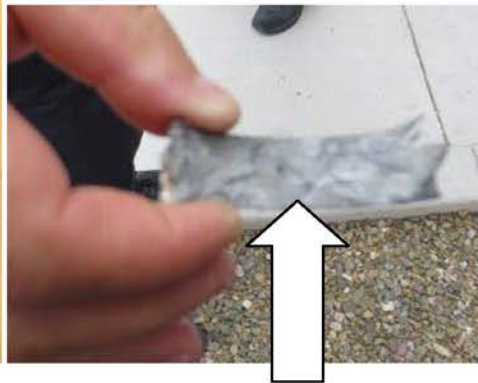
Composite Bearing showing 70% to 80% of the material worn away.

Based upon the investigations inspections conducted at the scene of the incident and during the repair of the vehicle, this appears to be related to a maintenance/training issue. The bushings in the sheave assemblies located at the tip of section 2 were worn away. This eventually led to the sheave rotating on the steel pivot pin. Over time, this caused the sheaves and pins to wear enough that the sheaves seized up and would not rotate. As the ladder continued to operate in this condition, the wire rope cables were sliding over the stationary sheaves. This led the cables to wear prematurely and decreased their load carrying capability. With a heavy load in the platform, the cables broke, which resulted in the ladder unexpectedly retracting.

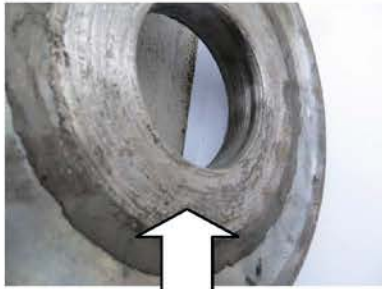
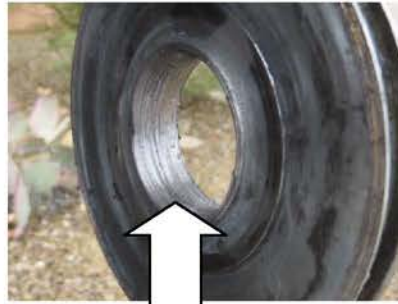
Sheave Wheel showing metal on metal contact and no lubrication. Note that the outside area was also rubbing on the bracket. This would make one assume that no lubrication is the cause of this wear.

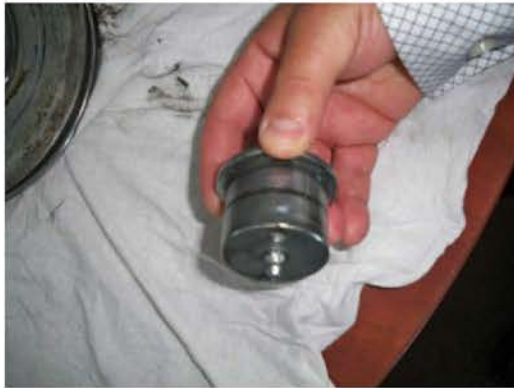
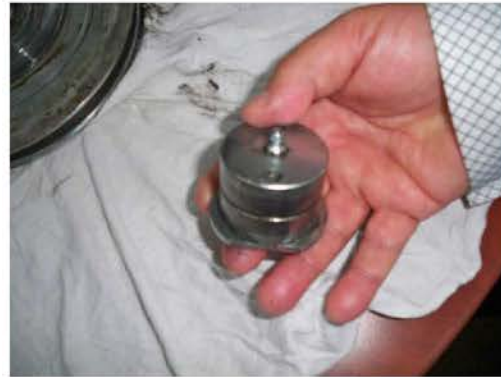
Sheave Wheel Pin with no wear

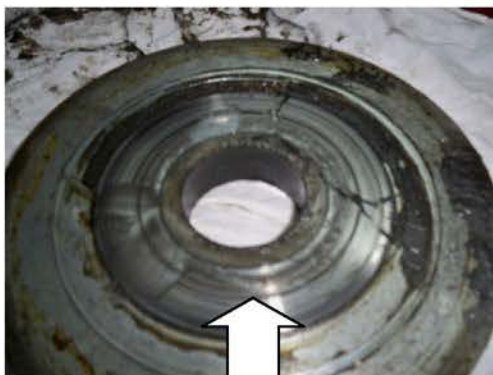
Sheave wheel with no wear, unlike the components on the Green Valley unit

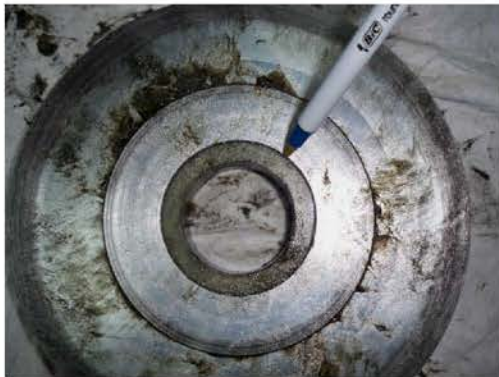
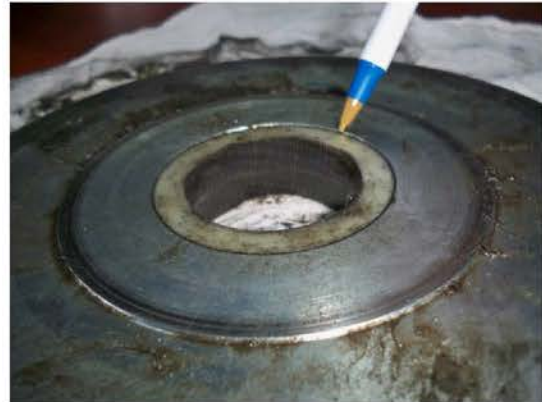
Composite Bearing as installed in the wheel. No signs of wear. This wheel is from the Rostraver unit that is one year older than the Green Valley unit.
