PE13-018

FORD

APPENDIX B

2011 – 2013 Ford F-150 Unexpected Reduction in Engine Power During Hard Acceleration

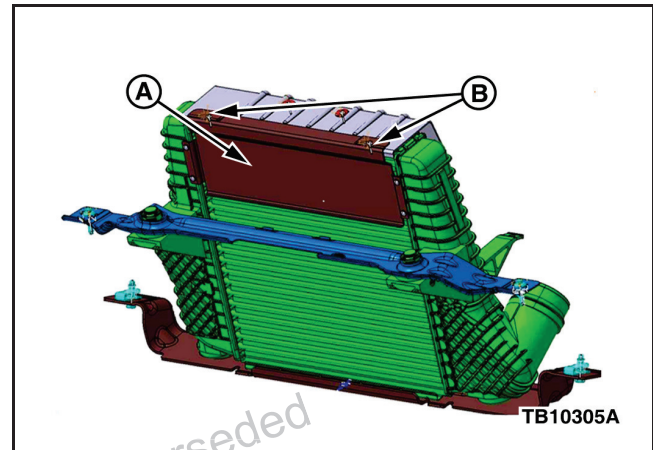
Figure 1 - Article 12-6-4

- Intermittent stumble and/or misfire on hard acceleration after an extended drive at highway speeds being more noticeable during humid or damp conditions.
- Intermittent engine surge during moderate to light loads at cruise.
- Powertrain control module (PCM) Misfire DTC P030x.
- PCM DTC P0430 and/or P0299.

1. Check for DTC P0430. Is DTC P0430 present?
 - a. Yes - Replace the left bank catalytic converter assembly. Refer to Workshop Manual (WSM), Section 309-00. Proceed to Step 2.
 - b. No - Proceed to Step 2.
2. Is the Charge Air Cooler (CAC) equipped with an air deflector plate? (Figure 1A)

- a. Yes - Proceed to Step 4.
- b. No - Proceed to Step 3.
3. Install CAC air deflector plate with two new push pins. (Figure 1B) Proceed to step 4.
4. Reprogram the PCM to the latest calibration using IDS release 79.02A or higher. This new calibration is not included in the 2012.5 DVD. Calibration files may also be obtained at www.motorcraft.com.

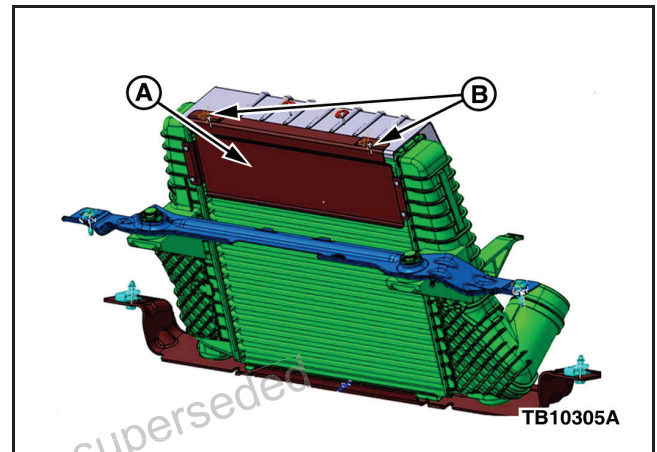
Figure 1 - Article 12-10-19

Some 2011-2012 F-150 vehicles equipped with a 3.5L gasoline turbocharged direct injection (GTDI) EcoBoost engine may exhibit an intermittent engine surge during moderate to light loads at cruise, stumble and/or misfire on hard acceleration after an extended drive at highway speeds during high humid or damp conditions. This could result in a steady or flashing malfunction indicator lamp (MIL) with diagnostic trouble codes (DTCs) primarily for misfire P0300, P0304, P0305, P0306. DTCs P0430 and/or P0299 may also be present.

1. Check for DTC P0430. Is DTC P0430 present?
 - a. Yes - Replace the left bank catalytic converter assembly. Refer to Workshop Manual (WSM), Section 309-00. Proceed to Step 2.
 - b. No - Proceed to Step 2.
2. Is the Charge Air Cooler (CAC) equipped with an air deflector plate? (Figure 1A)

- a. Yes - Proceed to Step 5.
 - b. No - Proceed to Step 3.
3. Install a new CAC, new air deflector plate, and original shield using new retaining pushpins. Refer to WSM, Section 303-12. (Figure 1B) Proceed to Step 4.
 4. Reprogram the PCM to the latest calibration using IDS release 79.02A or higher. This new calibration is not included in the 2012.5 DVD. Calibration files may also be obtained at www.motorcraft.com.
 5. Install a new CAC and the original air deflector plate and shield using new retaining pushpins. Refer WSM, Section 303-12.

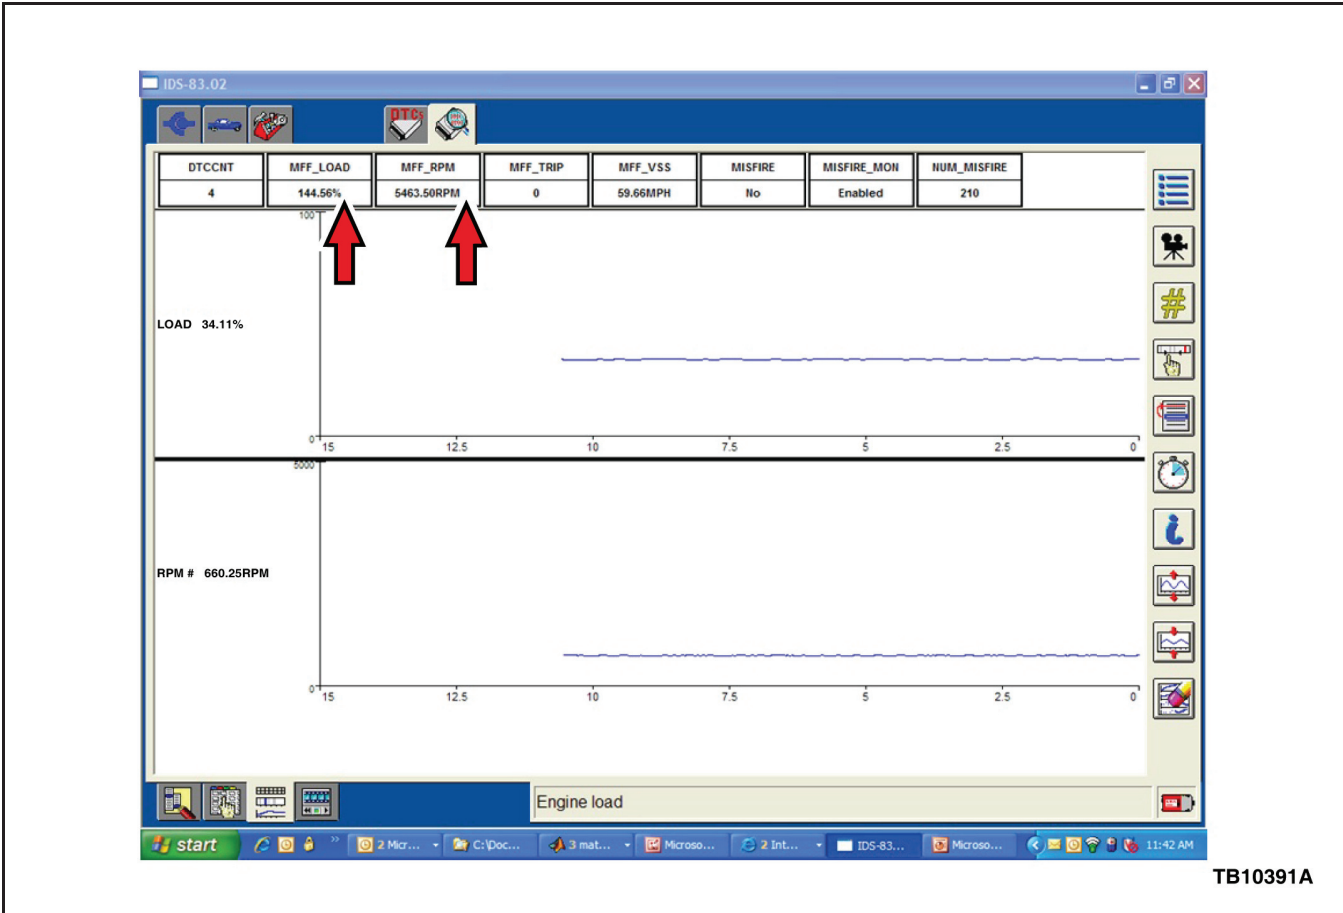
Figure 1 - Article 13-3-3

Some 2011-2012 F-150 equipped with a 3.5L gasoline turbocharged direct injection (GTDI) Ecoboost engine may exhibit an intermittent stumble and/or misfire on hard acceleration after an extended drive at highway speeds during high humid or damp conditions. This may result in either a steady or flashing malfunction indicator lamp (MIL). Diagnostic trouble codes (DTC s) P0304, P0305, P0306, or P0430 may also be present. Evidence of misfire may be available in Misfire Freeze Frame Data even with no active DTC's.

1. Acquire Misfire Freeze Frame Data and DTC¹s with the IDS. Use the following steps with IDS to obtain Misfire Freeze Frame Data.
 - a. Select Toolbox
 - b. Then Data Logger
 - c. Then Modules
 - d. Then PCM
 - e. Next select the following PIDS: MFF_LOAD and MFF_RPM
2. Check for DTC P0430. Is DTC P0430 present?
 - a. Yes - replace the left bank catalytic converter assembly. Refer to Workshop Manual (WSM), Section 309-00. Proceed to Step 3.
 - b. No - Proceed to Step 3.
3. Is the misfire concern only repeatable in humid or damp conditions?
 - a. Yes - proceed to Step 4
 - b. No - this article does not apply. Refer to Powertrain Control Emission Diagnosis (PC/ED) Manual Section 3: Powertrain Symptom Index to inspect such areas as Ignition, Compression, and Injection.
4. Does the Misfire Freeze Frame Data indicate engine speed above 2500 RPM and load 100% or above? (Figure 1)

- a. Yes - proceed to Step 5.
 - b. No - this article does not apply. Refer to PC/ED Manual Section 3: Powertrain Symptom Index to inspect such areas as Ignition, Compression, and Injection.
5. Is the Charge Air Cooler (CAC) equipped with an air deflector plate? (Figure 2A)

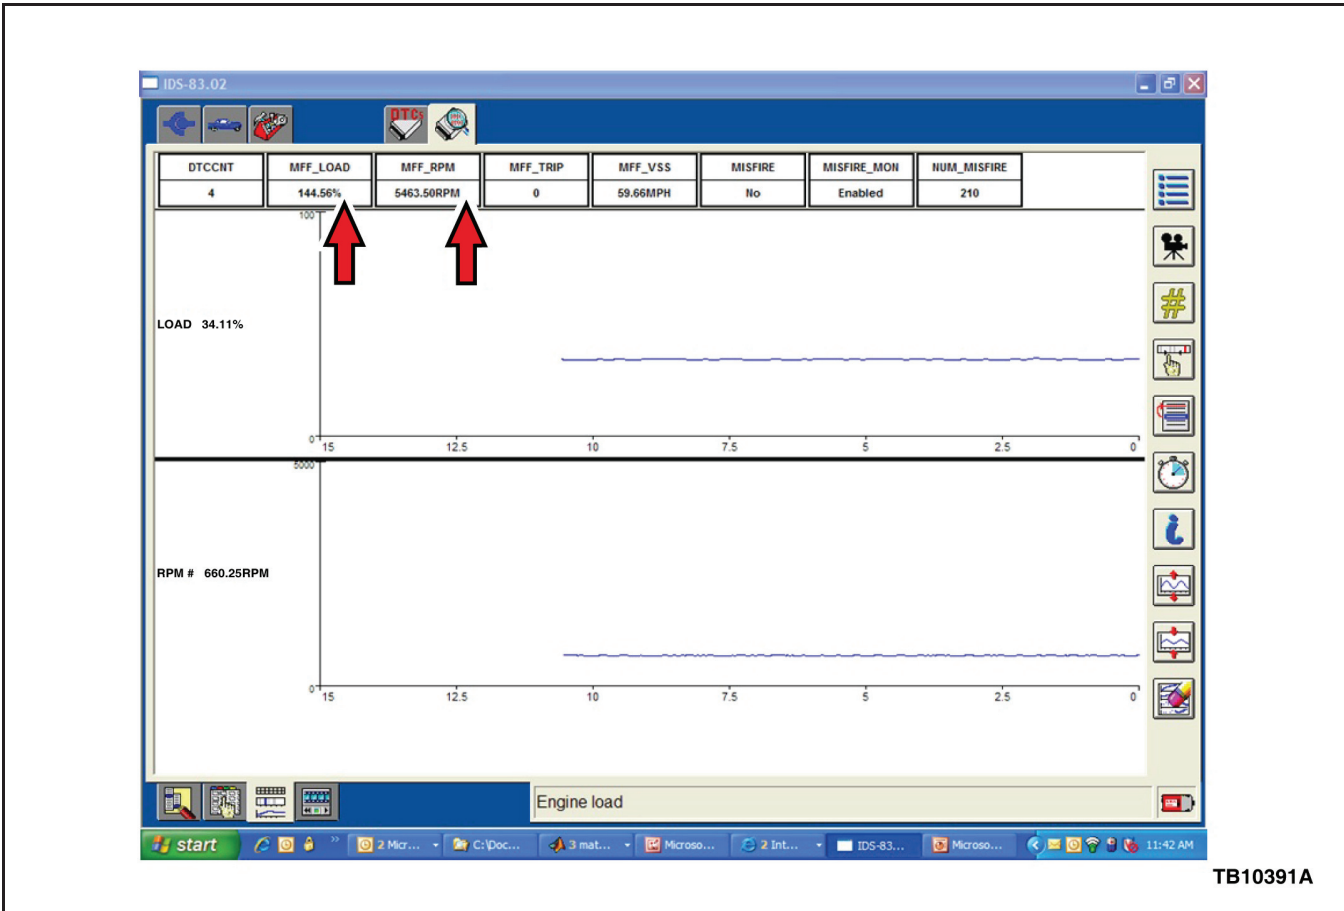
Figure 1 - Article 13-8-1

Some 2011-2012 F-150 equipped with a 3.5L gasoline turbocharged direct injection (GTDI) Ecoboost engine may exhibit an intermittent stumble and/or misfire on hard acceleration after an extended drive at highway speeds during high humidity or damp conditions. This may result in either a steady or flashing malfunction indicator lamp (MIL). Diagnostic trouble codes (DTCs) P0304, P0305, P0306, or P0430 may also be present. Evidence of misfire may be available in Misfire Freeze Frame Data even with no active DTCs.

- a. Select Toolbox
- b. Then Data Logger
- c. Then Modules
- d. Then PCM
- e. Next, select the following PIDs: MFF_LOAD and MFF_RPM.
2. Is the misfire concern only repeatable in humid or damp conditions?
 - a. Yes - Proceed to Step 3.
 - b. No - This article does not apply. Refer to Powertrain Control/Emissions Diagnosis (PC/ED) Manual Section 3: Powertrain Symptom Index to inspect such areas as Ignition, Compression, and Injection.
3. Does the Misfire Freeze Frame Data indicate engine speed above 2500 rpm and load 100% or above? (Figure 1)

- a. Yes - Proceed to Step 4.
 - b. No - This article does not apply. Refer to PC/ED Manual Section 3: Powertrain Symptom Index to inspect such areas as Ignition, Compression, and Injection.
4. Is vehicle equipped with latest level charge air cooler, engineering part number BL34-9L440-AE? (Figure 2)

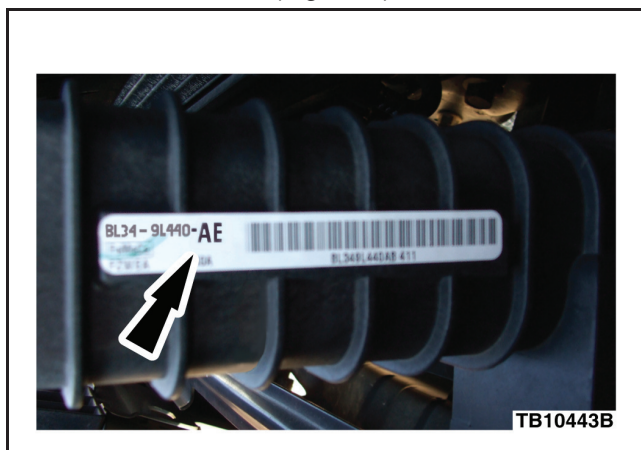
Figure 2 - Article 13-8-1

CARE NEEDS TO BE TAKEN NOT TO INSTALL THE REVISED BOTTOM AIR DEFLECTOR ONTO CHARGE AIR COOLER ENGINEERING PART BL34-9L440-AE AS IT WILL RESULT IN HIGHER MANIFOLD AIR CHARGE TEMPERATURES AND SIGNIFICANT LOSS OF ENGINE PERFORMANCE.
