PE13-018

FORD

APPENDIX B

2011 – 2013 Ford F-150 Unexpected Reduction in Engine Power During Hard Acceleration

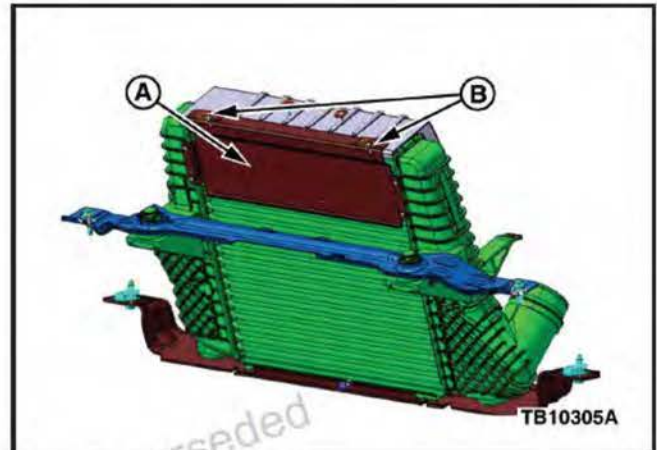
Figure 1 - Article 12-6-4

1. Check for DTC P0430. Is DTC P0430 present?
 - a. Yes - Replace the left bank catalytic converter assembly. Refer to Workshop Manual (WSM), Section 309-00. Proceed to Step 2.
 - b. No - Proceed to Step 2.
2. Is the Charge Air Cooler (CAC) equipped with an air deflector plate? (Figure 1A)

- a. Yes - Proceed to Step 4.
- b. No - Proceed to Step 3.
3. Install CAC air deflector plate with two new push pins. (Figure 1B) Proceed to step 4.
4. Reprogram the PCM to the latest calibration using IDS release 79.02A or higher. This new calibration is not included in the 2012.5 DVD. Calibration files may also be obtained at www.motorcraft.com.

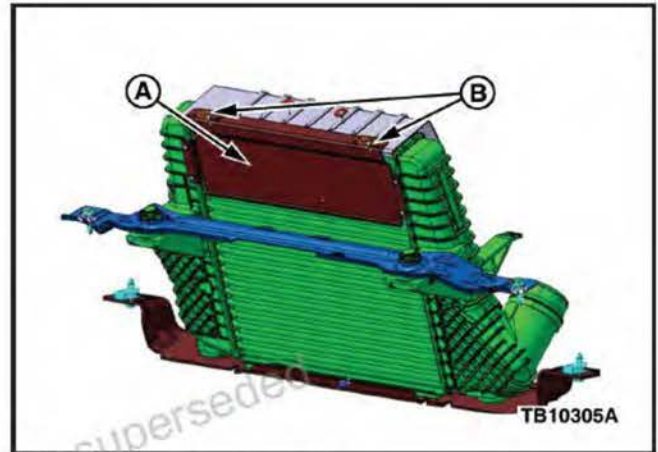
Figure 1 - Article 12-10-19

1. Check for DTC P0430. Is DTC P0430 present?
 - a. Yes - Replace the left bank catalytic converter assembly. Refer to Workshop Manual (WSM), Section 309-00. Proceed to Step 2.
 - b. No - Proceed to Step 2.
2. Is the Charge Air Cooler (CAC) equipped with an air deflector plate? (Figure 1A)

- a. Yes - Proceed to Step 5.
 - b. No - Proceed to Step 3.
3. Install a new CAC, new air deflector plate, and original shield using new retaining pushpins. Refer to WSM, Section 303-12. (Figure 1B) Proceed to Step 4.
 4. Reprogram the PCM to the latest calibration using IDS release 79.02A or higher. This new calibration is not included in the 2012.5 DVD. Calibration files may also be obtained at www.motorcraft.com.
 5. Install a new CAC and the original air deflector plate and shield using new retaining pushpins. Refer WSM, Section 303-12.

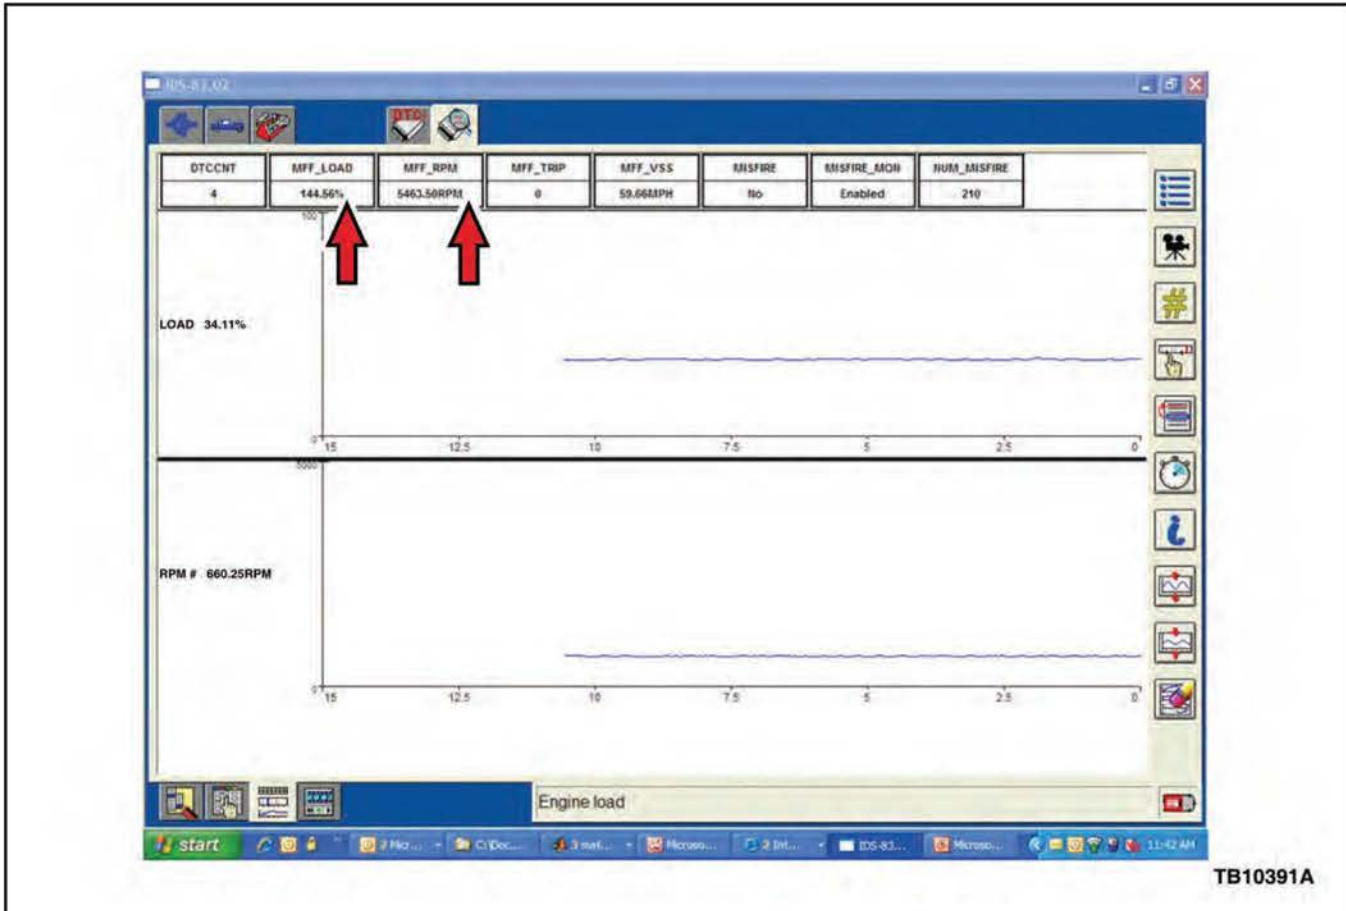
Figure 1 - Article 13-3-3

1. Acquire Misfire Freeze Frame Data and DTC¹s with the IDS. Use the following steps with IDS to obtain Misfire Freeze Frame Data.
 - a. Select Toolbox
 - b. Then Data Logger
 - c. Then Modules
 - d. Then PCM
 - e. Next select the following PIDS: MFF_LOAD and MFF_RPM
2. Check for DTC P0430. Is DTC P0430 present?
 - a. Yes - replace the left bank catalytic converter assembly. Refer to Workshop Manual (WSM), Section 309-00. Proceed to Step 3.
 - b. No - Proceed to Step 3.
3. Is the misfire concern only repeatable in humid or damp conditions?
 - a. Yes - proceed to Step 4
 - b. No - this article does not apply. Refer to Powertrain Control Emission Diagnosis (PC/ED) Manual Section 3: Powertrain Symptom Index to inspect such areas as Ignition, Compression, and Injection.
4. Does the Misfire Freeze Frame Data indicate engine speed above 2500 RPM and load 100% or above? (Figure 1)

- a. Yes - proceed to Step 5.
 - b. No - this article does not apply. Refer to PC/ED Manual Section 3: Powertrain Symptom Index to inspect such areas as Ignition, Compression, and Injection.
5. Is the Charge Air Cooler (CAC) equipped with an air deflector plate? (Figure 2A)

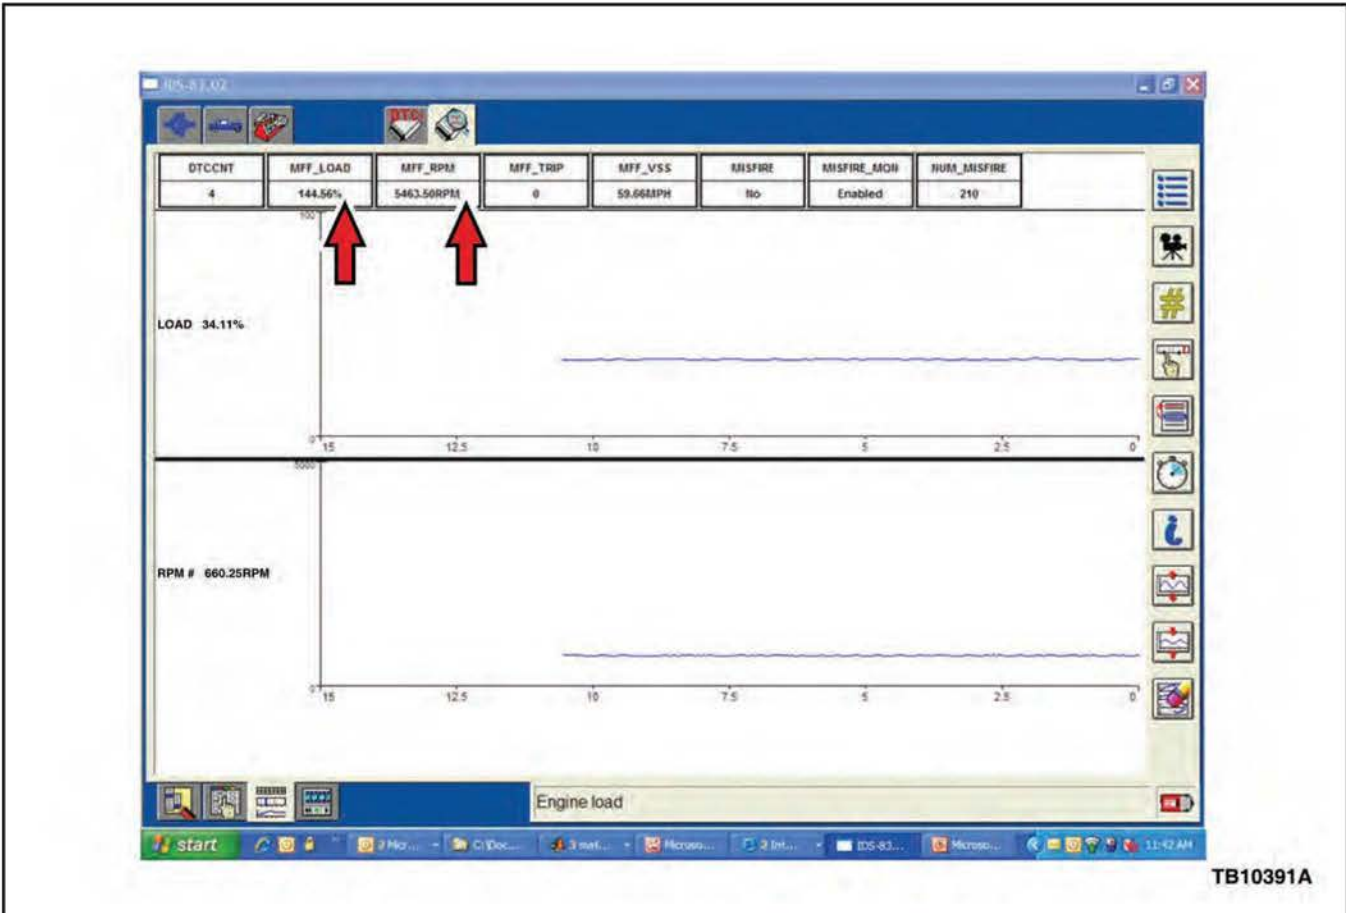
Figure 1 - Article 13-8-1

- a. Select Toolbox
- b. Then Data Logger
- c. Then Modules
- d. Then PCM
- e. Next, select the following PIDs: MFF_LOAD and MFF_RPM.
2. Is the misfire concern only repeatable in humid or damp conditions?
 - a. Yes - Proceed to Step 3.
 - b. No - This article does not apply. Refer to Powertrain Control/Emissions Diagnosis (PC/ED) Manual Section 3: Powertrain Symptom Index to inspect such areas as Ignition, Compression, and Injection.
3. Does the Misfire Freeze Frame Data indicate engine speed above 2500 rpm and load 100% or above? (Figure 1)

- a. Yes - Proceed to Step 4.
 - b. No - This article does not apply. Refer to PC/ED Manual Section 3: Powertrain Symptom Index to inspect such areas as Ignition, Compression, and Injection.
4. Is vehicle equipped with latest level charge air cooler, engineering part number BL34-9L440-AE? (Figure 2)

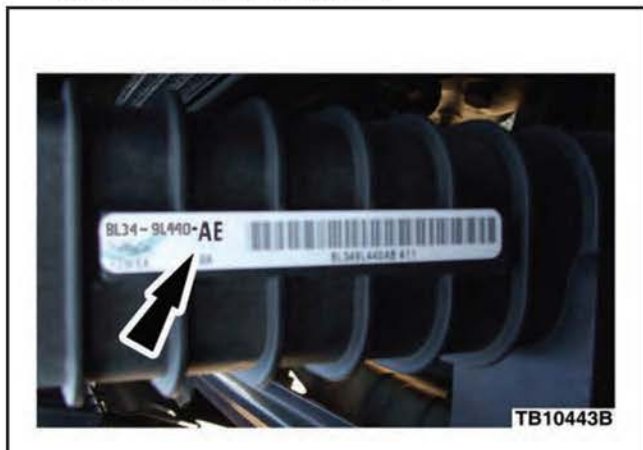
Figure 2 - Article 13-8-1

CARE NEEDS TO BE TAKEN NOT TO INSTALL THE REVISED BOTTOM AIR DEFLECTOR ONTO CHARGE AIR COOLER ENGINEERING PART BL34-9L440-AE AS IT WILL RESULT IN HIGHER MANIFOLD AIR CHARGE TEMPERATURES AND SIGNIFICANT LOSS OF ENGINE PERFORMANCE.

- a. Yes - This article does not apply. Refer to PC/ED Manual Section 3: Powertrain Symptom Index to inspect such areas as Ignition, Compression, and Injection.
- b. No - Proceed to Step 5.

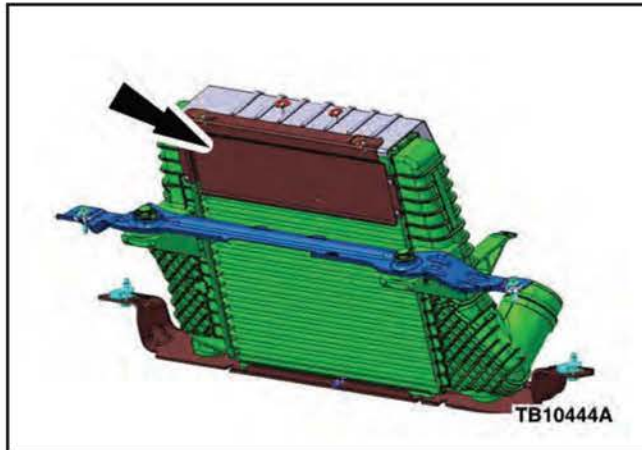
Figure 3 - Article 13-8-1

- 5. Is DTC P0430 present?
 - a. Yes - replace the left hand catalytic converter. Refer to Workshop Manual (WSM), Section 309-00. Proceed to Step 6.
 - b. No - Proceed to Step 6.
- 6. Is the Charge Air Cooler equipped with the top air deflector? (Figure 3)

- a. Yes - remove and discard. Refer to WSM, Section 303-12. Proceed to Step 7.
 - b. No - Proceed to Step 7.
7. Install revised bottom air deflector.
- a. Make sure that the lower forward facing bottom seven (7) tubes and eight (8) rows of fins on the Charge Air Cooler are dry and free of dirt and debris. (Figure 4)
