PE13-018

FORD

APPENDIX G

Engineering Review

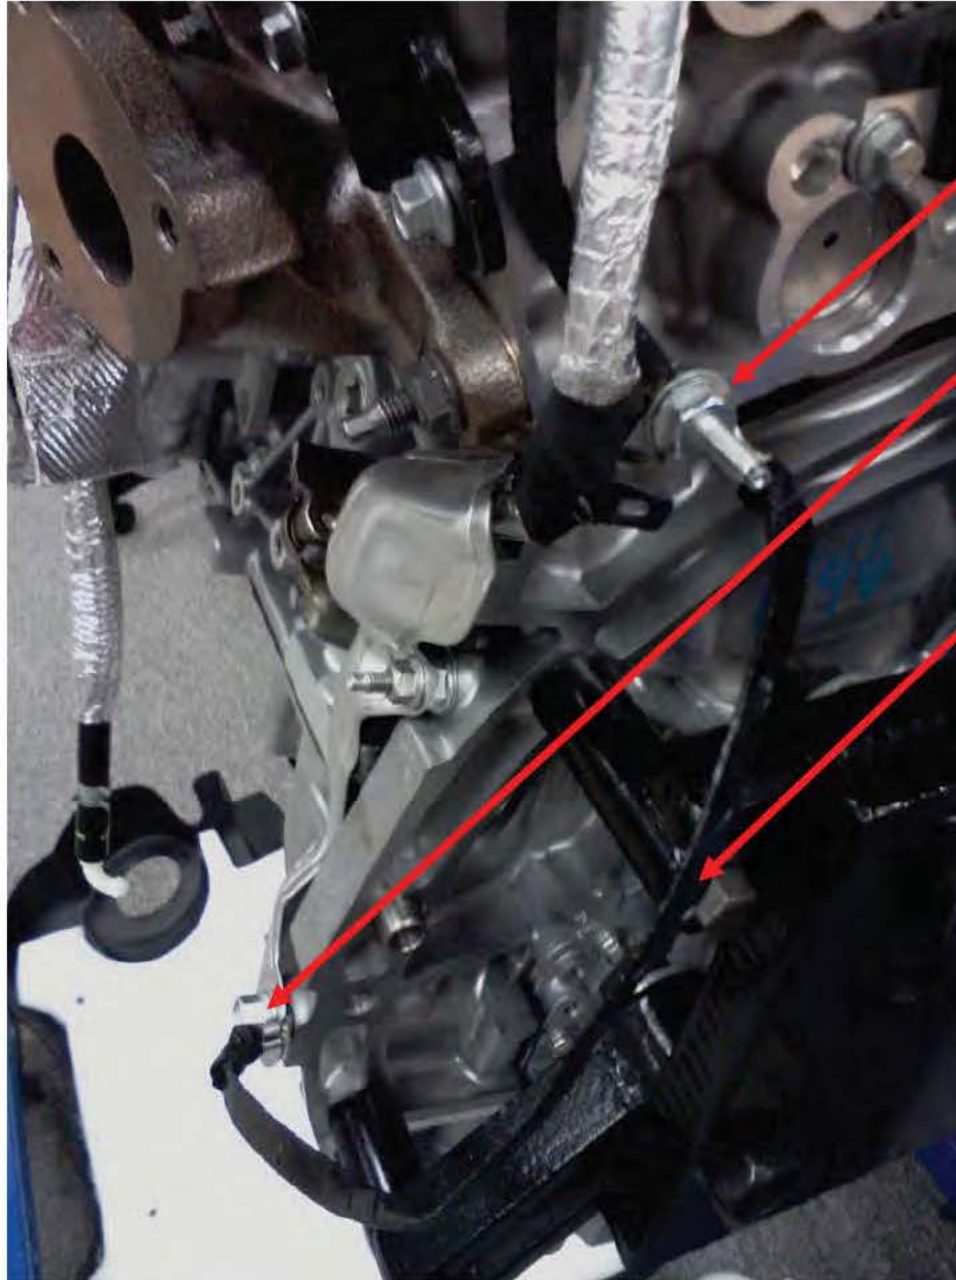
F-150 Service Ground Strap Instructions (Left/Driver side Rear of Engine)

Attach 7T4Z-19A095-A wire to G105 ground and crank position sensor heat shield lower bolt. Use a tie strap to secure wire to transmission shift cable. (Keep existing G105 ground eyelet in same position)

Install eyelet behind the stud. Torque to 10Nm (7 lb/ft) then rotate an additional 45 degrees

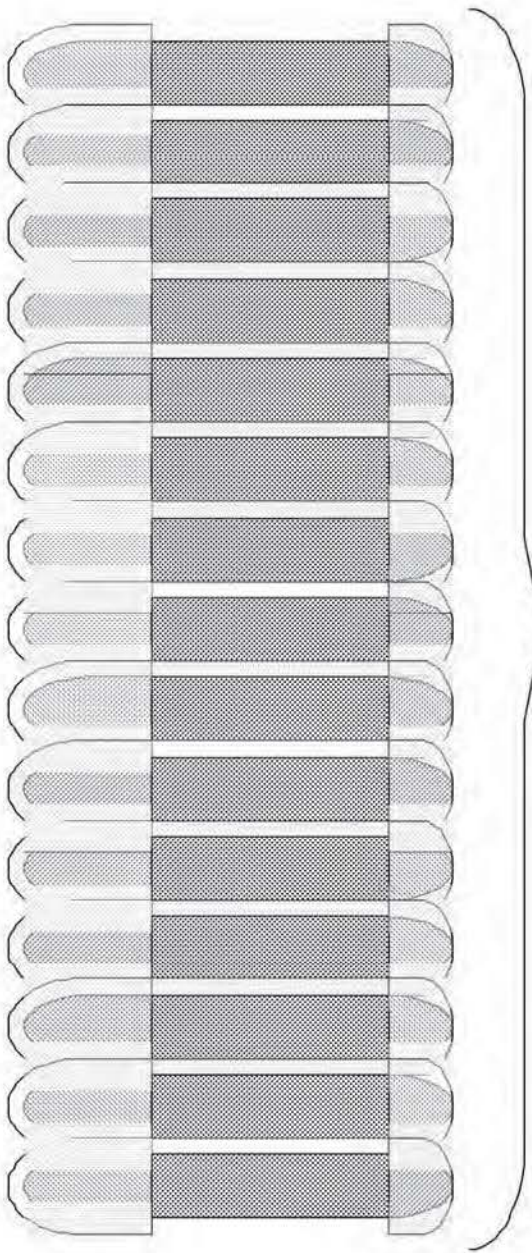
1 Part Yellow
covers 21 tubes

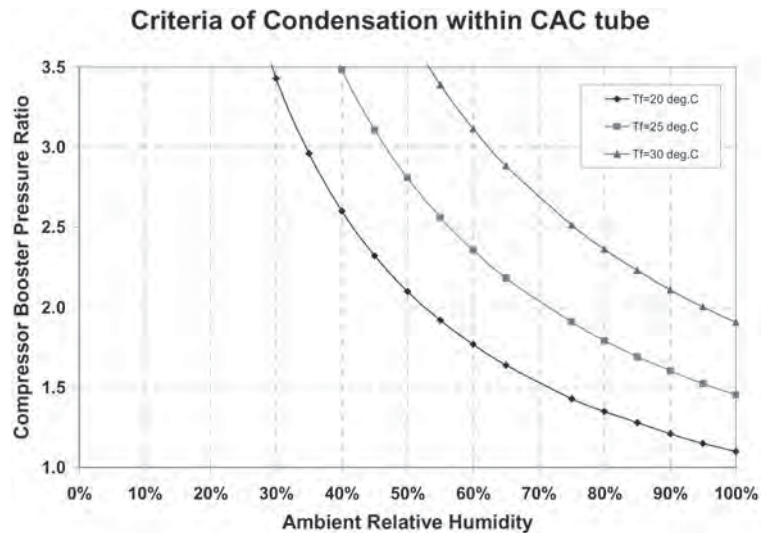
In the following Figure-1, the calculations of the criteria curves of condensation were based on a typical charge air cooler (CAC) internal pressure drop assumed to be at 100 mbar, and when the charged air of the engine manifold temperatures (T_f) are at 20, 25 and 30 degree C. Of which, the $T_f = 20$ degree C condition corresponds to the “ideal” thermal performance CAC with its manifold temperature (T_f) equals to ambient air temperature. For these charged air temperatures of engine manifold, if the vehicle charge air booster system operates above the areas of the respective plotted curves, then the condensation will occur inside the later section of charge air cooler tubes.

Figure 1. The criteria for an exemplified charge air system, including turbo-compressor-CAC at 20 degree C ambient

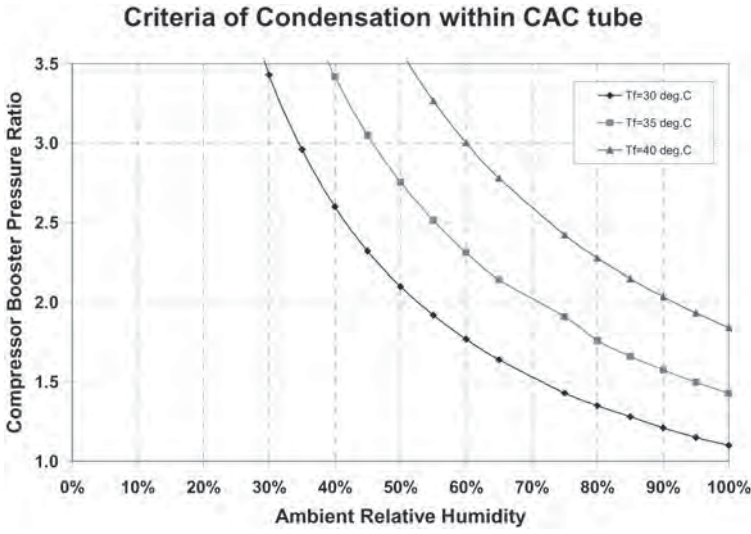
In the Figure-2, the similar calculations were conducted for higher ambient temperature: 30 degree C. Here, with the same assumption on charge air cooler (CAC) internal

pressure drop, the plots curves below were for the charged air of the engine manifold temperatures (T_f) are at 30, 35 and 40 degree C levels.

Figure 2. The criteria for an exemplified charge air system, including turbo-compressor-CAC at 30 degree C ambient

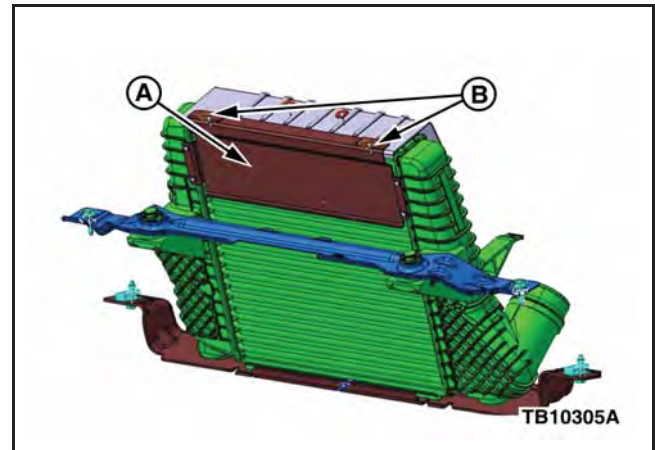
Figure 1 - Article 12-6-4

1. Check for DTC P0430. Is DTC P0430 present?
 - a. Yes - Replace the left bank catalytic converter assembly. Refer to Workshop Manual (WSM), Section 309-00. Proceed to Step 2.
 - b. No - Proceed to Step 2.
2. Is the Charge Air Cooler (CAC) equipped with an air deflector plate? (Figure 1A)

- a. Yes - Proceed to Step 4.
- b. No - Proceed to Step 3.
3. Install CAC air deflector plate with two new push pins. (Figure 1B) Proceed to step 4.
4. Reprogram the PCM to the latest calibration using IDS release 79.02A or higher. This new calibration is not included in the 2012.5 DVD. Calibration files may also be obtained at www.motorcraft.com.

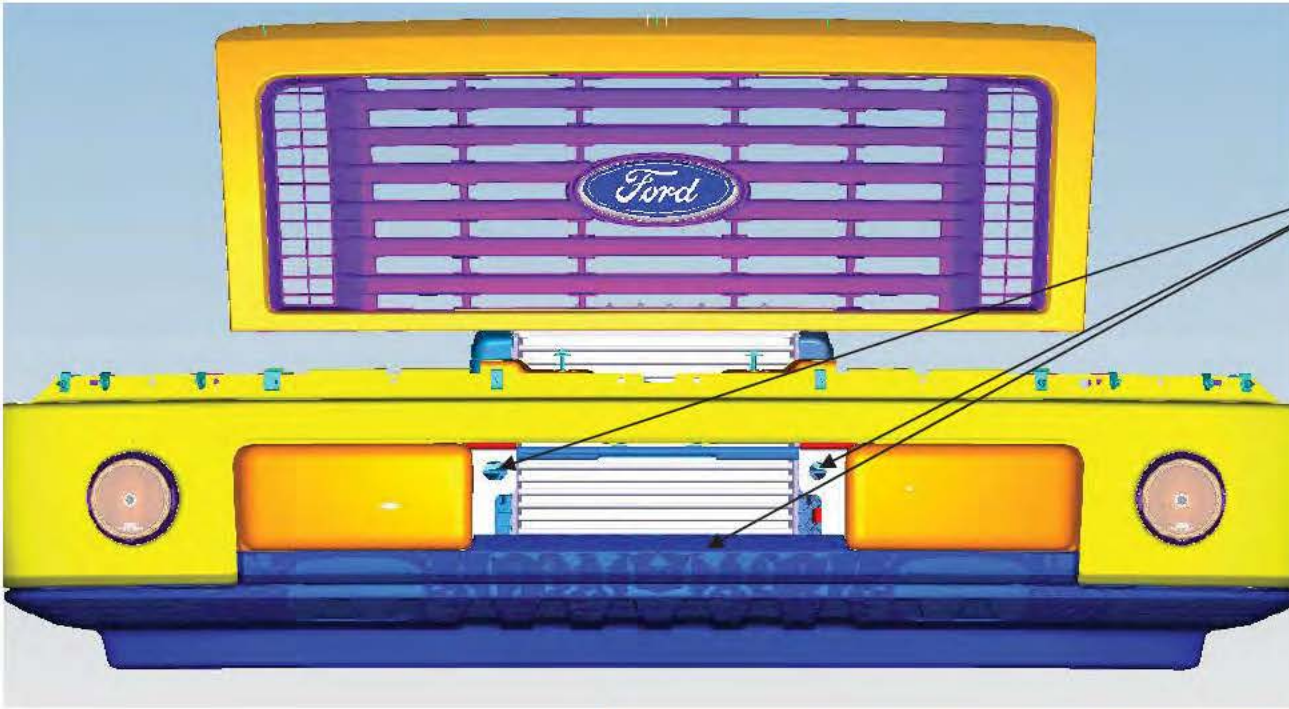
Inset plate that
mounts to holes
already available

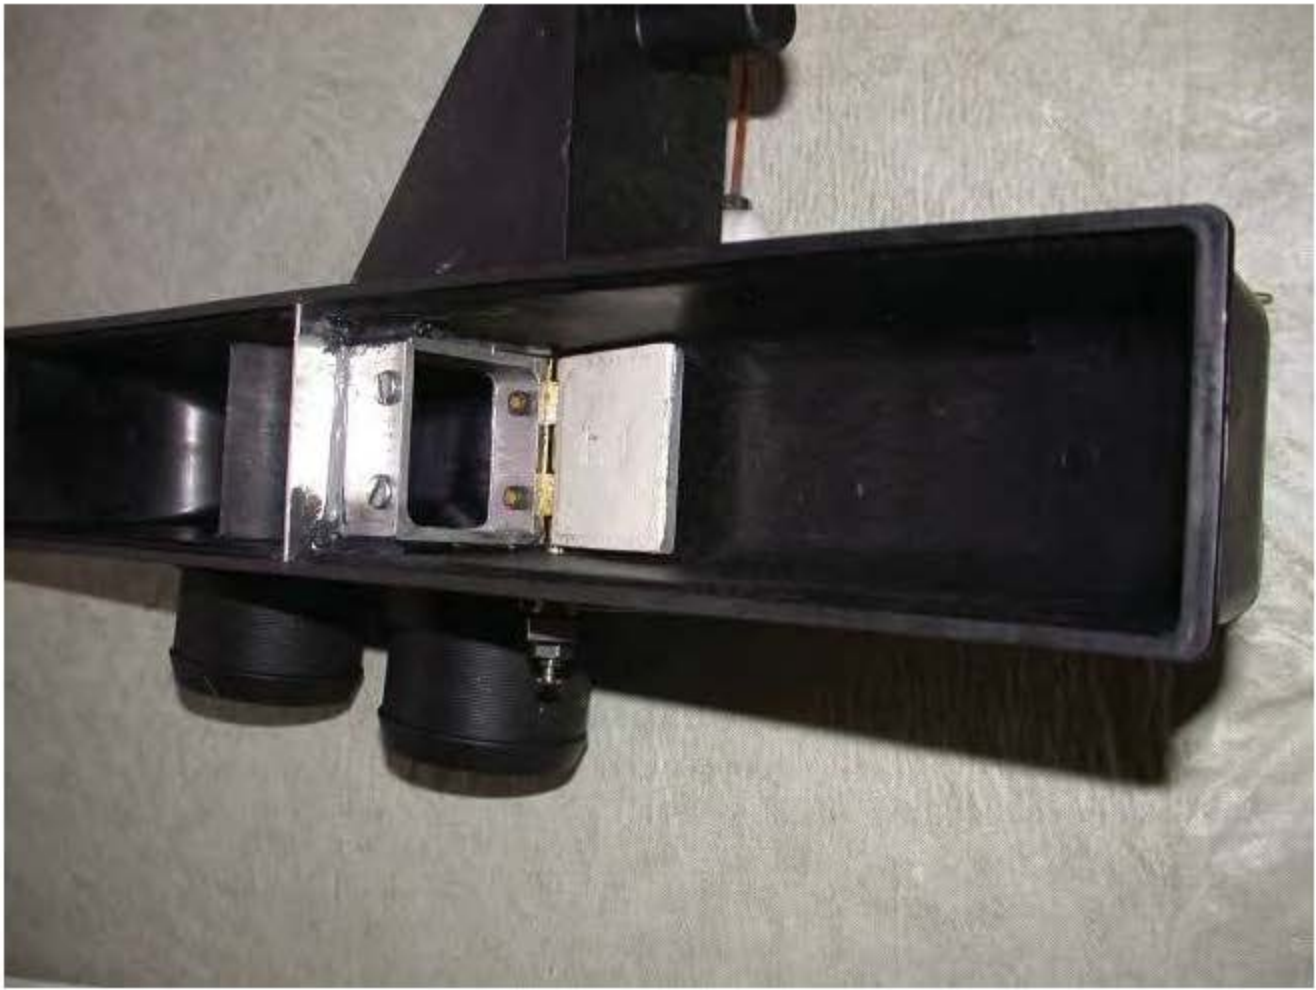
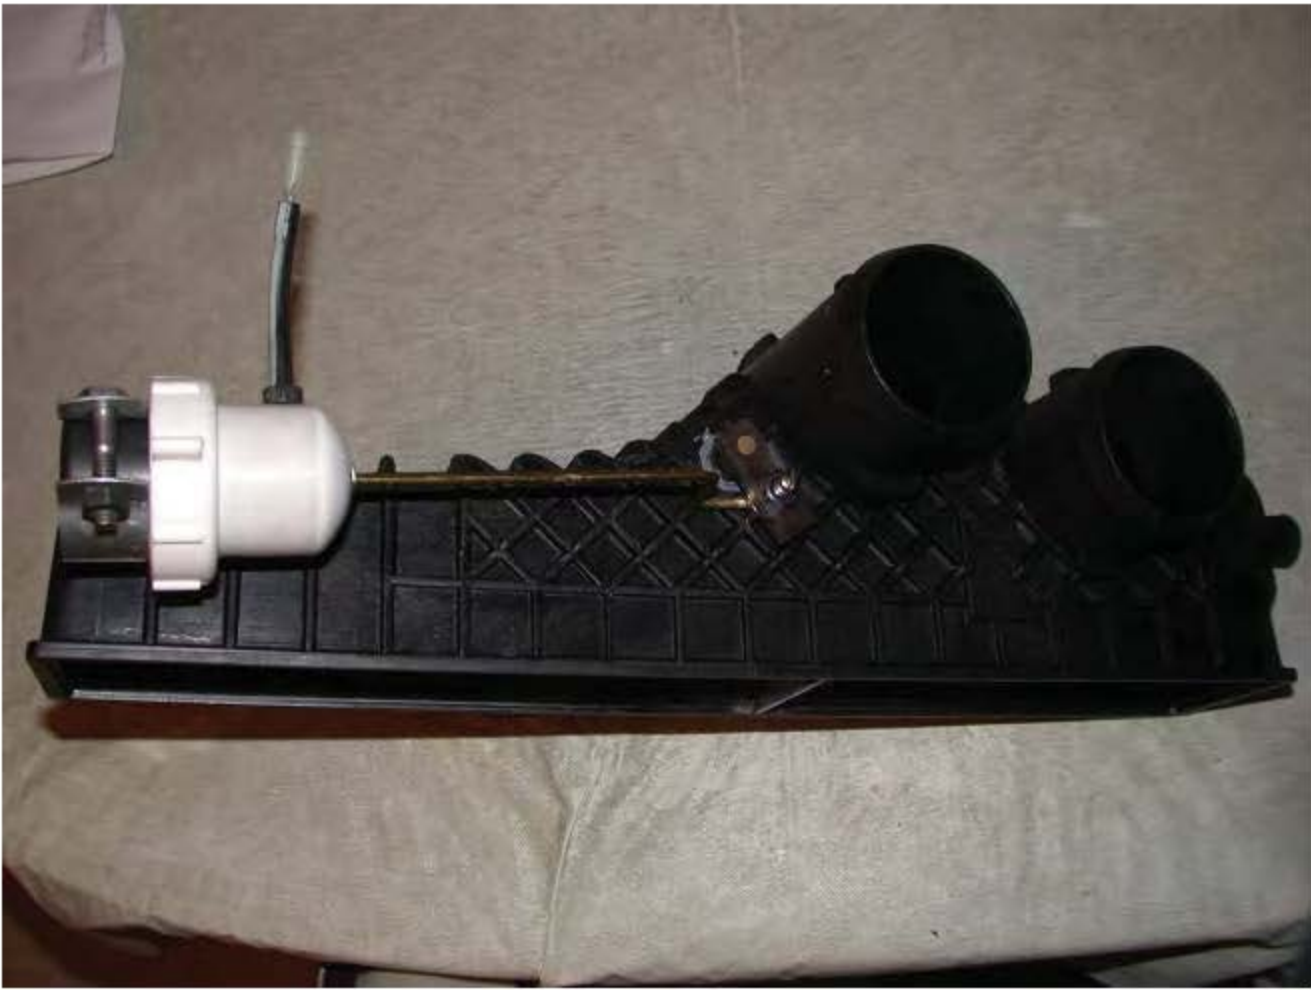
This is the boost actuated hot side variable CAC which Rick Germek and I have been working on as a possible PCA action. We plan on evaluating it for misfire this Friday in the WT. During low boost levels as encountered at cruise conditions it blocks air flow and condensation in the top 12 tubes of the CAC and greatly increases flow velocities in the lower 9 tubes thereby stripping water droplets out of the tubes. During WOT operation high boost levels fully open the flapper valve allowing flow through all 21 tubes thereby not hurting thermal efficiency..
