PE13-018

FORD

APPENDIX G

Engineering Review

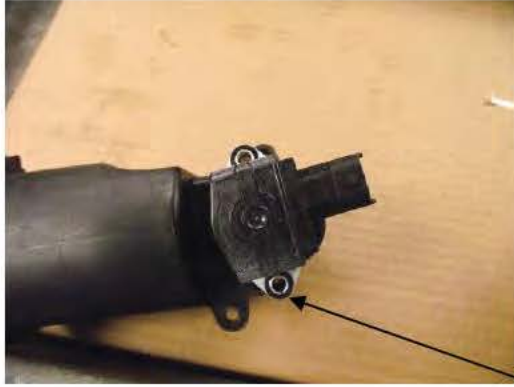
Need 2 screws/muffler for the muffler fitting, 10 screws total

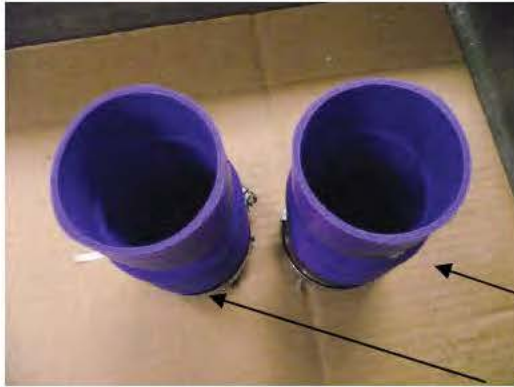
Need 10 hoses and 10 plugs for these hoses

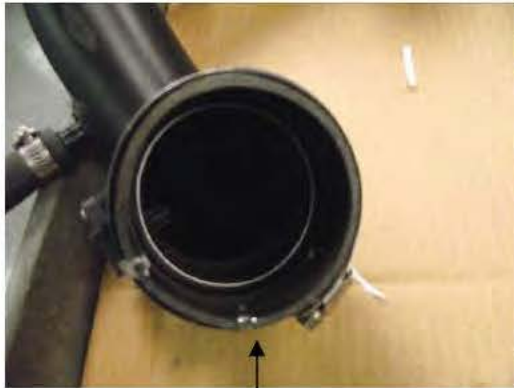
connects need to be plugged

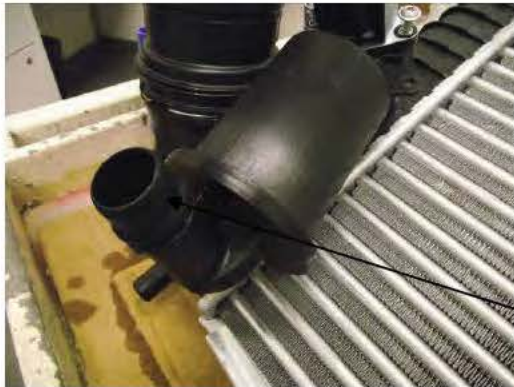
These five openings need to be plugged
