PE13-018

FORD

APPENDIX G

Engineering Review

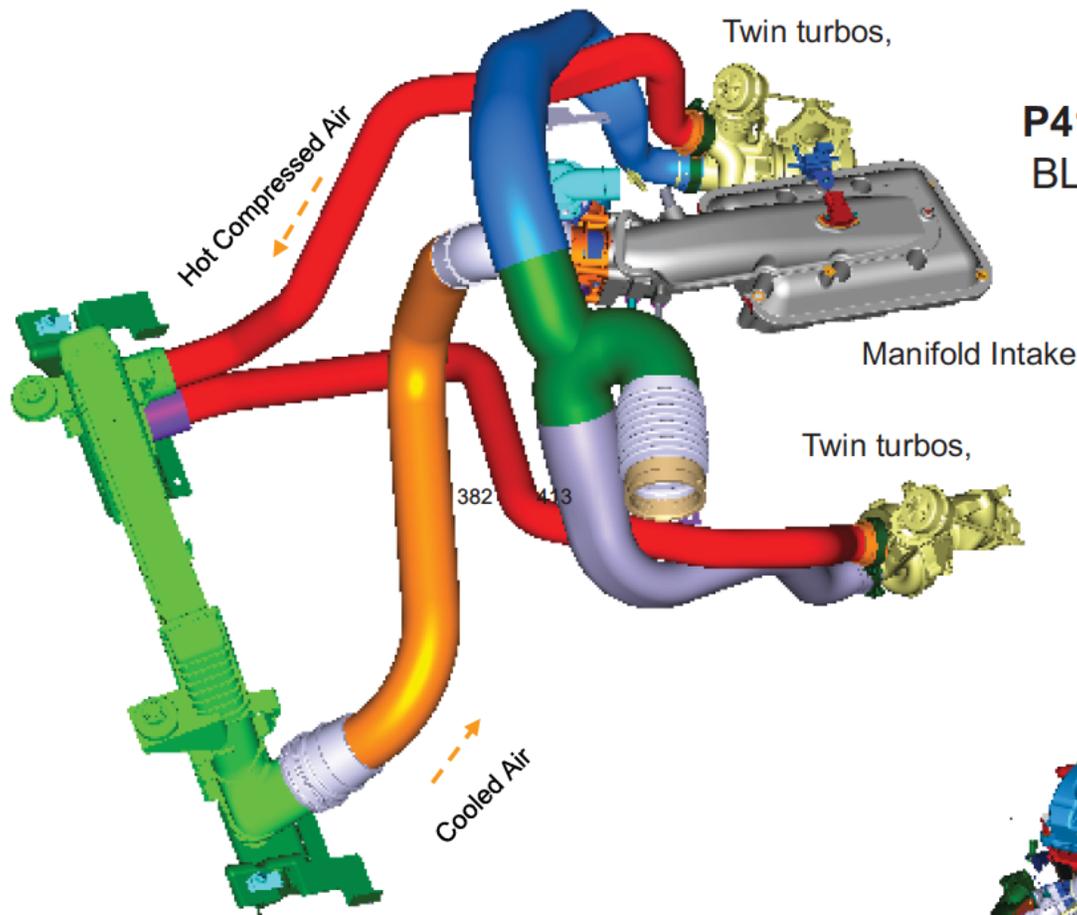
P415 F150 3.5L GTDI, Cross flow
 BL34-9L440-AB, 57x382x413 mm
