3.5L GTDI—INTERMITTENT STUMBLE/MISFIRE ON ACCELERATION FROM HIGHWAY CRUISE IN HUMID OR DAMP CONDITIONS WITH POSSIBLE DTC

TSB 12-10-19

2011-2012 F-150

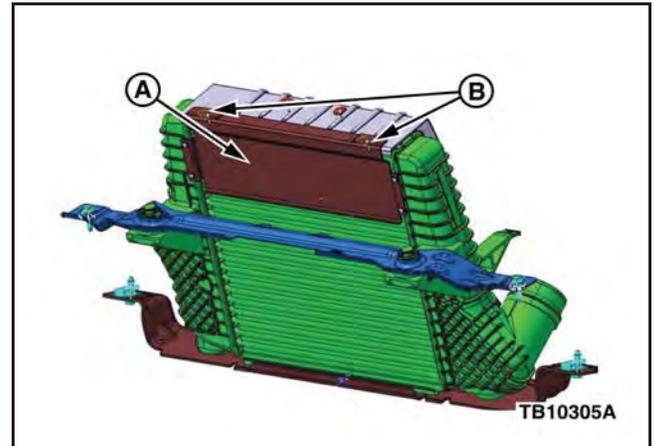
Figure 1 - Article 12-10-19

Some 2011-2012 F-150 vehicles equipped with a 3.5L gasoline turbocharged direct injection (GTDI) EcoBoost engine may exhibit an intermittent engine surge during moderate to light loads at cruise, stumble and/or misfire on hard acceleration after an extended drive at highway speeds during high humid or damp conditions. This could result in a steady or flashing malfunction indicator lamp (MIL) with diagnostic trouble codes (DTCs) primarily for misfire P0300, P0304, P0305, P0306. DTCs P0430 and/or P0299 may also be present.

1. Check for DTC P0430. Is DTC P0430 present?
 - a. Yes - Replace the left bank catalytic converter assembly. Refer to Workshop Manual (WSM), Section 309-00. Proceed to Step 2.
 - b. No - Proceed to Step 2.
2. Is the Charge Air Cooler (CAC) equipped with an air deflector plate? (Figure 1A)

- a. Yes - Proceed to Step 5.
 - b. No - Proceed to Step 3.
3. Install a new CAC, new air deflector plate, and original shield using new retaining pushpins. Refer to WSM, Section 303-12. (Figure 1B) Proceed to Step 4.
 4. Reprogram the PCM to the latest calibration using IDS release 79.02A or higher. This new calibration is not included in the 2012.5 DVD. Calibration files may also be obtained at www.motorcraft.com.
 5. Install a new CAC and the original air deflector plate and shield using new retaining pushpins. Refer WSM, Section 303-12.

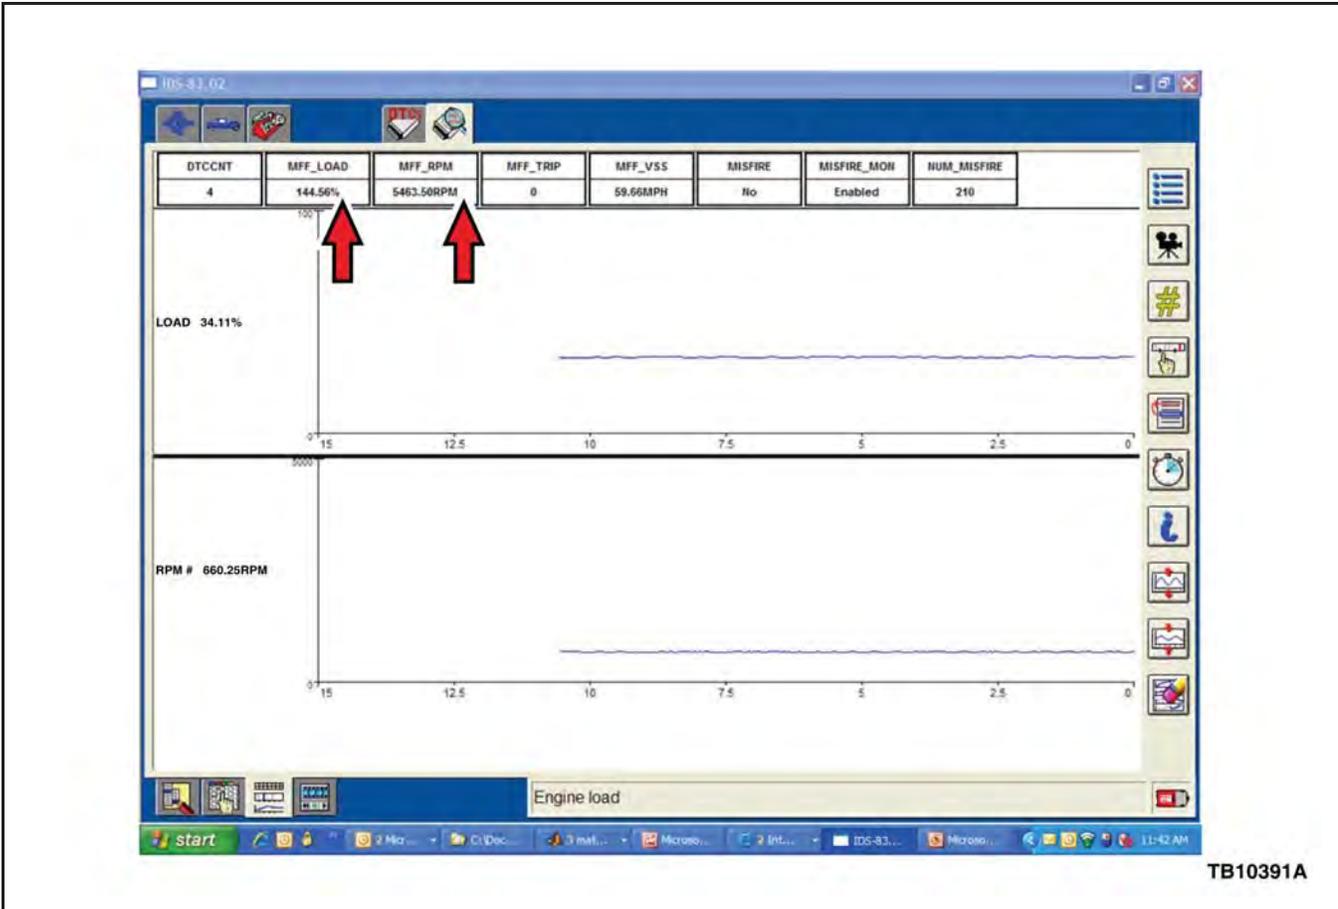
Figure 1 - Article 13-3-3

1. Acquire Misfire Freeze Frame Data and DTC¹s with the IDS. Use the following steps with IDS to obtain Misfire Freeze Frame Data.
 - a. Select Toolbox
 - b. Then Data Logger
 - c. Then Modules
 - d. Then PCM
 - e. Next select the following PIDS: MFF_LOAD and MFF_RPM
2. Check for DTC P0430. Is DTC P0430 present?
 - a. Yes - replace the left bank catalytic converter assembly. Refer to Workshop Manual (WSM), Section 309-00. Proceed to Step 3.
 - b. No - Proceed to Step 3.
3. Is the misfire concern only repeatable in humid or damp conditions?
 - a. Yes - proceed to Step 4
 - b. No - this article does not apply. Refer to Powertrain Control Emission Diagnosis (PC/ED) Manual Section 3: Powertrain Symptom Index to inspect such areas as Ignition, Compression, and Injection.
4. Does the Misfire Freeze Frame Data indicate engine speed above 2500 RPM and load 100% or above? (Figure 1)

- a. Yes - proceed to Step 5.
 - b. No - this article does not apply. Refer to PC/ED Manual Section 3: Powertrain Symptom Index to inspect such areas as Ignition, Compression, and Injection.
5. Is the Charge Air Cooler (CAC) equipped with an air deflector plate? (Figure 2A)

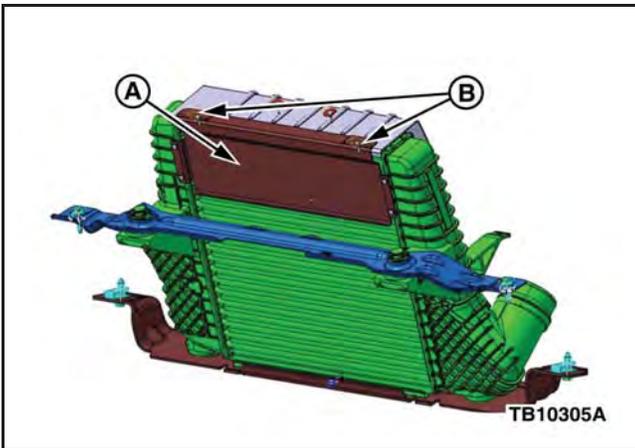
Figure 2 - Article 13-3-3

Some 2011-2012 F-150 equipped with a 3.5L gasoline turbocharged direct injection (GTDI) EcoBoost engine may exhibit an intermittent stumble and/or misfire on hard acceleration after an extended drive at highway speeds during high humid or damp conditions. This may result in either a steady or flashing malfunction indicator lamp (MIL). Diagnostic trouble codes (DTC s) P0304, P0305, P0306, or P0430 may also be present. Evidence of misfire may be available in Misfire Freeze Frame Data even with no active DTC's.

- a. Yes - proceed to Step 8.
 - b. No - proceed to Step 6.
6. Install a new CAC, new air deflector plate, and original shield using new retaining push pins. Refer to WSM, Section 303-12. (Figure 2B) Proceed to Step 7.
 7. Reprogram the PCM to the latest calibration using IDS release 79.02A or higher. This new calibration is not included in the 2012.5 DVD. Calibration files may also be obtained at www.motorcraft.com.
 8. Install a new CAC and the original air deflector plate and shield using new retaining push pins. Refer WSM, Section 303-12.
