PE13-020

HONDA

13V-412 JC2 2003-2004 Honda
Odyssey SRS unit malfunction
service bulletin 10-24-2013

Safety Recall: Electrical Noise May Cause Inadvertent Front Airbag Deployment

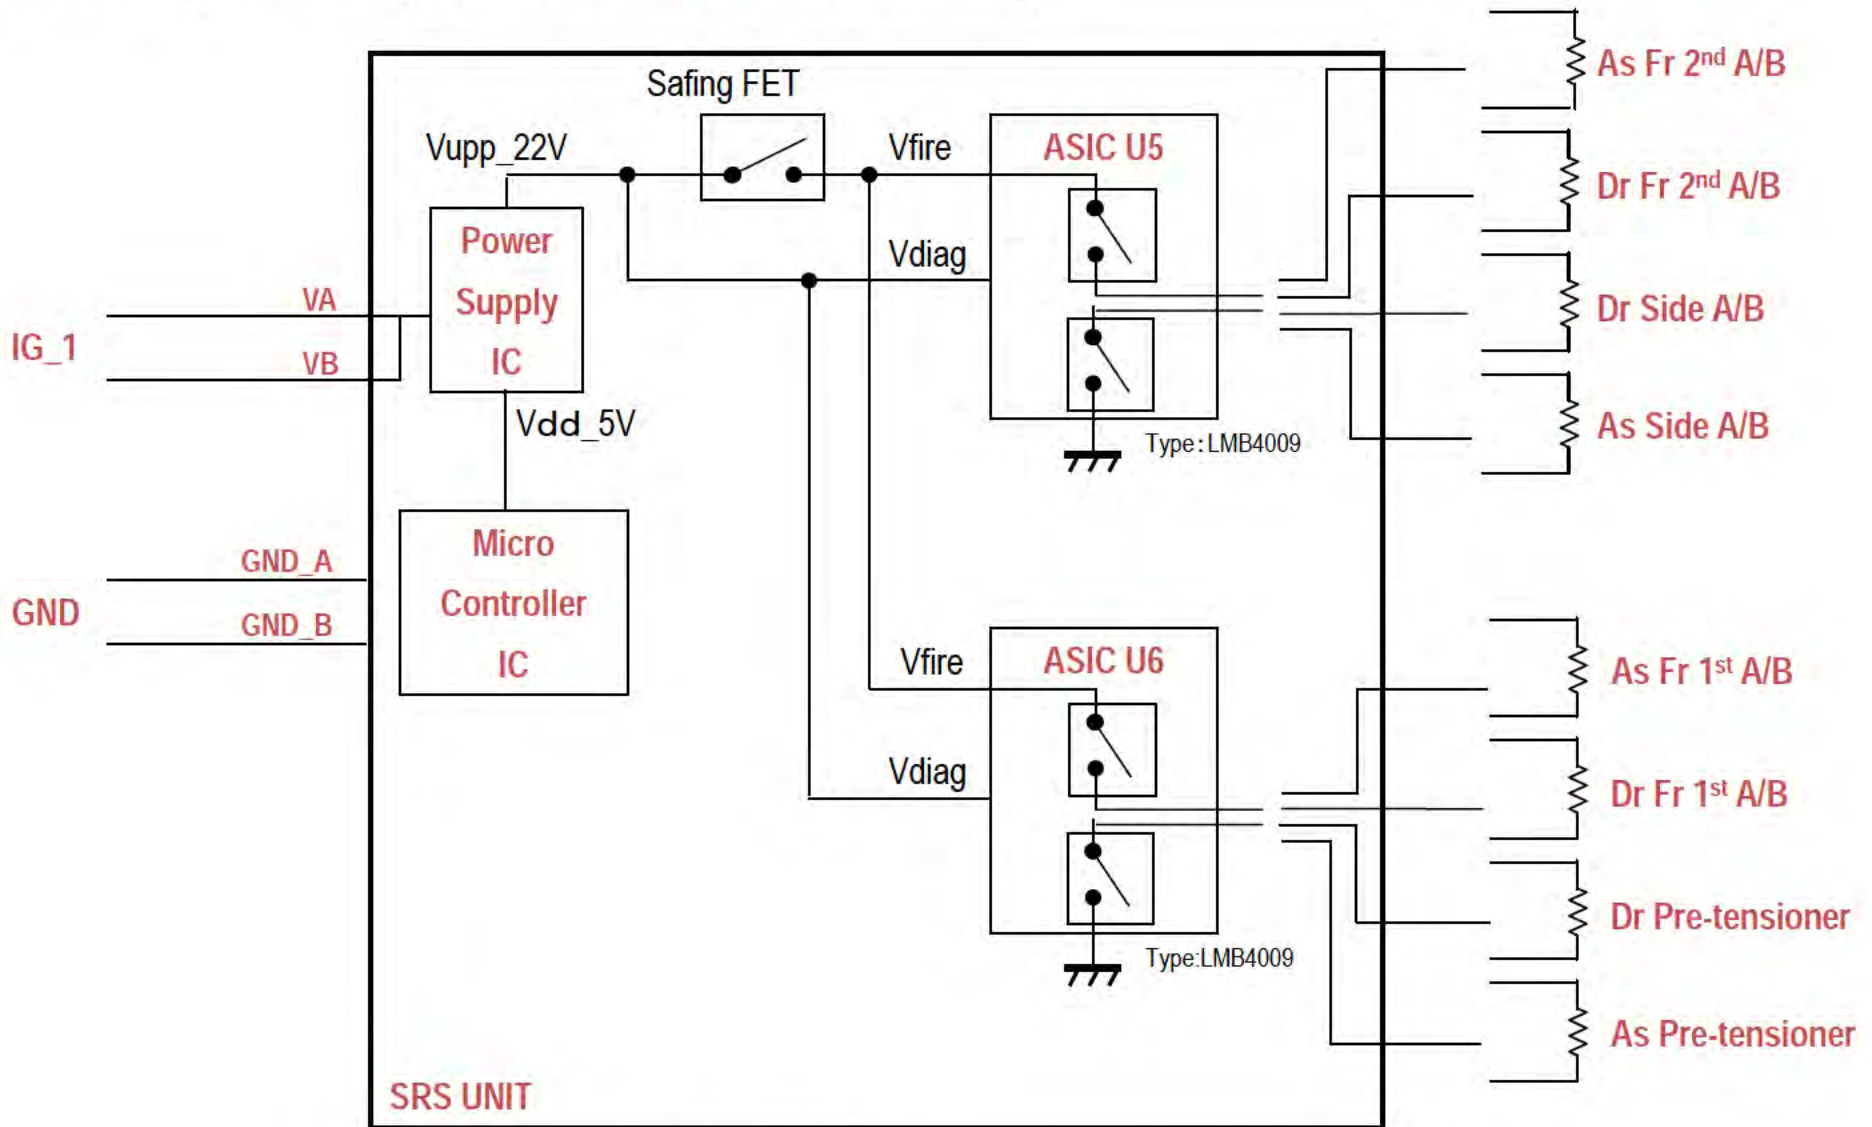
SRS system diagram (Without side curtain)

Micro Controller IC controls SW in each FET.

Vfire: power source for deployment, Vdiag: power source for ASIC control
