| FTIR No : PR200702B00001 [Automobile] | | Report Date 2007 / 02 / 03 | |
| Subject | RW420 with Code B1312 High Resisance on Pass Sensor | | |
| VIN | JS2YA415X75 | Model Name | RW420 |

| Possible causal Part No. | 85101-80JS0-CNH | Possible causal Part Name | R.H. Front Seat Cushion |

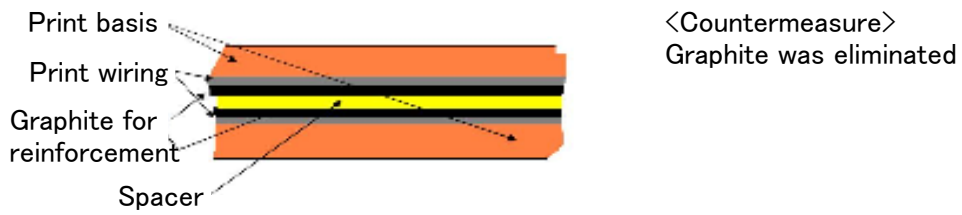
1, A crack on the print wiring of the sensor mat

| <Result> 1, A minor crack occurred on the print wiring of the sensor mat. Graphite was used for reinforcement. But because of different extensibility between graphite and the print basis, the crack occurred when it was bent. 2, A crack occurred on EOL(End of Line resister). |

<Cause>
The cracks were due to insufficient endurance..

<Countermeasure>
1, Graphite was eliminated in order to increase flexibility of the print wiring after Jun, 2008.
2, The shape of the resistance was changed from the rectangle to the circle in order to improve the tolerance in occurring a crack.
3, The slit on the felt for protection was eliminated in order to ease stress on the serpentine part. The serpentine part was made to thin in order to increase flexibility. The print basis on the fixing parts were eliminated in order to ease stress on the serpentine part.

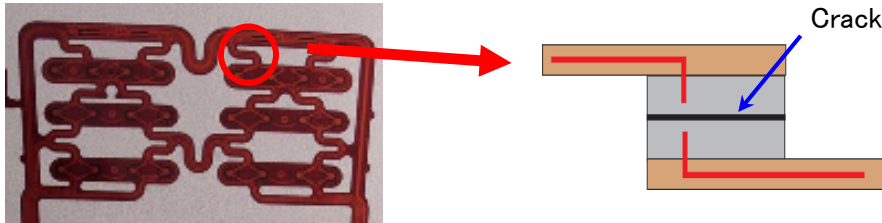
2, A crack on the print wiring of the sensor mat

The shape of the resistance was changed from the rectangle to the circle in order to improve the tolerance in occurring a crack.

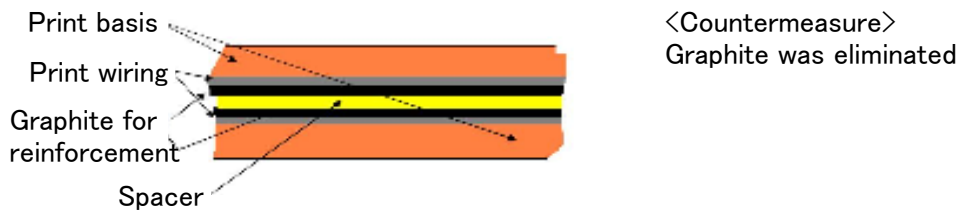
1, A crack on the print wiring of the sensor mat

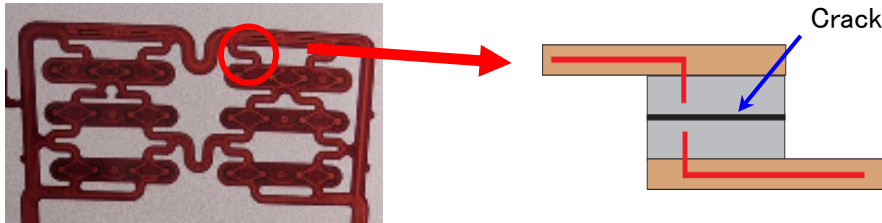
2, A crack on the print wiring of the sensor mat

The shape of the resistance was changed from the rectangle to the circle in order to improve the tolerance in occurring a crack.

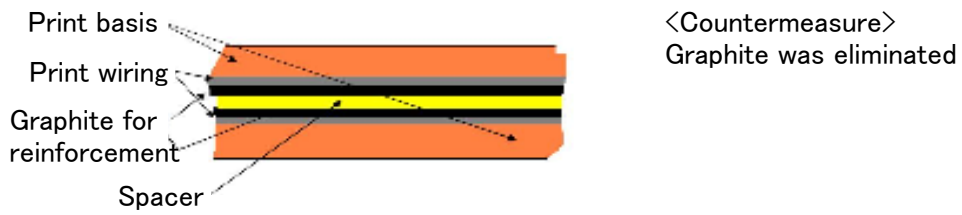
1, A crack on the print wiring of the sensor mat

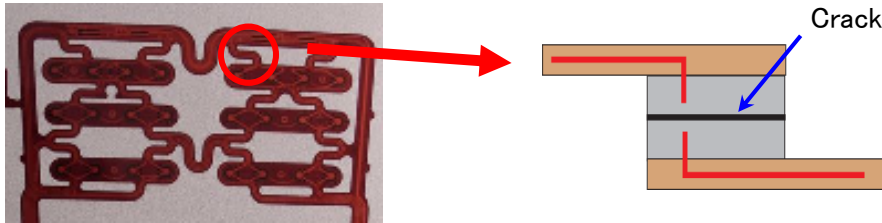
2, A crack on the print wiring of the sensor mat

The shape of the resistance was changed from the rectangle to the circle in order to improve the tolerance in occurring a crack.

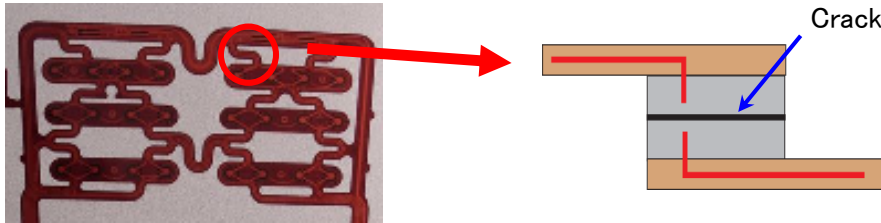
2, A crack on the print wiring of the sensor mat

The shape of the resistance was changed from the rectangle to the circle in order to improve the tolerance in occurring a crack.

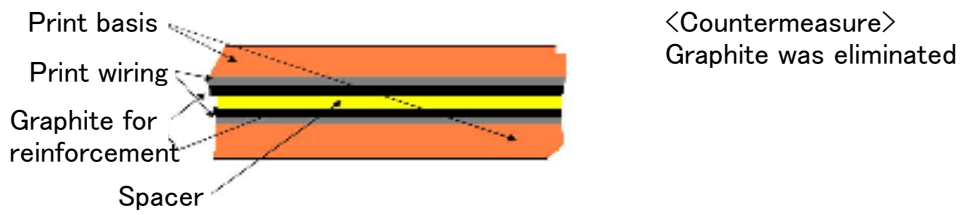
| <Result> 1, A minor crack occurred on the print wiring of the sensor mat. Graphite was used for reinforcement. But because of different extensibility between graphite and the print basis, the crack occurred when it was bent. 2, A crack occurred on EOL(End of Line resister). |

<Cause>
The cracks were due to insufficient endurance..

1, A crack on the print wiring of the sensor mat

<Countermeasure>
1, Graphite was eliminated in order to increase flexibility of the print wiring after Jun, 2008.
2, The shape of the resistance was changed from the rectangle to the circle in order to improve the tolerance in occurring a crack.
3, The slit on the felt for protection was eliminated in order to ease stress on the serpentine part. The serpentine part was made to thin in order to increase flexibility. The print basis on the fixing parts were eliminated in order to ease stress on the serpentine part.

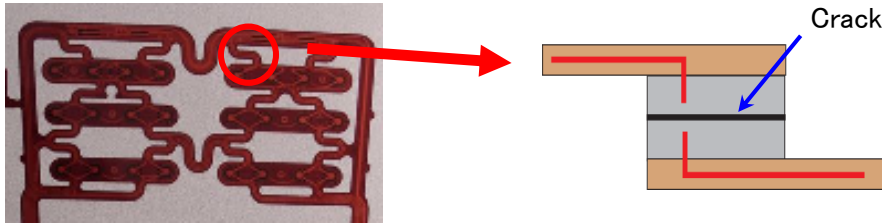
2, A crack on the print wiring of the sensor mat

The shape of the resistance was changed from the rectangle to the circle in order to improve the tolerance in occurring a crack.

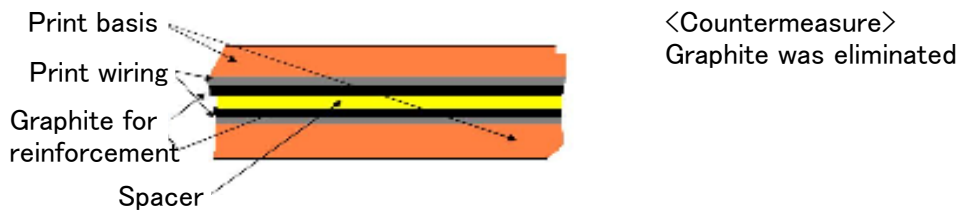
1, A crack on the print wiring of the sensor mat

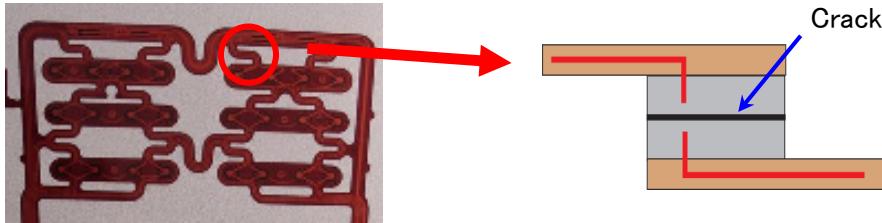
2, A crack on the print wiring of the sensor mat

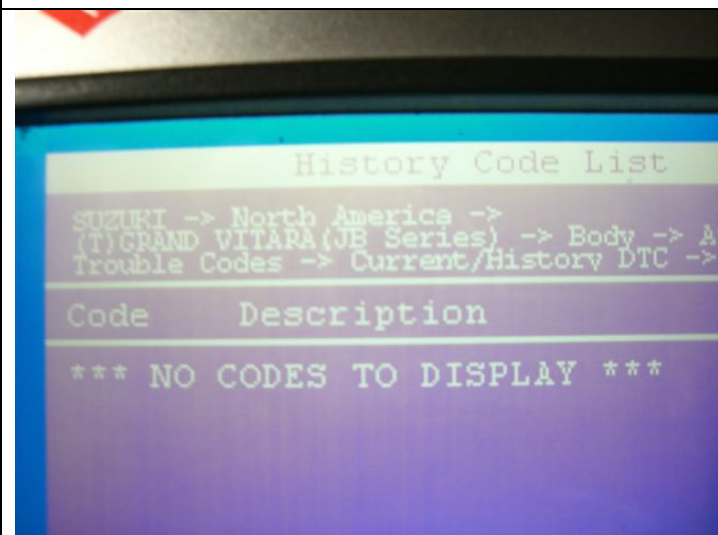
Current code list: none found
