**Memorandum to File**

**Quality Control Failure Analysis**

- Broken tank brackets securing Passenger Side CNG fuel tank
- Part Number; N/A
- Manufactured by subcontractor (Mechanical Raisin Harvesting)
- Date of Manufacture; prior to April 2012
- Installation Date; 06/29/11
- Number of vehicles involved; one
- Number of vehicles with same design within fleet (\* originally 6)
- Number of Vehicles affected; 18 at four locations

## VEHICLE ONE Effected Vehicle

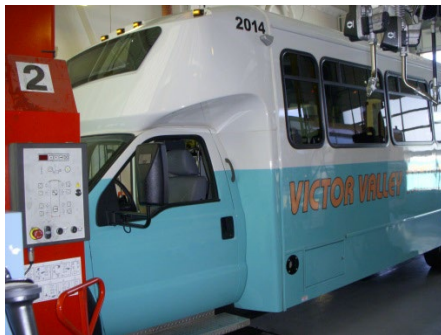
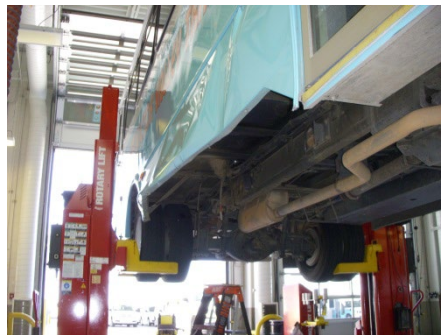
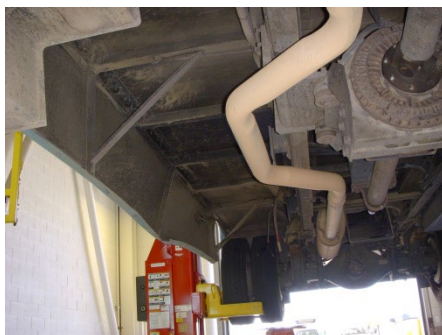
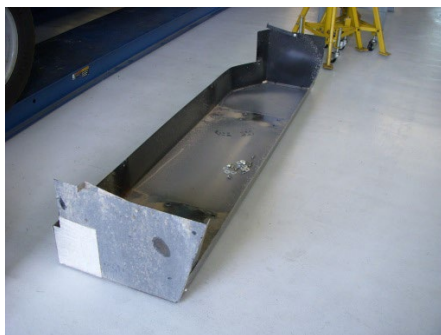
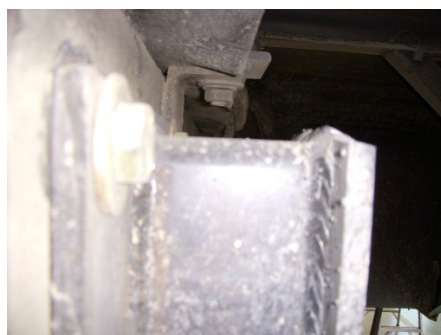
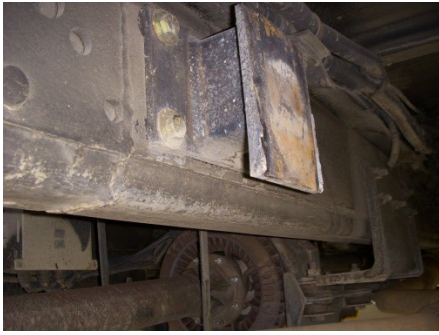
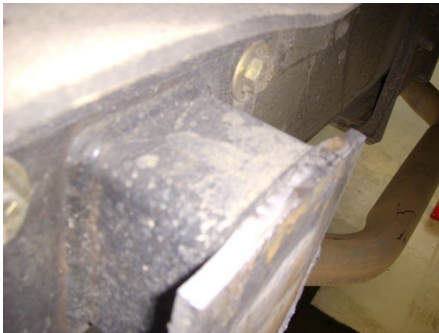
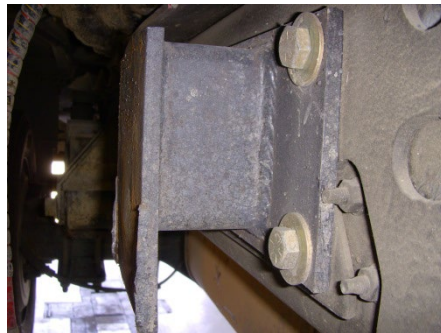
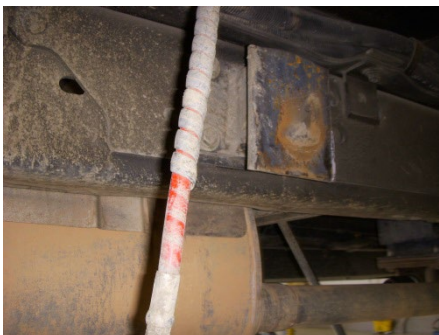
Broken P/S forward CNG mounting bracket

BUS 2014 WITH FAILED BRACKETS

Broken bracket mount that remained bolted to the frame

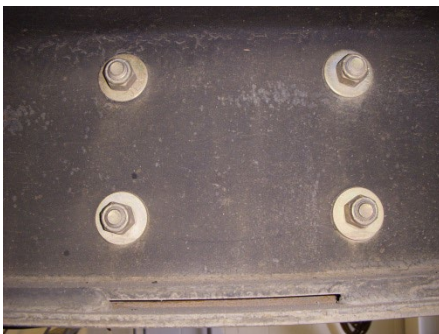
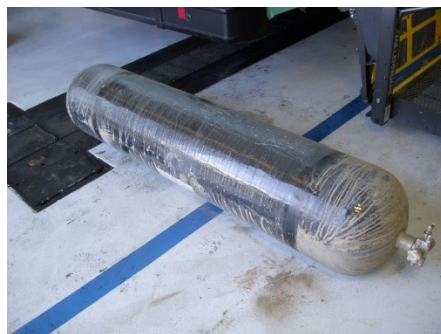
Dislodged tank from bus #2014

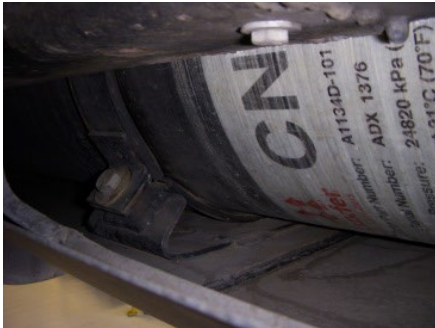
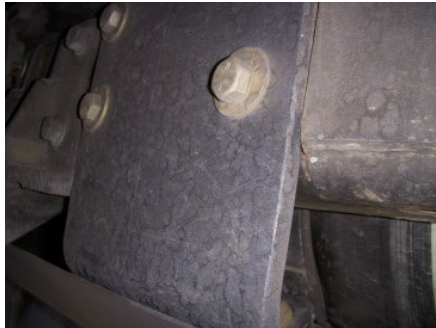
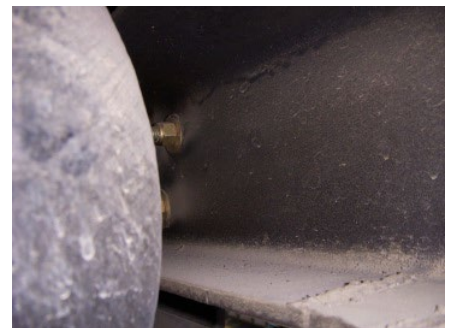
Bus #2011: INITIAL TANK INSPECTION; no visible damage on tank mountings

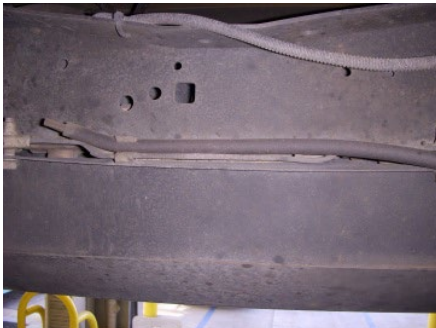
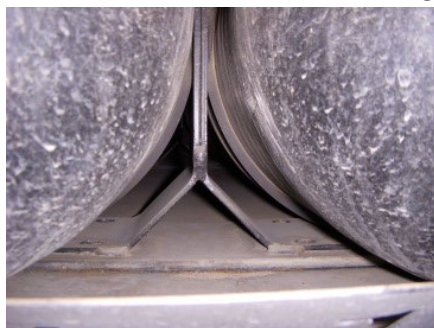
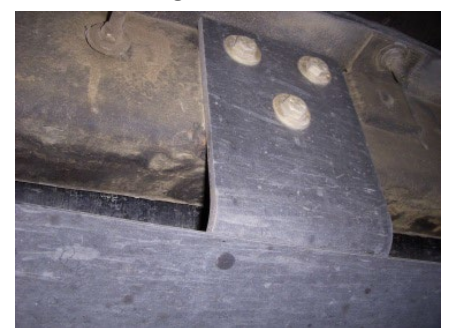
Bus #2011: INITIAL TANK INSPECTION; no visible damage on tank mountings

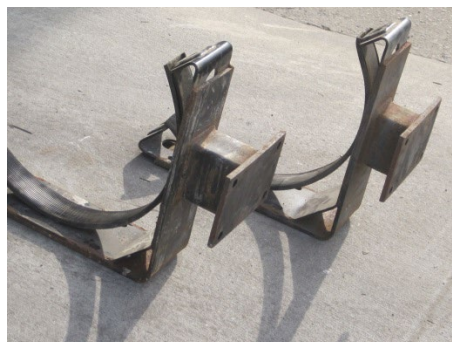
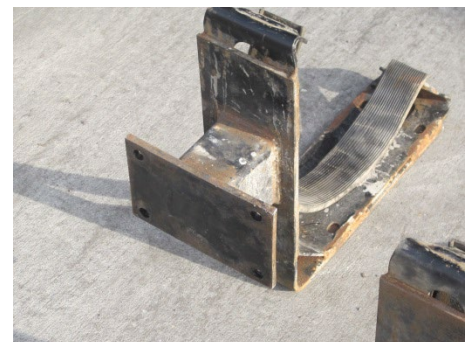
REMOVED BRACKET INSPECTION; no visible damage on tank mountings

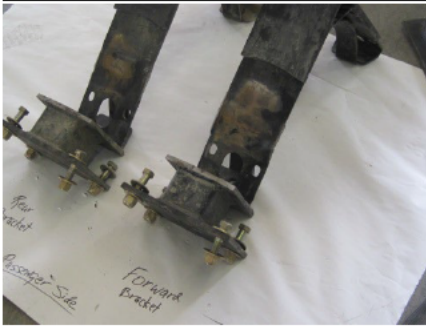
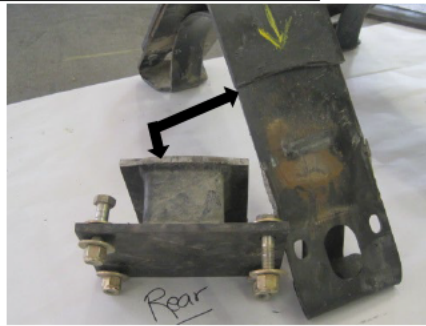
### Bus 2012: BROKEN BRACKETS AS REMOVED FROM THE BUS FRAME

These Brackets were used on our original builds. Additionally all affected vehicles have been examined with no signs of failure or fatigue. The failure on the cantilevered frame support showed signs of the metal failure above the weld on the cantilevered section. Signs of stress on the specific tear would indicate that the plate may have had a crack for a long time. That the tearing of the metal was gradual and not sudden.

frame mounting Cantilevered portion broken away from tank mounting base.

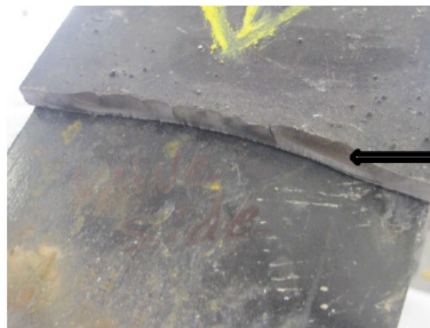
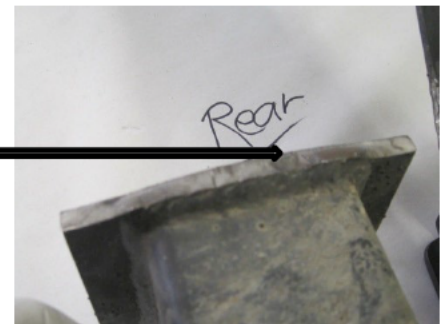
After our further examination of the failed brackets, we believe that the metal used on the brackets in question may have been faulty. The second possibility is that the bracket was not strong enough, nor the cantlevered support properly positioned to bear the weight of the tanks over an extended period of time. Our earlier analysis and production of the 2<sup>nd</sup> design was supported by the recent evaluations.

Tear approx. 1/4" above the weld

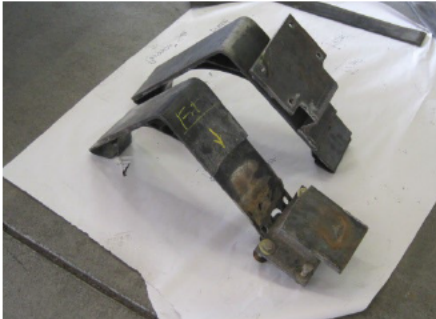
Old Brackets with 2<sup>nd</sup> design

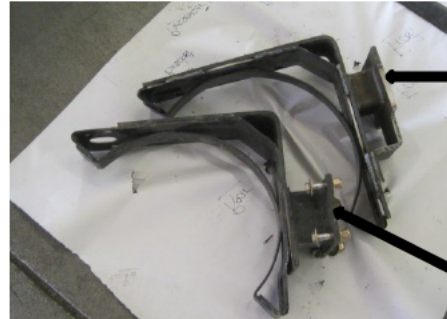
added strenght to Cantilevered extension. Mounted higher using heavier and larger material

Old bracket w/lower cantilevered frame mount
