# Service Bulletin

Bulletin No.: 08-05-22-009

**Subject:** Intermittently Brake Lights (Stop Lamp) Do Not Function Correctly, Extended Travel to Shift Out of Park, Cruise Control Inoperative, DTCs C0161/C0277 Set (Perform Repair as Outlined)

**Models:** 2004-2007 Chevrolet Malibu, Malibu Maxx  
2008 Chevrolet Malibu Classic  
2005-2009 Pontiac G6  
2007-2009 Saturn AURA

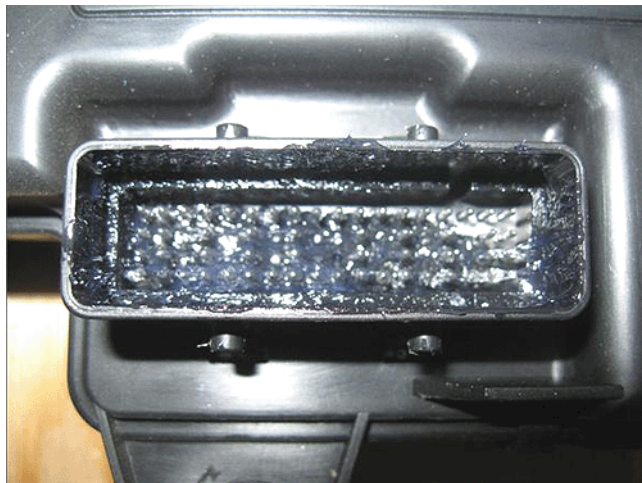
2214281

The most likely cause of this condition is high resistance due to terminal fretting corrosion in the body control module (BCM) C2 connector (specifically pins C2-18, C2-31 and C2-59).

8. Apply dielectric lubricant (clear gel) GM P/N 12377900 (In Canada, use P/N 10953529) on the BCM C2 pins (apply with a one-inch nylon bristle brush) on all the C2 connector pins (this will treat the pins against fretting corrosion).
9. Reconnect the C2 connector back on the BCM and re-latch.
10. Reinstall the right side front floor console side trim panel.

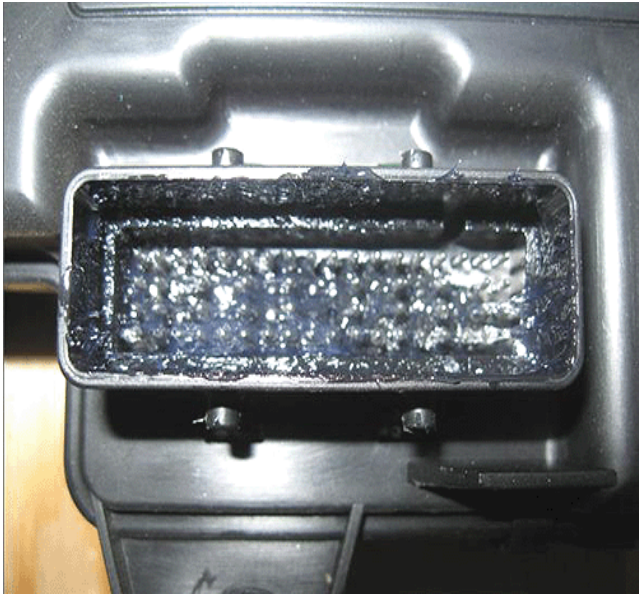
General Motors has decided that a defect, which relates to motor vehicle safety, exists in *certain* 2005-2006 model year Pontiac G6 vehicles. Some of these vehicles have a condition where the brake lamps may not operate properly because of fretting corrosion in a wiring connector. Fretting corrosion in the connector could cause the brake lamps to illuminate when the brake pedal has not been depressed, or the lamps may not illuminate when the brake pedal is depressed. In addition, the cruise control may not engage, or greater brake pedal force may be required to shift the vehicle out of PARK. Brake lamps that are not operating properly may not warn a driver in a following vehicle of the braking status and could lead to a crash without prior warning.

4. Apply dielectric lubricant on the BCM C2 pins (apply with a one-inch (25 mm) nylon bristle brush) on all the C2 connector pins. This will treat the pins against fretting corrosion.
5. Reconnect the C2 connector back on the BCM and re-latch.
6. Reinstall the right side front floor console side trim panel.

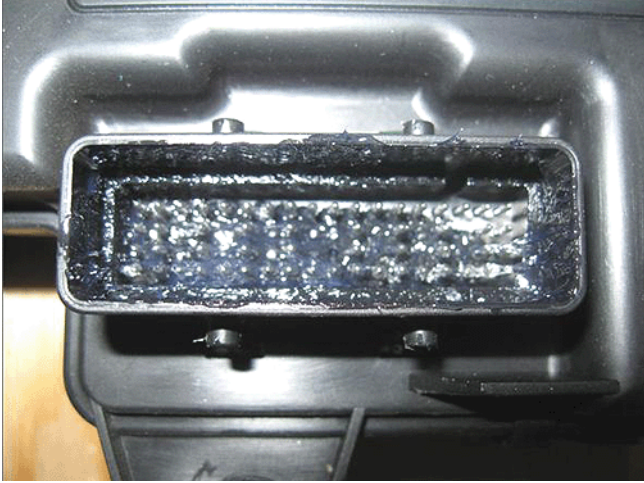
2214281

**Note:** Fretting corrosion looks like little dark smudges on electrical terminals and appear where the actual electrical contact is being made. In less severe cases it may be unable to be seen or identified without the use of a magnifying glass.

3. With a one-inch nylon bristle brush, apply dielectric lubricant to both the module/component side and the harness side of the affected connector(s).
  4. Reconnect the affected connector(s) and wipe away any excess lubricant that may be present.
  5. Attempt to duplicate the condition by using the following information:
    - DTC Diagnostic Procedure
    - Circuit/System Description
    - Conditions for Running the DTC
    - Conditions for Setting the DTC
    - Diagnostic Aids
    - Circuit/System Verification
- If the condition cannot be duplicated, the repair is complete.
- If the condition can be duplicated, then follow the appropriate DTC, Symptom or Circuit/System Testing procedure (refer to SI).

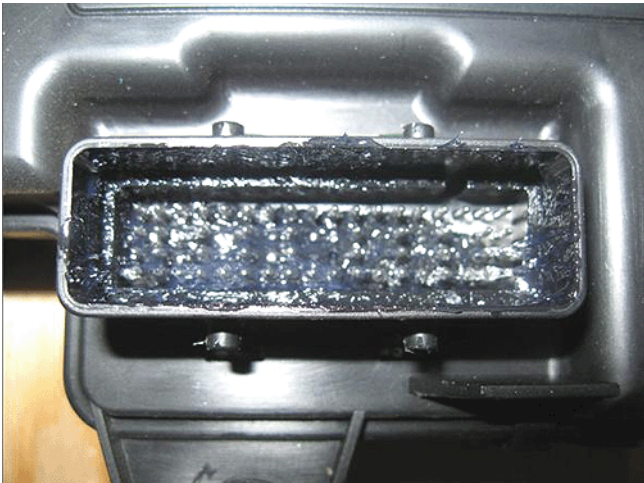
2214281

**Note:** Fretting corrosion looks like little dark smudges on electrical terminals and appear where the actual electrical contact is being made. In less severe cases it may be unable to be seen or identified without the use of a magnifying glass.

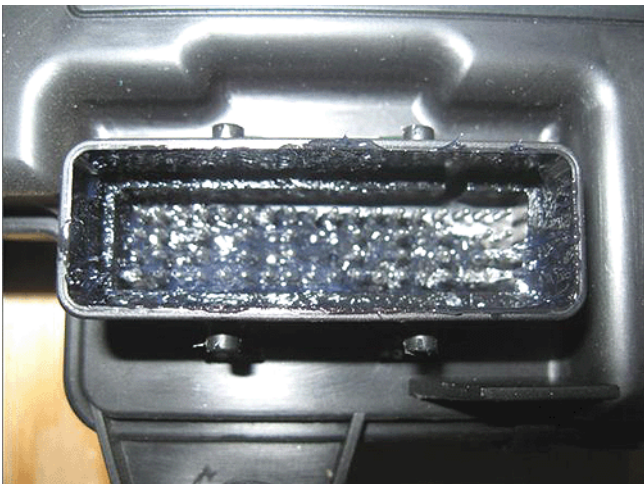
2214281

**Note:** Fretting corrosion looks like little dark smudges on electrical terminals and appear where the actual electrical contact is being made. In less severe cases it may be unable to be seen or identified without the use of a magnifying glass.

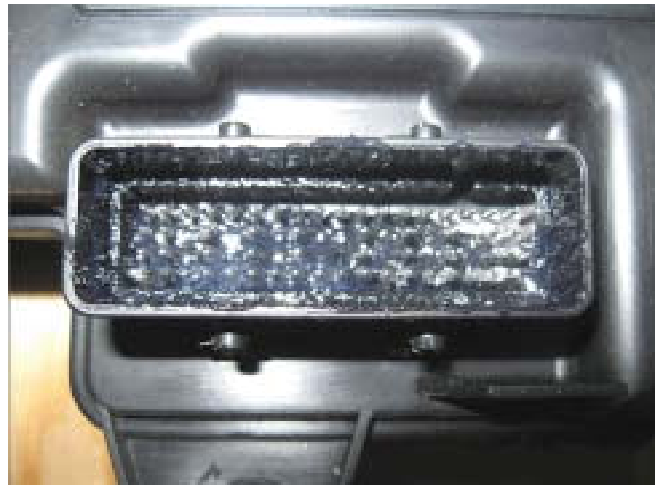
2214281

**Note:** Fretting corrosion looks like little dark smudges on electrical terminals and appear where the actual electrical contact is being made. In less severe cases it may be unable to be seen or identified without the use of a magnifying glass.

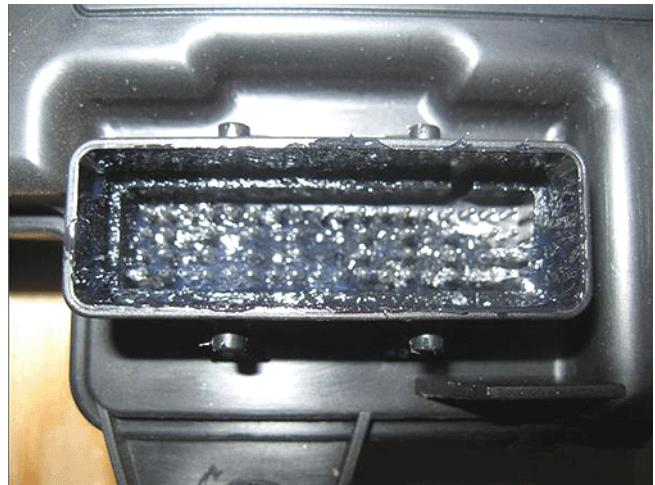
2214281

**Note:** Fretting corrosion looks like little dark smudges on electrical terminals and appear where the actual electrical contact is being made. In less severe cases it may be unable to be seen or identified without the use of a magnifying glass.

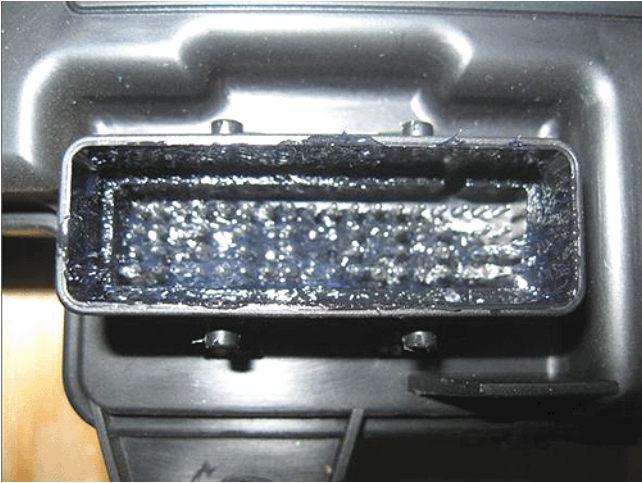
2214281

**Note:** Fretting corrosion looks like little dark smudges on electrical terminals and appear where the actual electrical contact is being made. In less severe cases it may be unable to be seen or identified without the use of a magnifying glass.
