2005-2009MY Pontiac G6 Stop Lamp VOQ and Warranty IPTV graphed in Month of Build

2012CY Update of G6 Stop Lamp Warranty Claims

#08-05-22-009: Intermittently Brake Lights (Stop Lamp) Do Not Function Correctly, Extended Travel to Shift Out of Park, Cruise Control Inoperative, DTC C0161/C0277 Set (Perform Repair as Outlined) - (Dec 4, 2008)

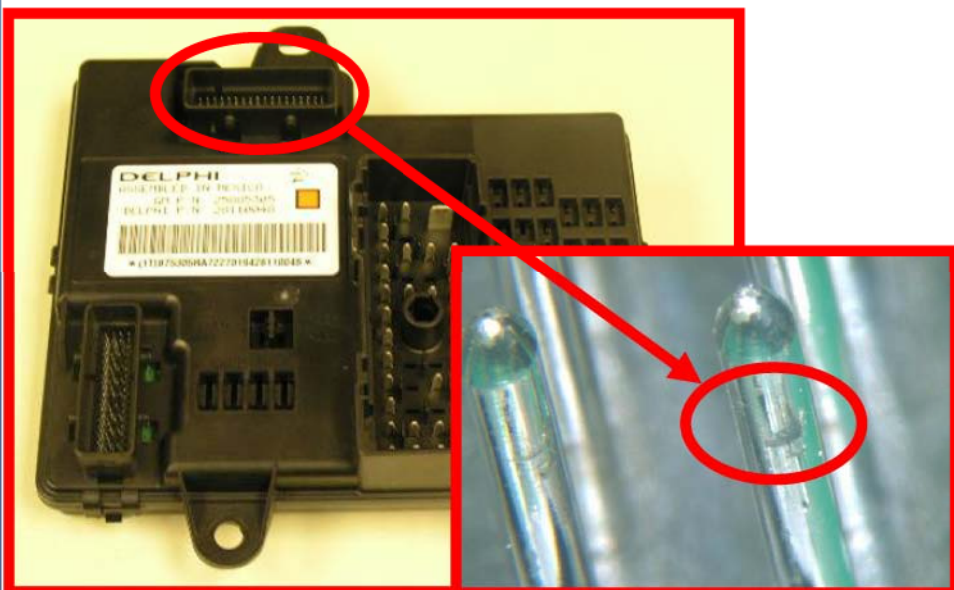
Condition: Certain fretting corrosion in the Body Control Module connector causes an increase in resistance that results in a lower BAS signal voltage to the BCM.

Effect of the Condition: A driver in a following vehicle may not be able to discern the braking status of the vehicle in front of them. Operators whose vehicles have this condition may notice that the cruise control will not engage and the brake pedal requires additional travel to remove the gear shift mechanism from PARK or DRIVE. Additionally, the transmission converter clutch will not engage.

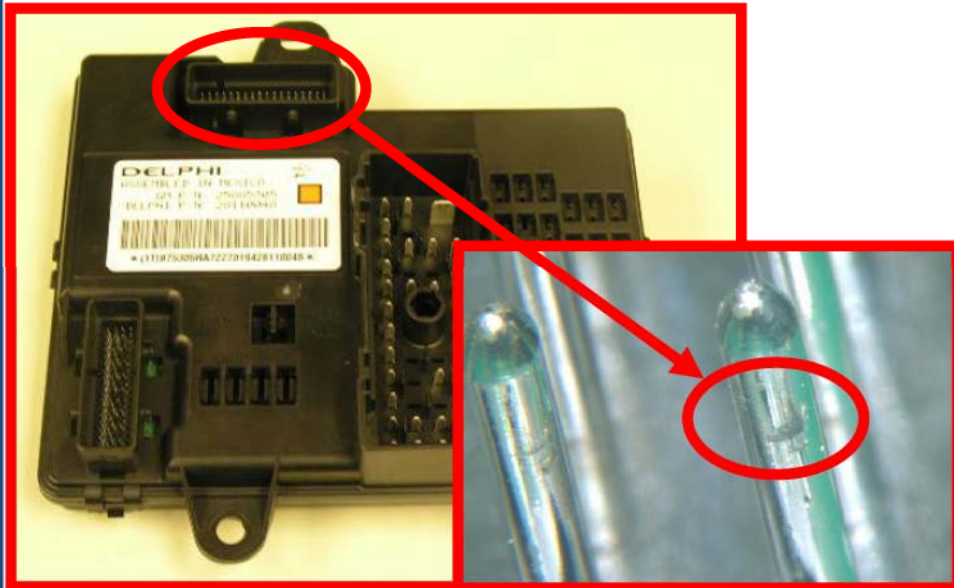
Condition: Certain fretting corrosion in the Body Control Module connector causes an increase in resistance that results in a lower BAS signal voltage to the BCM.

Potential Field Action: Apply dielectric lubricant (clear gel) on all the BCM C2 connector pins. Apply with a one-inch nylon bristle brush. (this will treat the pins against fretting corrosion).

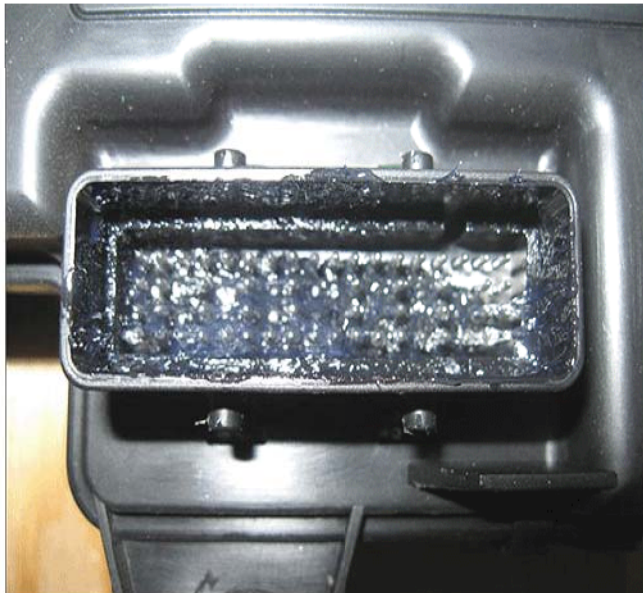
Subject: Intermittently Brake Lights (Stop Lamp) Do Not Function Correctly, Extended Travel to Shift Out of Park, Cruise Control Inoperative, DTCs C0161/C0277 Set (Perform Repair as Outlined)

Apply dielectric lubricant (clear gel) GM P/N 12377900 (In Canada, use P/N 10953529) on the BCM C2 pins (apply with a one-inch nylon bristle brush) on all the C2 connector pins (this will treat the pins against fretting corrosion).

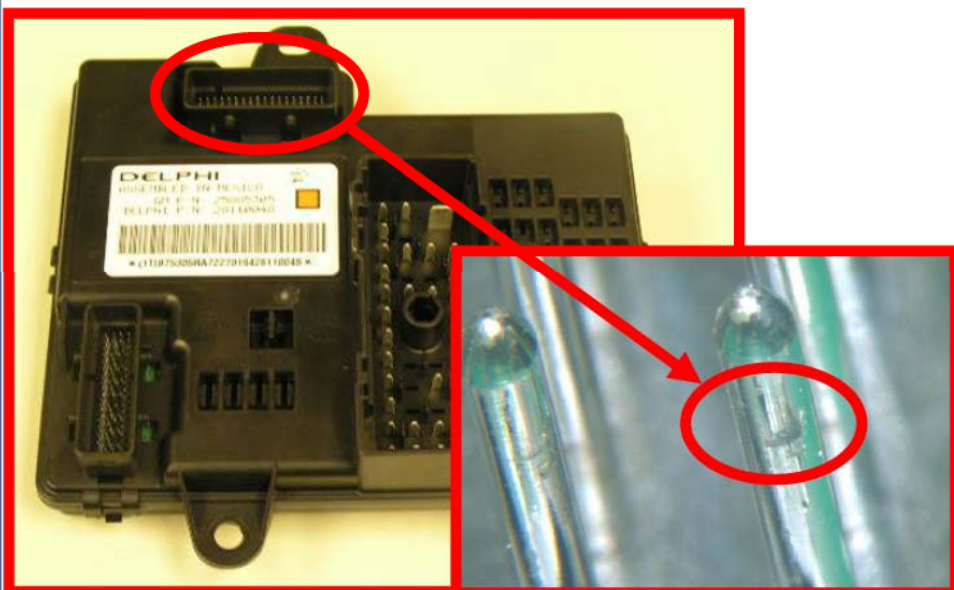
Condition: Certain fretting corrosion in the Body Control Module connector causes an increase in resistance that results in a lower BAS signal voltage to the BCM.

Effect of the Condition: A driver in a following vehicle may not be able to discern the braking status of the vehicle in front of them. Operators whose vehicles have this condition may notice that the cruise control will not engage and the brake pedal requires additional travel to remove the gear shift mechanism from PARK. Additionally, the transmission converter clutch will not engage.

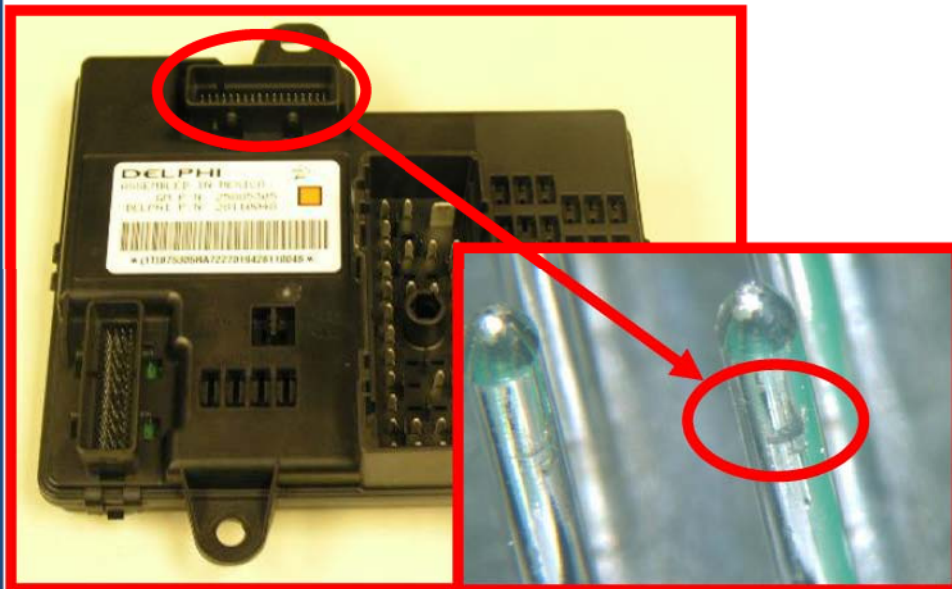
Condition: Certain fretting corrosion in the Body Control Module connector causes an increase in resistance that results in a lower BAS signal voltage to the BCM.

Potential Field Action: Apply dielectric lubricant (clear gel) on all the BCM C2 connector pins. Apply with a one-inch nylon bristle brush. (this will treat the pins against fretting corrosion).

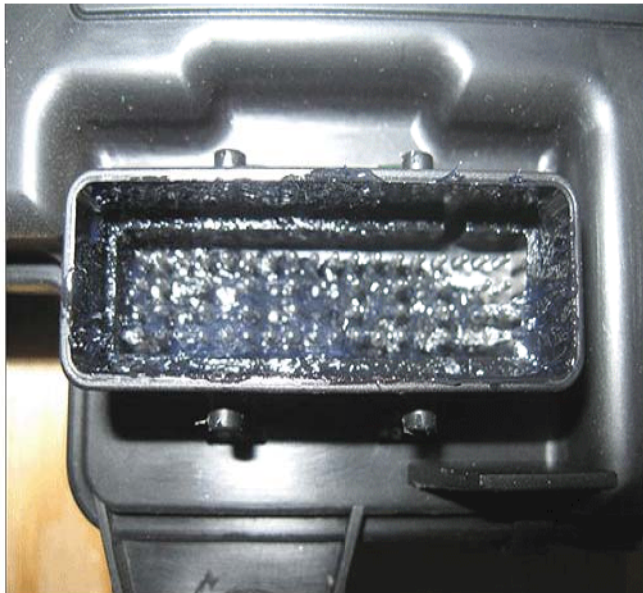
Subject: Intermittently Brake Lights (Stop Lamp) Do Not Function Correctly, Extended Travel to Shift Out of Park, Cruise Control Inoperative, DTCs C0161/C0277 Set (Perform Repair as Outlined)

Apply dielectric lubricant (clear gel) GM P/N 12377900 (In Canada, use P/N 10953529) on the BCM C2 pins (apply with a one-inch nylon bristle brush) on all the C2 connector pins (this will treat the pins against fretting corrosion).

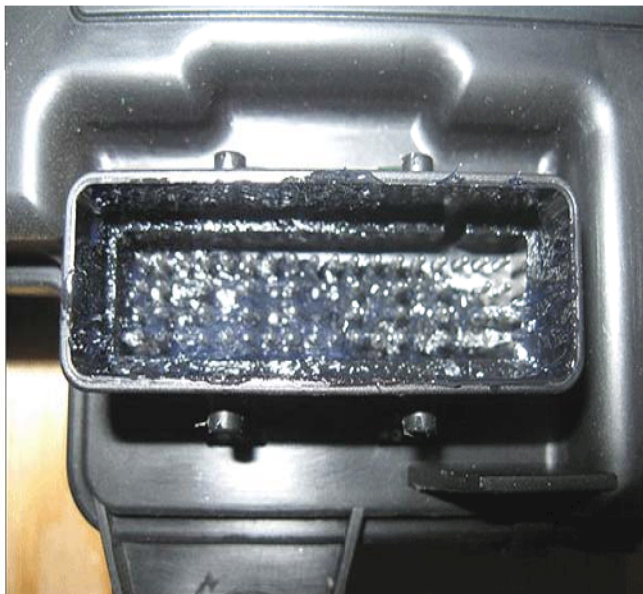
Subject: Intermittently Brake Lights (Stop Lamp) Do Not Function Correctly, Extended Travel to Shift Out of Park, Cruise Control Inoperative, DTCs C0161/C0277 Set (Perform Repair as Outlined)

Apply dielectric lubricant (clear gel) GM P/N 12377900 (In Canada, use P/N 10953529) on the BCM C2 pins (apply with a one-inch nylon bristle brush) on all the C2 connector pins (this will treat the pins against fretting corrosion).
