RQ13-002

2012 Camaro-Cruze-Verano-
Sonic airbag connector-20 Jan
13 NHTSA

Shorting Bar within the Driver's Airbag Connector

**Model Year: 2012 Cruze, Verano, Camaro, and Sonic
4,101 vehicles**

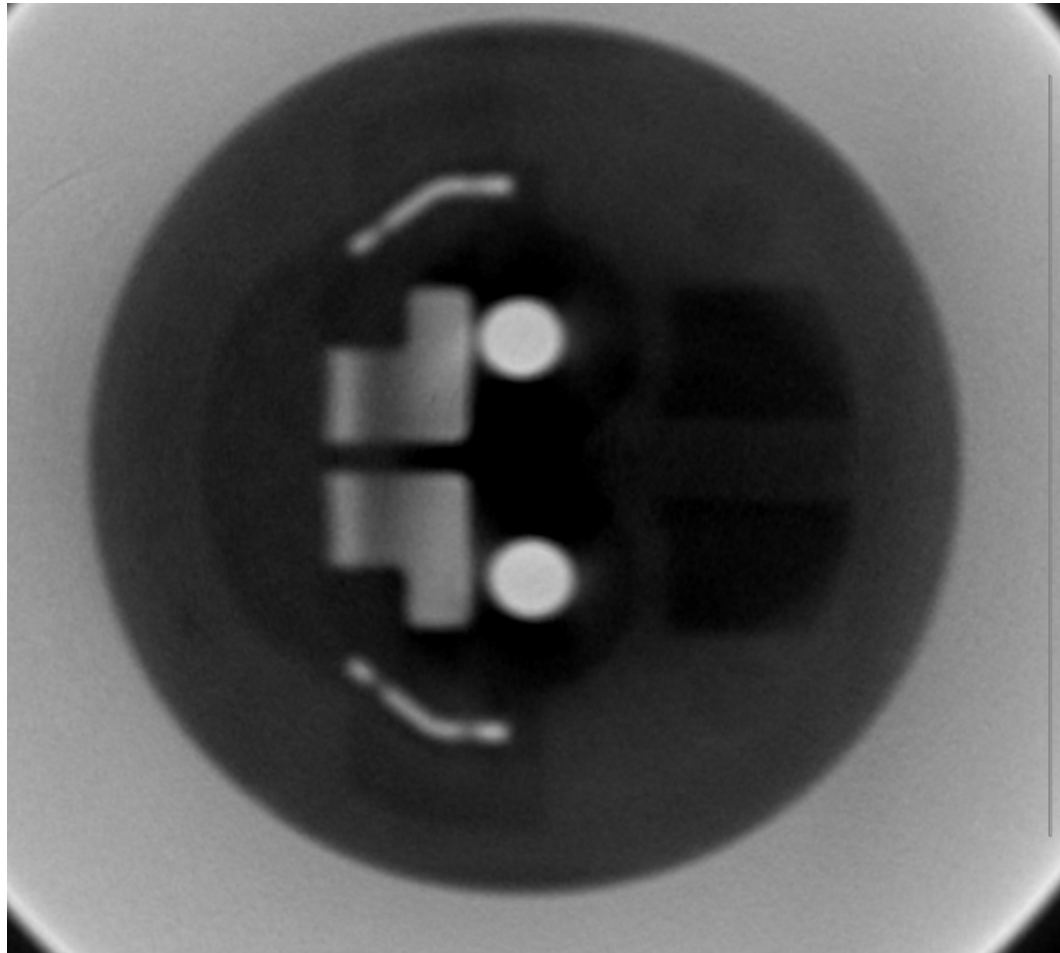
Technical Root Cause: During the retainer seating process the shorting bars were not fully retracted to prevent contact with the airbag terminals.

*X-Rays of Assembled Male and Female Connector
Shorting Bar Damaged*

Potential Field Remedy: Replace the clock spring.

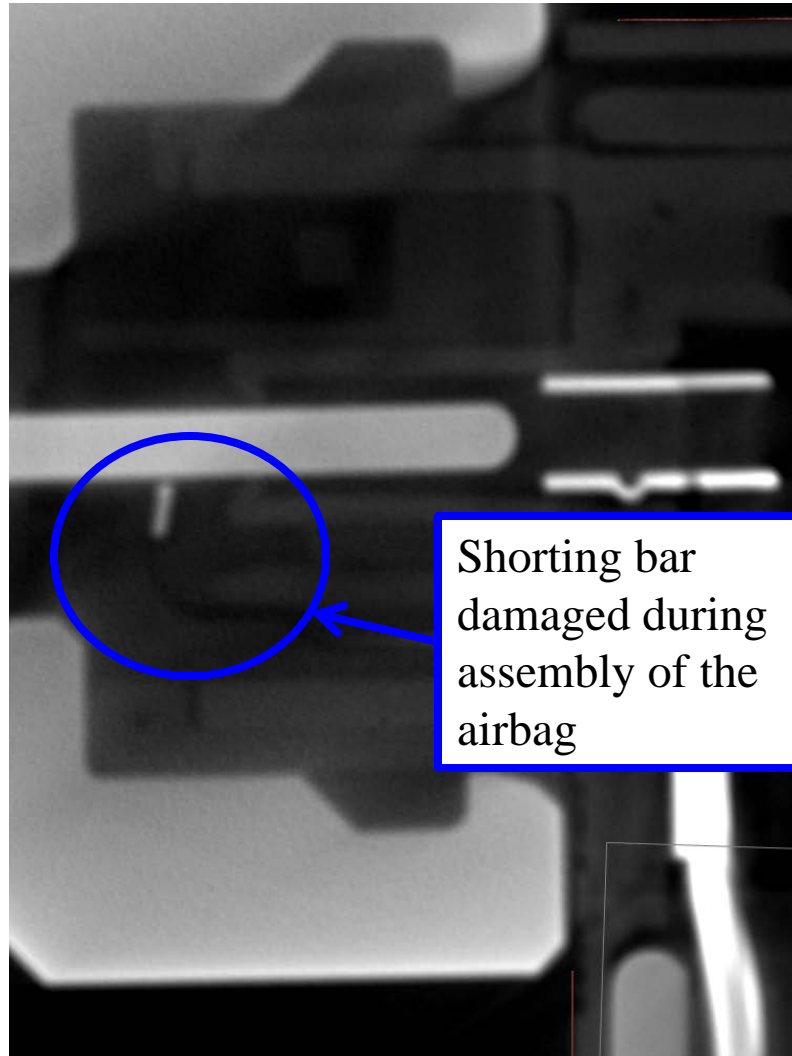
X-Rays of Assembled Male and Female Connector Shorting Bar Damaged

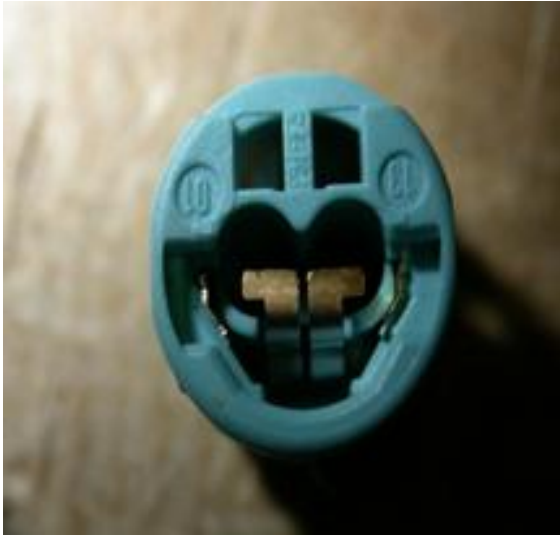
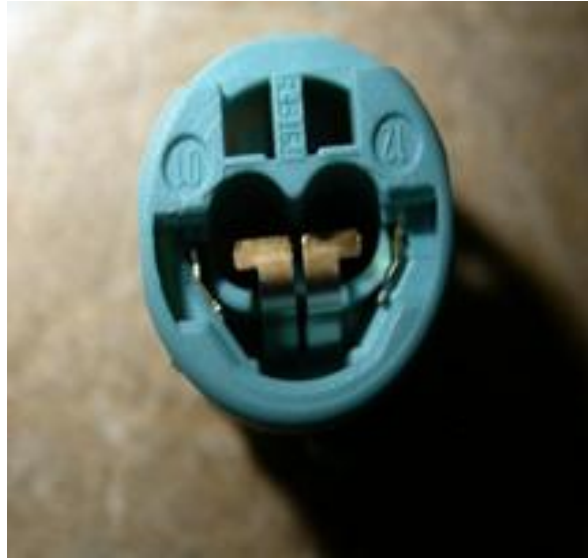
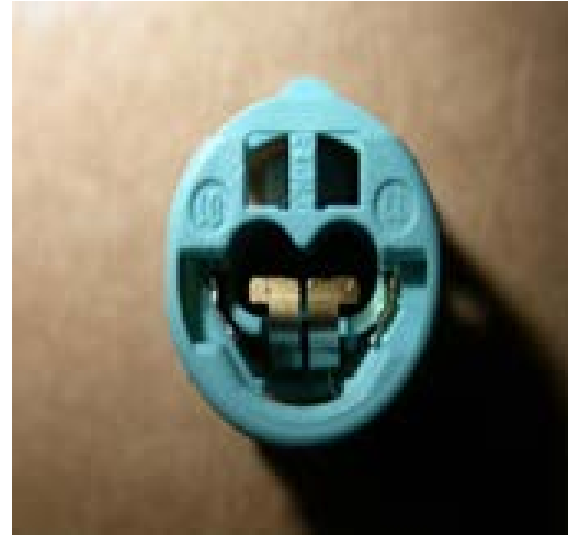
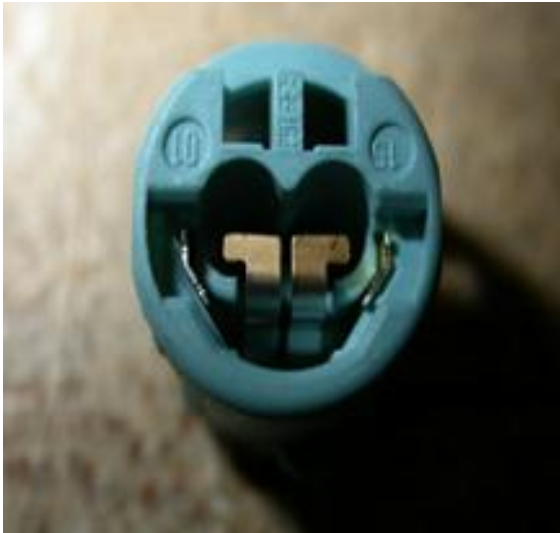
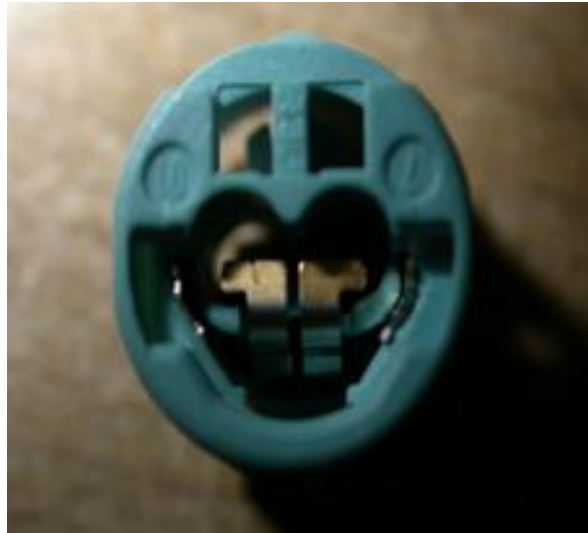
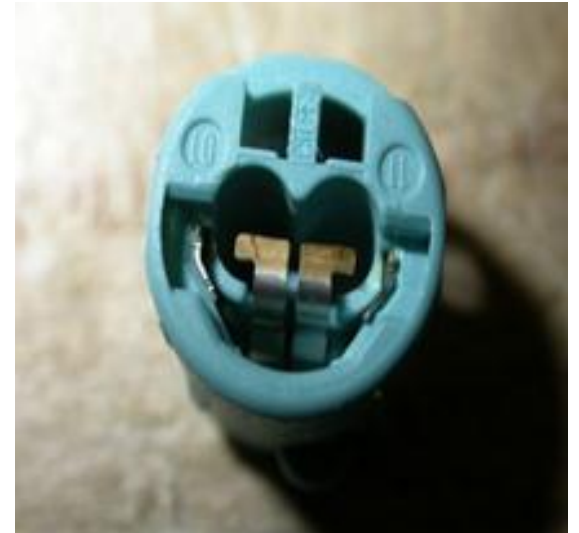
Pictures of Damaged Parts

2012 Chevrolet Cruze, Verano, and Sonic

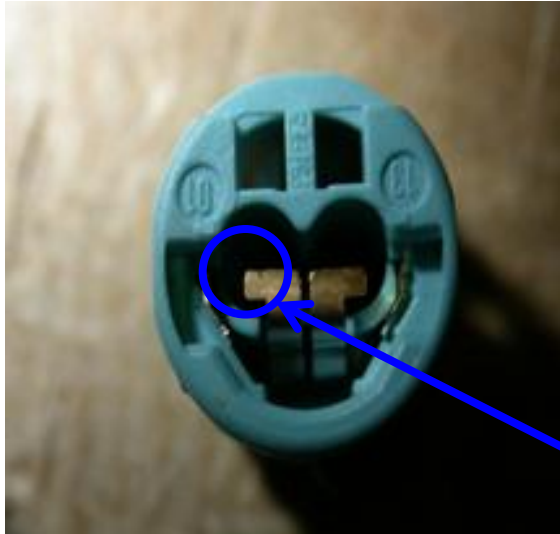
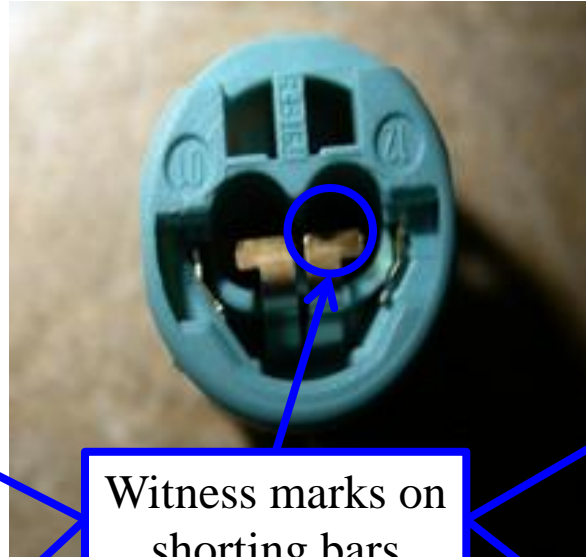
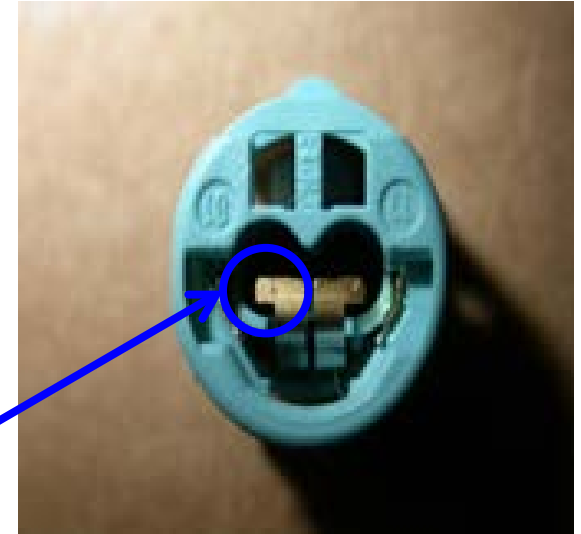
Pictures of Damaged Parts

Witness marks on shorting bars

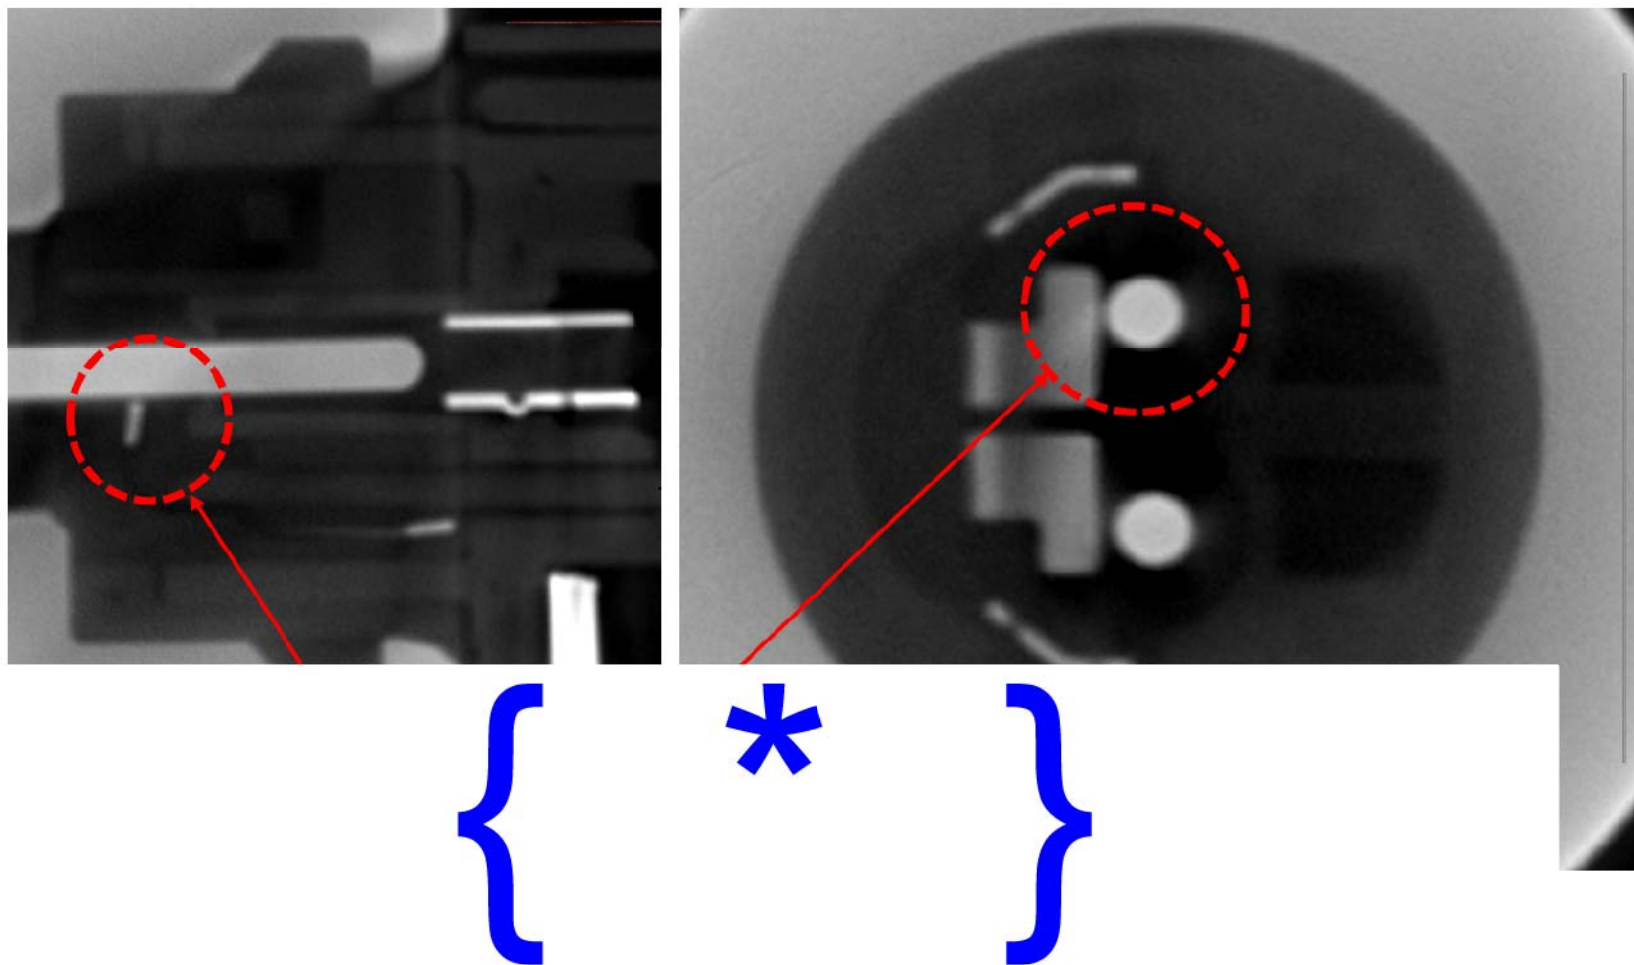
2012 Chevrolet Cruze, Verano, and Sonic X-Rays of Assembled Male and Female Connector Shorting Bar Damaged

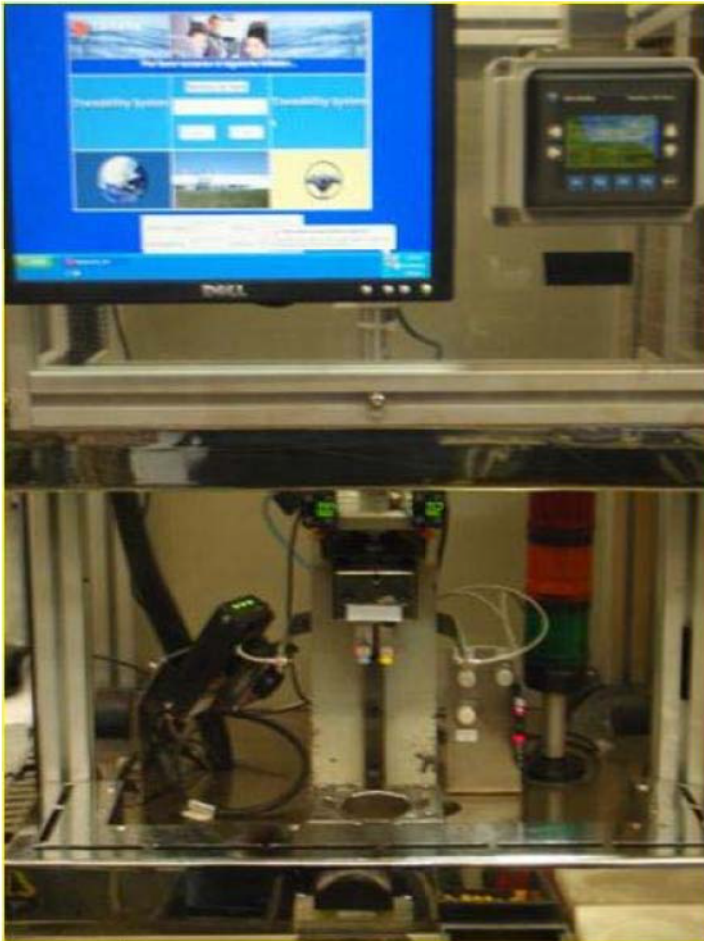
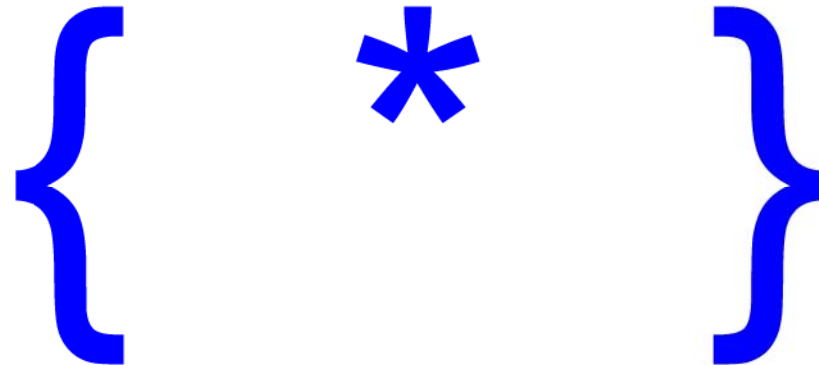
2012 Chevrolet Cruze, Verano, and Sonic Root Cause

The length of the Push Tab was measured using a microscope. The push tab length of the primary chamber shorting clip insertion tool was shorter than the secondary chamber shorting clip insertion tool.

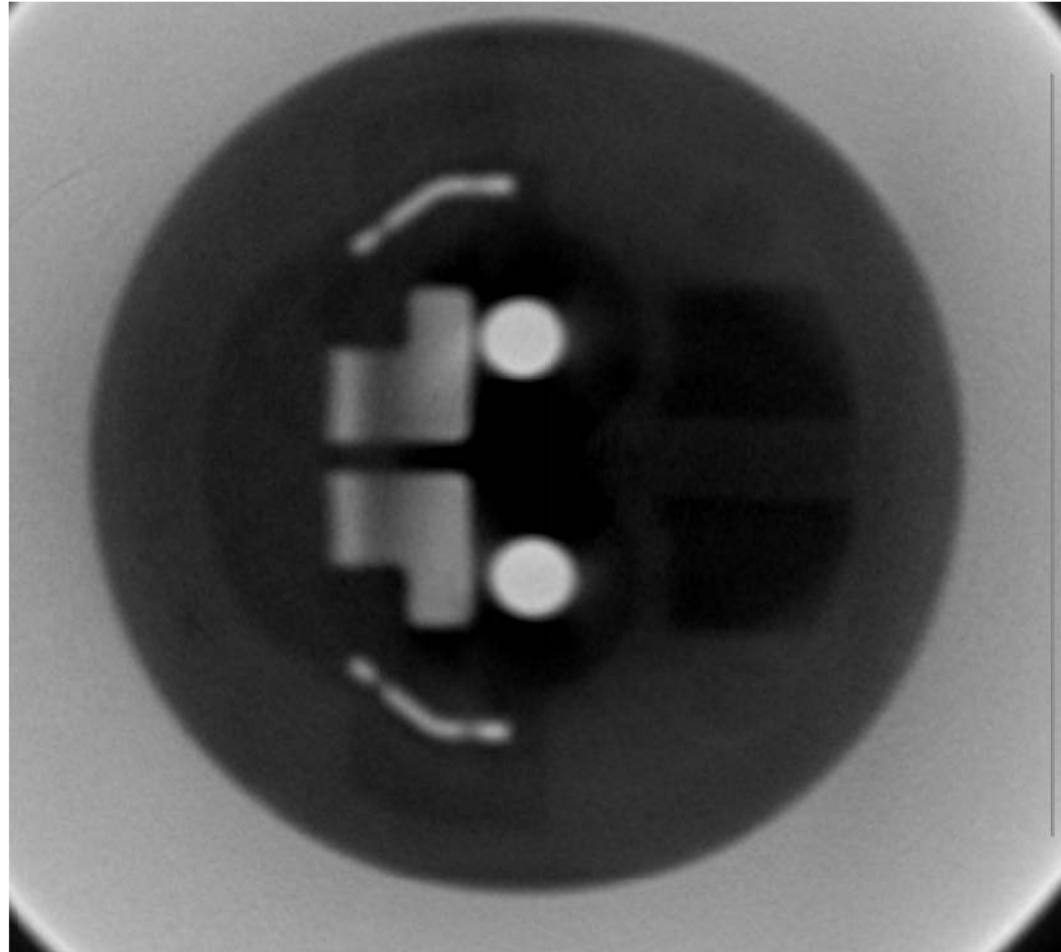
*2012 Chevrolet Cruze, Verano, and Sonic
X-Rays of Assembled Male and Female Connector
Shorting Bar Damaged*

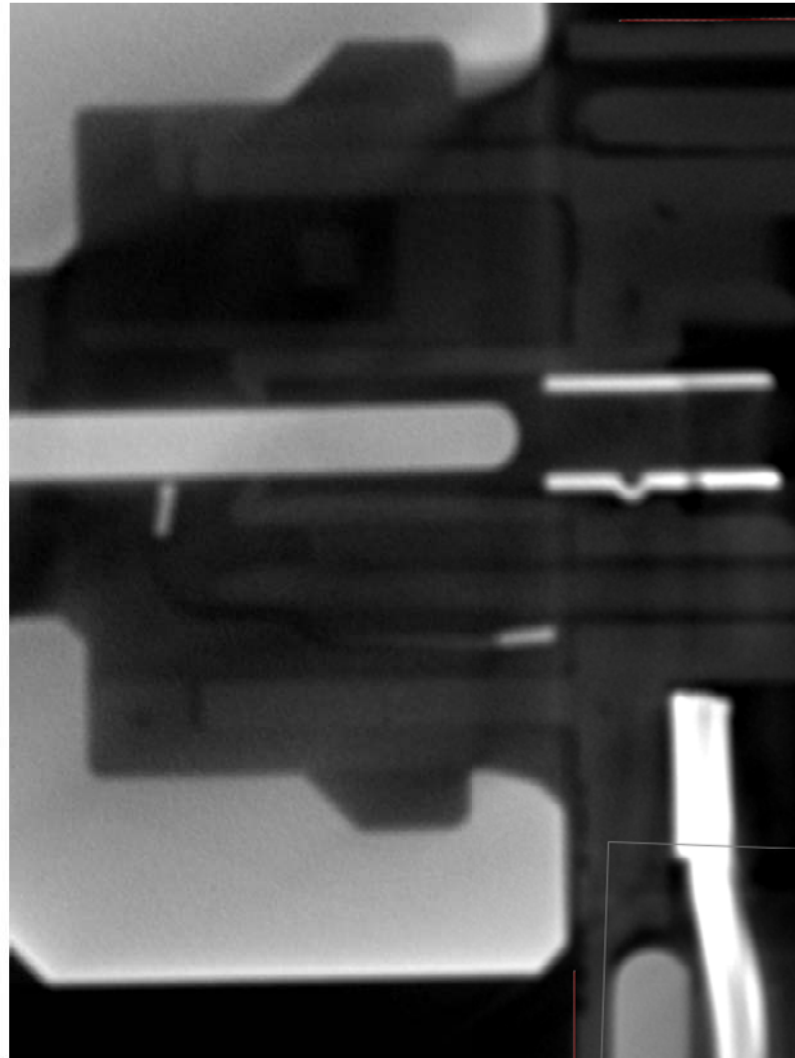
*2012 Chevrolet Cruze, Verano, and Sonic
X-Rays of Assembled Male and Female Connector
Shorting Bar Damaged*

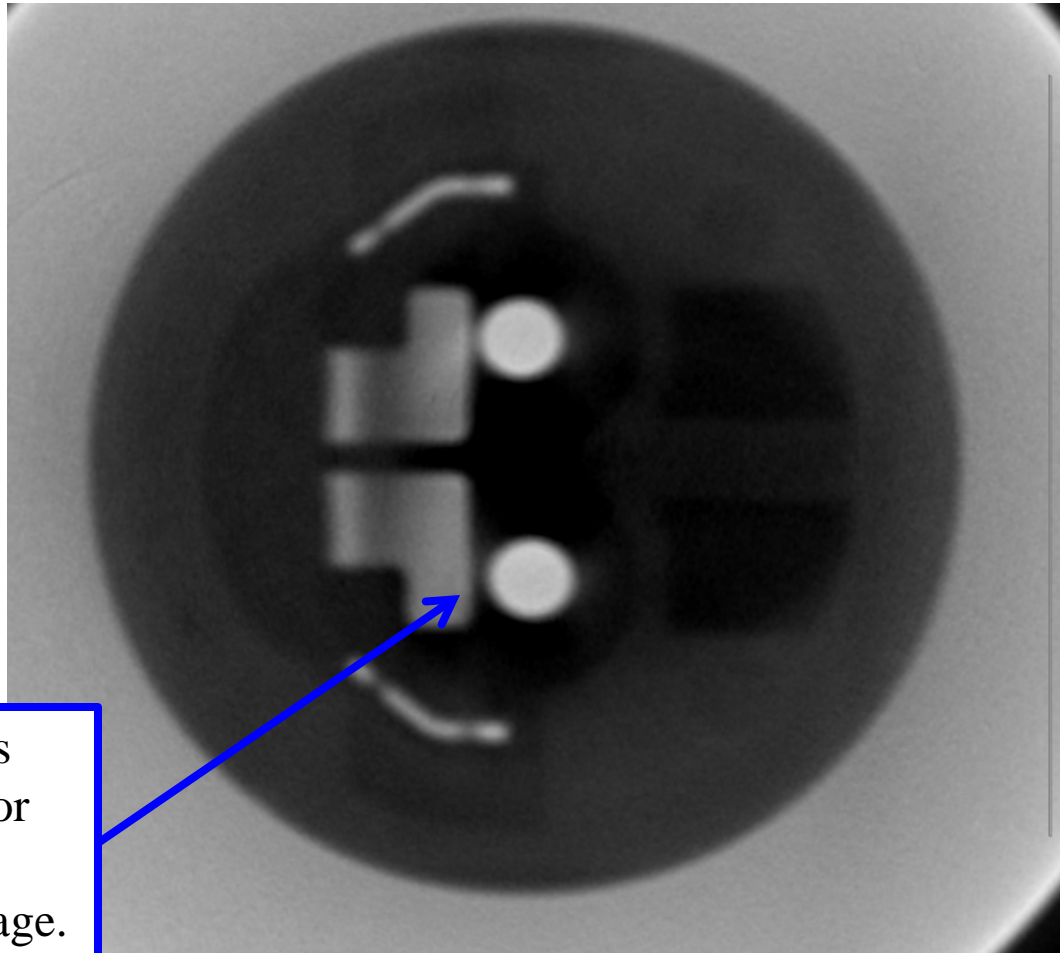
X-Rays of Assembled Male and Female Connector Shorting Bar Damaged

Movement in this damaged connector could short the associated airbag stage.

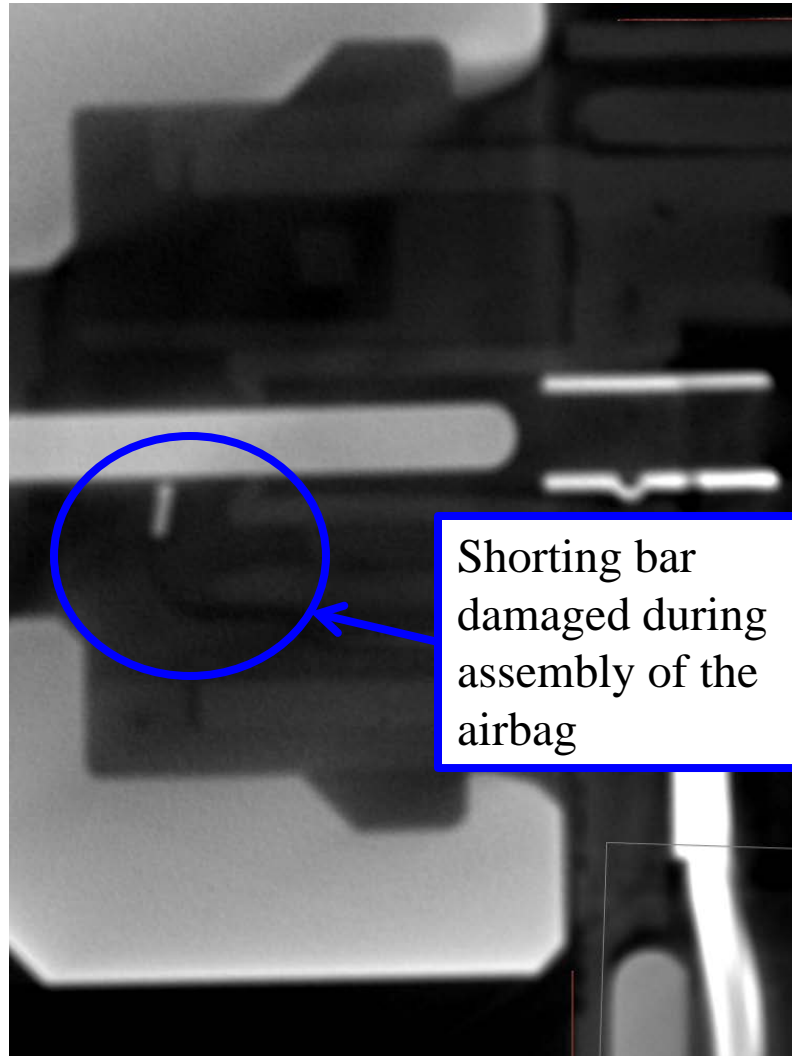
X-Rays of Assembled Male and Female Connector Shorting Bar Damaged

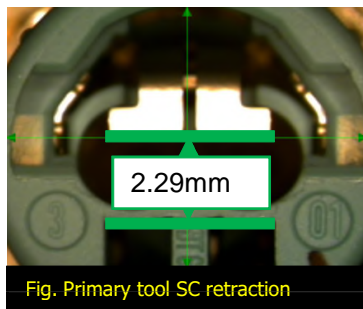
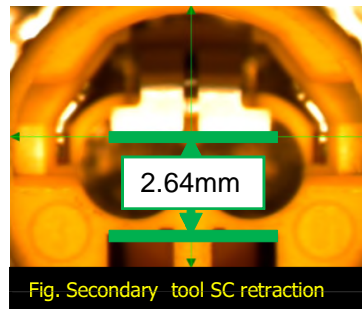
Root Cause (Snake chart point 2)

Examination of the manufacturing process found that the shorting bar was not fully retracted during insertion process resulting in interference/contact between initiator pins and shorting bar. Additional comparisons were made to secondary stage (no reported issues) and a 0.3 mm shorter difference in tab (simulated cpa) length was detected in the insertion tool itself.

On approximately May 25th, the primary shorting clip installation tooling was detected to be damaged and repaired by plant maintenance changing the effect work point of the tool. This tool was not covered by normal equipment preventative maintenance plan, so no documentation was kept.

On June 16th the primary stage installation tool was replaced with a dimensional revised tool. This new tool matched the secondary stage tool for dimensional and design intent.
