Subject: 71-1035097733 PAR Case Sent to ESIS - No Action Required

A product allegation claim has been made in your region. The customer is alleging airbag nondeployment, wheels locked up and Onstar inoperative in a collision . This case is being escalated to ESIS because insurance involvement.

██████████
2012 Chevrolet Sonic
1G1JC5SHXC4██████████
CENTURY III CHEVROLET, WEST MIFFLIN PA (BAC) 113496
Kevin Codd, Body Shop Manager

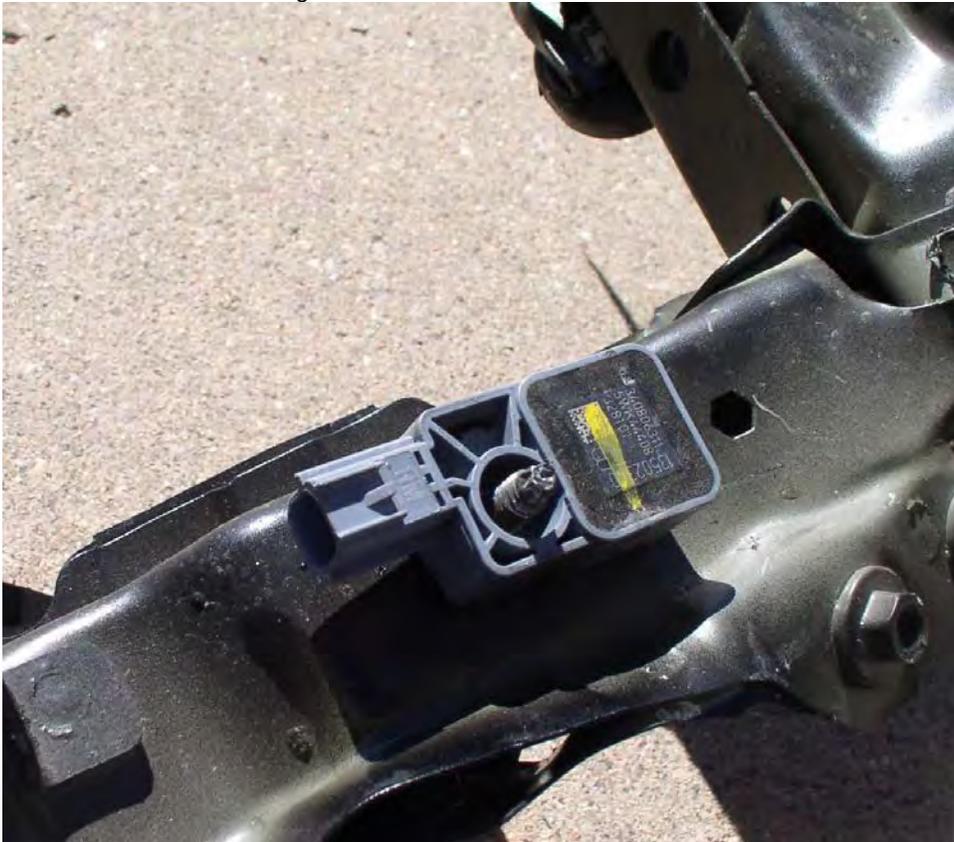
40 Left impact sensor intact and un-damaged

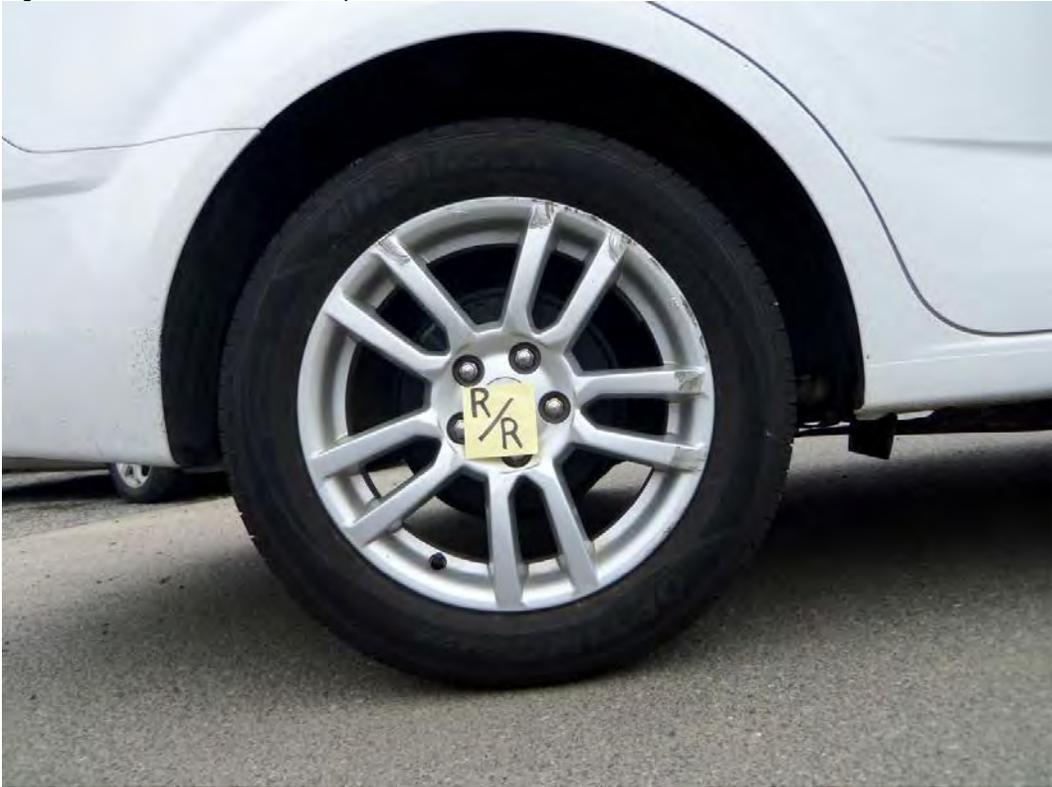
<u>Photo #</u>	<u>Description / Photo</u>	<u>Damage (Yes/No)</u>
15	Right Rear Wheel and Tire. See photo #16 for details.

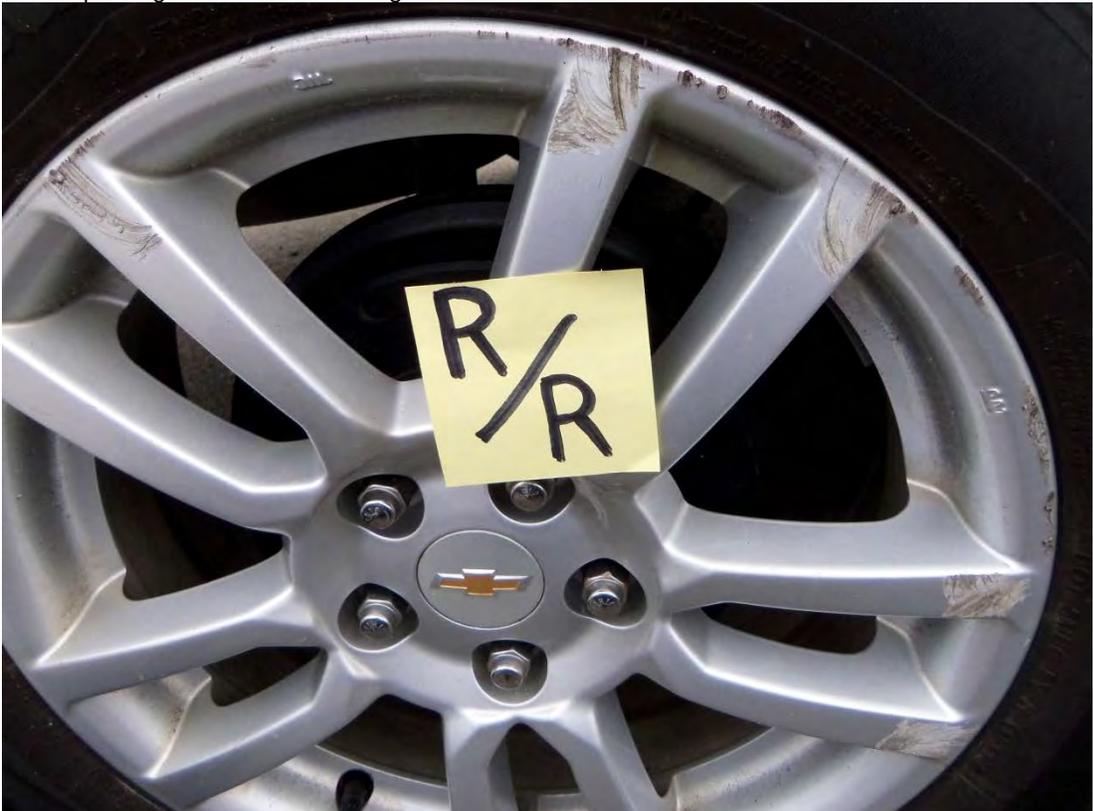
Yes
16	Close Up of Right Rear Wheel Damage.

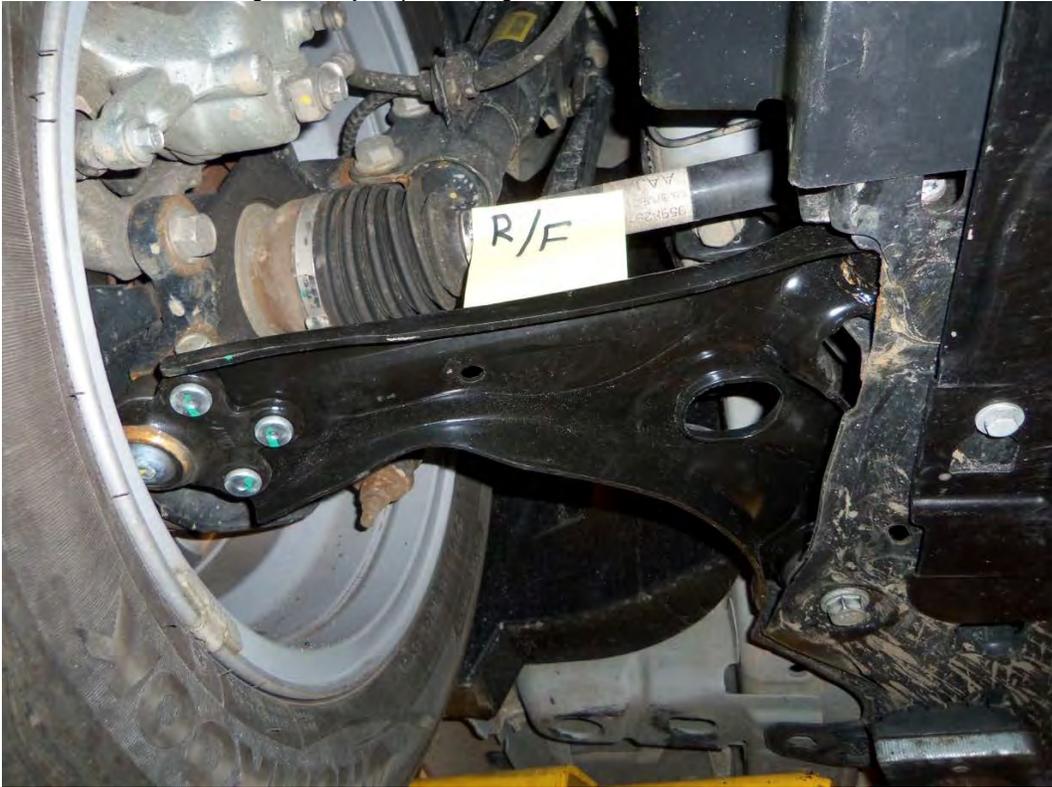
Photo #	Description / Photo	Damage (Yes/No)
29	<p>Undercar Photo Showing Recently Replaced Right Side Lower Control Arm.</p>

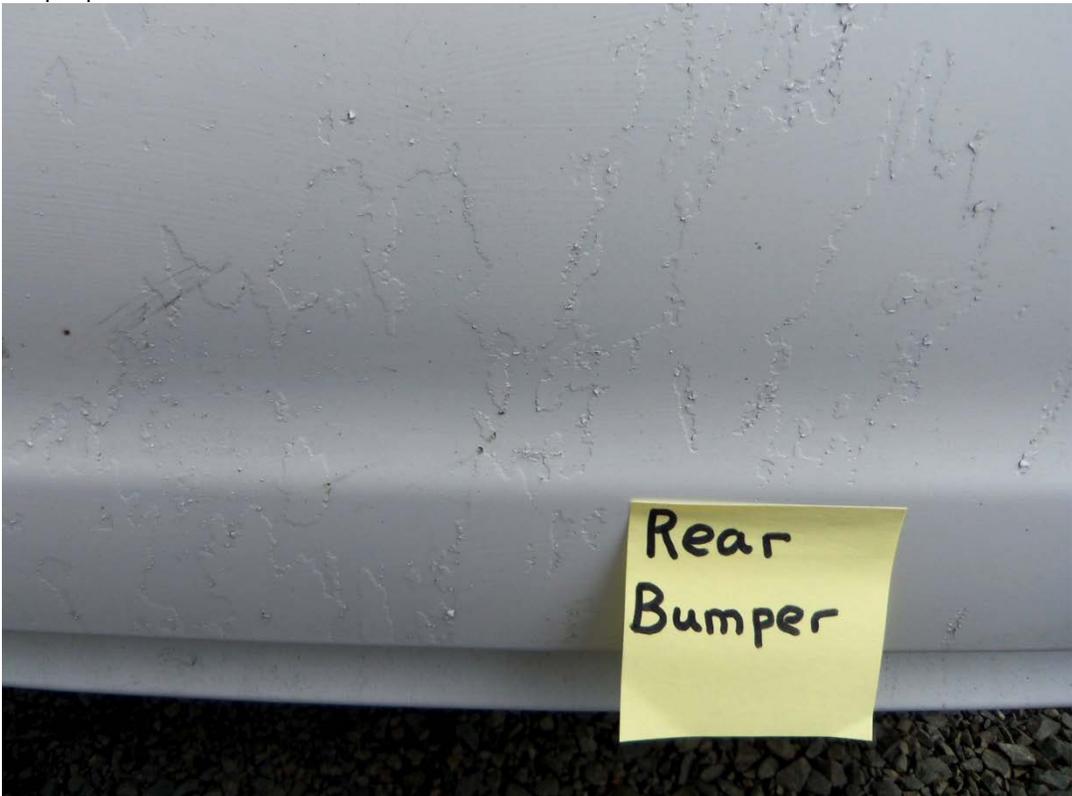
No
30	<p>Rear Bumper Fascia. This is pre-existing damage. Customer allegedly used spray cans to re-paint rear bumper prior to incident.</p>

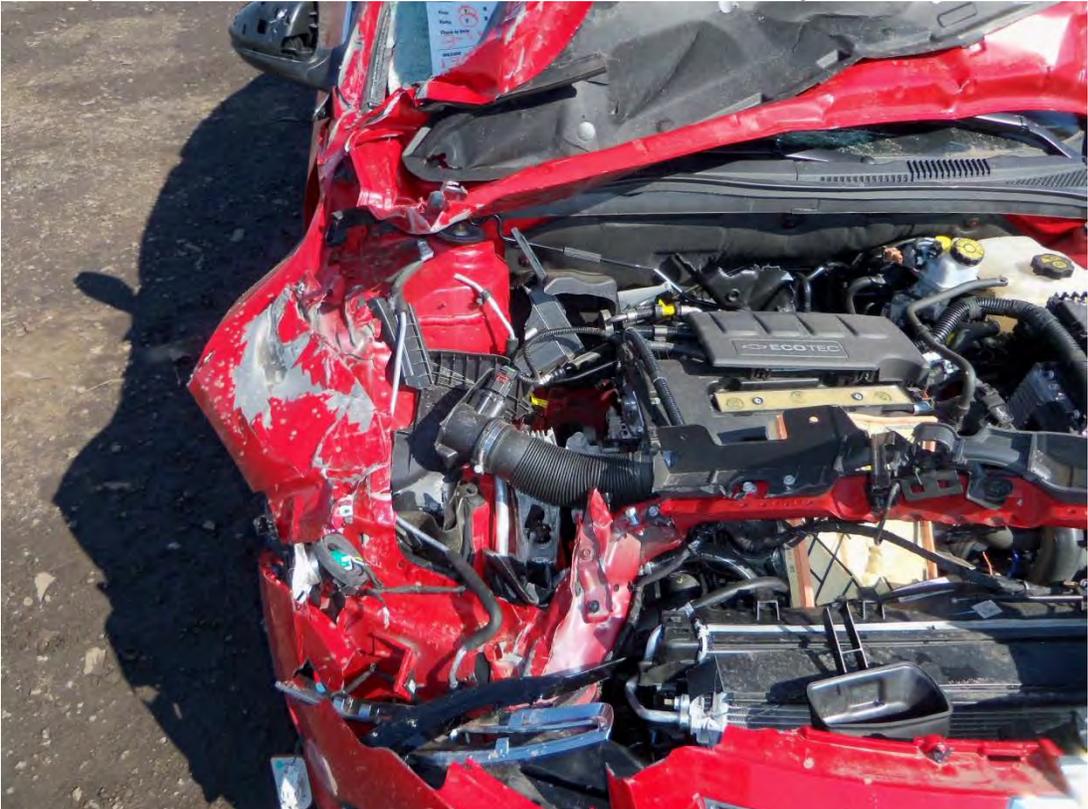
Yes
26	Passenger Side Front Fender Taken From Above. Note Under Hood Damage

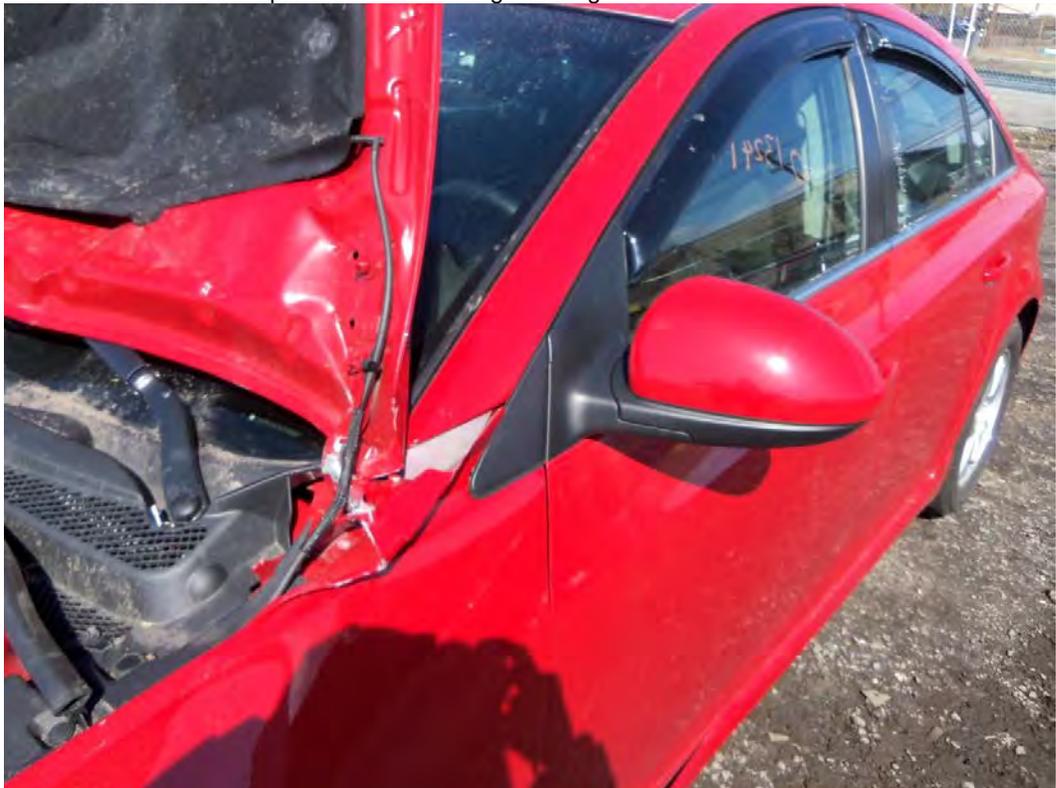
Yes
28	<p data-bbox="217 1146 1273 1167">Driver's Side Exterior "A" pillar. Note Hood Hinge Damage. Note Exterior Side Window Vent Shades.</p>

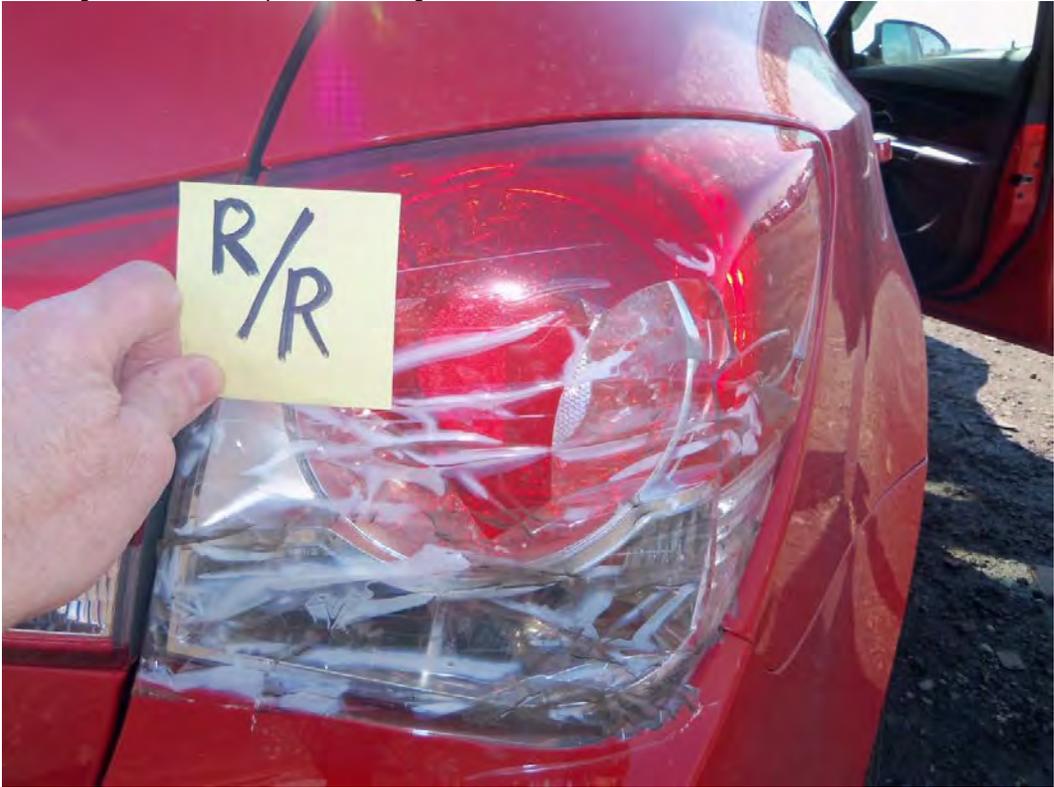
<u>Photo #</u>	<u>Description / Photo</u>	<u>Damage (Yes/No)</u>
29	Passenger Side Tail Lamp. Prior Damage

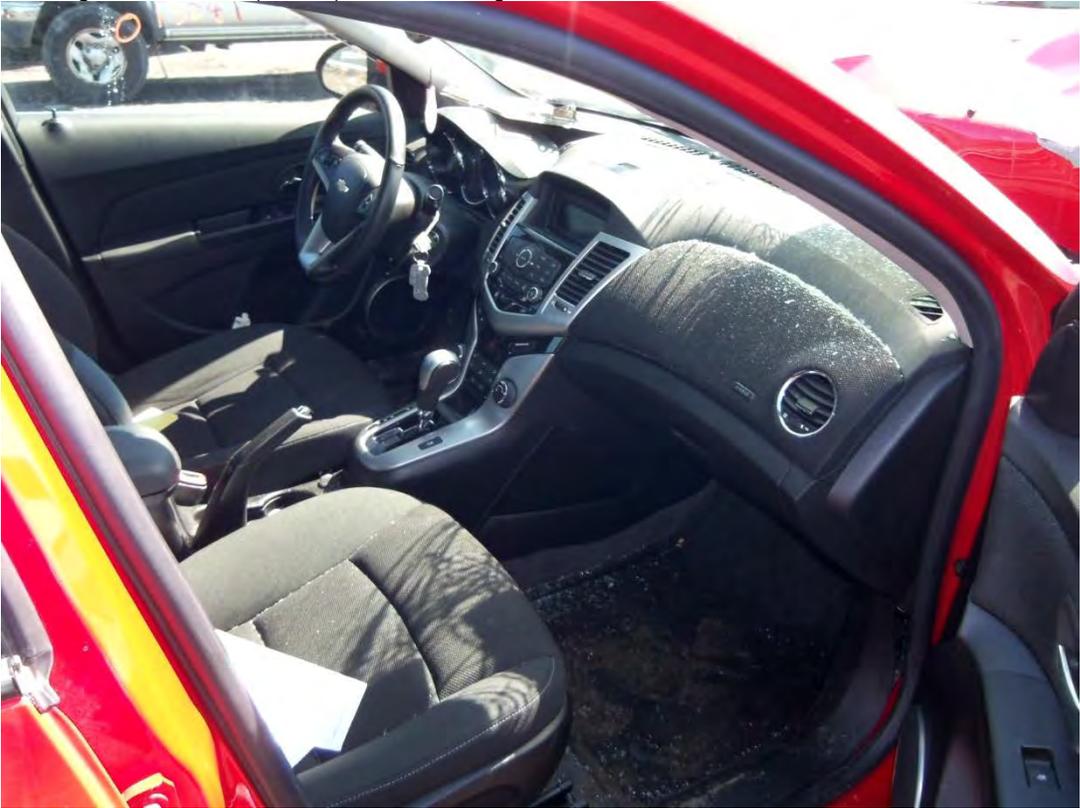
Photo #	Description / Photo	Damage (Yes/No)
41	<p>Passenger's Side Front (Interior). Note broken glass from windshield.</p>

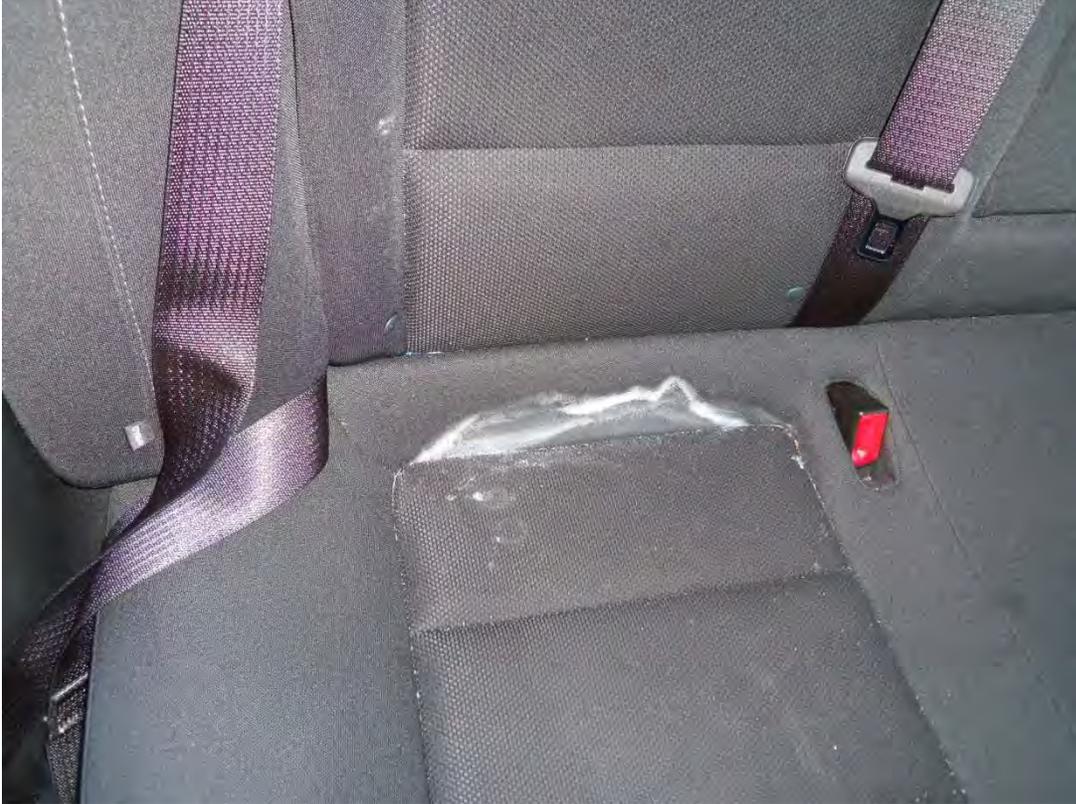
Photo #	Description / Photo	Damage (Yes/No)
43	<p>Passenger's Side Rear Seat Stain.</p>

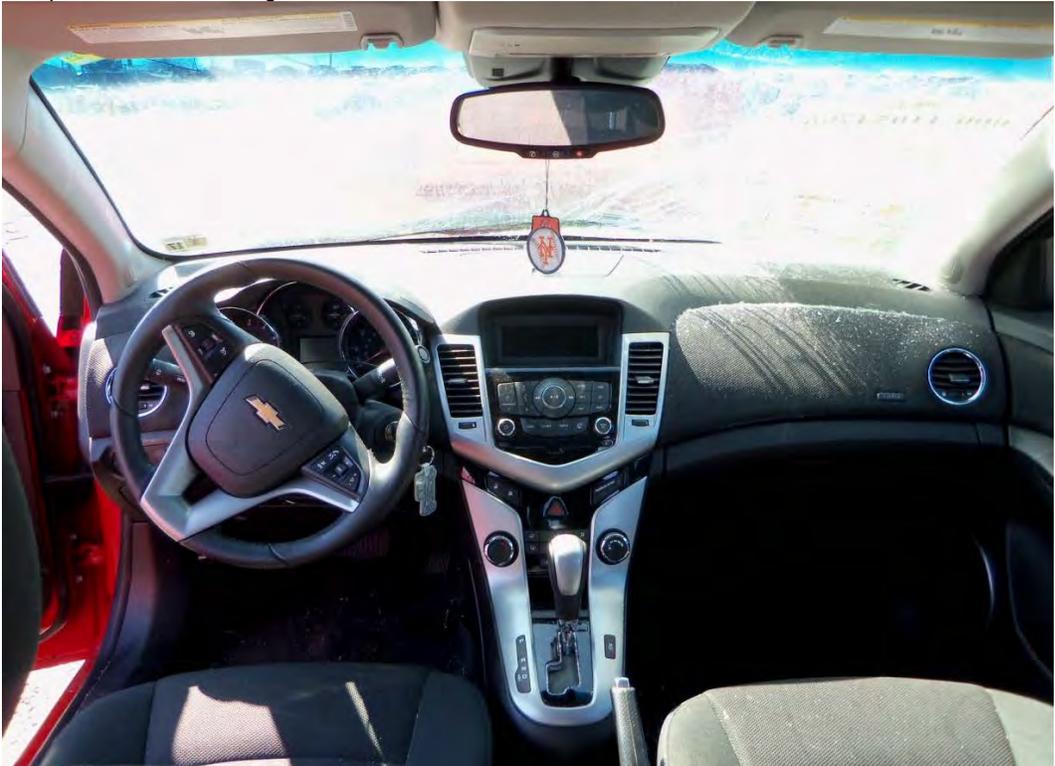
No
48	<p>Complete IP. Note Damaged Windshield</p>

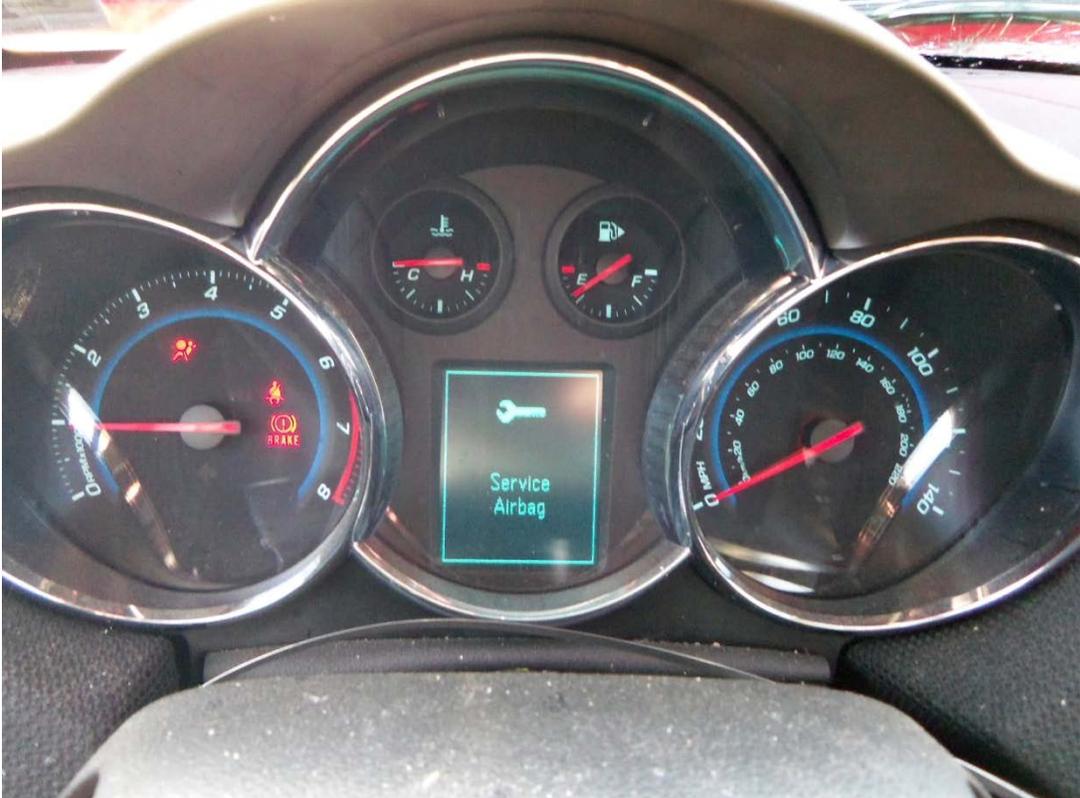
Photo #	Description / Photo	Damage (Yes/No)
51	Instrument Cluster with Engine Running. Note Airbag Warning Lamp and Service Message

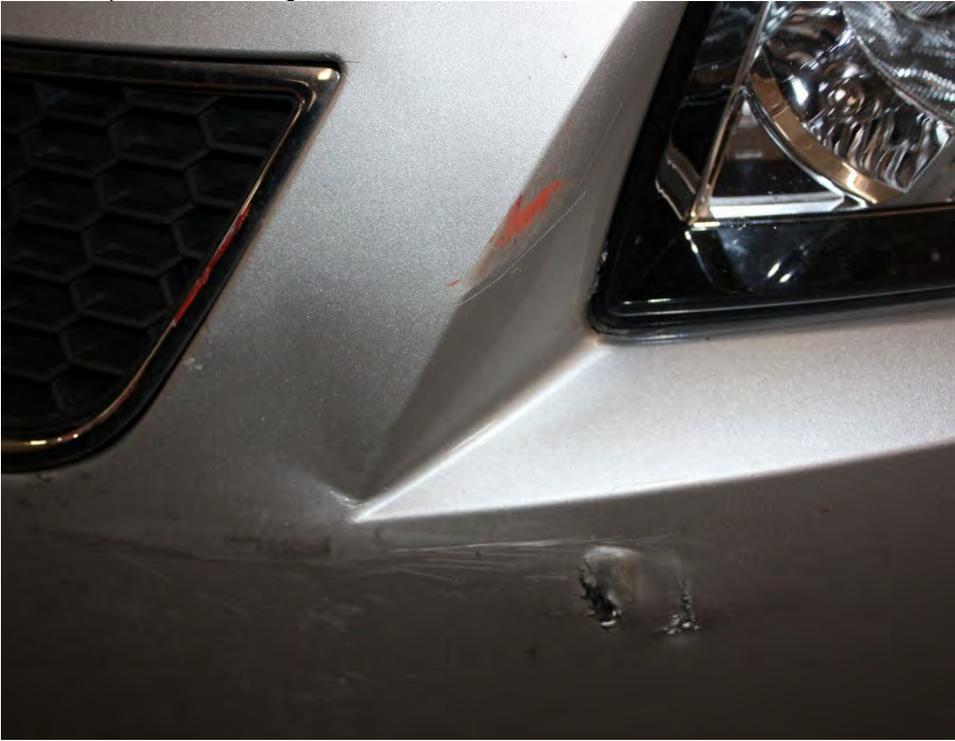
Photo #	Description / Photo	Damage (Yes/No)
15	<p>Front Bumper Cover Damage</p>
