RQ13-003

ATTACHMENT 1

Bulletin No.: 10-00-89-017Z

**Subject:** Car and Truck Fix it Right the First Time Issues

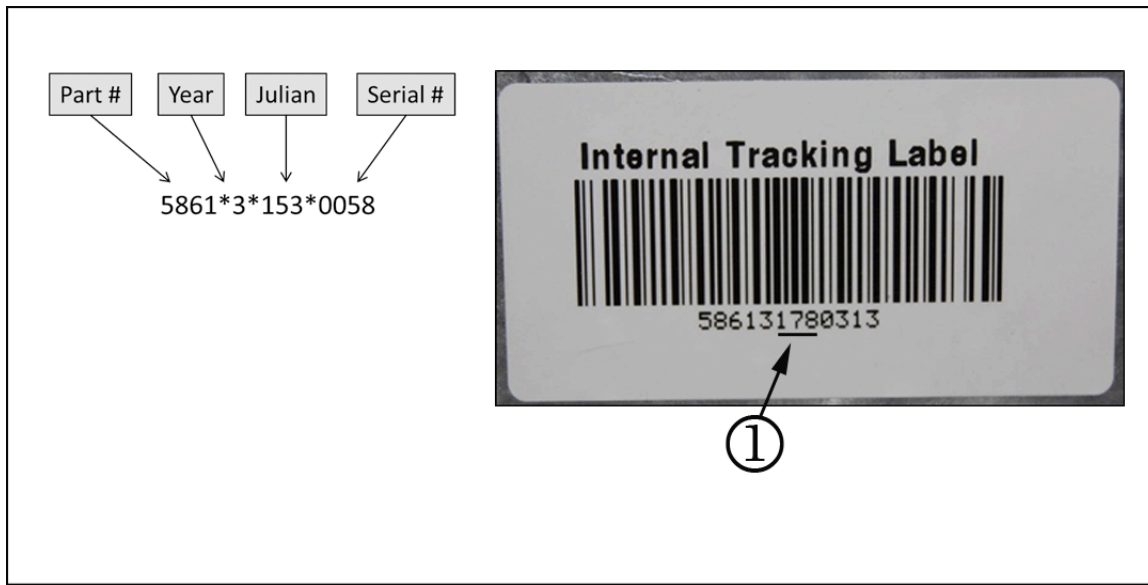
3600552

**Important Part Inspection**

**Note:** Do NOT install GCMs with a Julian date of 171 through 199. Return those modules according to Special Return Bulletin #G\_0000171850.

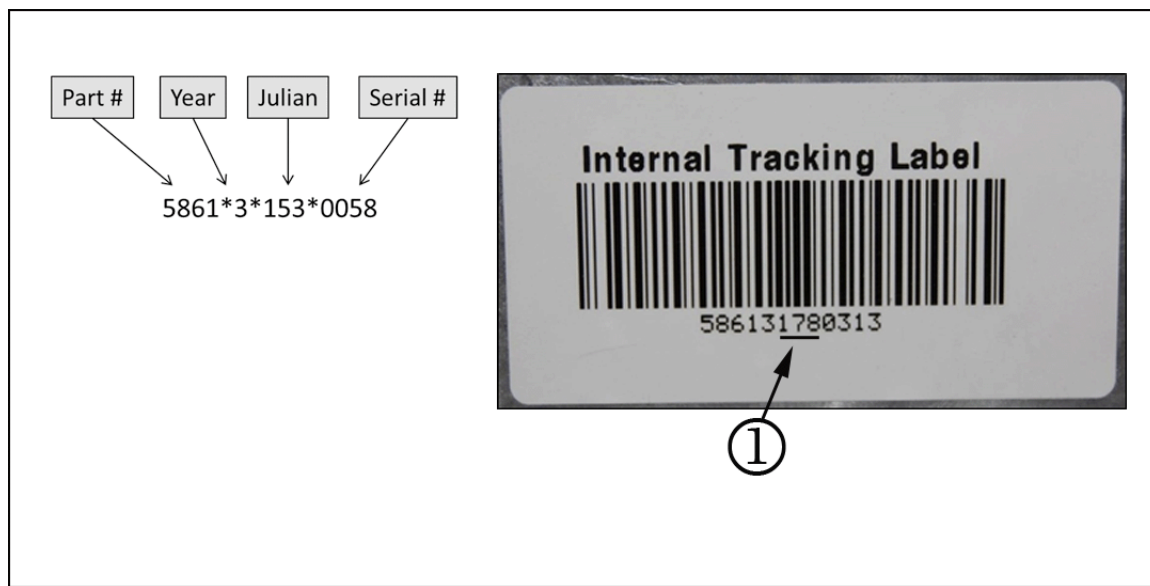
Generator Control Modules (GCM) with part number 24269448 or 24266403 require an inspection prior to installation in a vehicle. GCMs with part number 24267940 or 24267941 do NOT require inspection prior to installation in a vehicle.

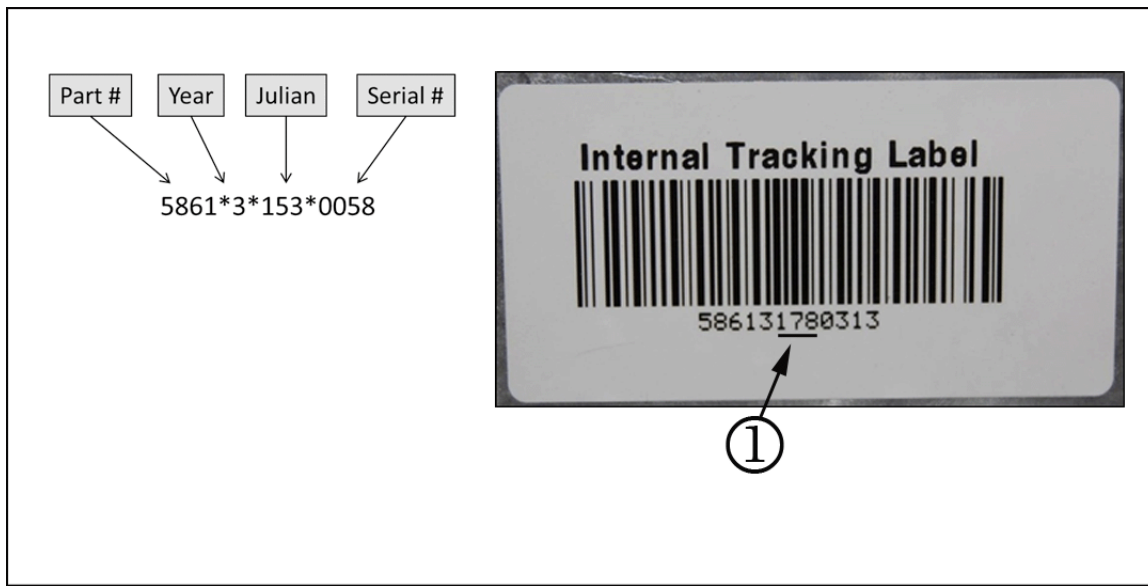
3600552

**Important Part Inspection**

2. Determine the Julian date (1) as shown above.
  - If the Julian date (1) is 171 through 199, proceed to step 3.
  - If the Julian date (1) is NOT 171 through 199, provide the GCM to the technician for installation in the vehicle.

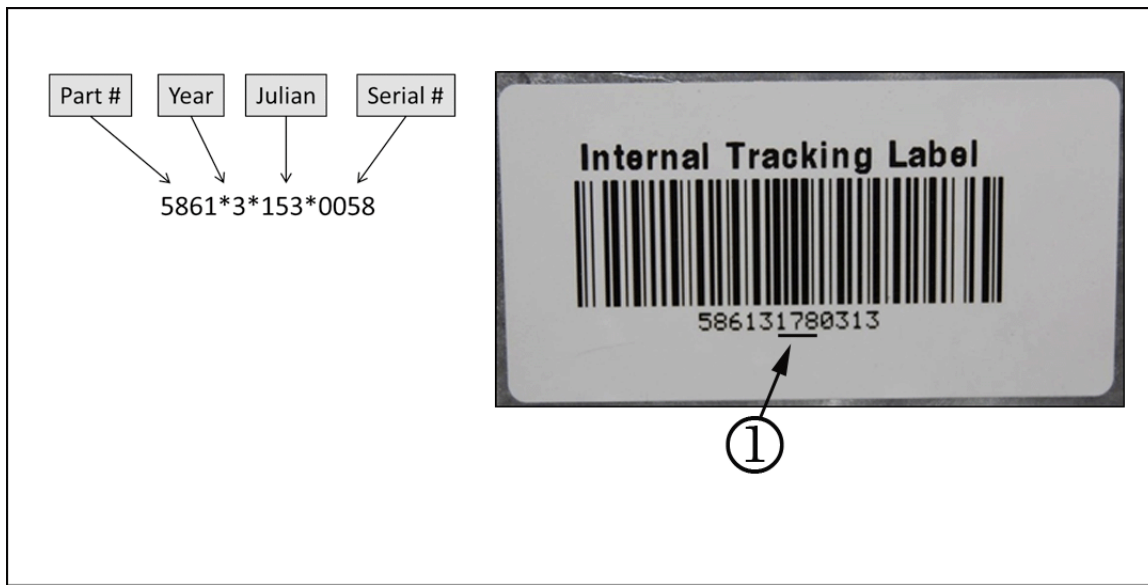
3600552

**Important Part Inspection**

2. Determine the Julian date (1) as shown above.
  - If the Julian date (1) is 171 through 199, proceed to step 3.
  - If the Julian date (1) is NOT 171 through 199, provide the GCM to the technician for installation in the vehicle.

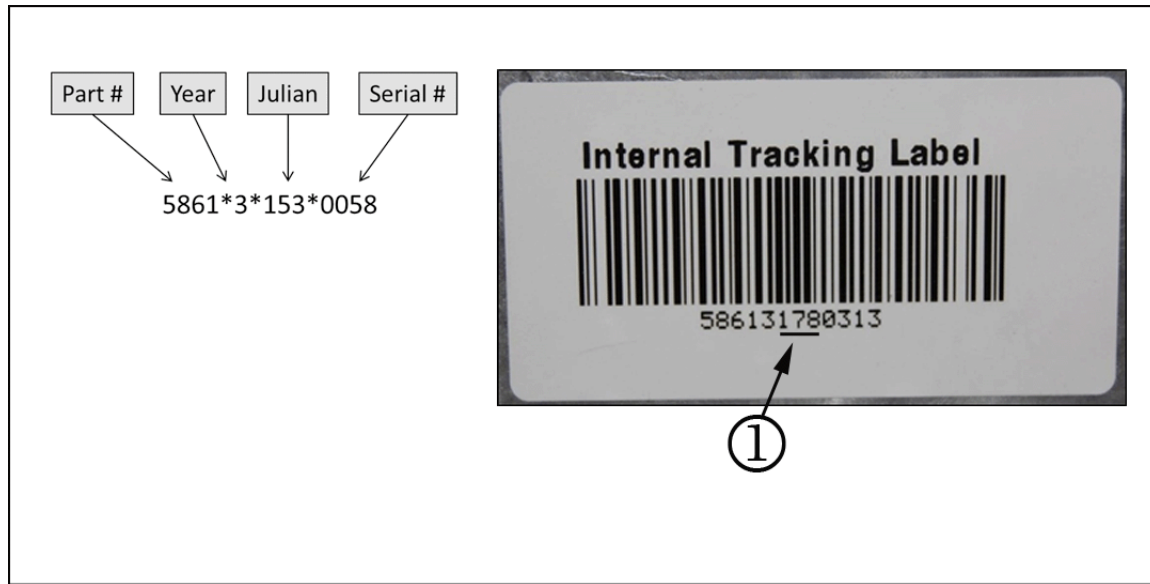
3600552

### **Part Inspection Procedure**

1. Locate the barcode label on the new GCM.
2. Determine the Julian date (1) as shown above.
  - If the Julian date (1) is 171 through 199, proceed to step 3.
  - If the Julian date (1) is NOT 171 through 199, install the GCM in the vehicle.
