RQ13-003

RQ13-003 Request 9 Partial III Response

Action 9-B: Investigation and analysis of single vehicle BPIM/APM failure on Shanghai General Motors (SGM) vehicle.

Action 9-C: GM Investigation of BPIM (GCM) isolation related issues.

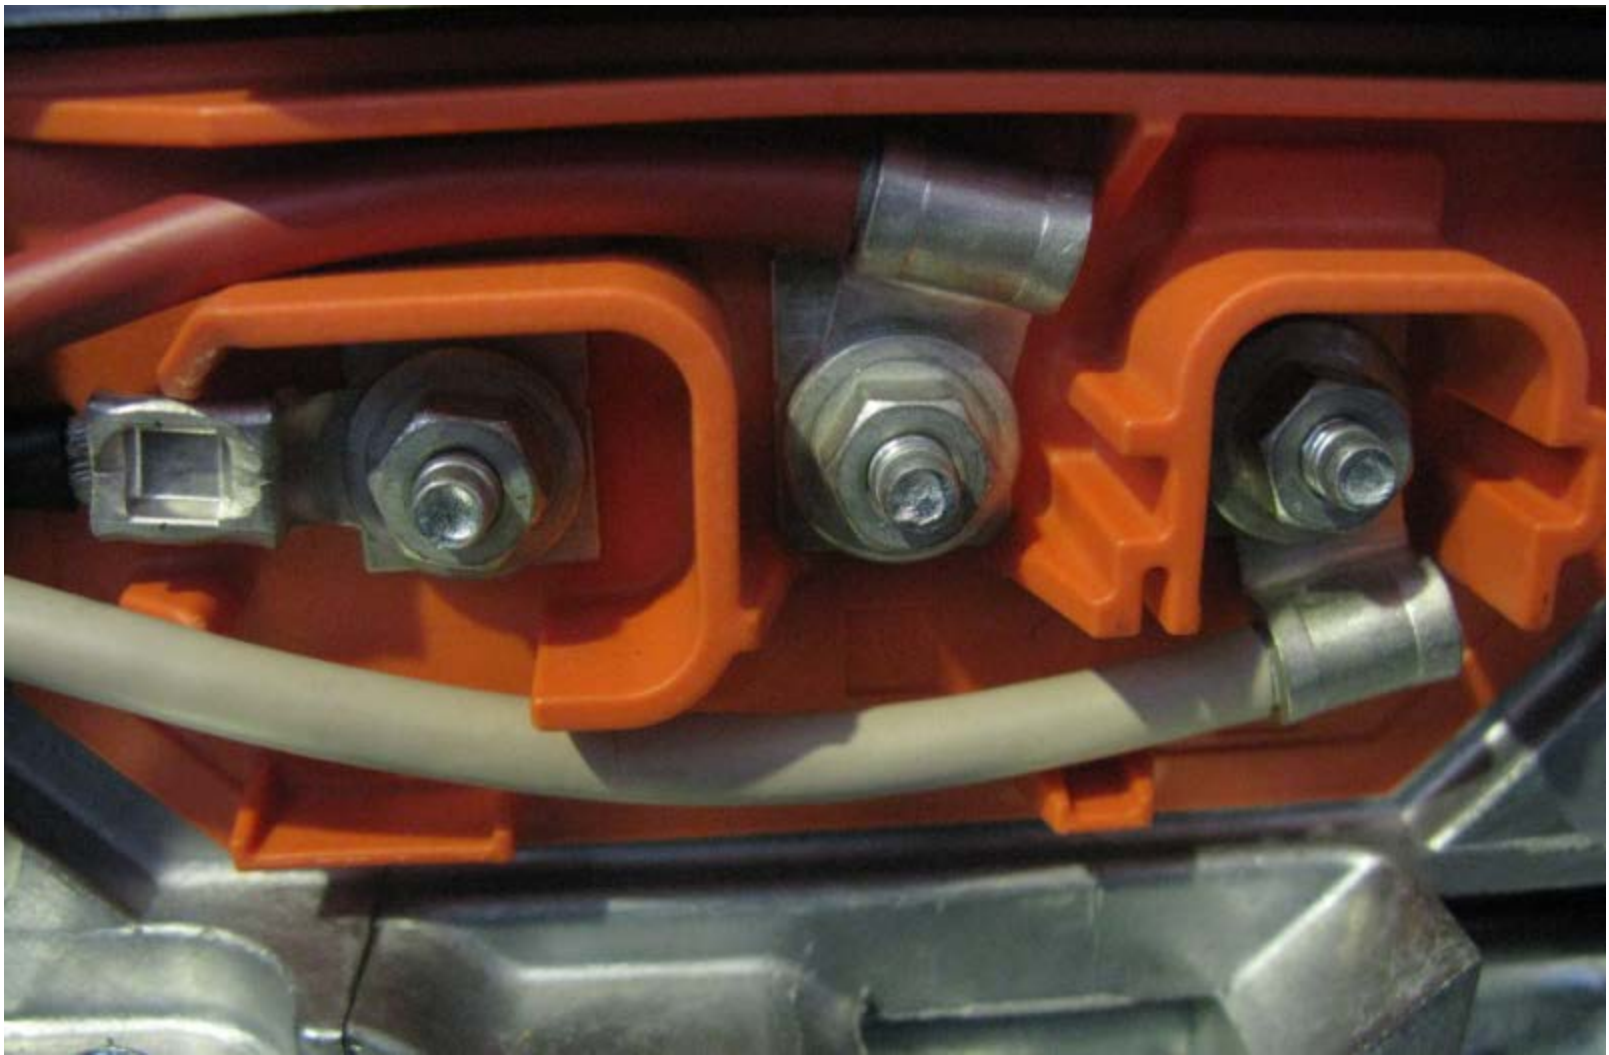
3 Phase Terminal Leads: New Powerpack (known good)
LQ56184111109004

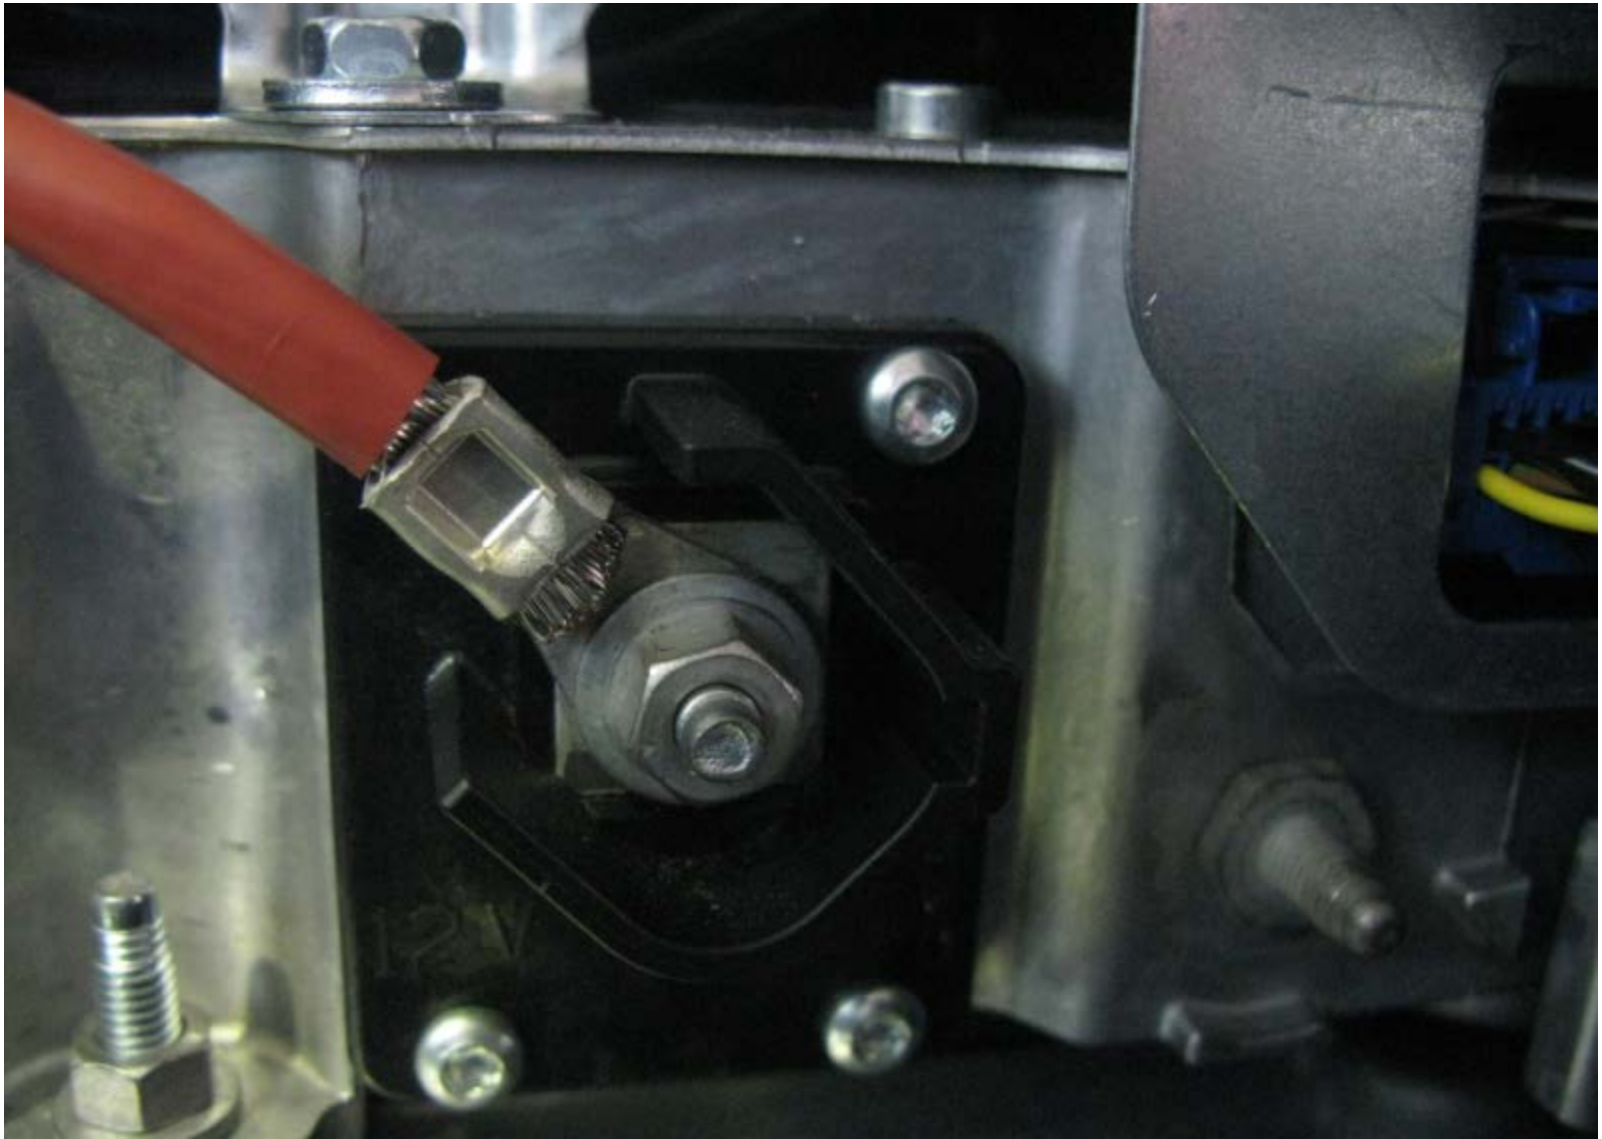
12V Accy terminal: New Powerpack (known good)
LQ56184111109004

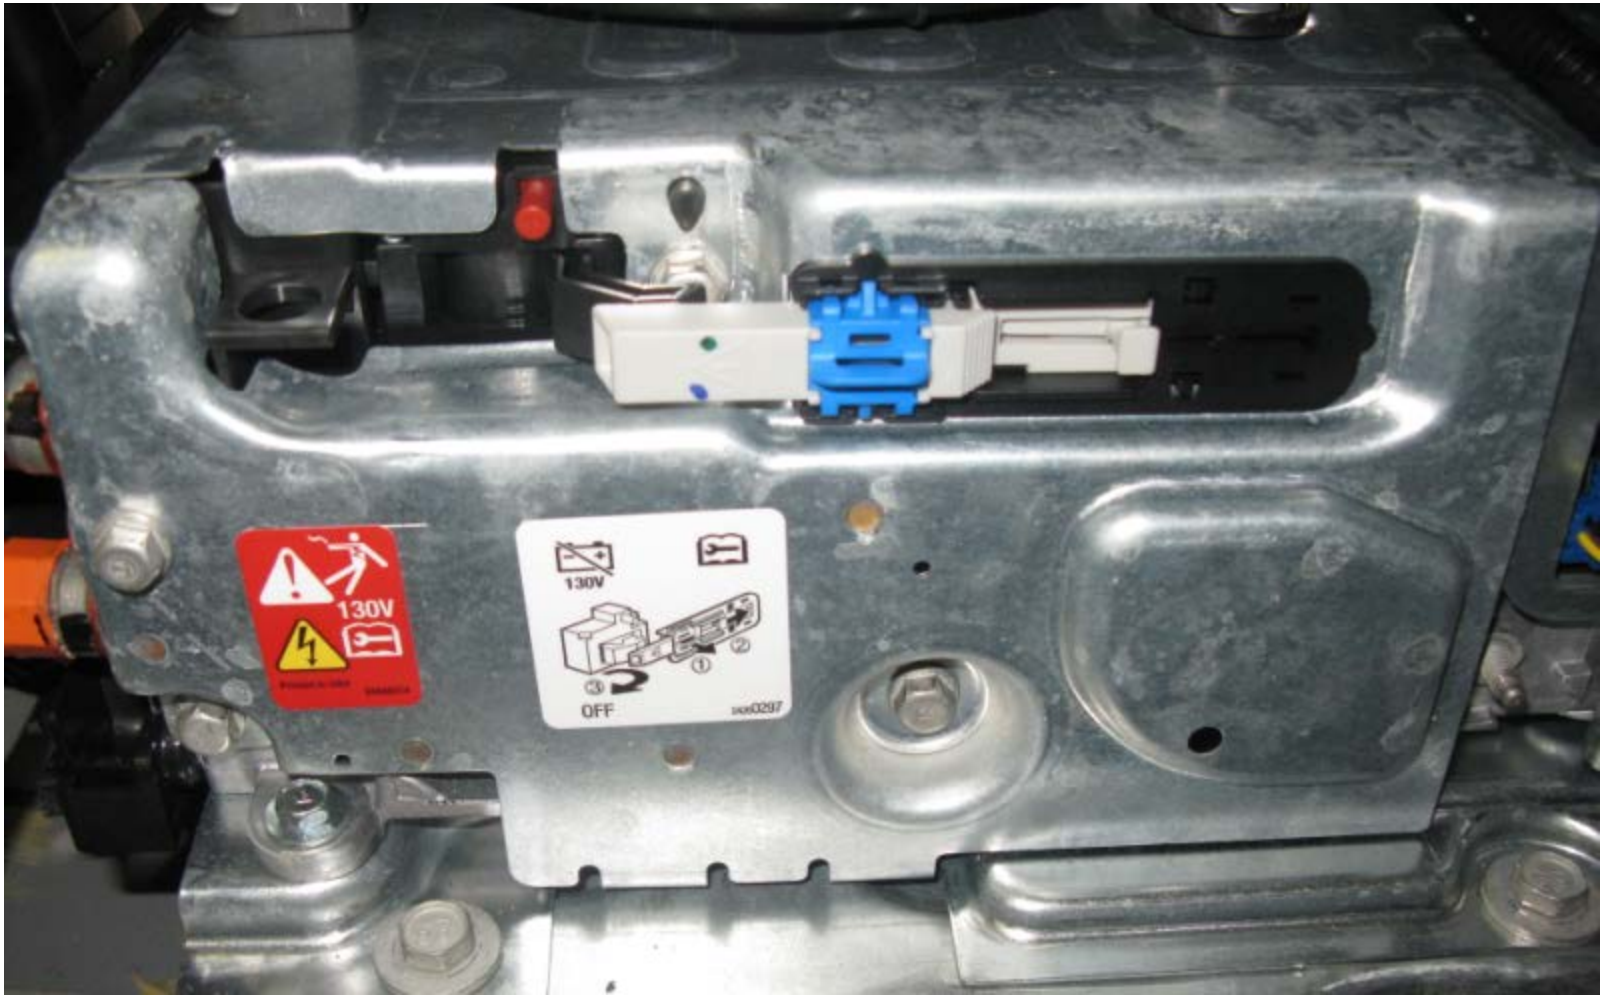
New cover installed
