## RQ13-003 Request 9 Partial III Response

**Action 9-A:** Design, Development, and Validation Plan and Testing Specifications for the Generator Control Module (GCM) in the subject vehicles.

**Action 9-B:** Investigation and analysis of single vehicle BPIM/APM failure on Shanghai General Motors (SGM) vehicle.

**Action 9-C:** GM Investigation of BPIM (GCM) isolation related issues.

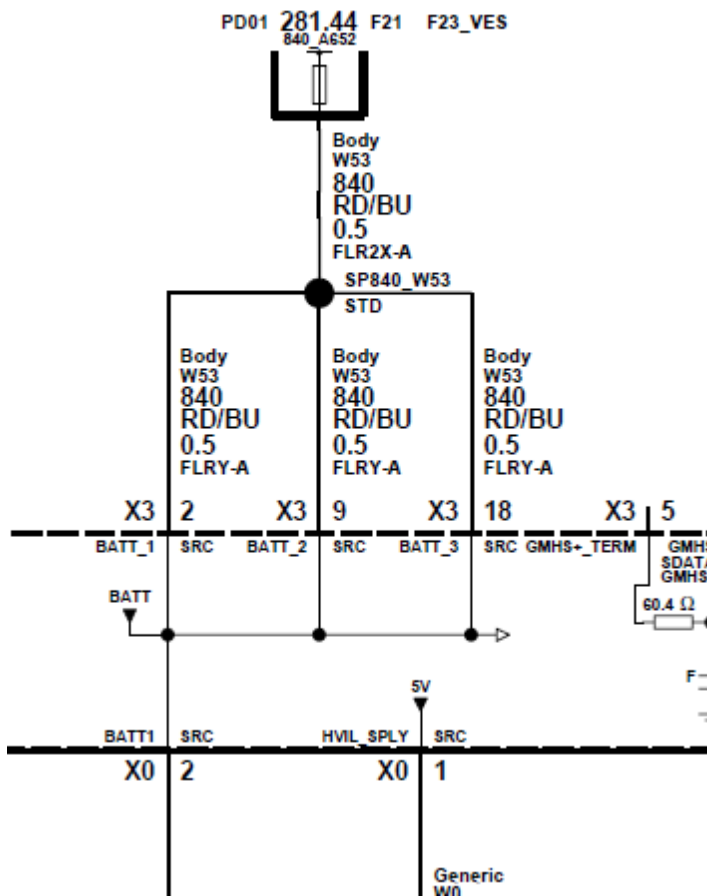
- Jump started the vehicle but 12V charging not functional
- Checked the fuse (F23 as shown in the picture). It was broken

- 
- Checked wire harness of X3-2, X3-9 and X3-18. They were in good conditions
- Every time pull plug X3 and reconnect – causing F23 fuse broken
- Burn mark found in all the three powerpack signal connectors (X1, X2, X3)
- Engineers thought powerpack has short circuit inside so replaced powerpack. Fuse F23 functioned normally but 12V battery charging still not functional.
- Checked 175A fuse (from APM to 12V battery) and found it was broken as well
- Replaced 175A fuse. Now the vehicle is normal

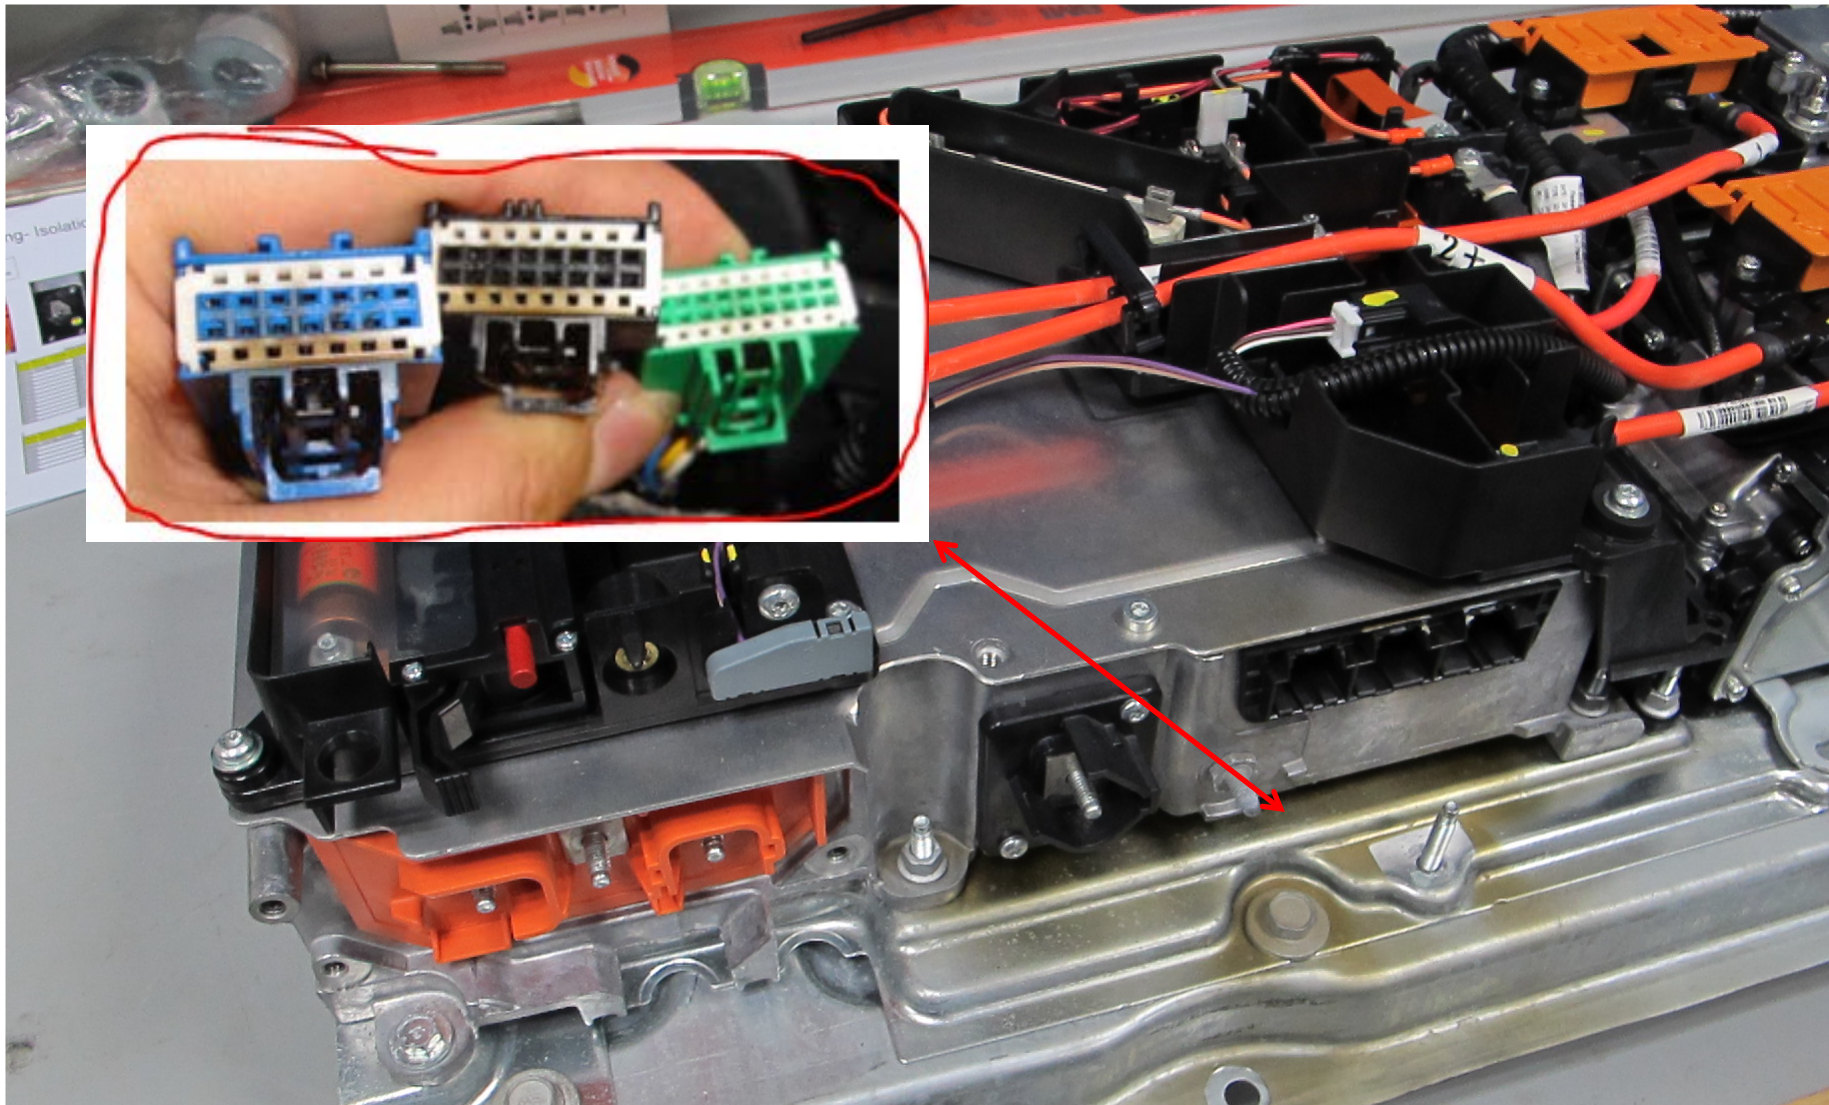
Evidence of arcing on 12V Low Voltage Connectors.

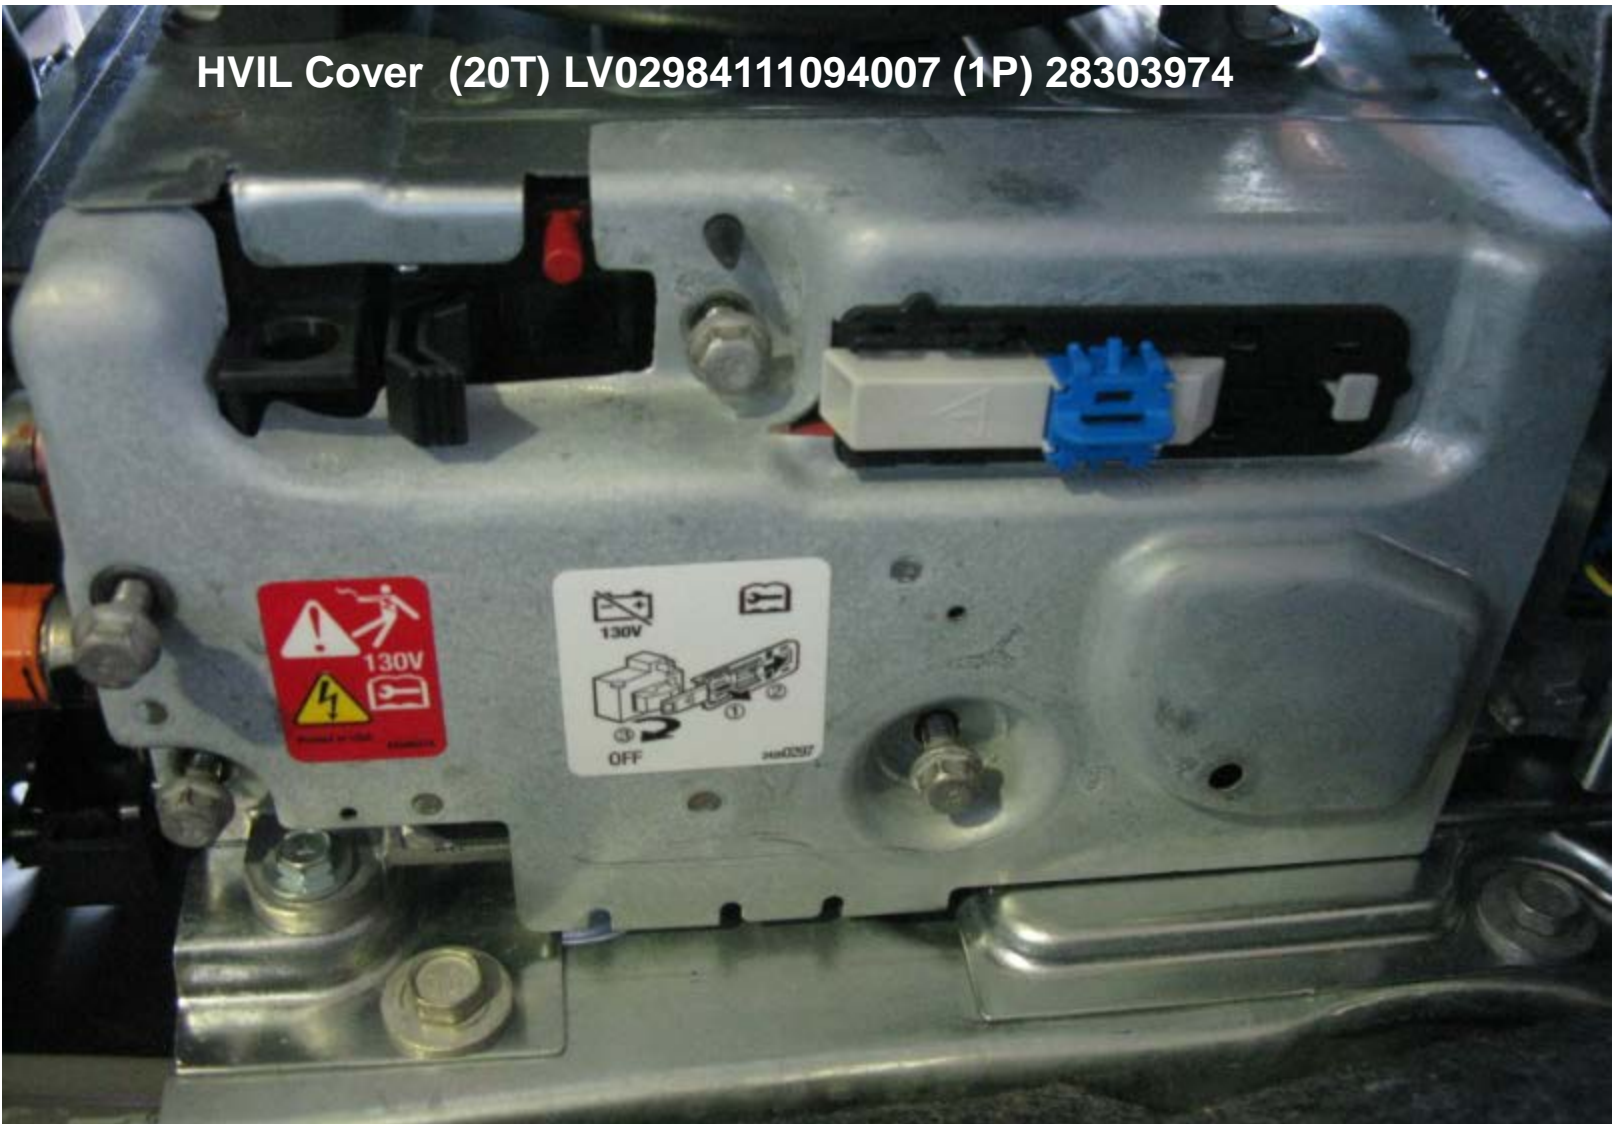
HVIL Cover (20T) LV02984111094007 (1P) 28303974

Original HVIL Cover from reported failure: High Voltage Isolation Failure 06July 2011

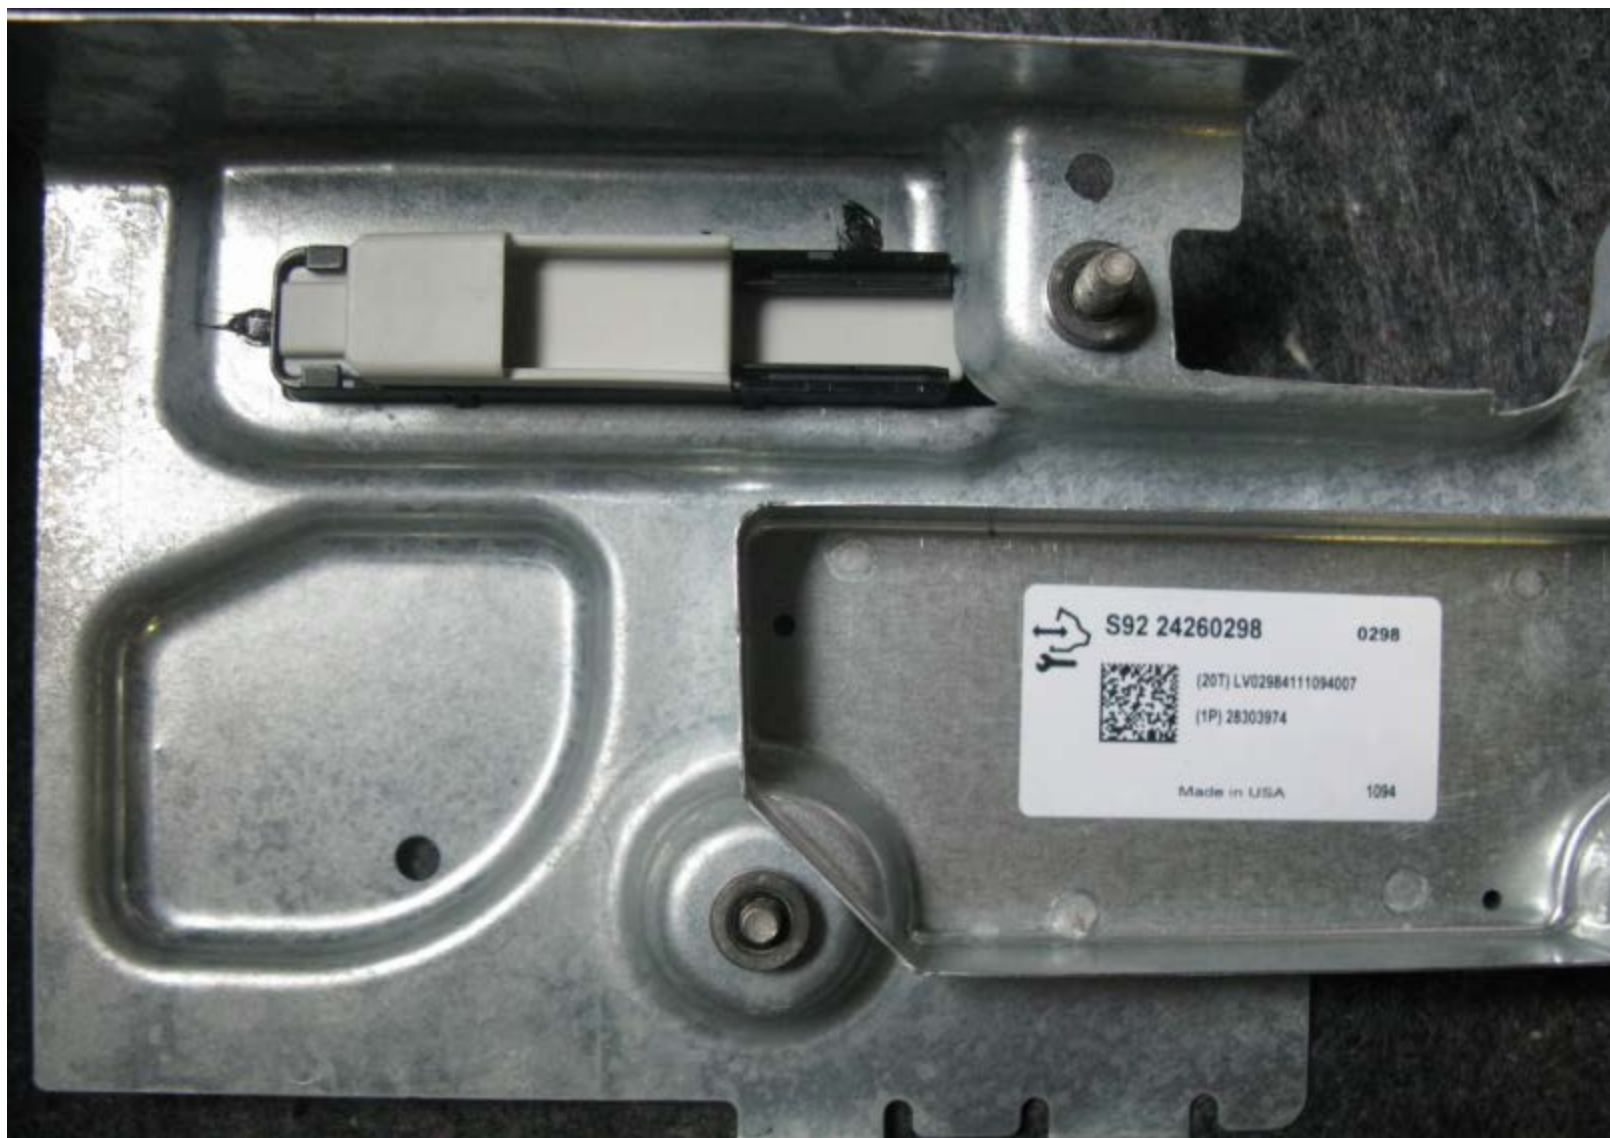
Original HVIL Cover (back)

Resistance recheck: 3050ohm

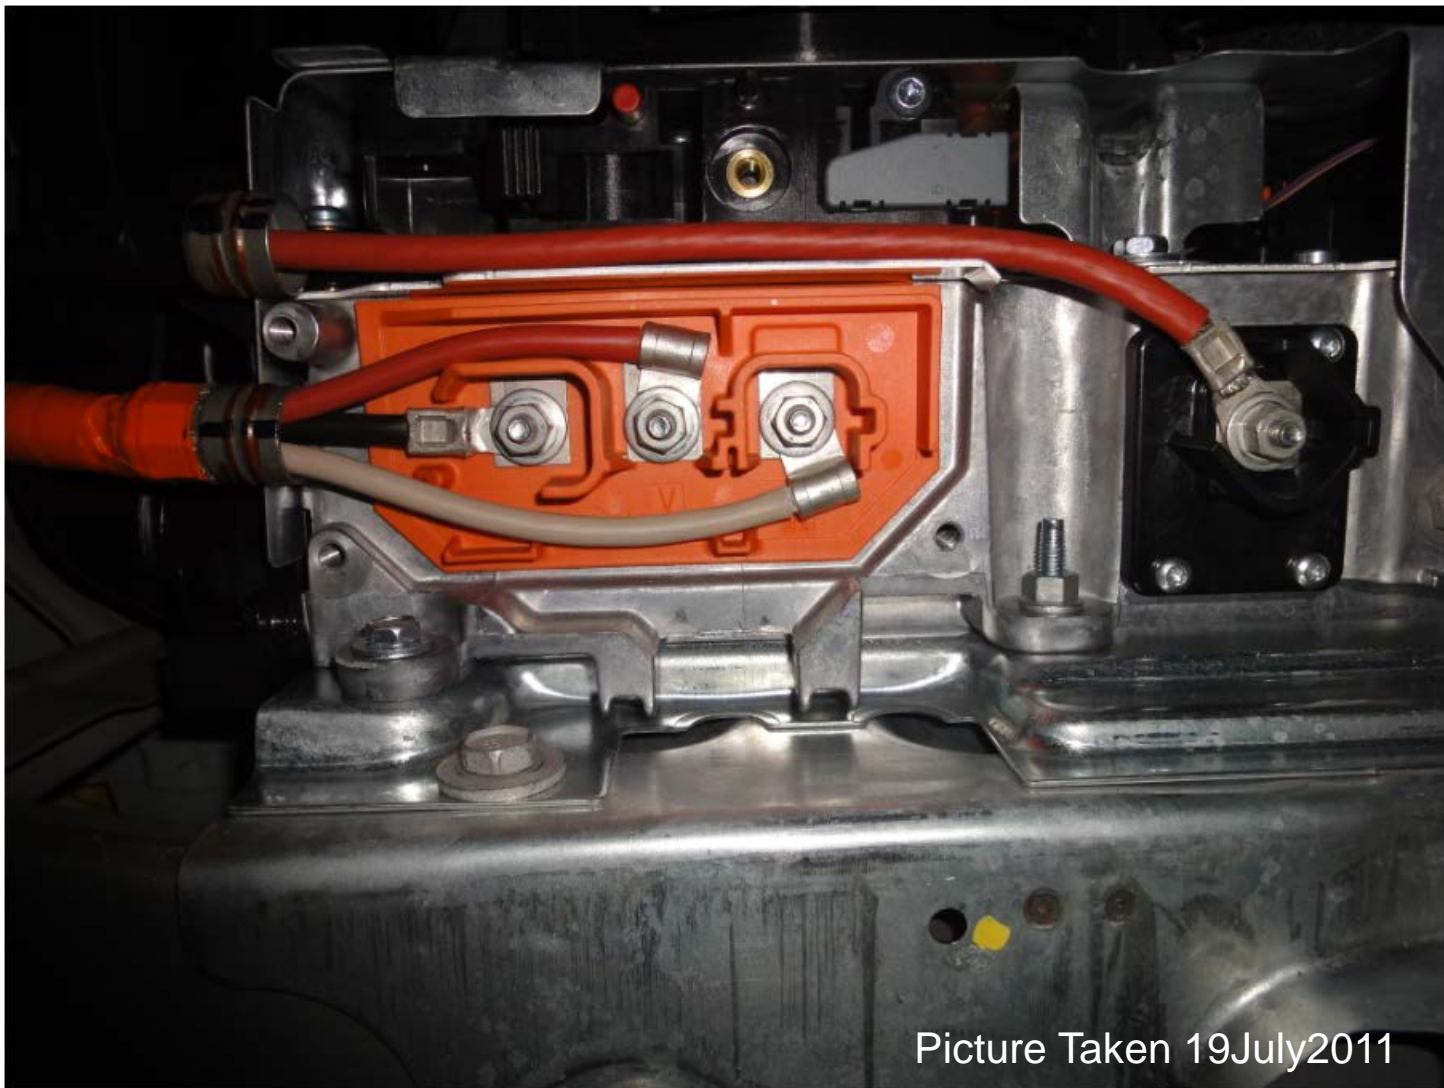
3 Phase Terminal Leads: Powerpack LQ58124111143006

Focus point of picture on wire lead connector – looking for evidence of arcing; source of the discoloration to original Powerpack. No evidence found.

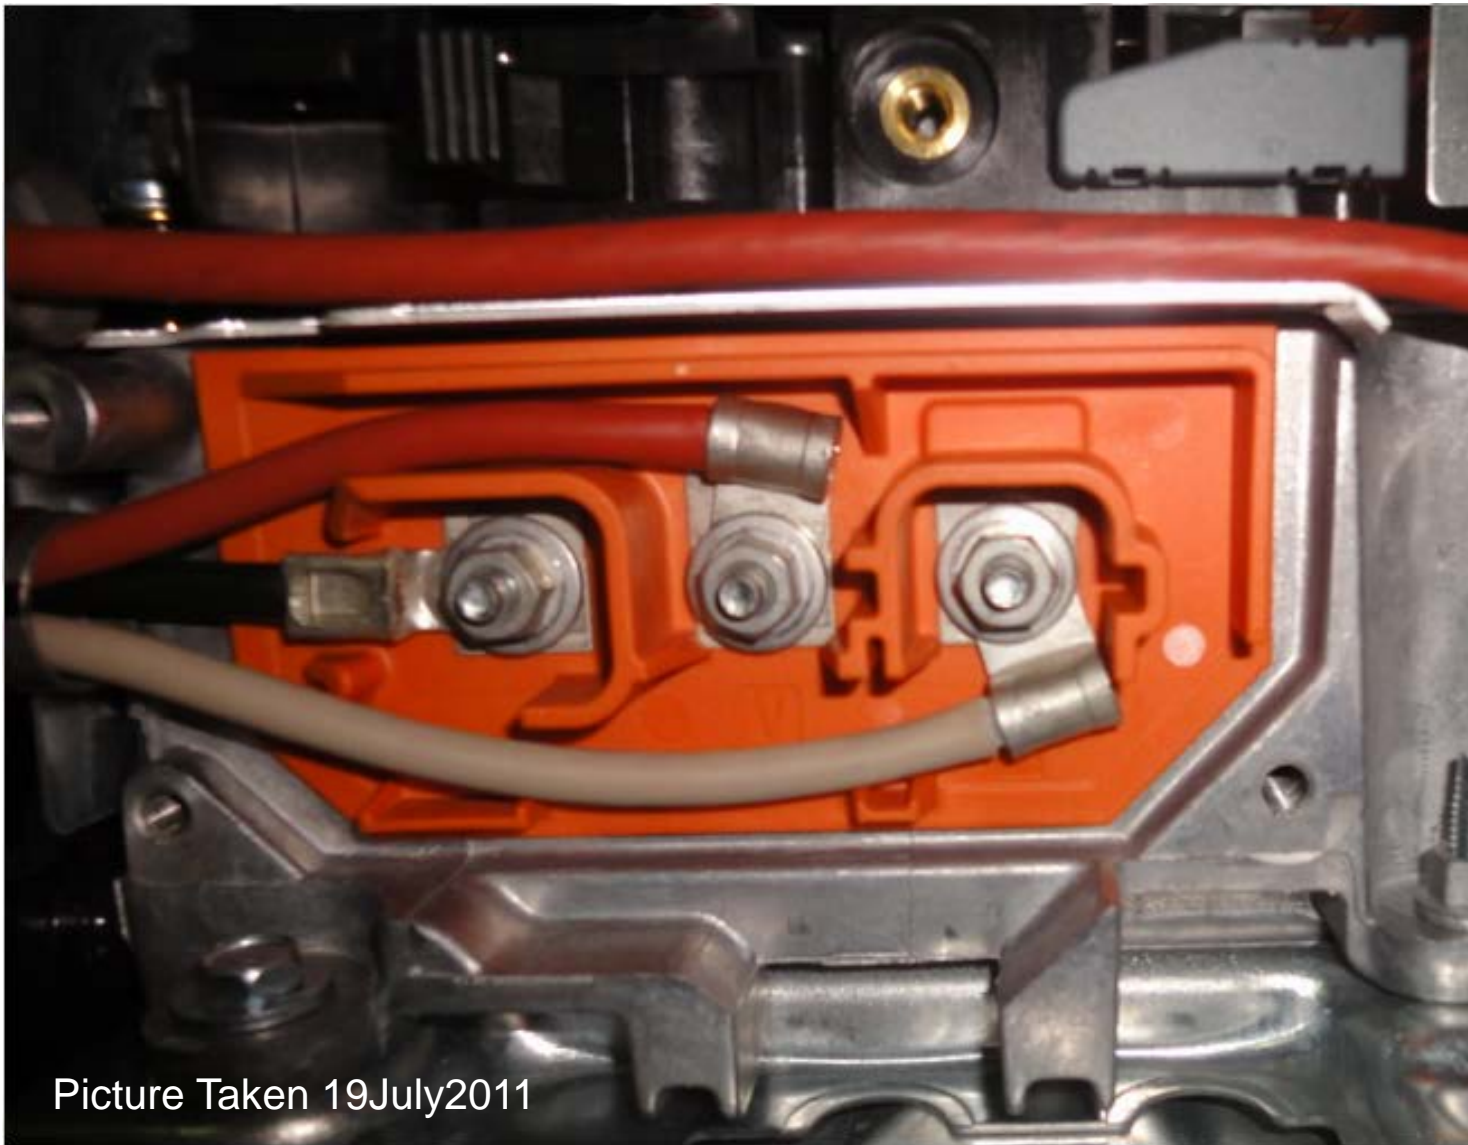
3 Phase Terminal Leads: Powerpack LQ58124111143006  
Focus point of picture on wire lead connector – looking for evidence of arcing; source of the discoloration to original Powerpack. No evidence found.

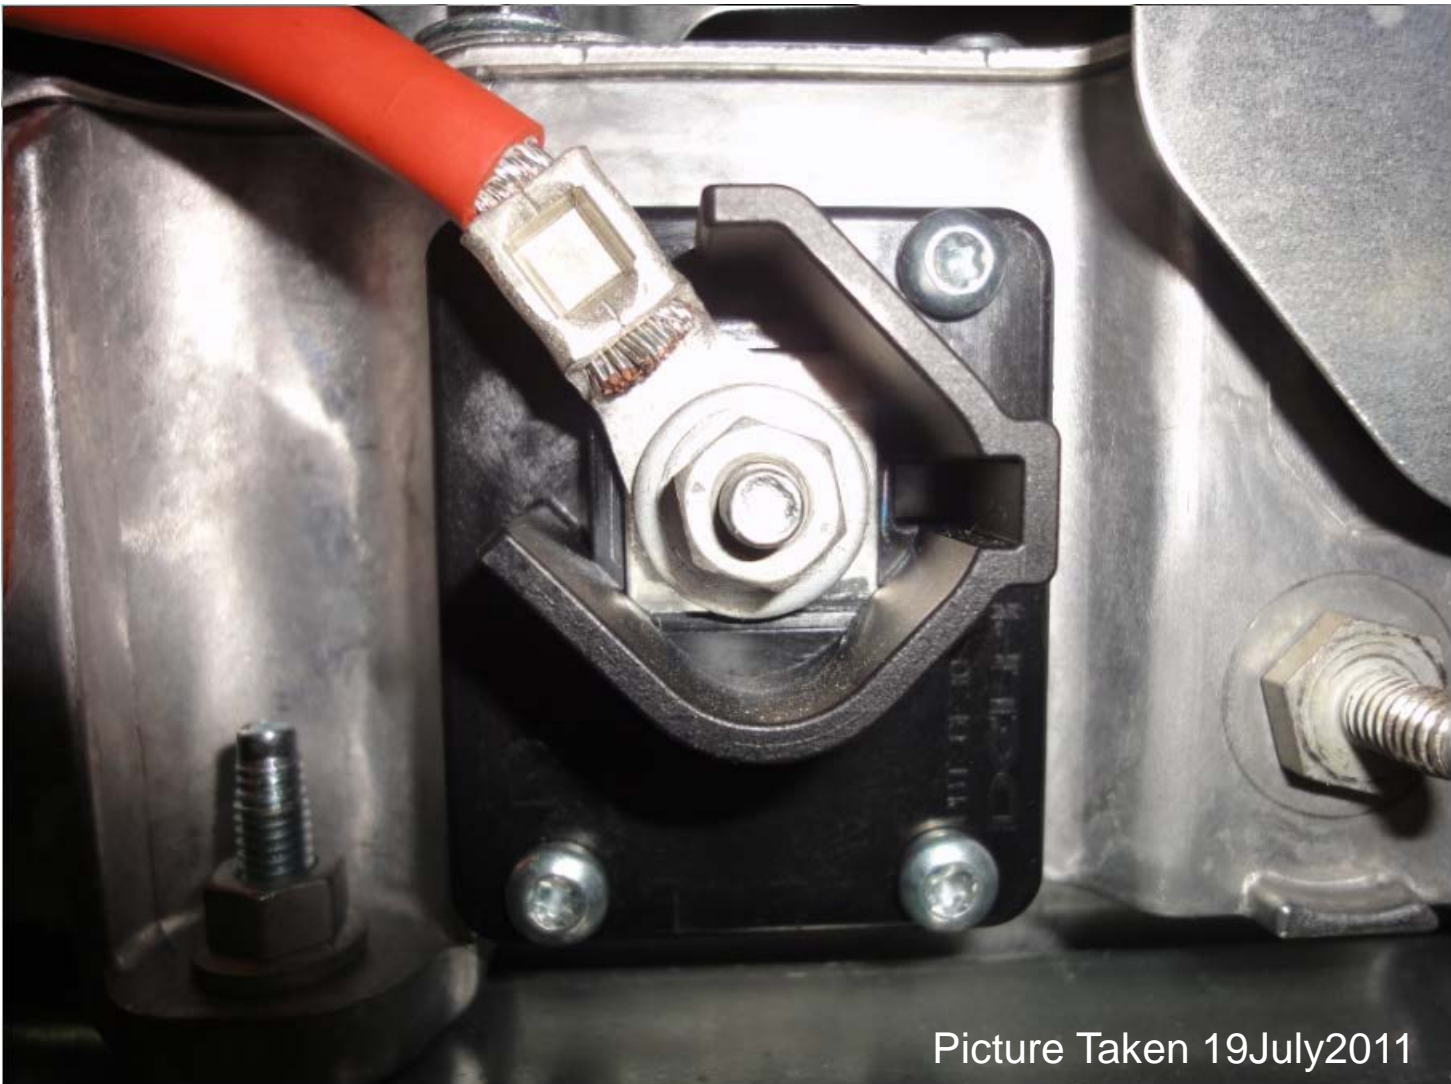
12V Accy Lead: Powerpack LQ58124111143006

Focus point of picture on wire lead connector – looking for evidence of arching; source of the discoloration to original Powerpack. No evidence found.

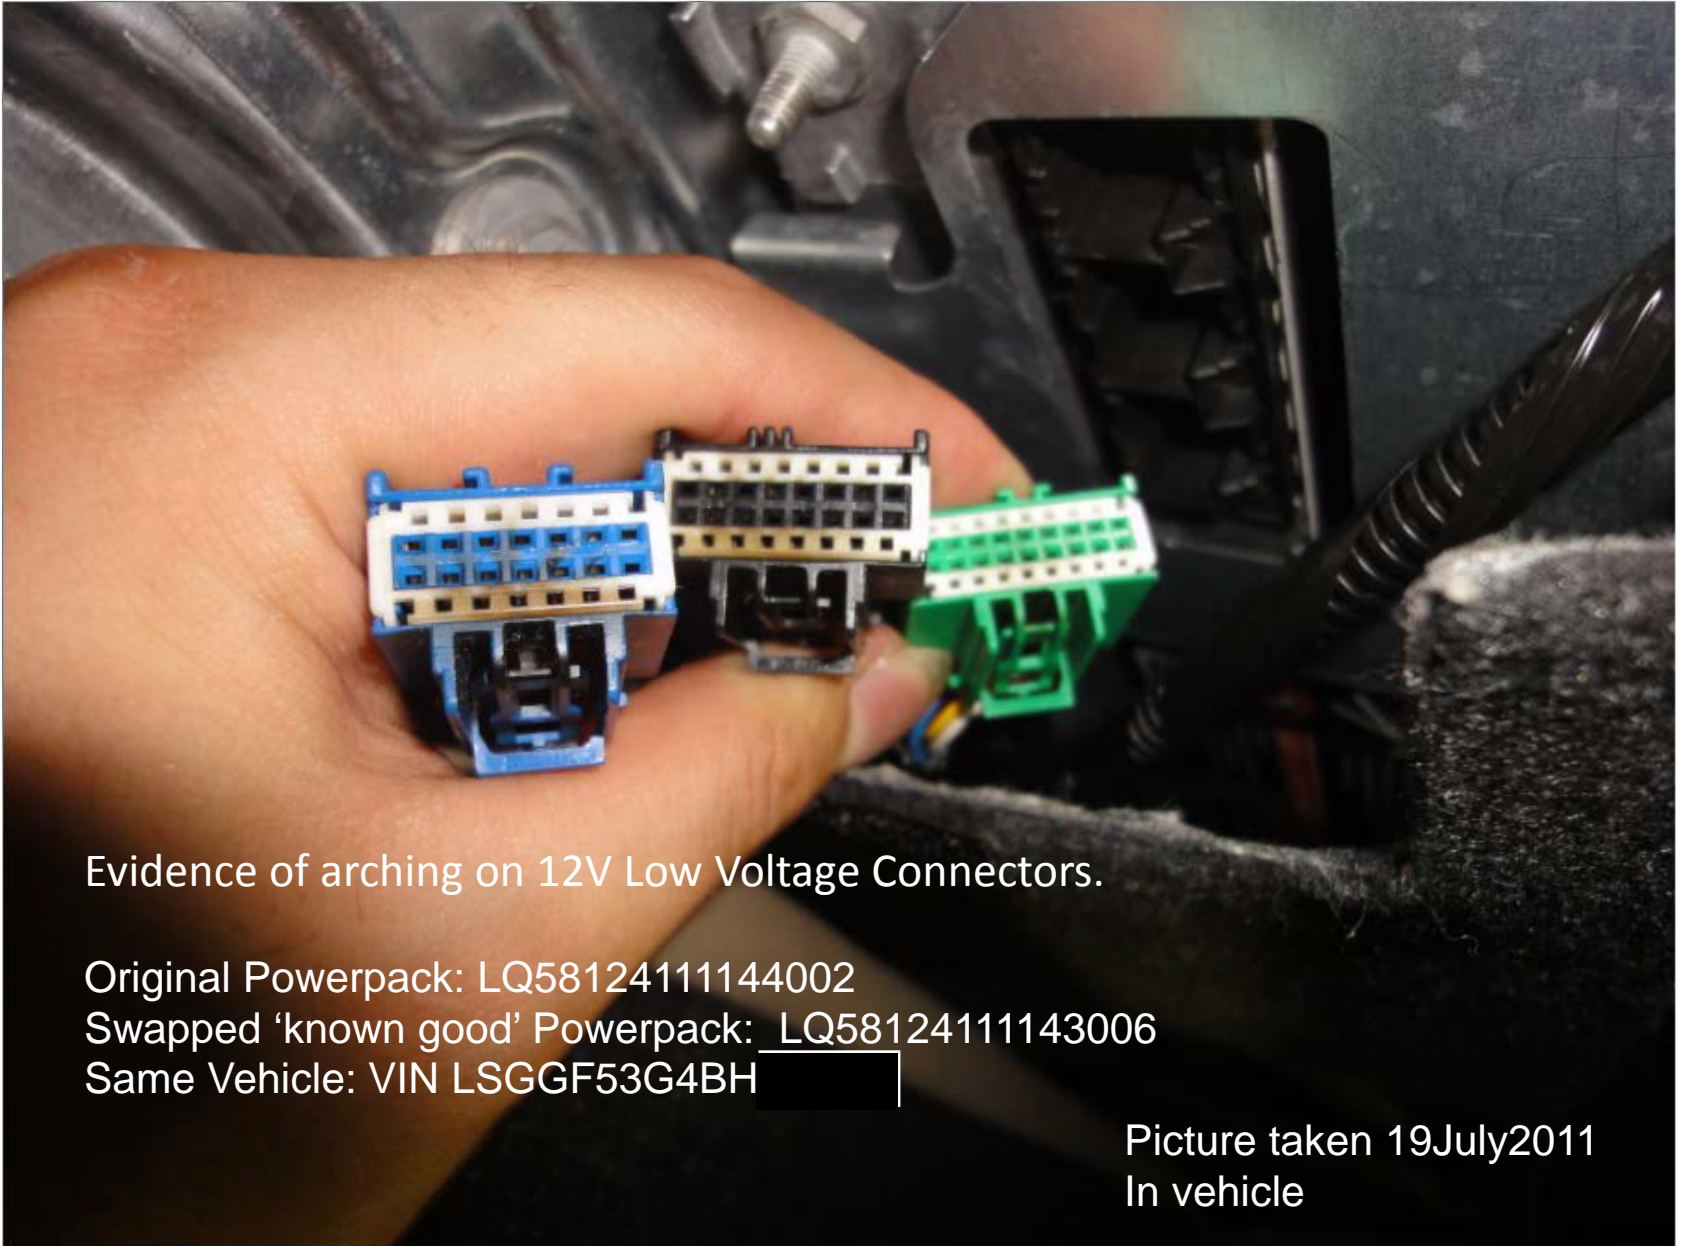
Evidence of arcing on 12V Low Voltage Connectors.

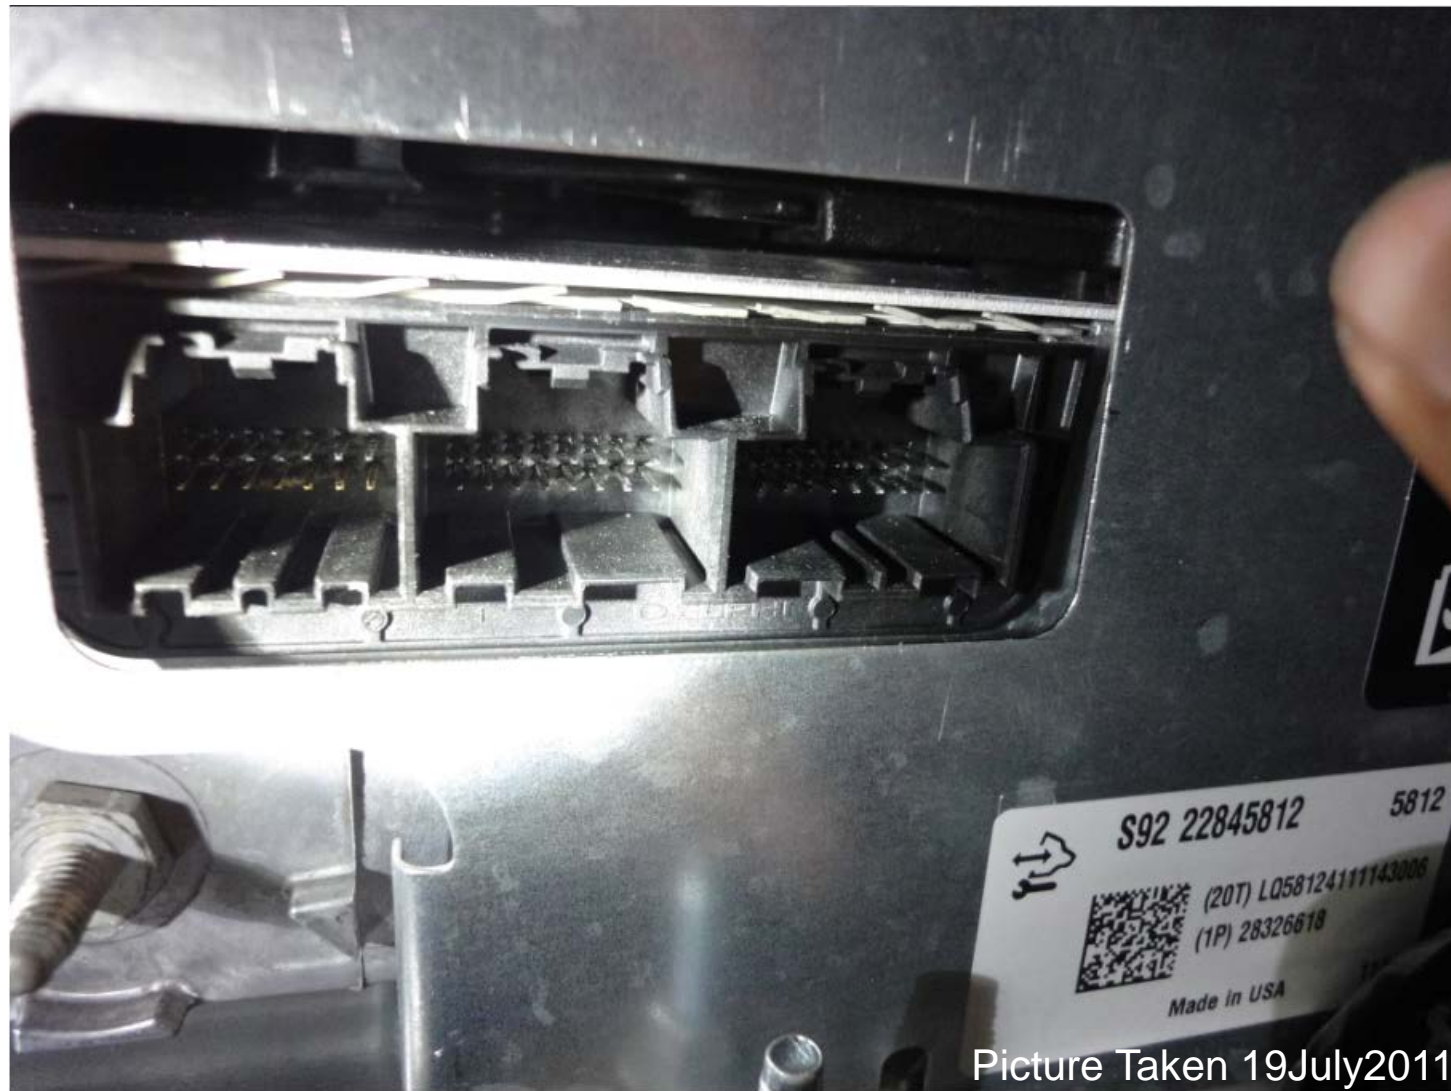
BPIM 12 signal connector(powerpack side)

Note: This is NEW powerpack (LQ58124111143006) and do not expect to see damage.

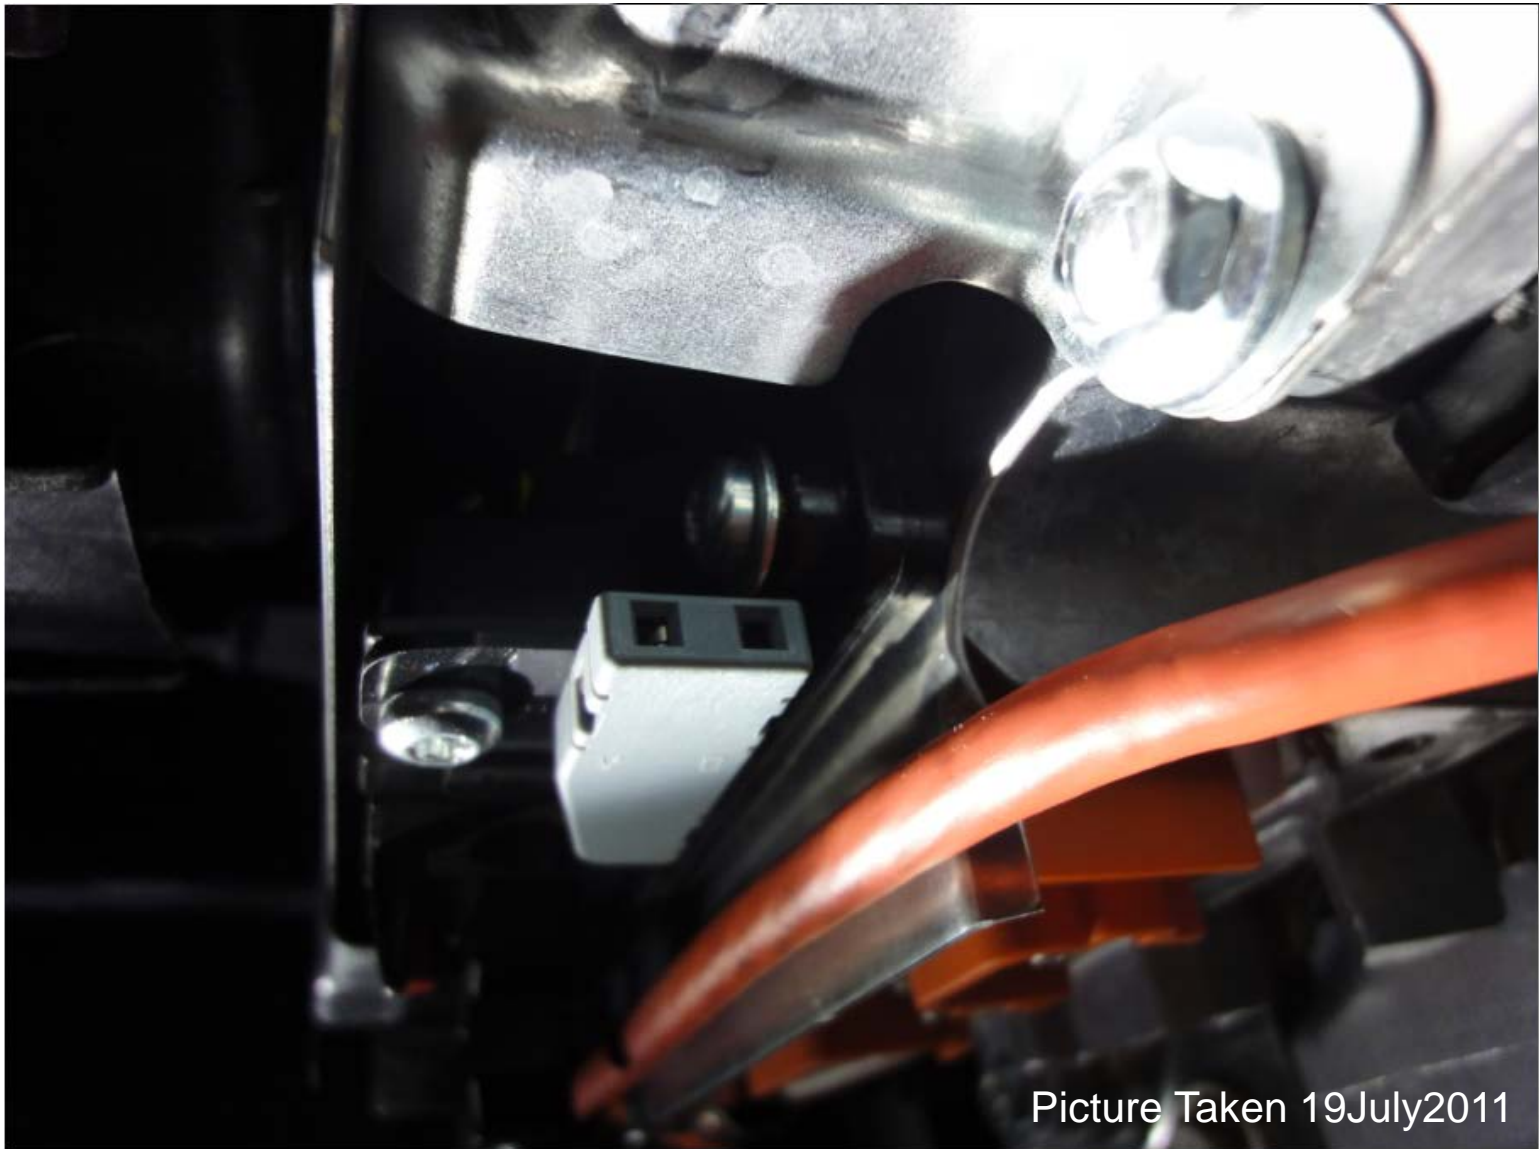
HVIL terminal (powerpack side)

Note: This is new powerpack (LQ58124111143006) and do not expect to see damage on pack.
