RQ13-003

GM

ATTACHMENT A

Q09B

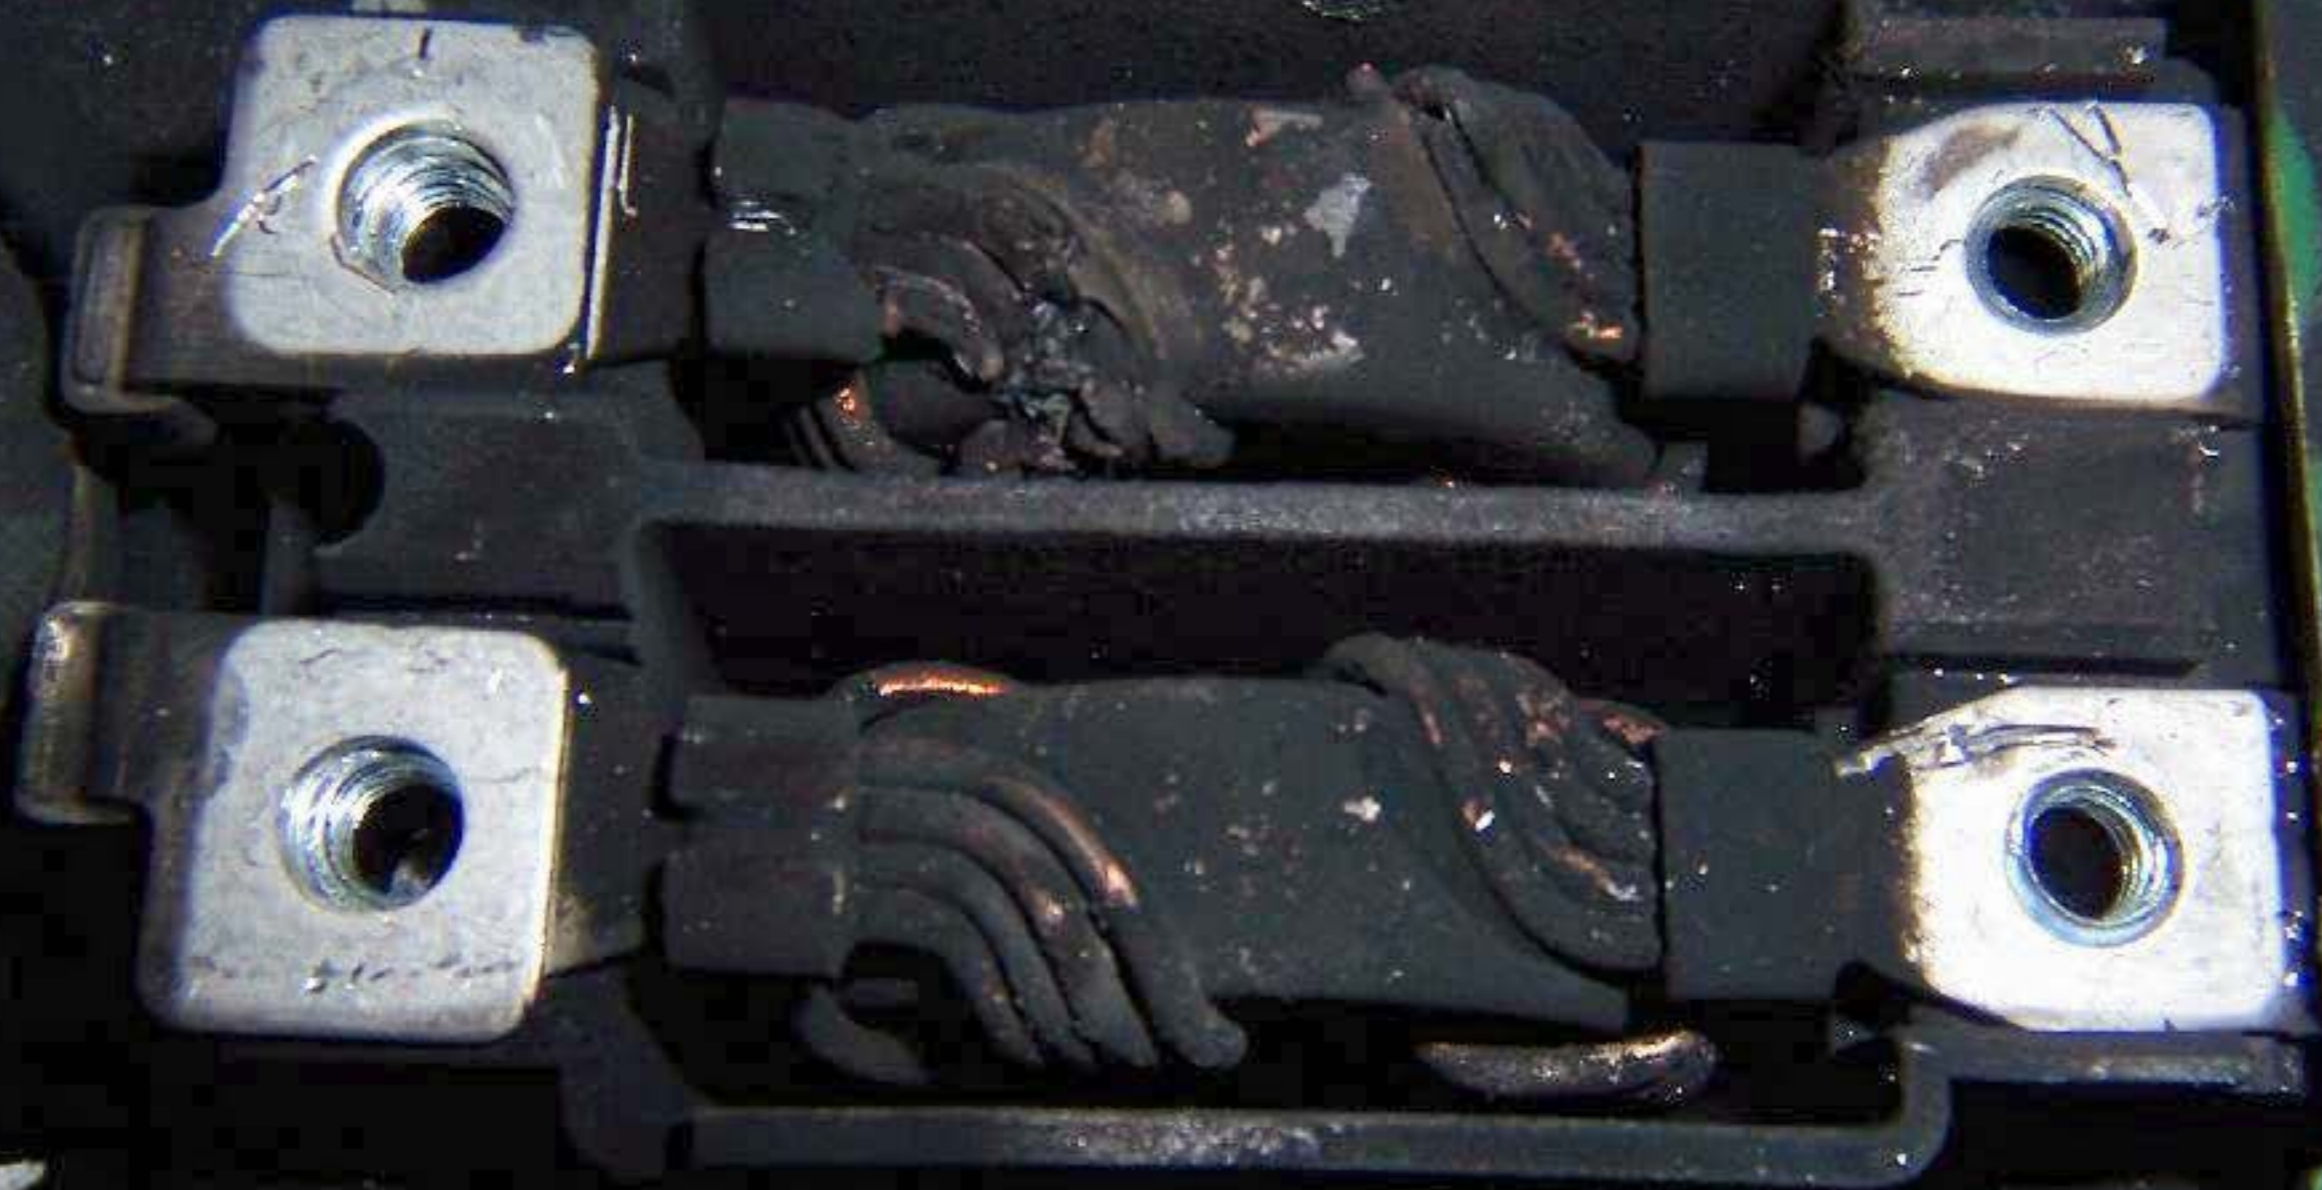
100_2718

Warranty 81
inductor coils

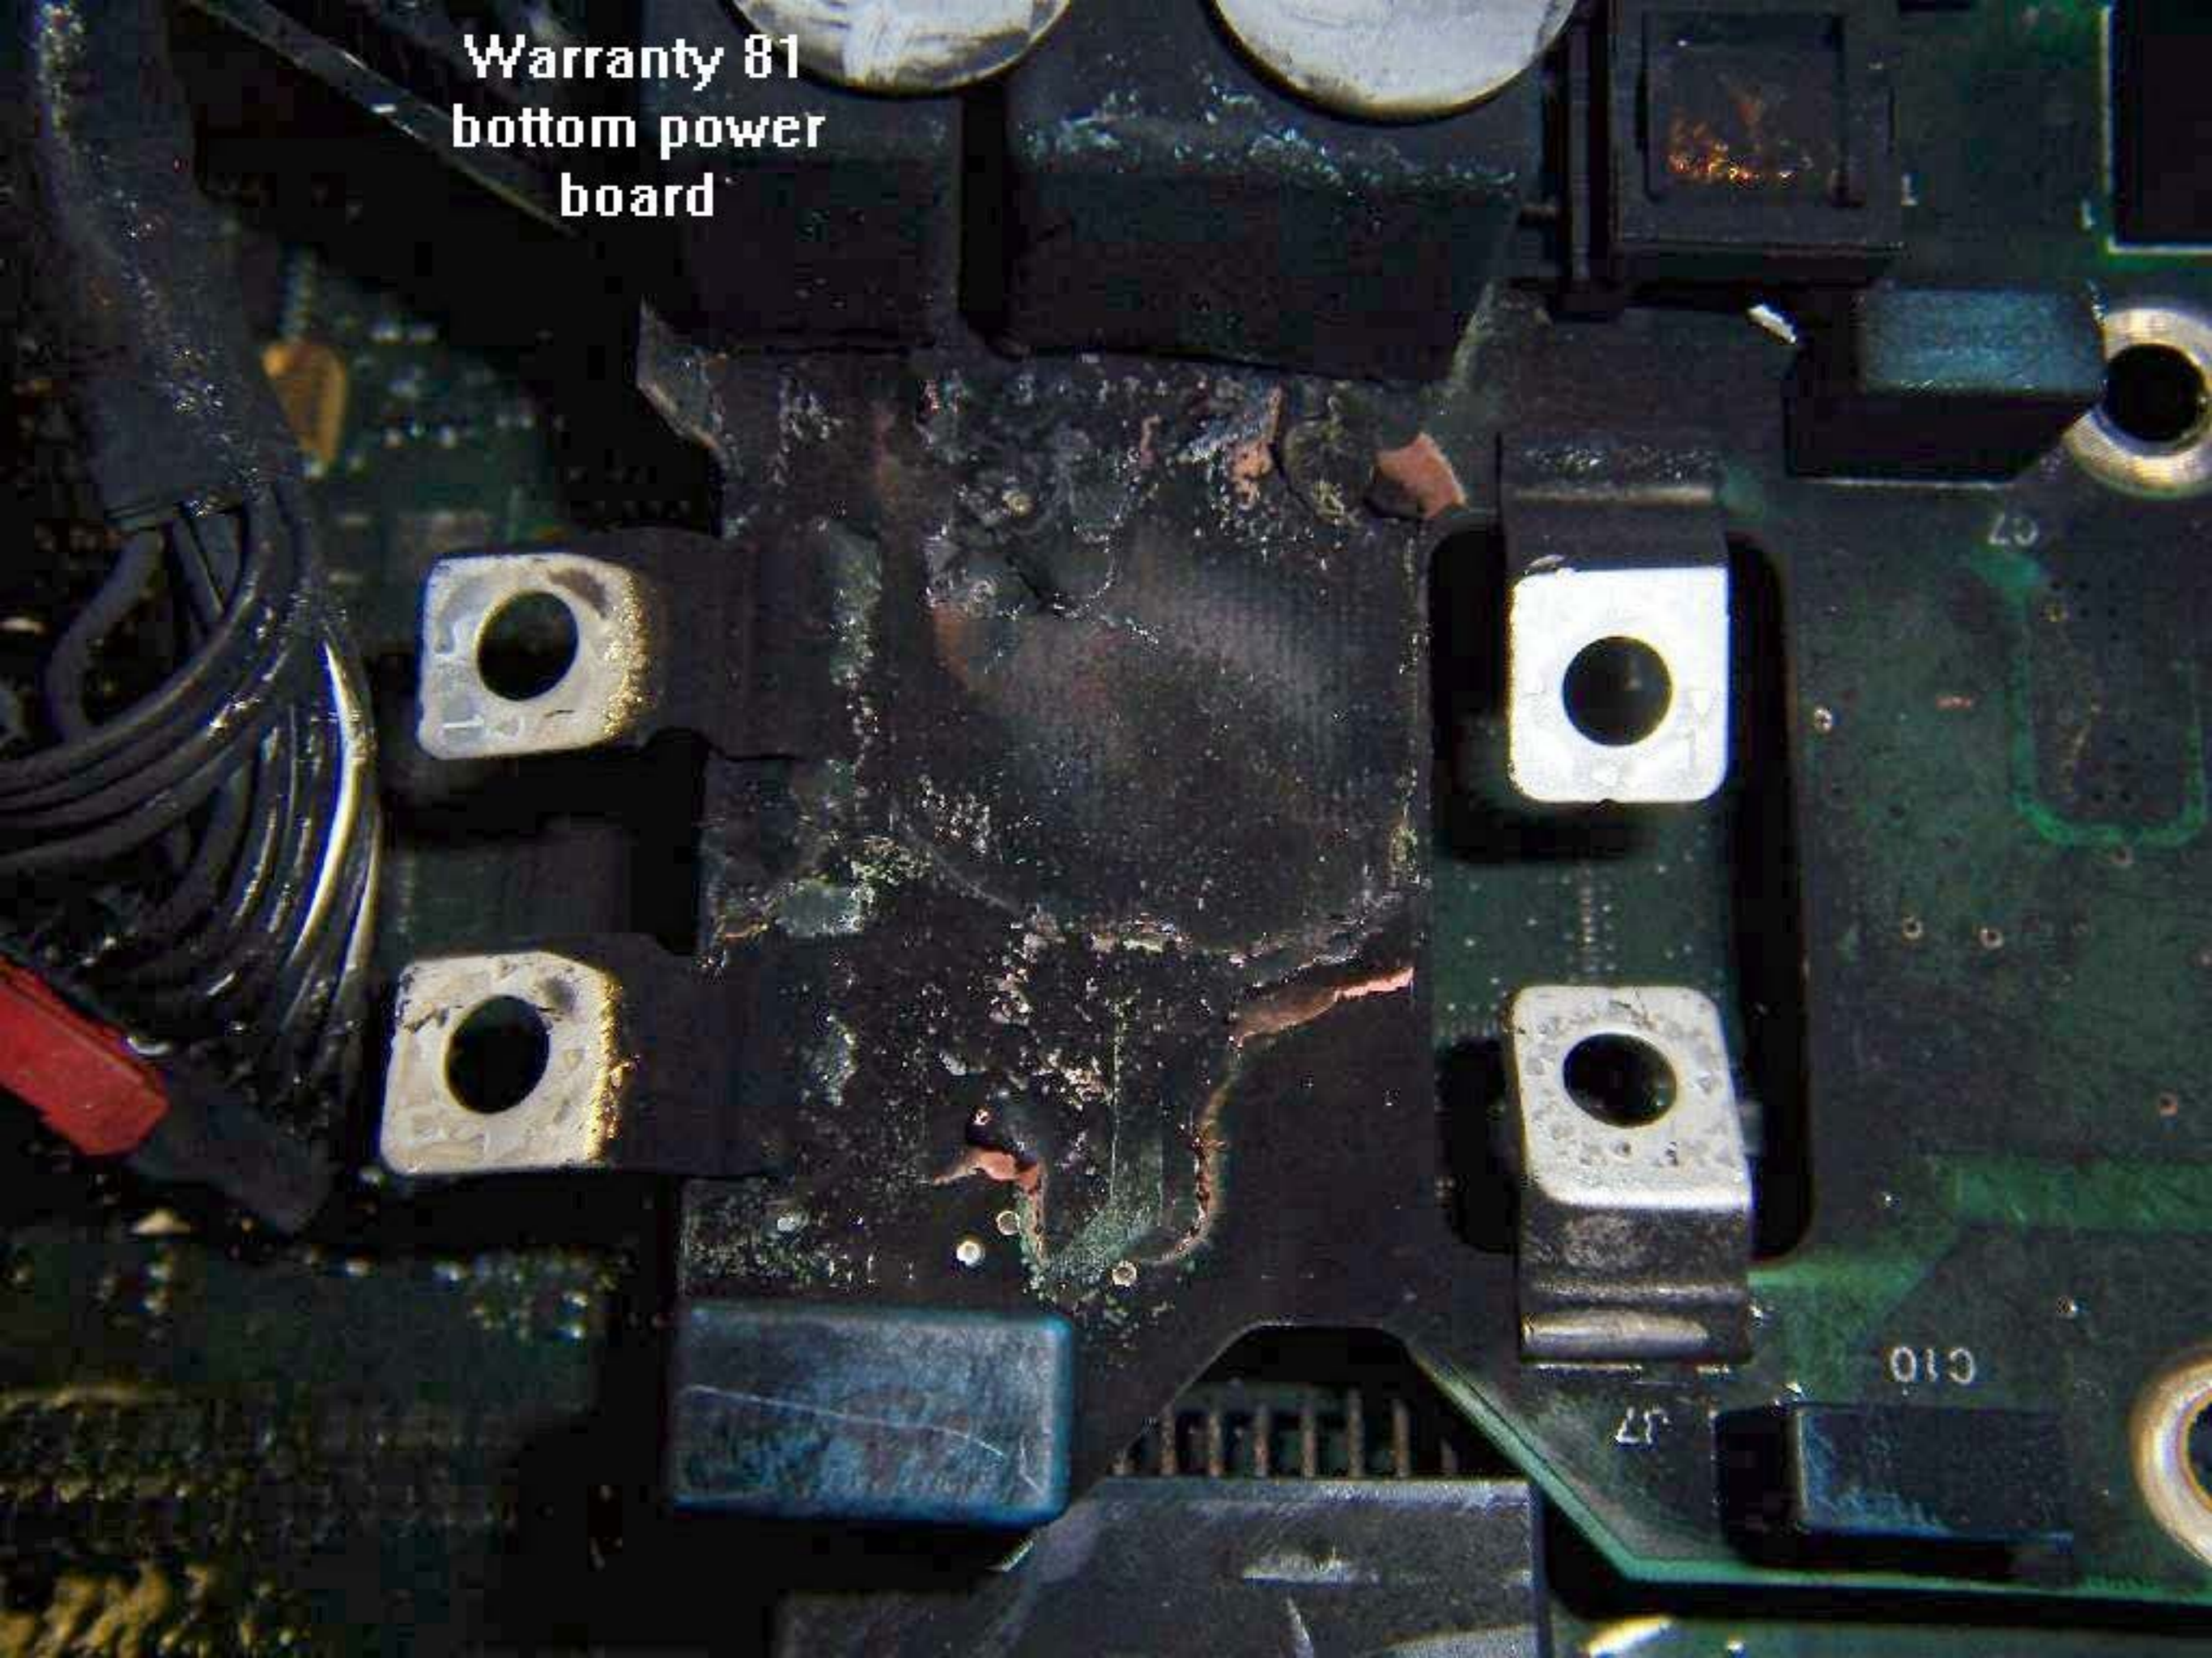
100_2719

Warranty 81
bottom power
board

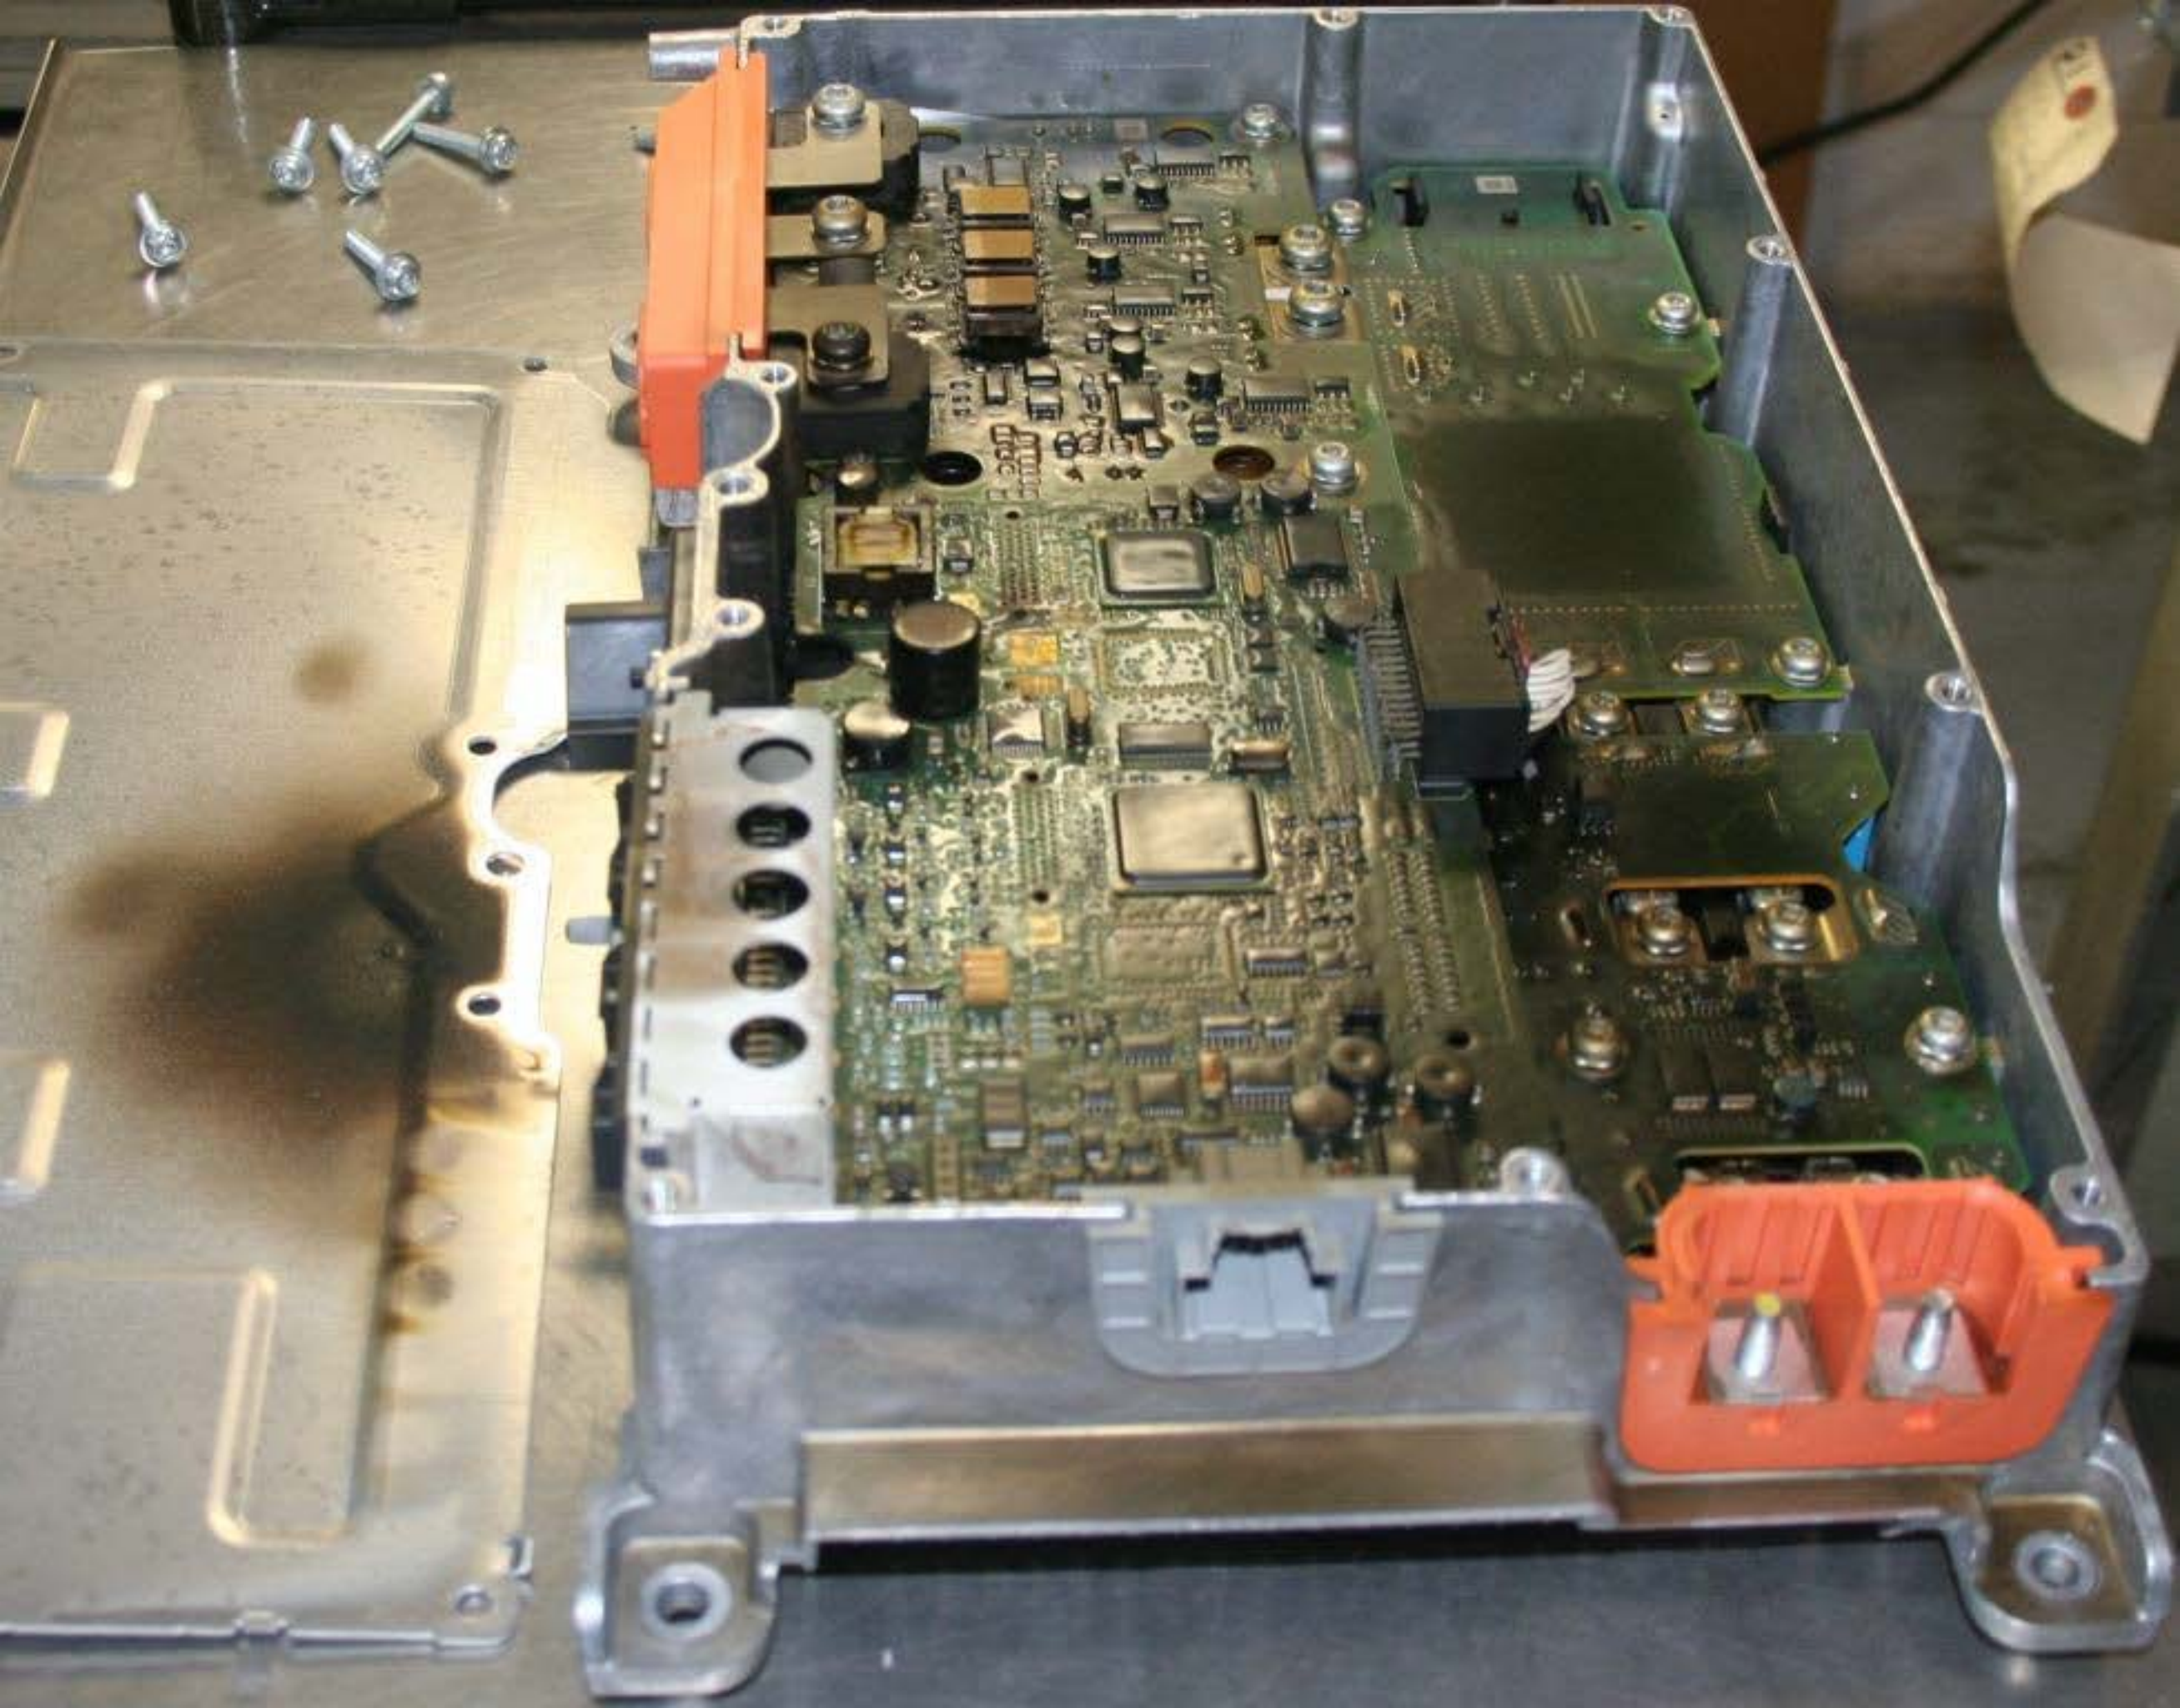
BAS SGM Blown Fuse 30013-
024_Compressed

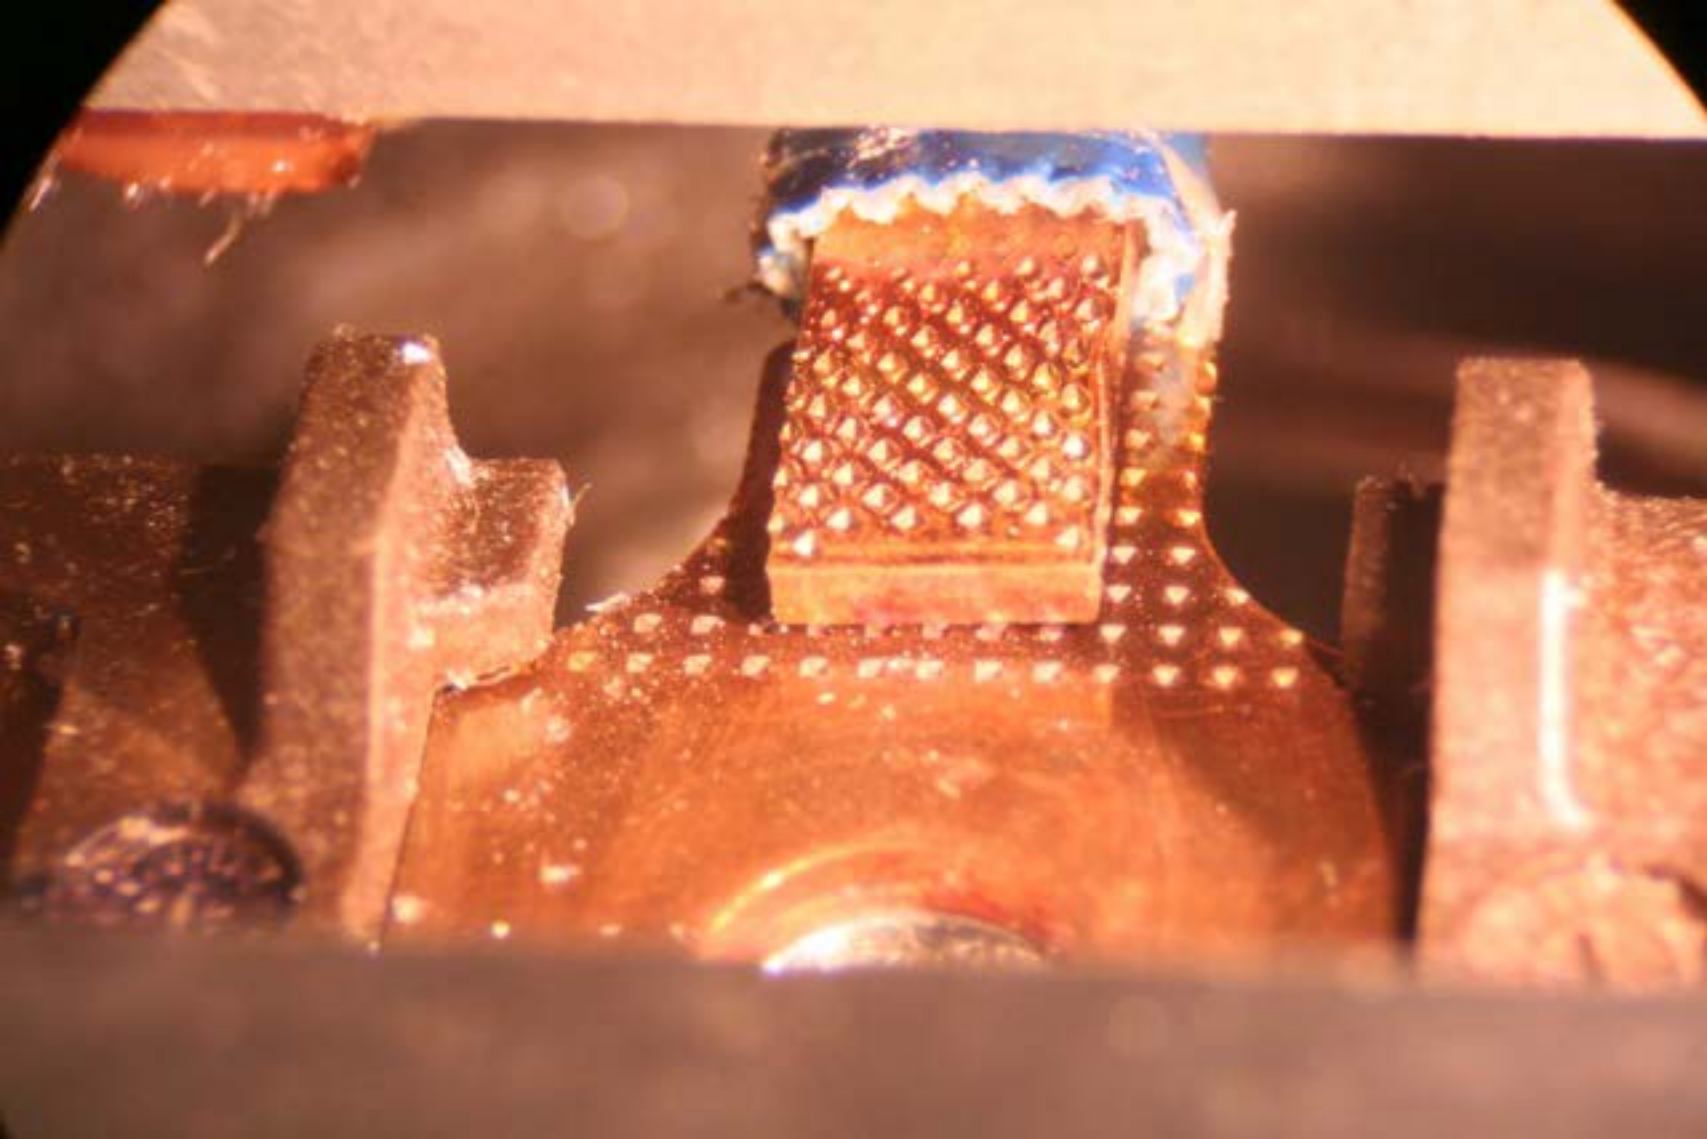
BpimWar65MGUWeld 001rs

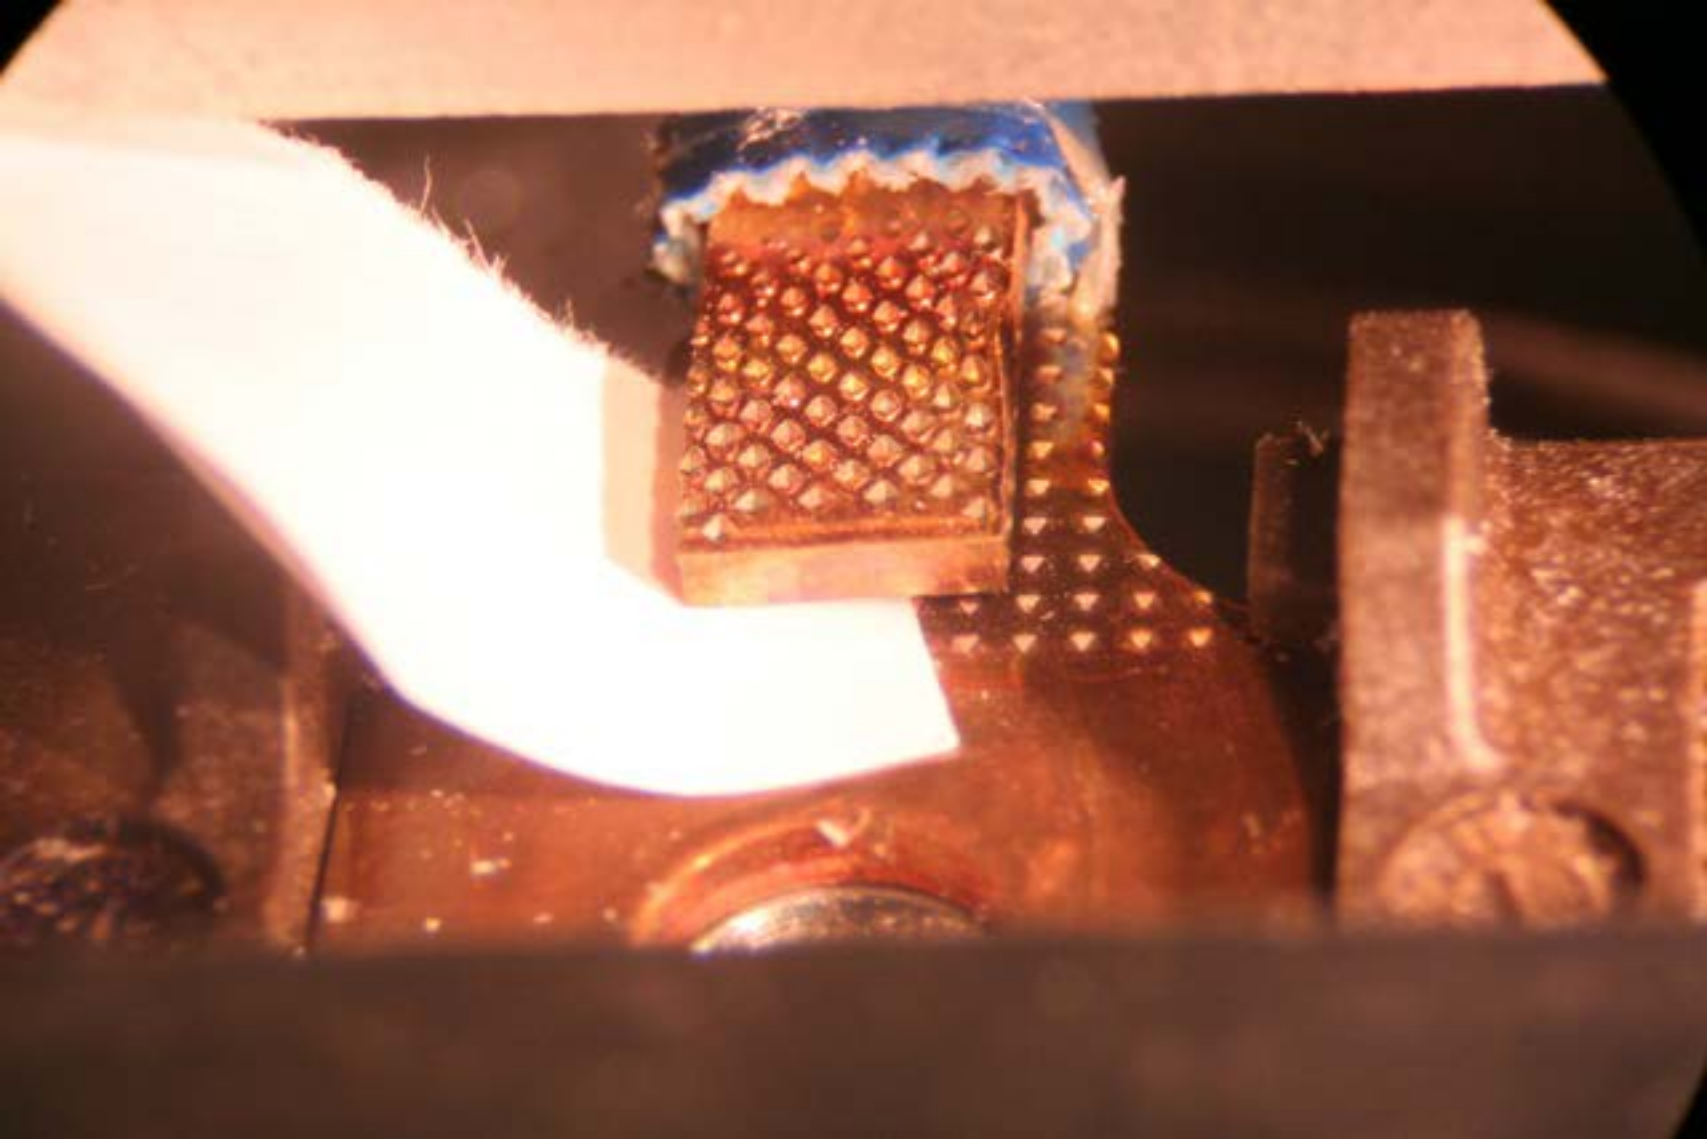
BpimWar65MGUWeld 002rs

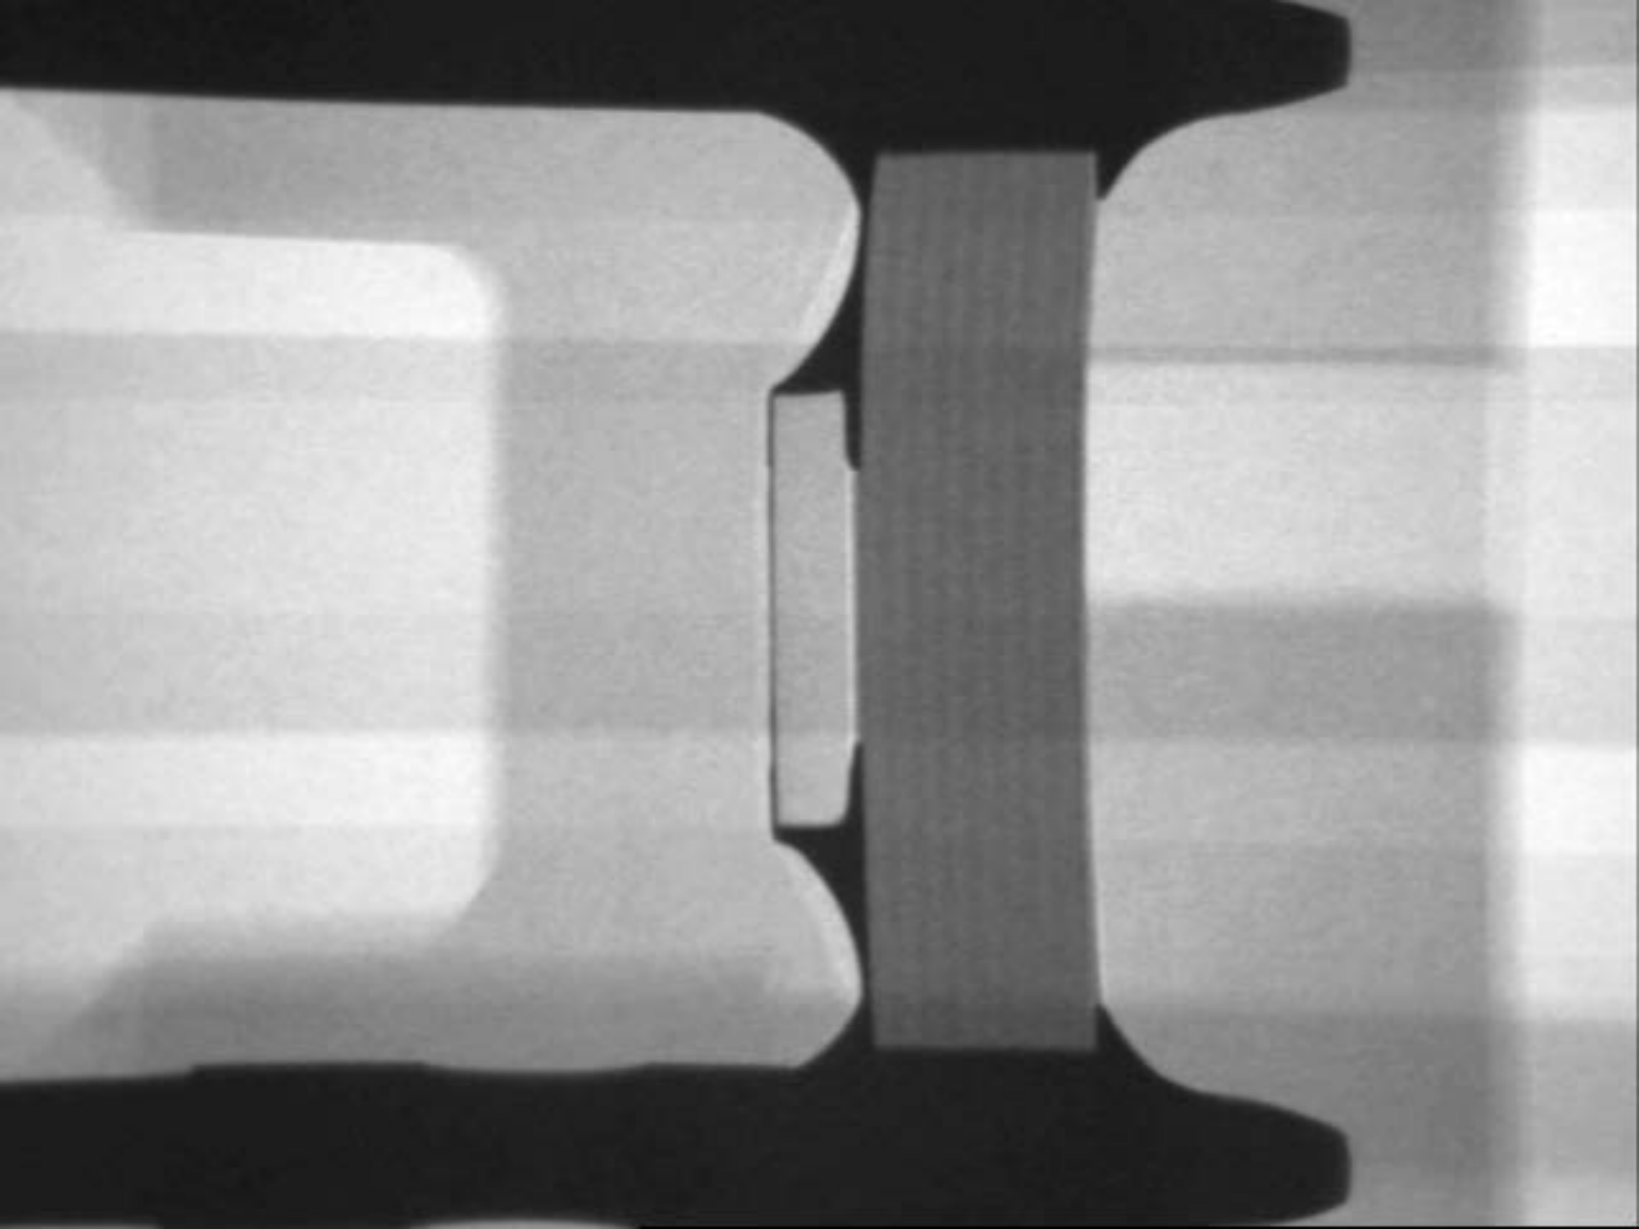
Iso fault retn cover

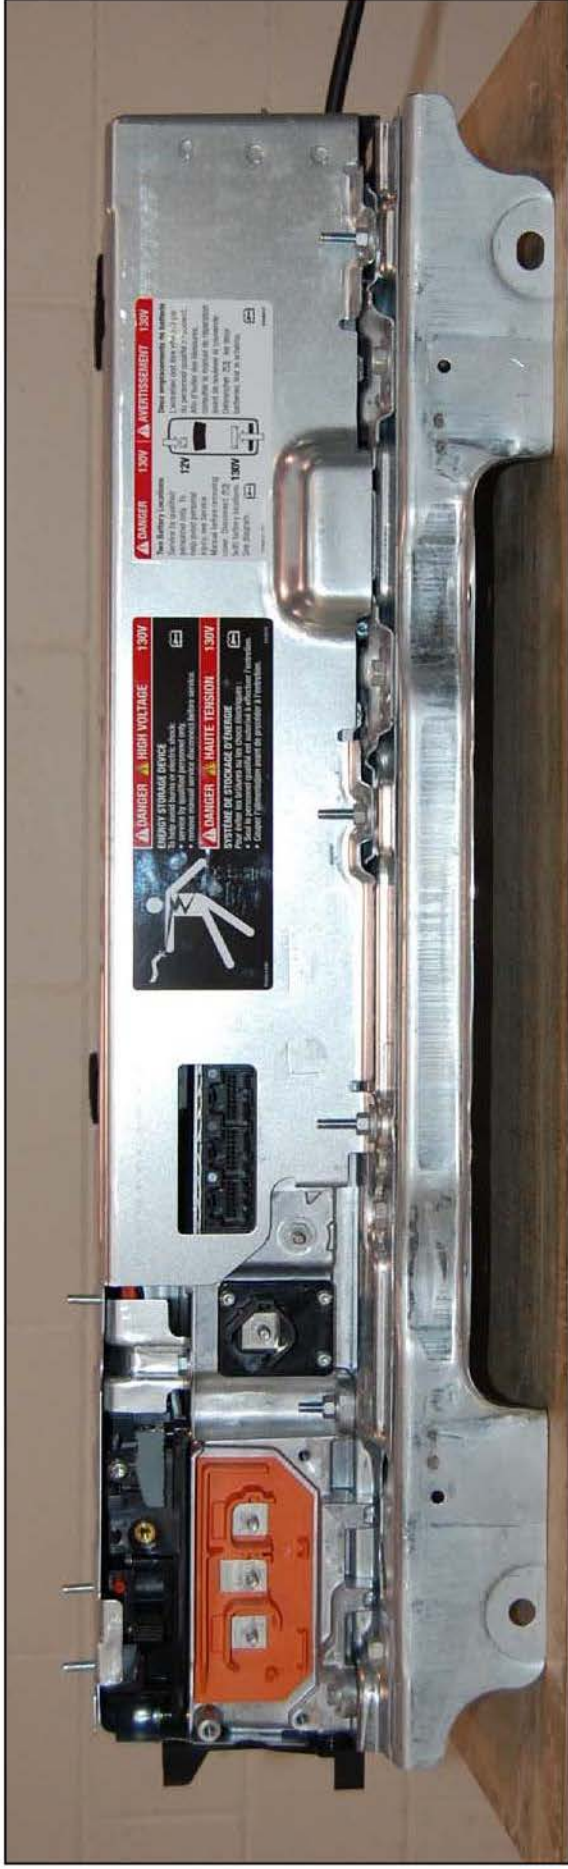
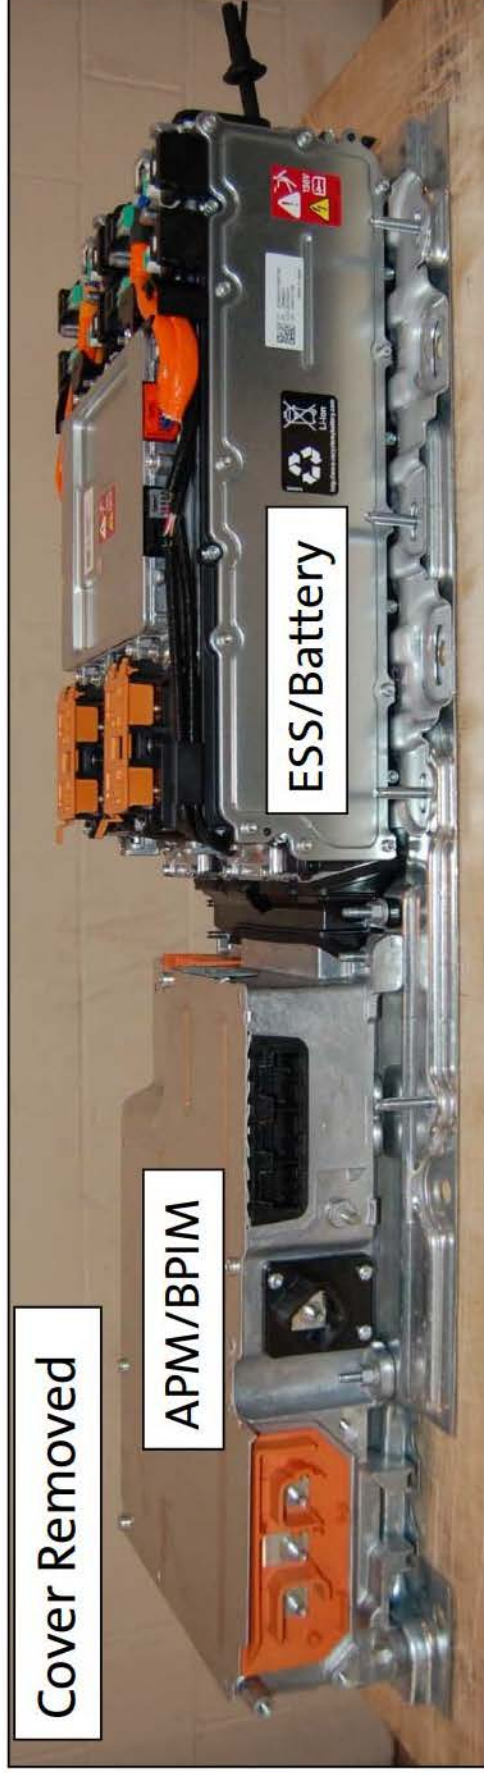
Powerpack pictures

Black marks found on Powerpack sheet metal and BPIM electrical connector.

Connector still functional and in vehicle, no other distress to vehicle noted.
