E-Assist Warranty Analysis

Date: October 25, 2012

2012 – 2013 Malibu, Regal, LaCrosse – eAssist – BPIM/APM Circuit Boards

eAssist: BPIM/APM Circuit Board Failures

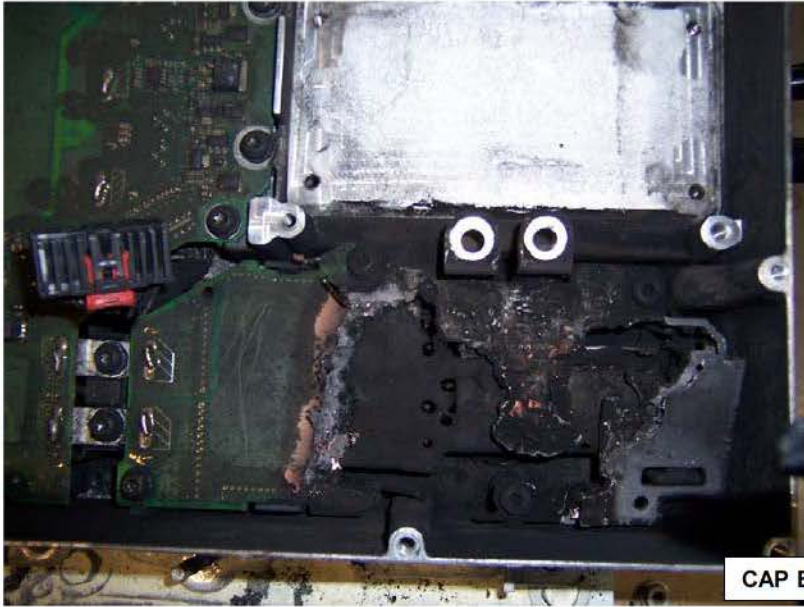
CAP Board Severely Damaged

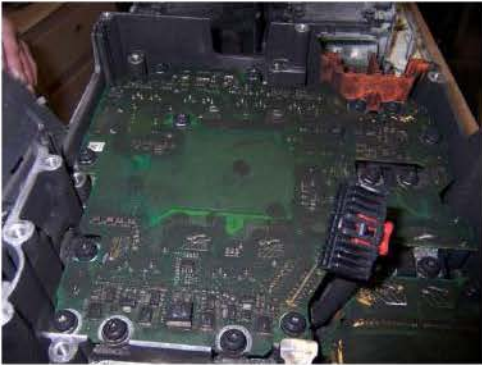
Power Board Only Collateral Damage / Sooted

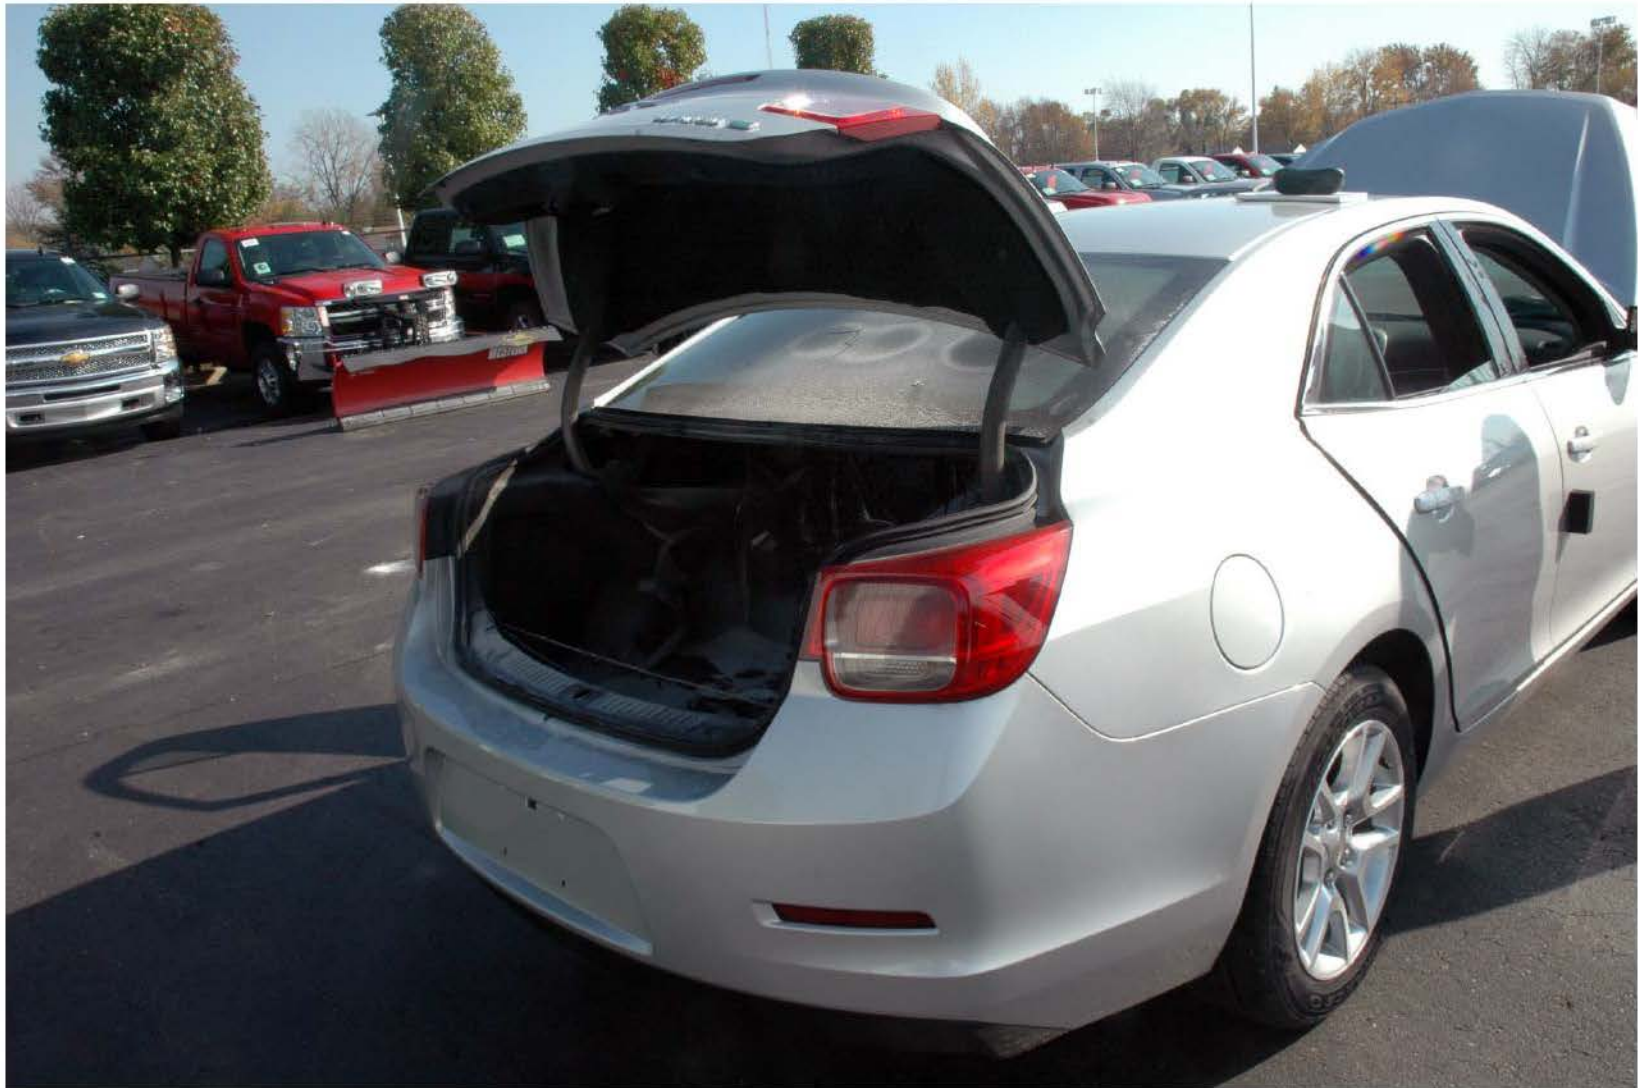
Incident description: One hour into the idle portion of test procedure called out in service bulletin 12238 observer noticed smoke coming from trunk. The fire was extinguished by dealership personnel with a dry chemical extinguisher. The fire damage was confined to the interior compartment/cargo (trunk) compartments.

The 12V battery was disconnected some time after incident. FPE took photos. Arrangements were made to have vehicle shipped to MPG. Vehicle arrived at MGP on Oct. 26th at 12:00 pm

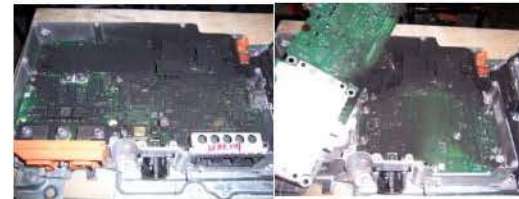
- ◆ Pack 195 - Pwr PCB HV Isolation
- ◆ Pack 211 - Pwr PCB HV Isolation
- ◆ Pack 212 - “White Marsh Type” Pwr PCB
- ◆ Pack 214 - “White Marsh Type” Pwr PCB
- ◆ Pack 226 - Pwr PCB HV Isolation smoke damage
- ◆ Pack 232 - Pwr PCB HV Isolation smoke damage
- ◆ Pack 234 - Pwr PCB HV Isolation smoke damage
- ◆ Pack 250 - Pwr PCB HV Isolation smoke damage
- ◆ Pack 262 - Pwr PCB HV Isolation smoke damage
- ◆ Pack 265 - Pwr PCB HV Isolation smoke damage
- ◆ Pack 290 - Pwr PCB HV Isolation smoke damage
- ◆ Pack 308 - Pwr PCB Thermal damaged to multiple layers of PCB
- ◆ Pack 326 - “White Marsh Type” Pwr PCB
- ◆ Pack 334 - “White Marsh Type” Pwr PCB
- ◆ Pack 359 - “White Marsh Type” Pwr PCB
- ◆ Pack 370 - “White Marsh Type” Pwr PCB
- ◆ Pack 395 - Pwr PCB HV Isolation

“White Marsh Type”

“Smoke damage”
