- NHTSA has contacted GM in regard to (est.) 82 cases of thermal verbatims included in TREAD reports for eAssist vehicles
- Root cause is shorting between layers of printed circuit boards inside metal-encased eAssist inverter / DC-DC converter (“BPIM/APM”), which is part of the eAssist “Powerpack” (metal box in trunk that contains BPIM/APM and Lithium-Ion battery)

- Approximately 54,000 LaCrosse/Regal/Malibu vehicles built prior to January 2013 have potential for this issue. There are three different “buckets” of vehicles with different risk profiles, one higher than the other two.

eAssist: BPIM/APM Circuit Board Failures

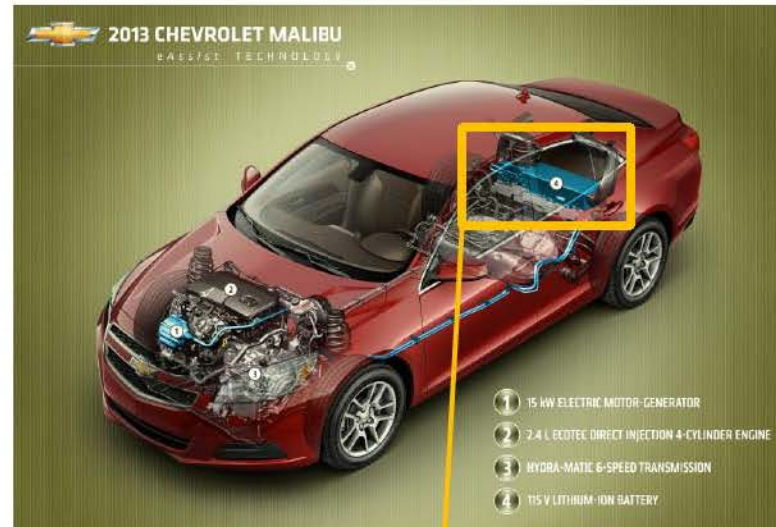
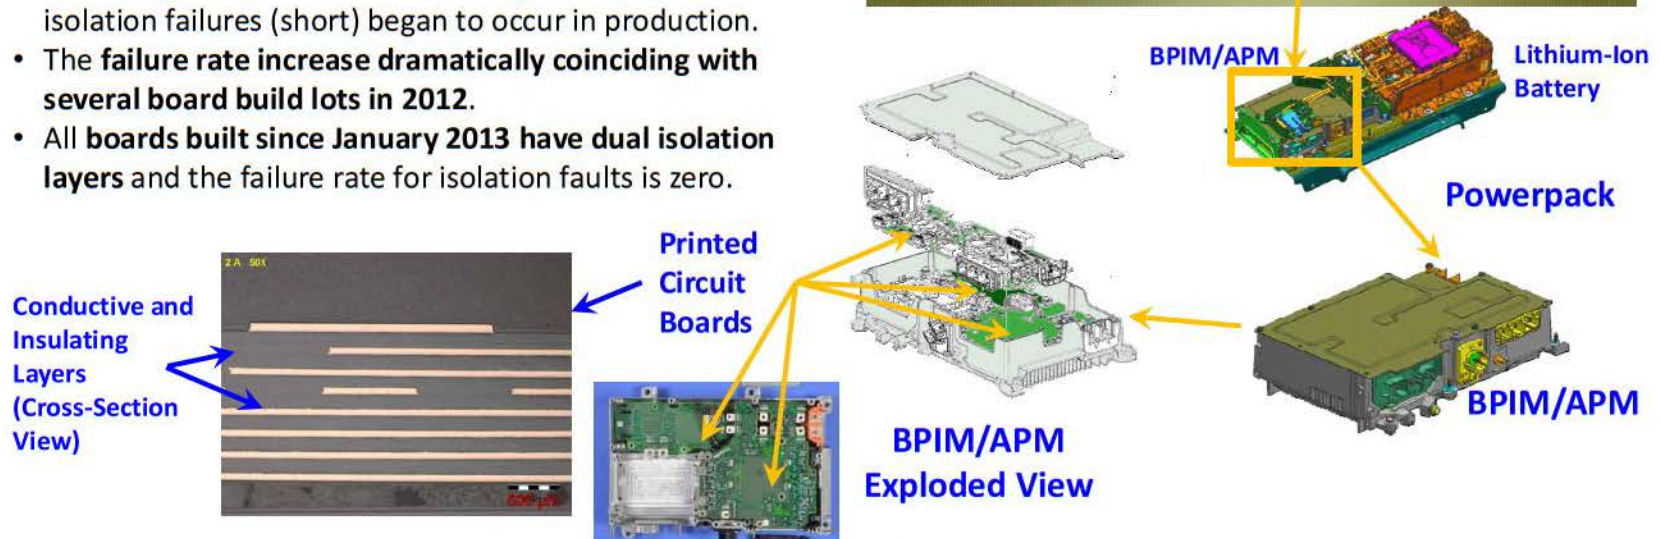
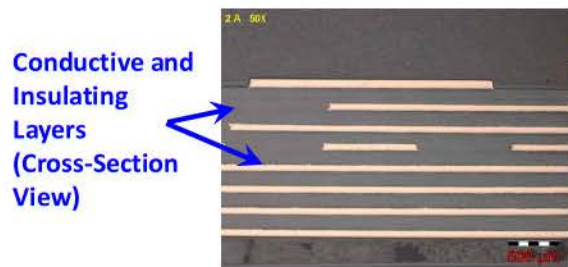
- All eAssist vehicles have a **Powerpack** which contains a **BAS Power Inverter Module (BPIM) / Accessory Power Module (APM)**.
- The BPIM/APM contains three multi-layered **Printed Circuit Boards (PCBs)** comprised of conductive layers separated by isolating layers.
- General practice is for two layers of isolation between conductive layers or one layer of adequate thickness.
- The three PCBs in the eAssist BPIM/APM have **at least one instance of conductive layers separate by only one isolating layer**.
- This design showed **no issues during validation** but some isolation failures (short) began to occur in production.
- The **failure rate increase dramatically coinciding with several board build lots in 2012**.
- All **boards built since January 2013 have dual isolation layers** and the failure rate for isolation faults is zero.

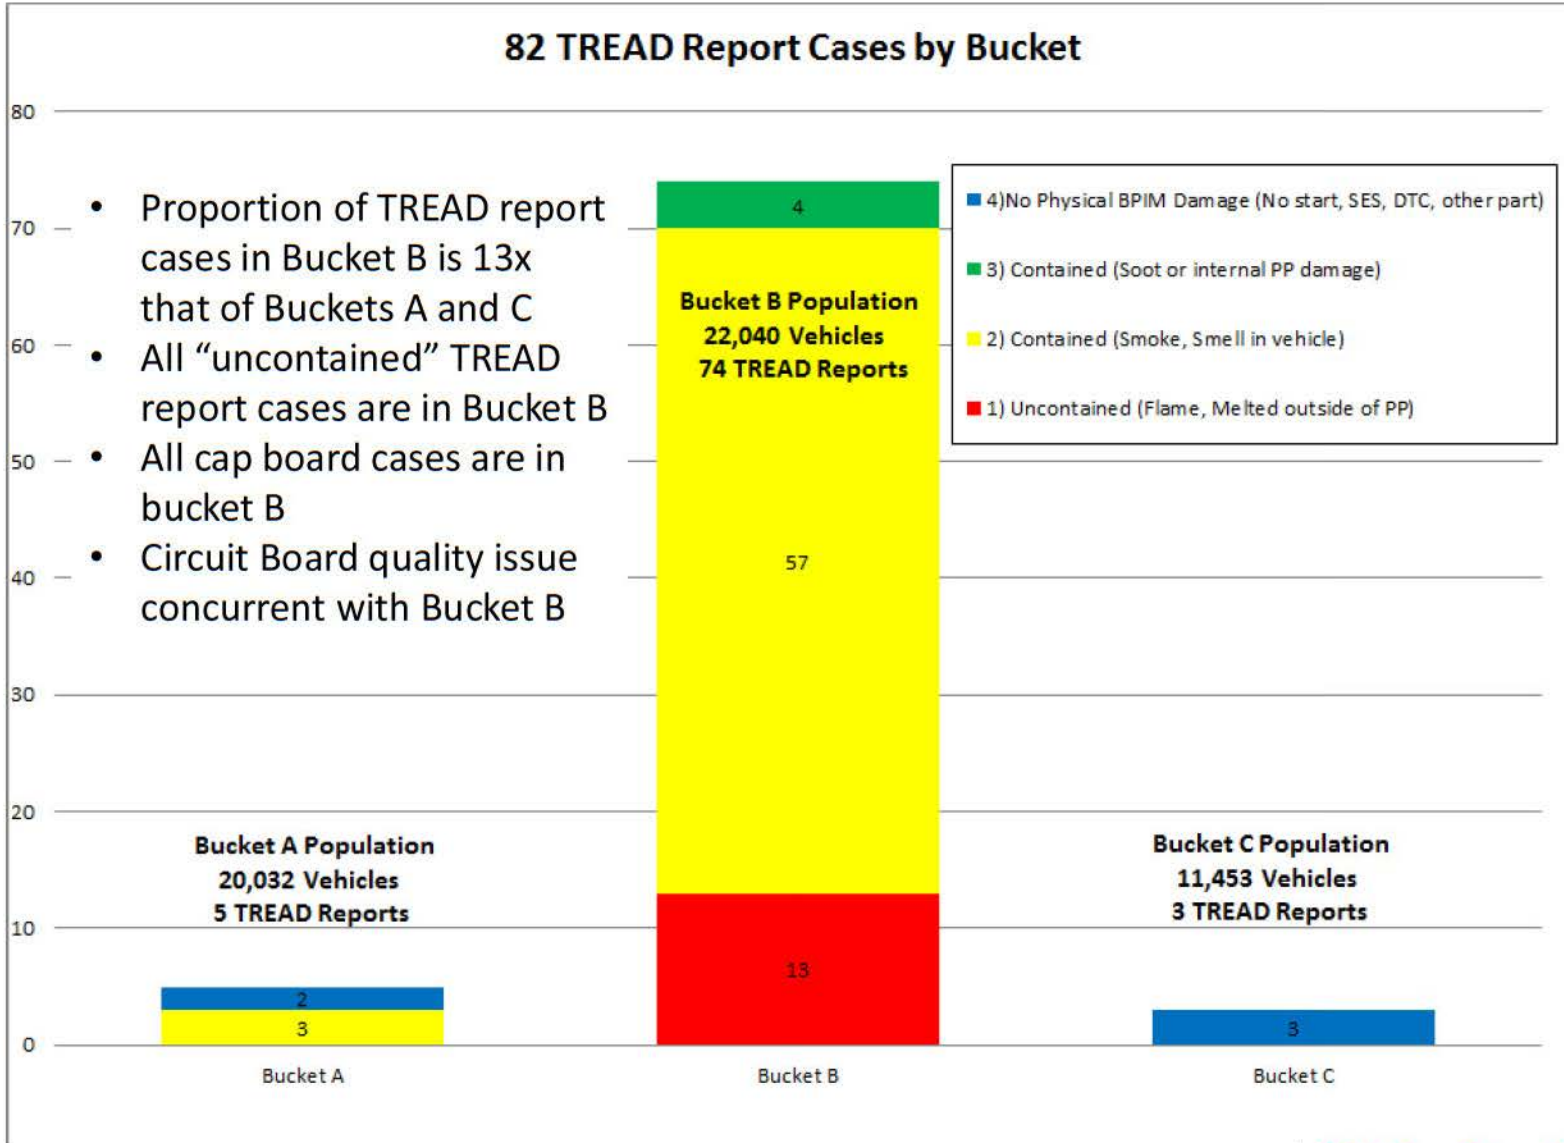
82 TREAD Report Cases by Bucket

- Proportion of TREAD report cases in Bucket B is 13x that of Buckets A and C
- All “uncontained” TREAD report cases are in Bucket B
- All cap board cases are in bucket B
- Circuit Board quality issue concurrent with Bucket B
