RQ13-004

HYUNDAI-KIA

RESPONSE TO REQUEST 8

# Elantra Touring CAB deployment verification test – (2/12/14)

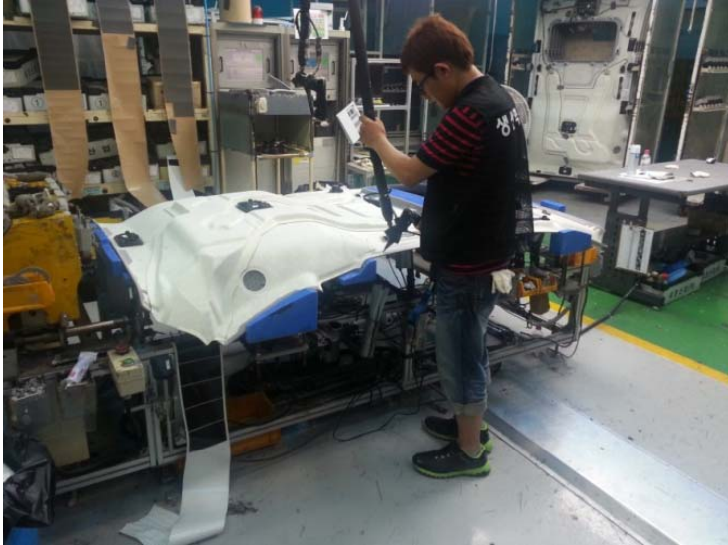
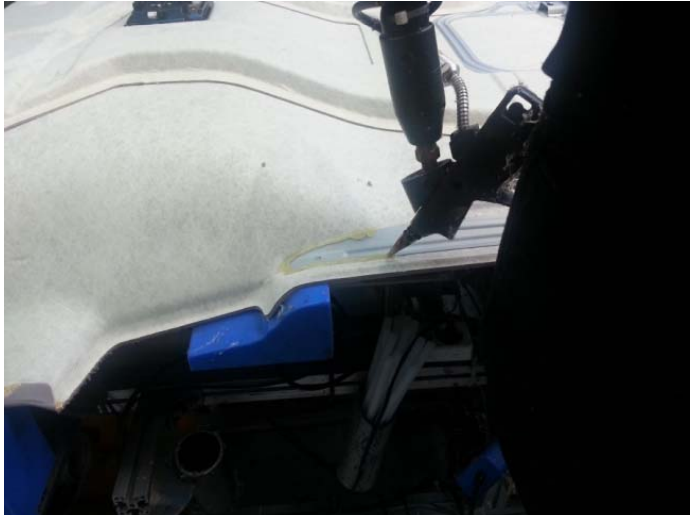
| EXPLANATION | <p>◆ Process<br/>Apply hot-melt on the side-bracket edges. (FRT/RR_LH/RH) : Human operator<br/>-Checking applied-condition of hot-melt in comparison with the master sample.<br/>-Making sure that the adhesive is properly applied to the bracket at both ends</p> <p>◆ TOOL: HOT MELT APPLICATOR SYSTEM (Same tool is used for Elantra Touring and Veracruz)</p> |

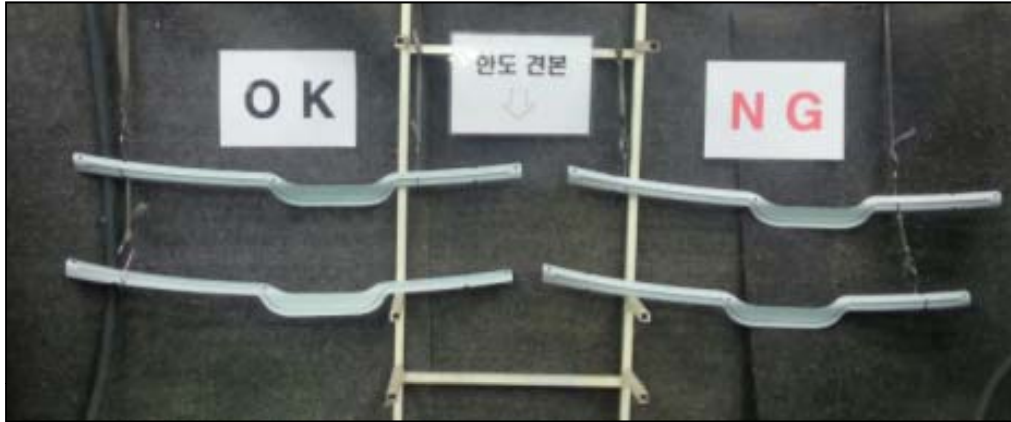
OK : Normal condition

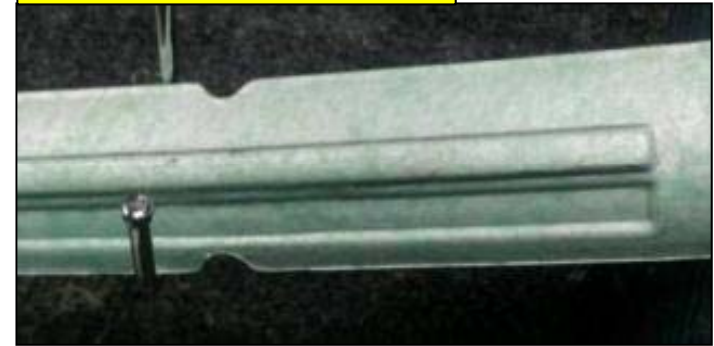
NG : Insufficient spray(overall)
