Reference: NVS-212ef; PE13-027

Attached is Chrysler Group LLC's response to the referenced inquiry PE13-027. In performing the analysis and reaching conclusions, and by providing the information contained herein, Chrysler Group LLC is not waiving its claim to attorney work product and attorney-client privileged communications.

A1. Chrysler Group LLC ("Chrysler") notes that the subject vehicles in response to PE 13-027 are 2012MY Jeep Grand Cherokee (WK) vehicles and any vehicles with substantially similar subject components, which includes the 2011MY, 2013MY and 2014MY Jeep Grand Cherokee's and 2011-2014MY Dodge Durango's.

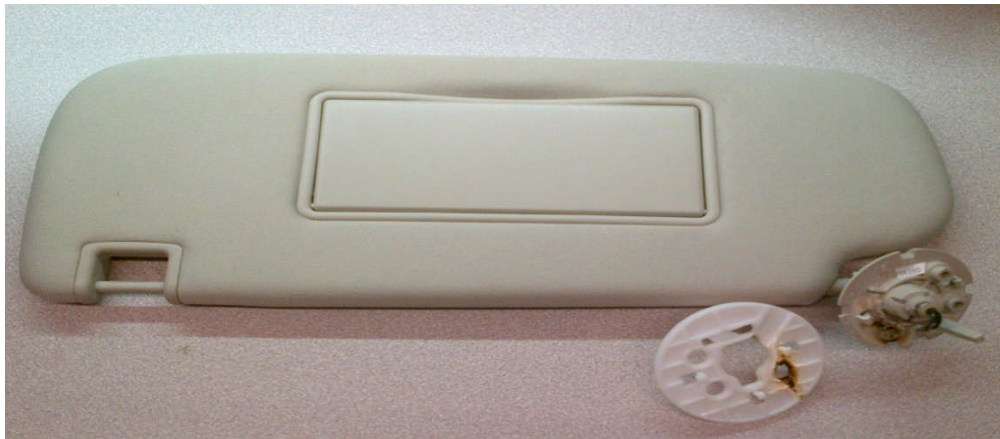
Chrysler's investigation of the 22 reported fires, in which an inspection was performed, determined the root cause of vanity lamp wiring resistive short was damage due to a visor screw being driven through the vanity lamp wiring. The investigation also determined that the damage was caused during the re-assembly process of the sun visor to the headliner after repair, and not during vehicle assembly.

Chrysler arranged for an inspection of the vehicle, which revealed only localized minor thermal damage around the sun visor assembly. The photograph below shows evidence of a resistive short within the sun visor wiring at a screw location. This part was shipped to NHTSA in response to Q10.

Inspection photograph of CAIR # 23858386 (VOQ # 10536895)

Chrysler investigated the vehicle's history to determine whether any prior roof system repairs had been completed and found none. A follow up interview with the dealership service manager identified that the vehicle's owner had reported extensive hail damage to the roof and that it had been previously repaired. The service manager believes that the vehicle was repaired by a third party body dent repair business. The service manager also believes, and

Chrysler agrees, this roof repair disassembly and reassembly of the sun visor caused the sun visor vanity lamp wiring damage.

Within the next 120 days, Chrysler will also introduce a change to the sun visor spacer component that positively locates the inline connector and sun visor pigtail during the reassembly of the sun visor to the headliner. This can be reviewed in CBI Enclosure 9 – Change History CBI, “New Production Visor Spacer.pdf”.
