Truck Equipment Service Co. response to Preliminary Evaluation  
[PE13-032]

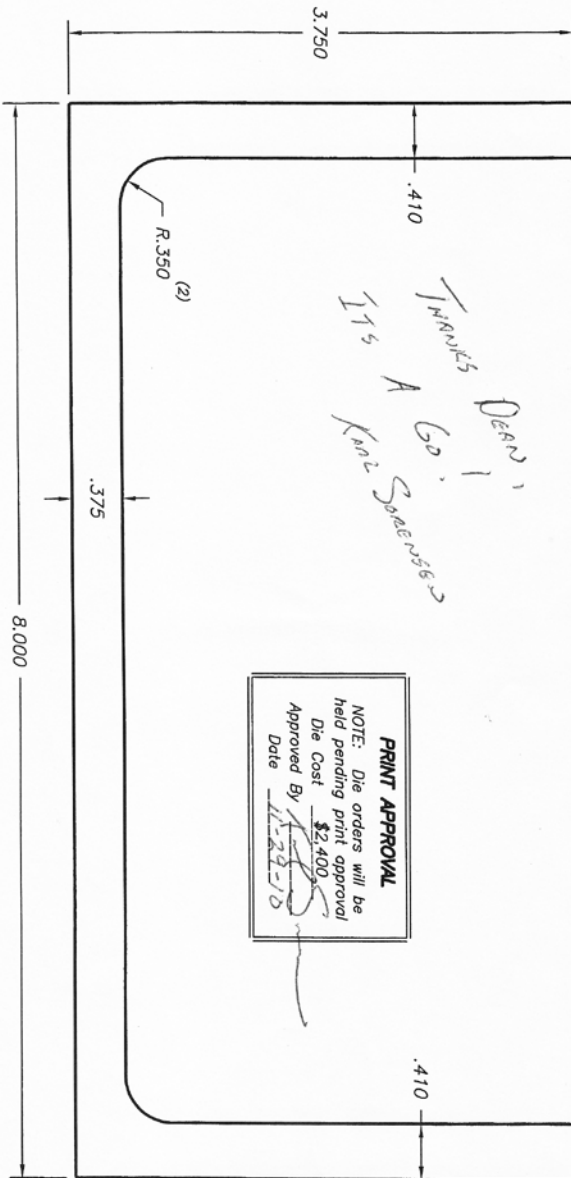
8" CHANNEL W/.375 BASE  
END USE CODE  
PART NO.  
DWG. NO.  
SECTION NUMBER

When the 8" channels showed signs of failing, we worked with our aluminum extrusion supplier (SAPA) to make a running engineering change to increase the thickness of the web on the 8" channel from .250" to .375".

- (a) The alleged defect tended to occur on trailers with a shallower kingpin setting (i.e. 18") , and a higher payload trailer such as 3 and 4 axle units.
- (b) The forces on the front end of the 8" channel overcame the yield strength of the 8" channel with a .250" web thickness.
- (c) Out of the (4) 8" channels, cracks seemed to appear on the middle channels. Probably cause they are closer to the kingpin.

We also added (1) extra 5/8" Huck bolt fastener to the attaching angle located on the front of the 8" channel going from (2) to (3) fasteners. We ran a FEA analysis to confirm our modification plans. I am including that analysis as a separate attachment.

The modifications done to the pickup plate assembly were done to (4) 8" alum channels that run from the front nose rail to the back structural beam. This channel is an aluminum extrusion. We ordered a new die to produce this channel with a .375" thick web. The original web was .250" thick.

We also went from (2) to (3) 5/8" Huck bolts to attach the 8" channel to the front nose rail.
