Analysis of Fuel Tank Leaks on Model Year 2003-08 Mercedes-Benz E-Class Vehicles

FINAL REPORT

December 2014

U. S. Department of Transportation
National Highway Traffic Safety Administration

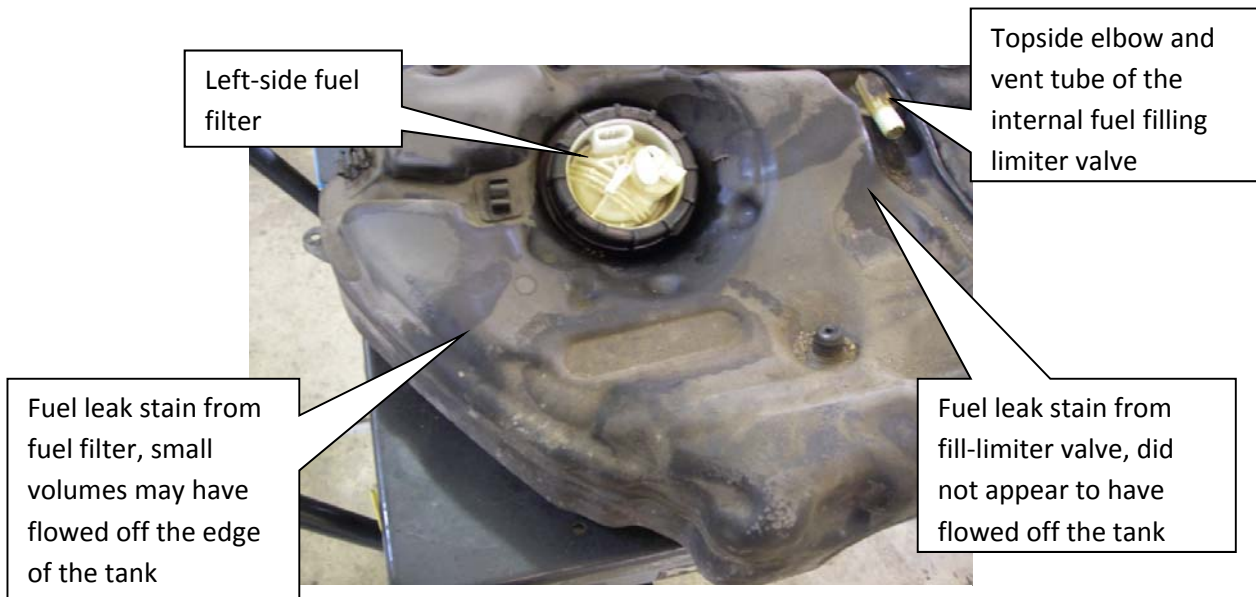
Most of the fuel tanks collected had stains⁶ indicating probable leak paths from around the fuel filter and fuel filling limiter valve, an example of which is shown in Figure 2. The fuel tank topside leaks were found to emanate from two main sources. The primary leak site was the left-side filter, which is located several inches below the full-fill line for the gasoline in the tank. This site could leak liquid gasoline when the fuel level was full or near full. The secondary leak

site (and only leak found on the fuel tank itself) was a crack along the bottom of the horizontal vent tube of the fuel filling limiter valve located at the very top outside the fuel tank, as shown in Figure 3 from inside the tube. This site is above the normal-full line, but could pass vapors or leak liquid fuel while driving due to sloshing from lateral or longitudinal accelerations, or by overtopping when refilling the fuel tank.

Figure 2 – Fuel Tank 05T with Fuel Leak Stains Around the Filter and the Fuel Filling Limiter Valve

On two of the six tanks, the stains indicated liquid fuel had leaked over the edge of the tank and onto the underbody aero-shield. Tank T05 leaked at the fuel filling limiter valve and at the filter.

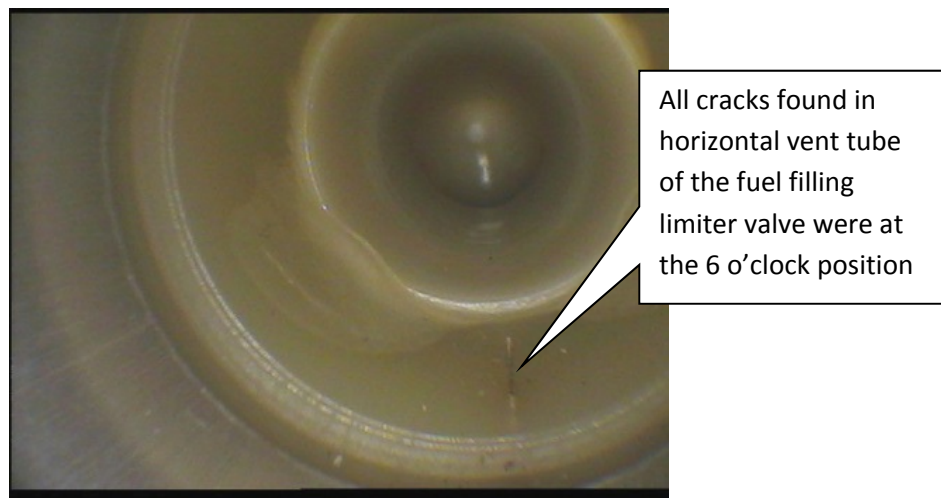
Figure 3 - A Borescope View of a Crack at the 6-O'Clock Position Inside the Horizontal Tube of the Fuel Filling Limiter Valve on Tank 15T

The witness stains on the tank indicated the fuel leaked over the edge at the left and right sides of the left saddle portion of the tank. Tank T12 leaked from the fuel filter and appeared to have spilled over the left side of the left saddle portion of the tank.

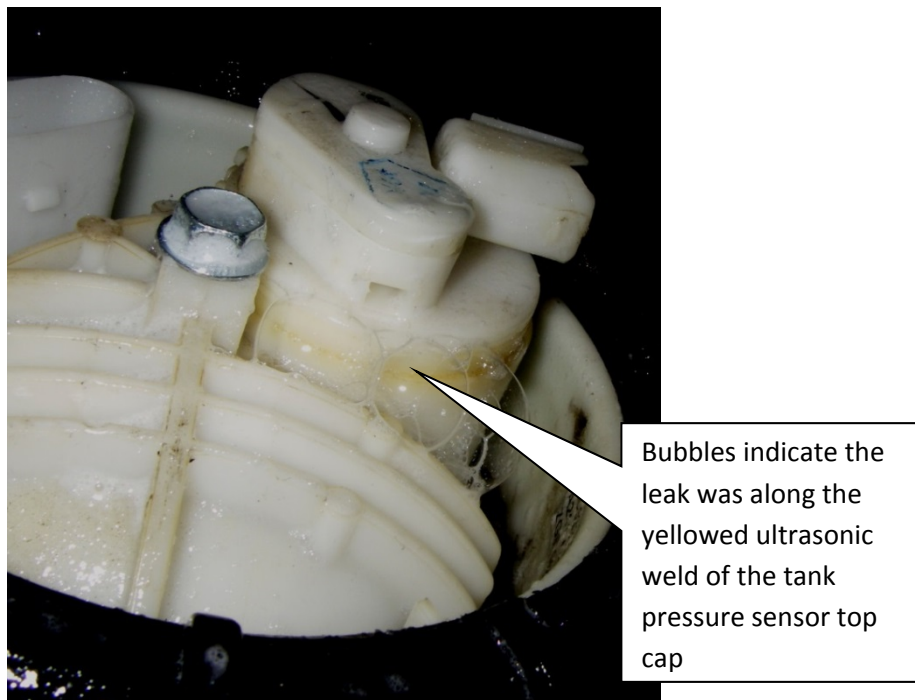
All of the top mounting plates of the left-side fuel filters had varying degrees of yellow stains indicating liquid or vapors of hydrocarbons had been leaking from the area of the OBDII tank pressure sensor along the seam for the top cap, as shown during a bubble test in Figure 4.

Figure 4 – While the Fuel Tank was Pressurized, Fuel Filter 11A was Sprayed with Soap to Verify the Leak along the Yellow Stain at the OBDII Pressure Sensor Seam

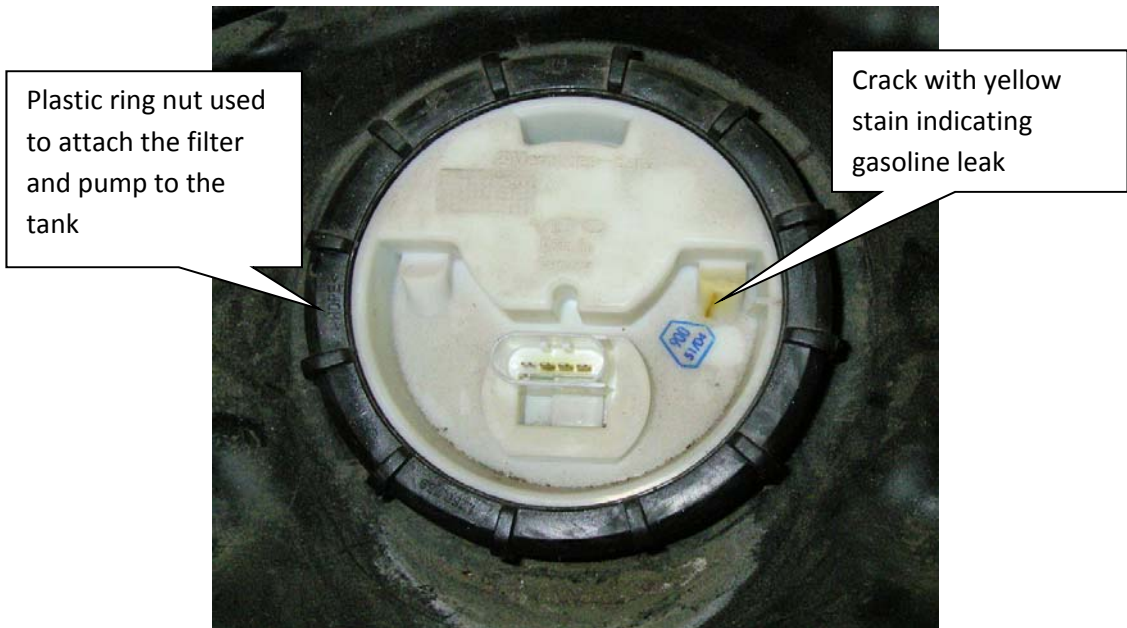
Most of the top plates of the right-side fuel pumps had a small crack and light yellow stain at the plastic receiver for the aluminum tubes that spring load the pump body into the bottom of the tank, as shown in Figure 5. Two of the fuel pump top plates had a more substantial stain that indicated the well area had probably contained liquid fuel, as shown in Figure 6.

Figure 5 – The Top Side Plate of Fuel Pump 05B was Cracked at the Receiver for One of the Internal Aluminum Rods

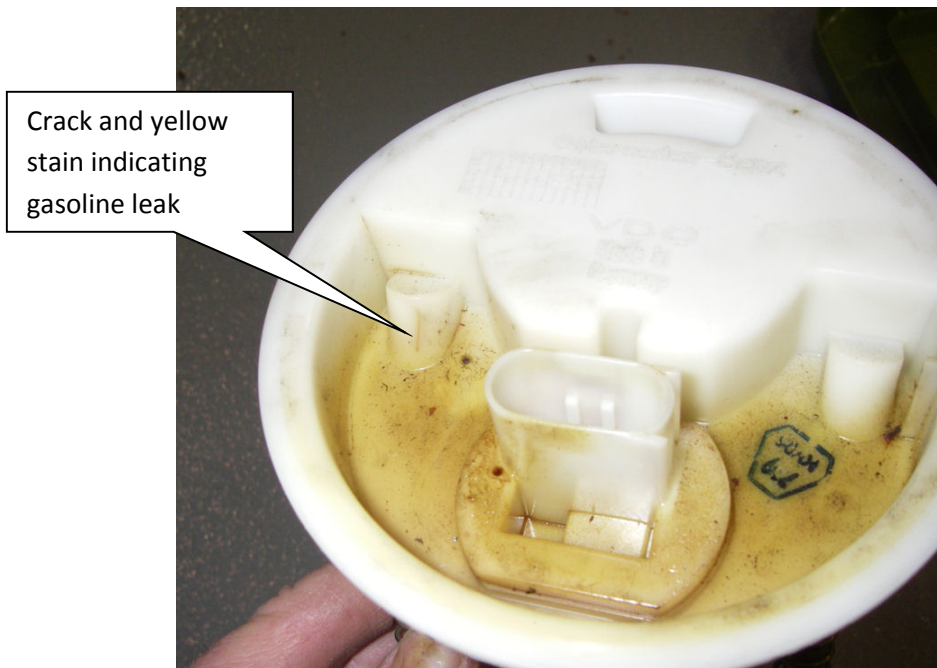
Figure 6 - The Top Side Plate of Fuel Pump 11B had a Small Crack and Significant Staining in Well Area Indicating a Previous Liquid Fuel Leak

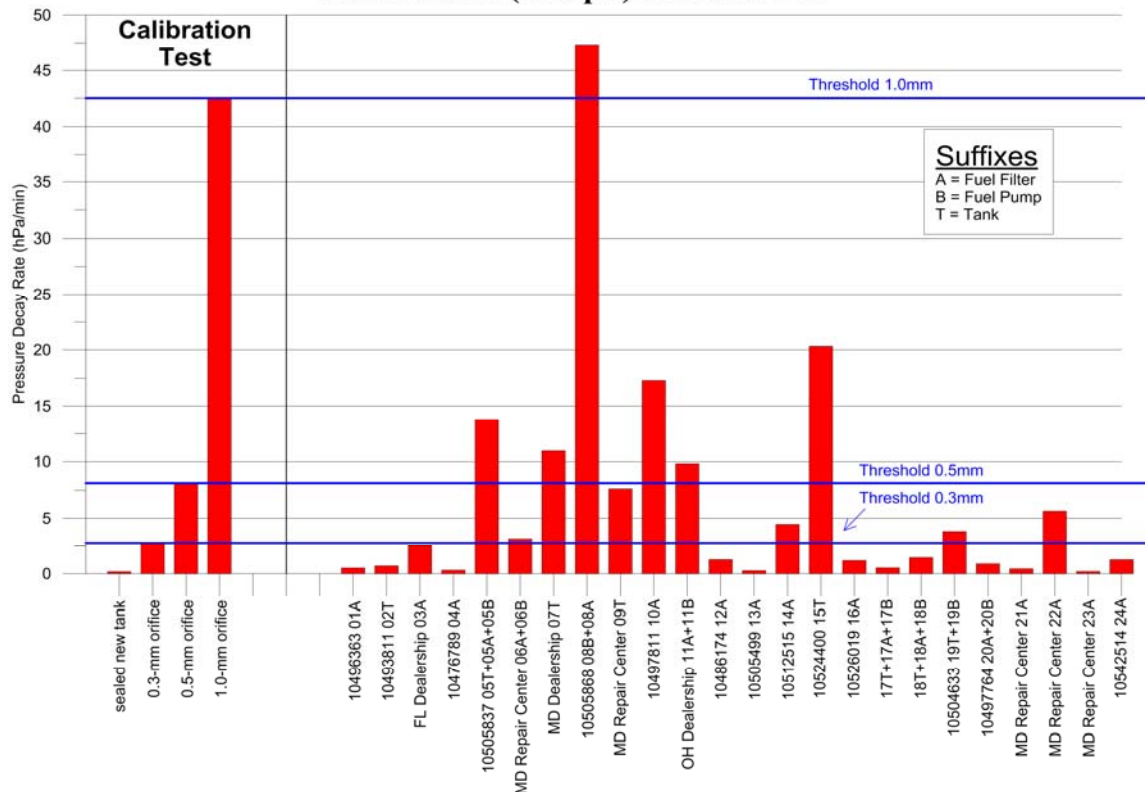
Figure 11 - The Total Leak Rate of All Components Combined into Fuel Tank Assemblies, When Possible, and the Leak Rates of Three Calibration Orifices and a New Tank

While these tanks are not required to be absolutely sealed, the OBDII thresholds are designed only for vapor leaks.

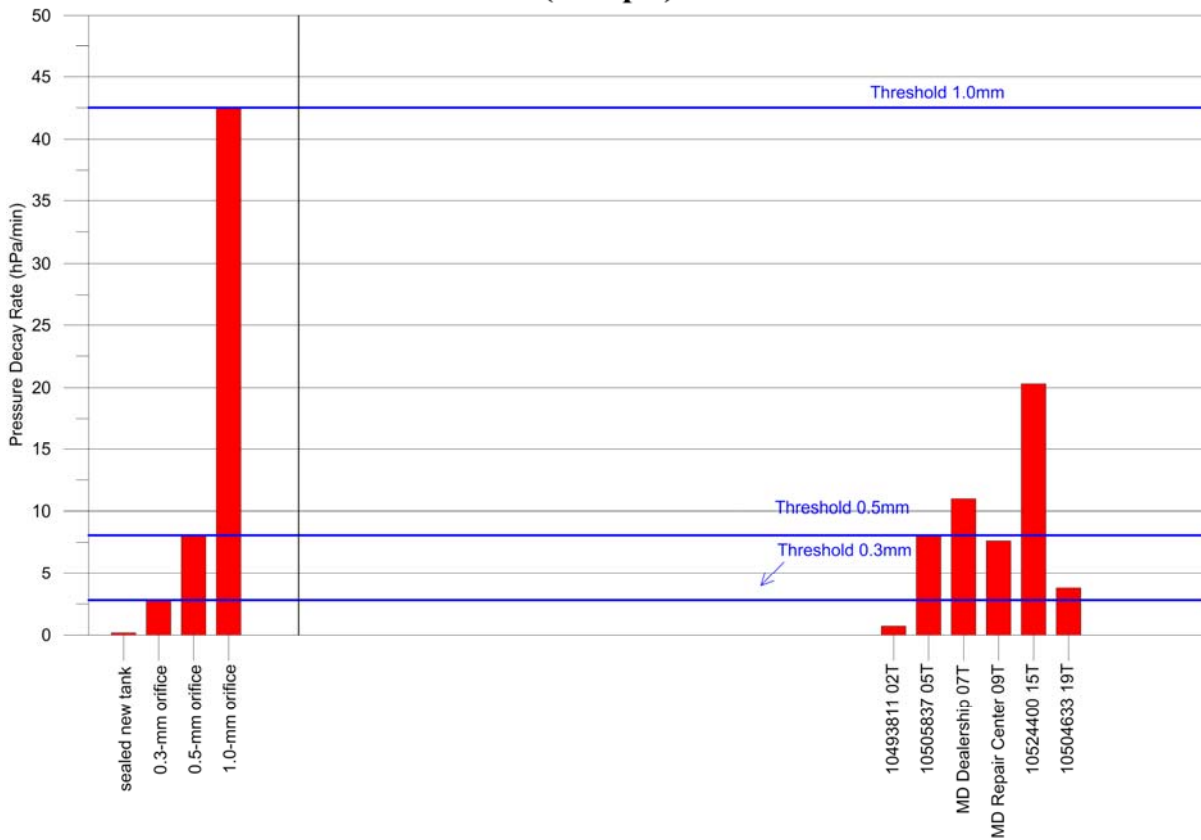
Data collected from the testing is also shown grouped by component, as tanks, filters, and pumps. The tank leak rates are shown in Figure 12. Only two tanks leaked above the 0.5-mm threshold that would have immediately illuminated the MIL. One tank (identified as tank 02T) leaked at a rate just slightly more than the new tank. The new tank may have been sealed better than the original 02T (with a white fuel filling limiter valve) since it was a newer design with an orange-colored fuel filling limiter valve, and was certified for all 50 states, including the California Air Resources Board (CARB) states. Previously the rest of the United States used an identical-appearing tank with a white fuel filling limiter valve; the CARB states had used a steel tank with six studs at each of the two topside ports, and the filter and pump were bolted to the tank. The manufacturer did not report the leak rate of any tanks from their component collections.

Figure 12 – The Leak Rates of the Fuel Tanks Showed Three Tanks were at or Above the Threshold for Immediate MIL Activation

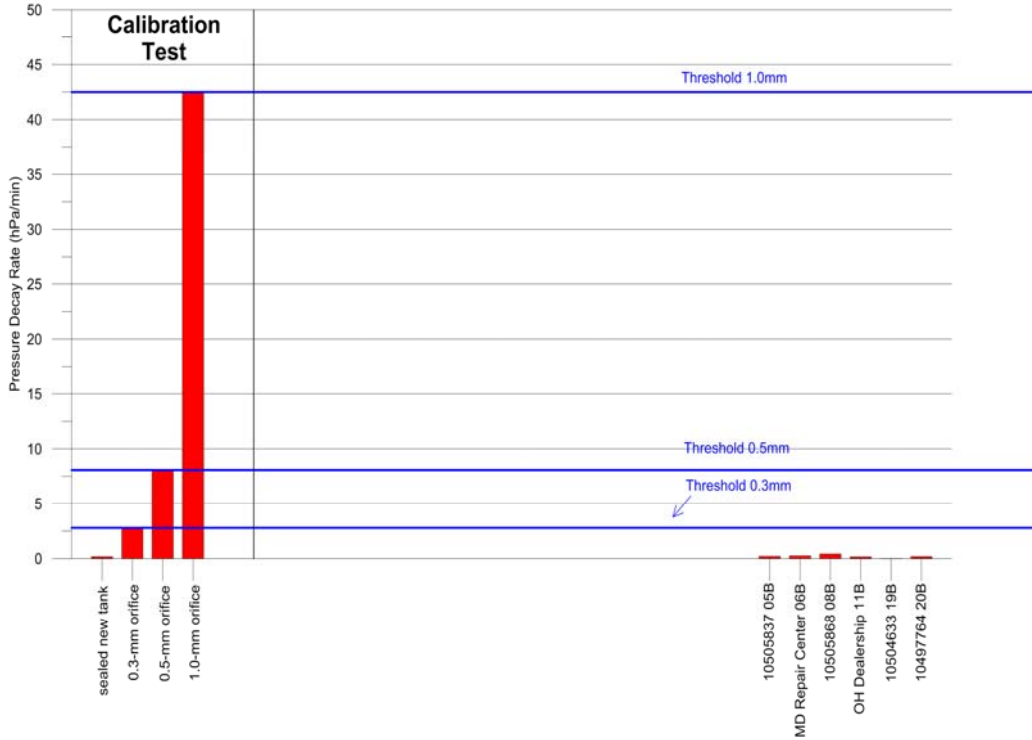
The leak rate on the top plate of the fuel pumps was very low and similar to the normal leak rate of the new tank, as shown in Figure 13. However, since the pump top plate is below the full line of the fuel tank, two of these leaks appeared to have pooled liquid gasoline into the top-side well but not over the lip and onto the fuel tank. While many of the right-side fuel-pump top-side plates had a small crack and yellow stain, no significant air leaks were found at any of these sites, including the two more heavily stained top plates.

Figure 13 – The Leak Rates of all Fuel Pump Top Side Plates was Insignificant

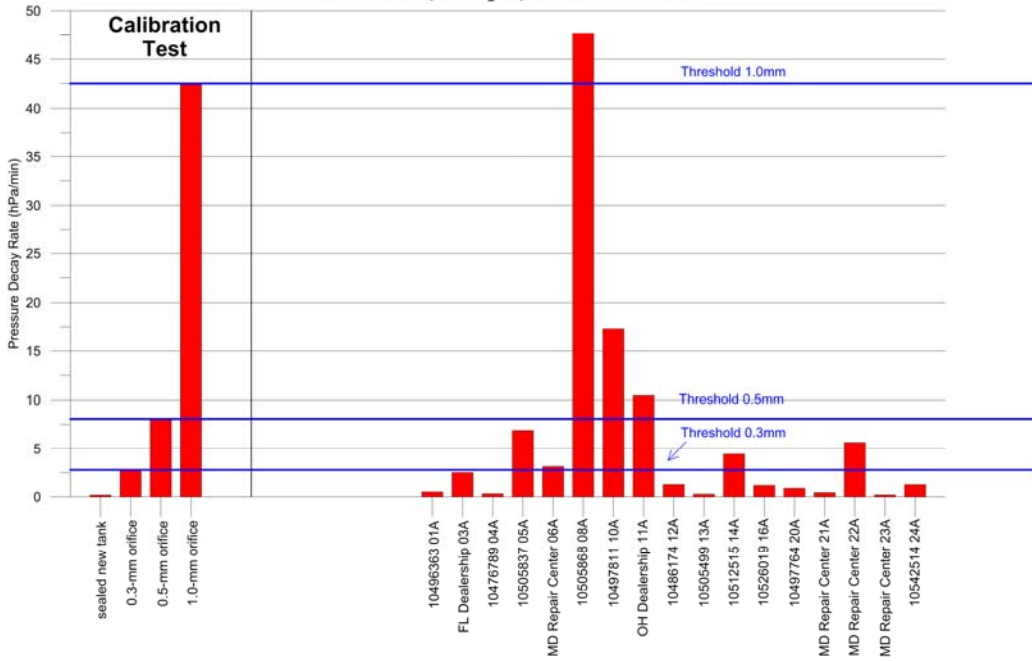
The leak rate of the filters was significantly different from the pumps, as shown in Figure 14. Fourteen of the 17 filters leaked at a rate that may not have immediately triggered a MIL, but could have still leaked liquid fuel since the opening location is below the full fuel level of the tank. Three of the filters leaked at a rate that would have immediately triggered the MIL and one of those leaked at a rate over the 1.0-mm threshold (VOQ 10505868).

Figure 14 – The Leak Rates of the Fuel Filters Indicated that 14 of the 17 Filters May Not Have Immediately Illuminated the MIL
