NHTSA Investigation EA13-003 Summary of Tests and Analysis

Mercedes-Benz

Overview W211 HDPE 80L Fuel Tank System

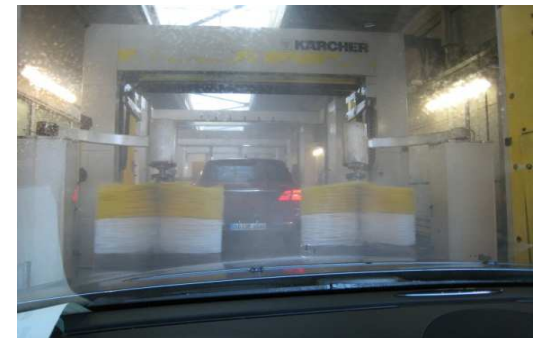
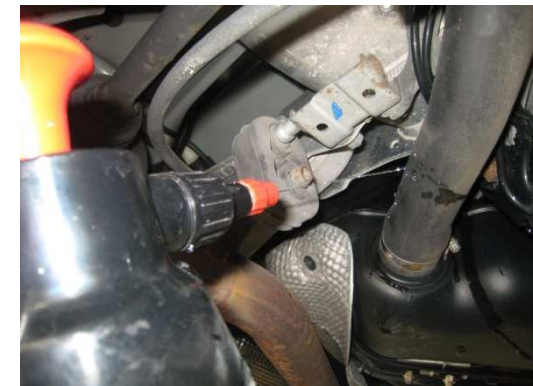
- ❑ Tests included:
 - Water-jet sprayer test
 - Car wash station test
 - High-pressure steam cleaner test
 - Heavy rain simulation test in SHED chamber
 - Vapor intrusion test in SHED chamber

- Leak proof sealing performance of cover plates confirmed, even under worst-case conditions
- No wicking of fuel up wiring harness into passenger compartment
- No pressure differential

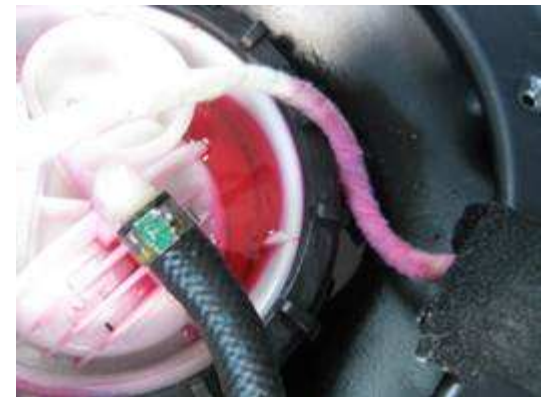
- Tests included:
 - Test of potential wicking effect of fuel along wiring harness
 - Cabin pressure differential test
