# ODI RESUME

**Investigation:** EA 14-002  
**Prompted by:** PE13-035  
**Date Opened:** 05/12/2014  
**Investigator:** Michael Lee  
**Approver:** Stephen Ridella  
**Subject:** Panoramic Glass Sunroof Breakage

**Manufacturer:** Kia Motors America  
**Products:** Model Year (MY) 2011-2013 Kia Sorento  
**Population:** 65,347

## ENGINEERING ANALYSIS CLOSING REPORT

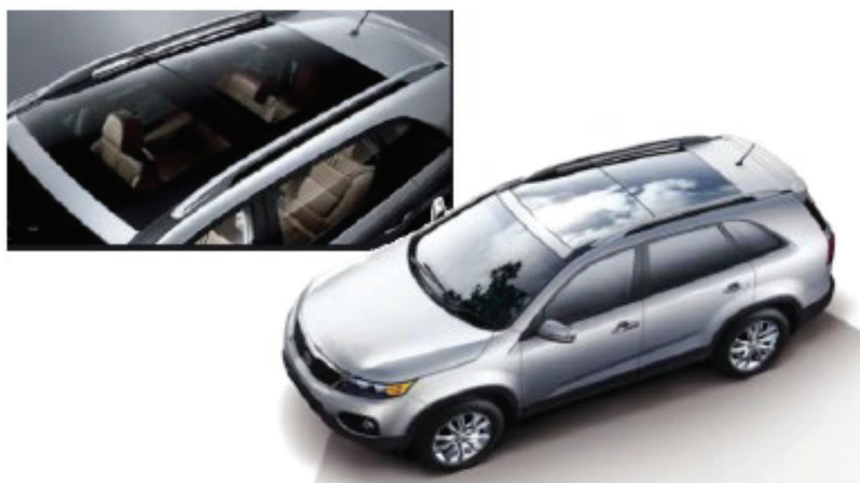
**DESCRIPTION OF COMPONENT OR VEHICLE SYSTEM:** The model year 2011-2013 Kia Sorento vehicles (subject vehicles) are equipped with panoramic sunroofs as shown below. The sunroof is divided into two panels, one in the front, and one in rear, and the front section can be retracted (moved to open position). The glass is tempered (a form of heat-treatment) and designed to fracture into granular chunks, (i.e., small nuggets typically referred to as cutlets) in contrast to non-tempered glass that can break into large pieces with sharp edges.

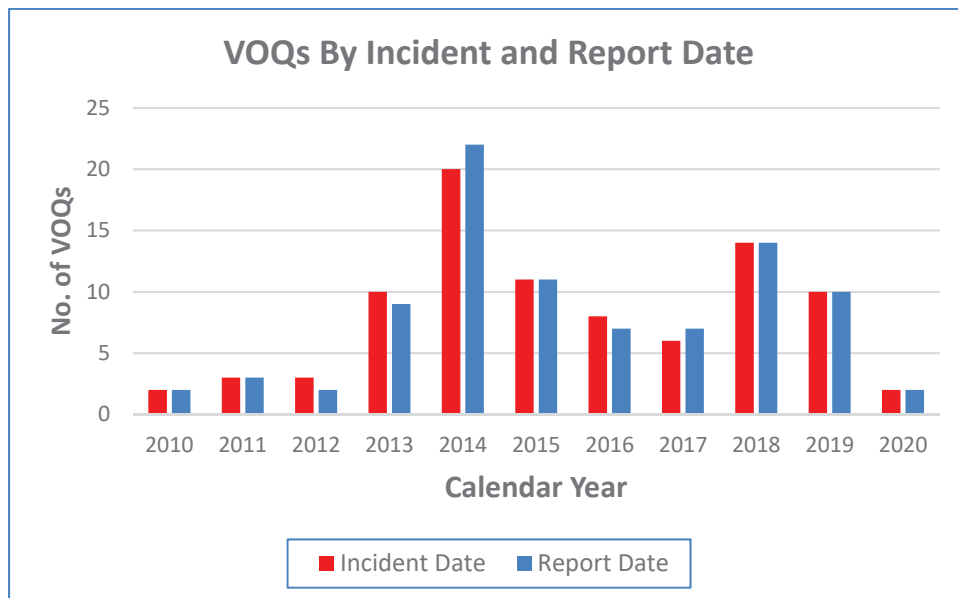
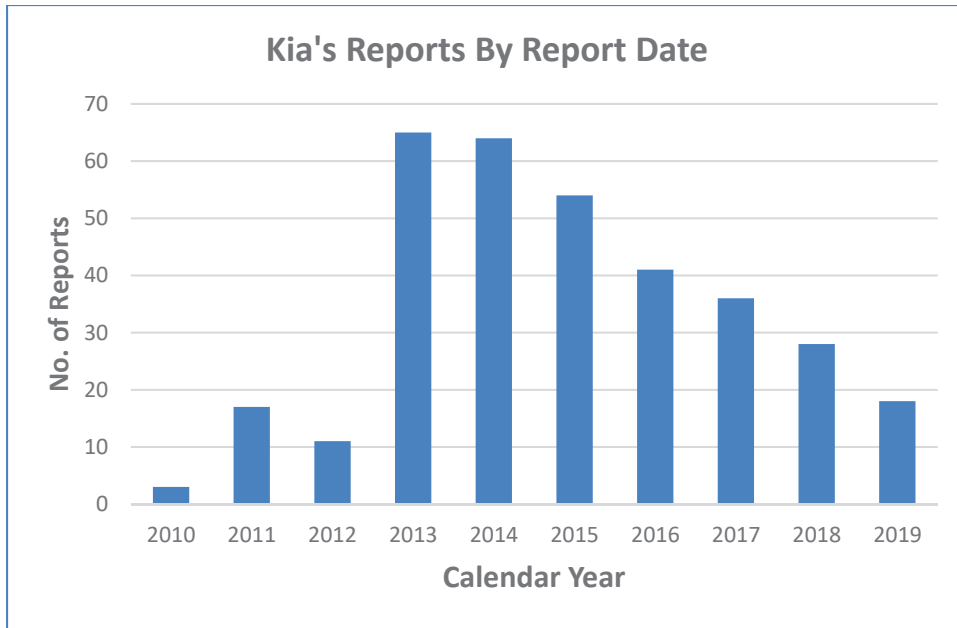
The manufacturer report counts shown above were received by Kia through October 8, 2019, the date of ODI’s last request for Kia field data. Both the ODI and Kia reports show a generally declining trend over the last few years, as shown in the charts below.<sup>1</sup>

<sup>1</sup> Kia reports do not consistently state an incident date, therefore only the report dates can be accurately reported.

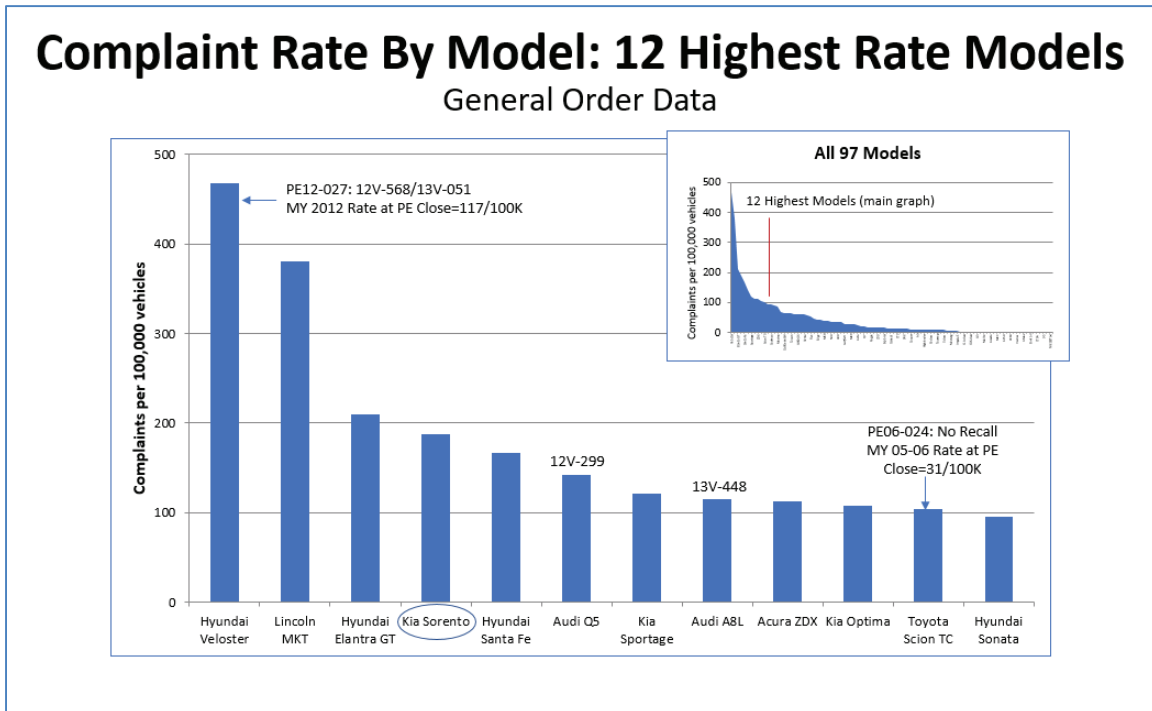
Via a General Order issued by NHTSA's Office of Chief Counsel in April 2016, ODI conducted a comprehensive, industry-wide peer review of reports of spontaneous sunroof glass shattering. The review covered 13 vehicle manufacturers, 97 vehicle models and 11 model years (2006 to 2016), totaling approximately ten million vehicles that utilized panoramic glass sunroofs greater than 0.5 meters square. This review found that spontaneous sunroof glass shattering is not an uncommon occurrence: More than 4,000 complaints of such occurrences were reported by the 13 manufacturers. While the Kia Sorento did stand out from other vehicle models, other models of Audi, Ford, Hyundai and Kia vehicles also stood out (see graph below). Some of these models were associated with recalls, however others were not. No crashes and only a few moderate or greater injuries were reported in the more than 4,000 incidents.
