ODI RESUME

Investigation: PE 14-005
Date Opened: 02/10/2014
Investigator: Paul Simmons
Approver: Frank Borris
Subject: Brake Booster Failure

Manufacturer: Mazda Motor Corp.
Products: 2010-2011 Mazda CX-9
Population: 62,319

Problem Description: Owners allege experiencing incidents of hard brake pedal feel and increased brake effort.

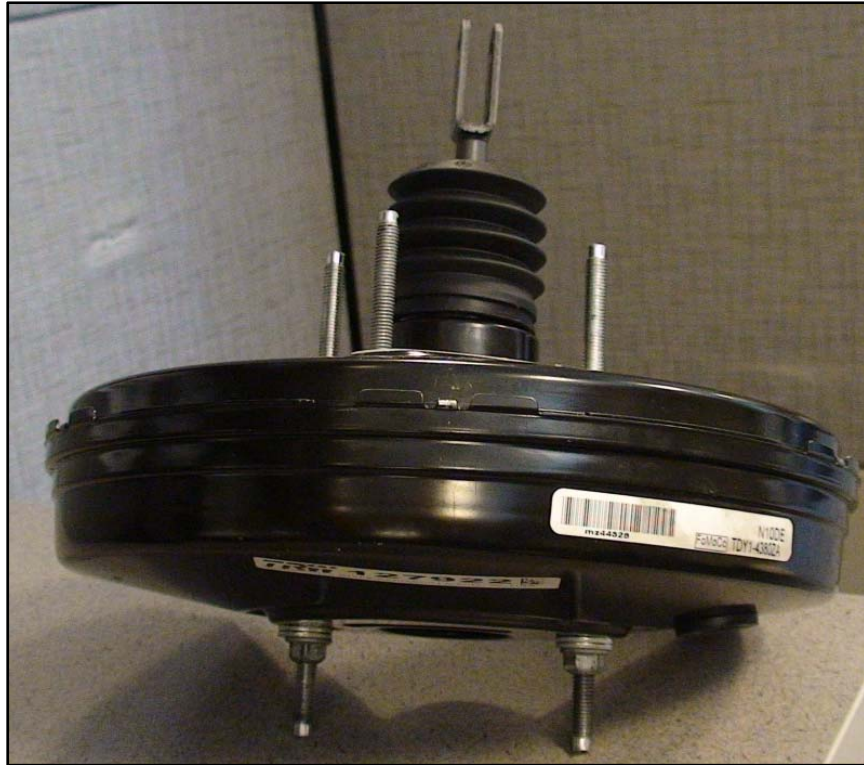
Figure 1. CX-9 brake booster assembly.

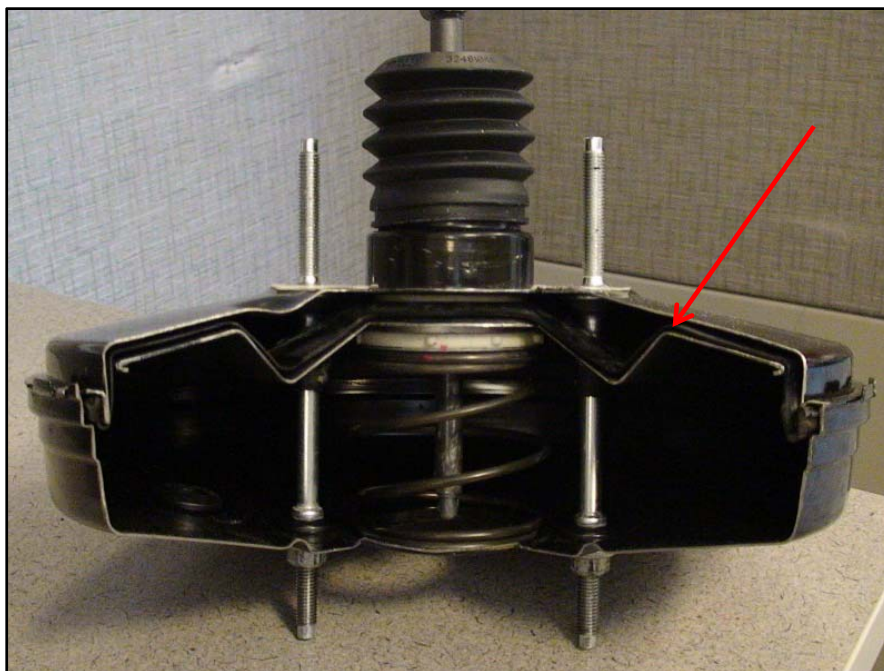
In its response to the Office of Defects Investigation's (ODI) information request letter for PE14-005, Mazda identified a problem with booster diaphragms developing tears near the outer seal/circumference that can result in noise and degraded booster performance as the tears grow in length (Figures 1-3). The tears allow leakage from the ambient to the vacuum sides of the diaphragm that reduces the differential pressure across the diaphragm and produces a hissing noise after the tears have reached 10-12 mm in length. The problem was caused by wear of the mold used for the diaphragm forming process, which resulted in increased thickness and stress in the bending area of the diaphragm. Continuous operation in environments with high ambient temperatures accelerates the hardening of the diaphragm material, further increasing the stress in the bending area and contributing to tear initiation and propagation rate. Analysis of failure data indicates that the tool wear condition affected vehicles produced after June 2010 and operated in hot states (Figures 4-6). In February 2013 the supplier introduced a new mold and changes to the diaphragm thickness monitoring process to correct the condition in production vehicles.

Figure 2. Booster cut-away showing diaphragm.

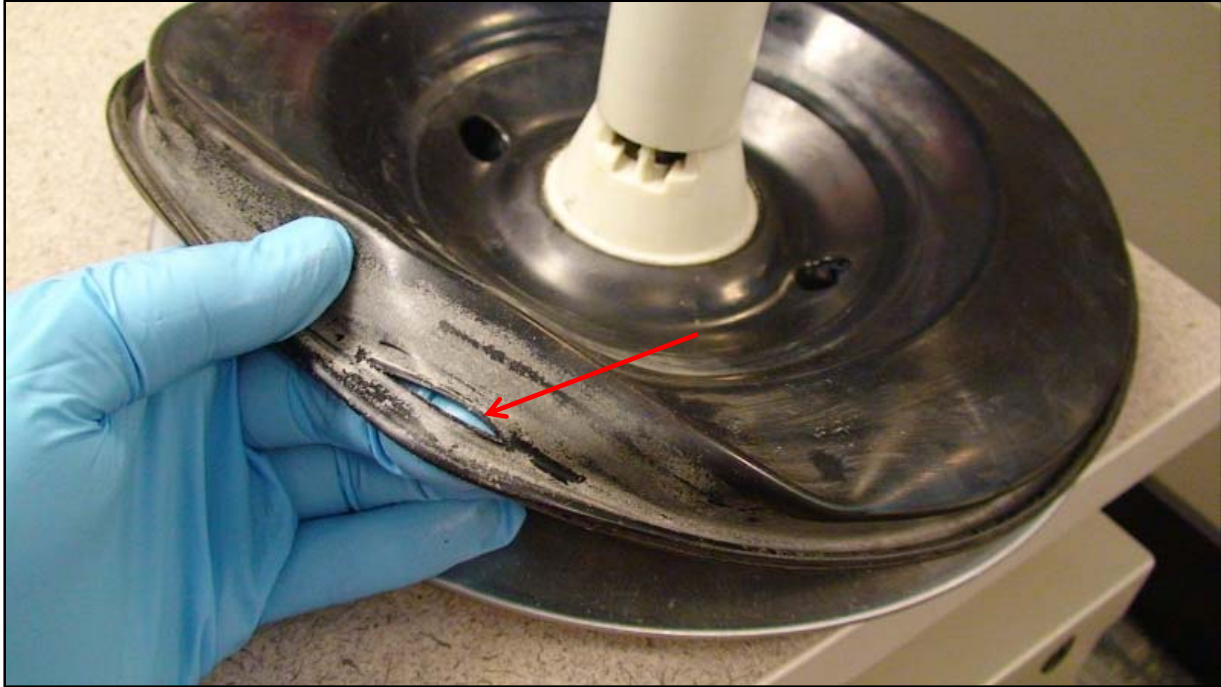
Analysis of complaint and supplier test data indicates that the diaphragm tear condition is a progressive failure that develops slowly over time. Smaller tears have little effect on system performance. As the tear continues to grow, the effects become more evident. The hard pedal and increased effort are experienced during initial pedal application, but are diminished as the pedal is pressed further by the driver and the tear is partially sealed by the outer wall of the booster. This change from a hard to a soft pedal feel is described by some drivers as a spongy pedal. For tear lengths that were observed in warranty return parts, testing demonstrated that most booster performance can be recovered with increasing pedal apply speed and apply force. None of the tears measured in return parts grew large enough to cause a complete loss of brake booster function.

Figure 3. Diaphragm tear location (30 mm tear).

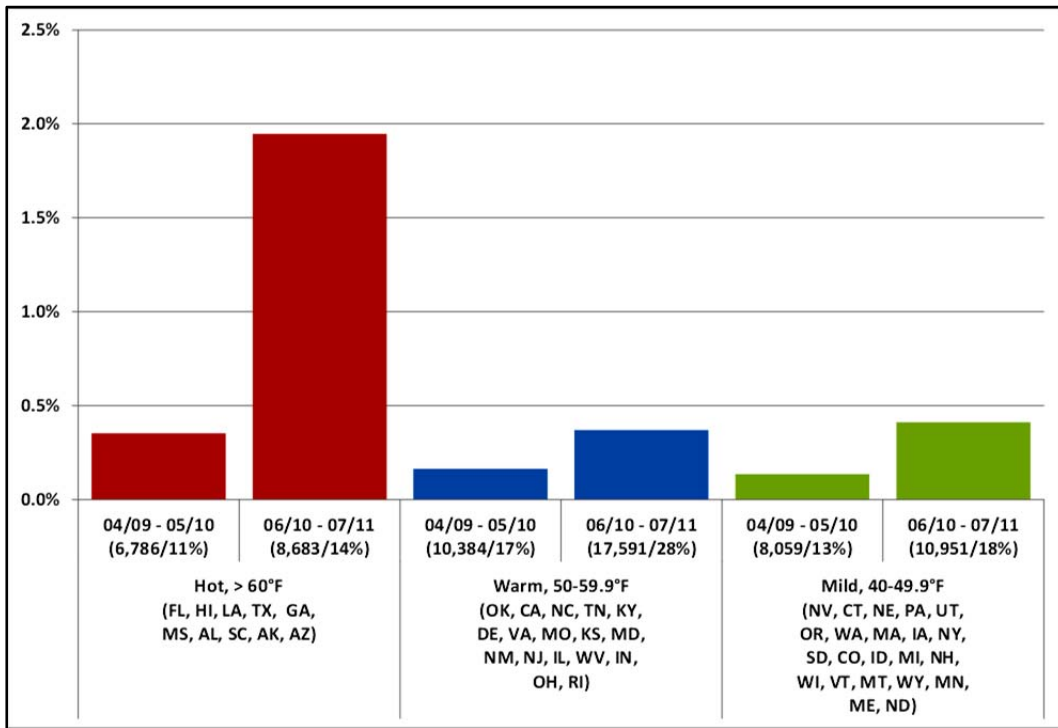
Figure 4. MY 2010-2011 Mazda CX-9 booster failure rates by production range and region.

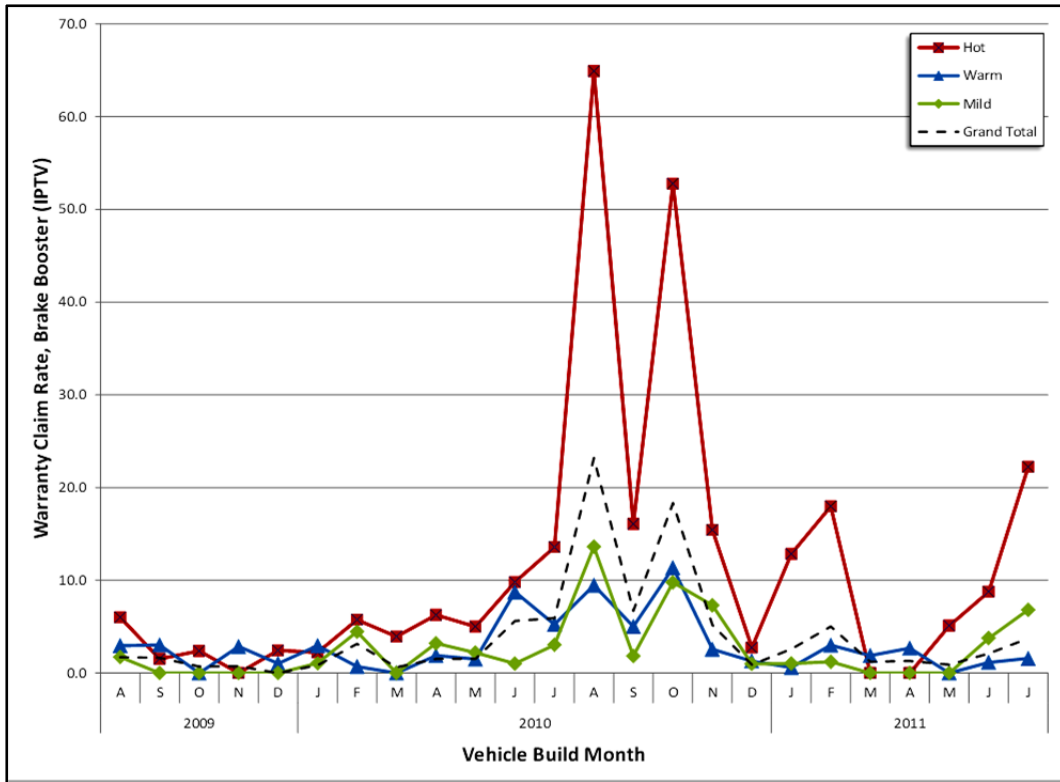
Figure 5. MY 2010-2011 Mazda CX-9 booster failure rates by region and vehicle build month.

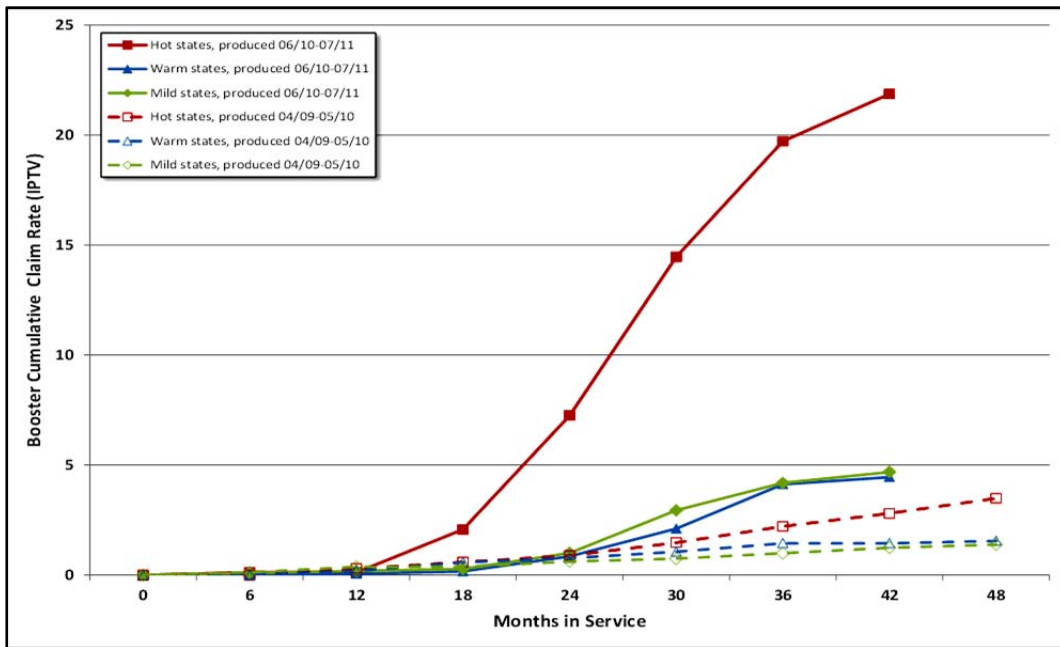
Figure 6. MY 2010-2011 Mazda CX-9 booster failure rate by region, production range and months in service.
