## ODI RESUME

| <b>Investigation:</b> | PE 14-006 | <b>Date Closed:</b> | 05/22/2015 |
| <b>Subject:</b> | Motorcycle steering lockup | | |

| <b>Products:</b> | 2008-2015 Vision |

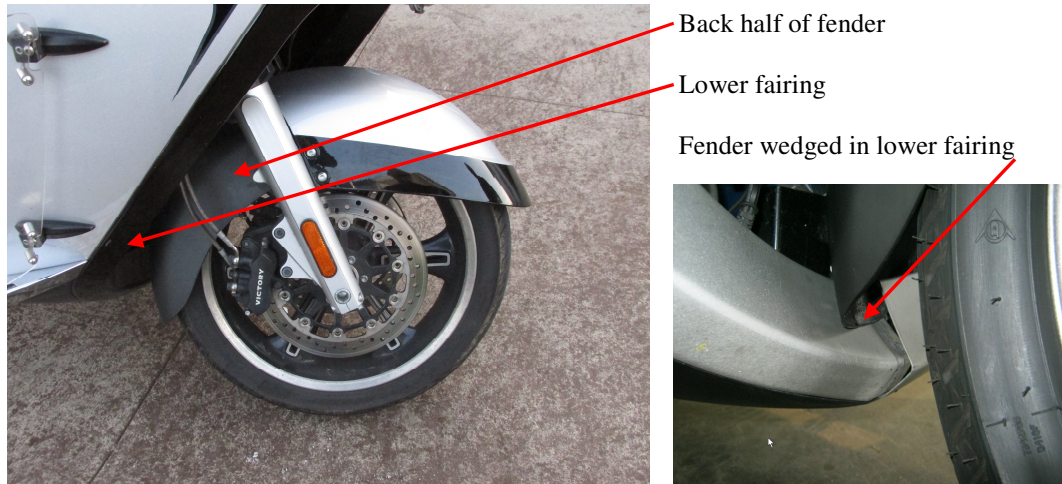
The subject motorcycles are equipped with a two-piece, plastic, front fender. The back half (the all-black portion in the photo below) is secured to the fork with a single fastener on each side. It is secured to the front half of the fender with two plastic pushpins.

The back half of the subject 2-piece fender is alleged to cause steering lockup when it partially separates and becomes wedged in the lower faring.

1. The fender is no longer firmly attached to the fork sliders;
2. The forks are compressed sufficiently to allow the fender's trailing edge to clear the lower fairing chinbar;
3. The fender has rotated sufficiently so that it is positioned between the chinbar and battery; and
4. The forks rebound before the fender moves back to its original position.

Polaris concluded that a fender separation of the type owners allege, does not represent an unreasonable risk to motor vehicle safety, but does compromise owner satisfaction with its Victory Visions. Consequently, on April 28, 2015, Polaris advised the agency that it decided to undertake a consumer satisfaction campaign to improve fender durability on all MY 2008-15 Victory Vision motorcycles regardless of mileage, time in service, or ownership status. Owners will receive notification of this campaign by June 20, 2015. A copy of Polaris' April 28, 2015 letter to us about this program is in the public file for this PE.
