# ODI RESUME

**Investigation:** PE 14-014  
**Date Opened:** 05/20/2014  
**Investigator:** Jeff Quandt  
**Approver:** Stephen Ridella  
**Subject:** Excessive Brake Pedal Travel  
**Date Closed:** 05/13/2015  
**Reviewer:** Jeff Quandt

**Manufacturer:** Nissan North America, Inc.  
**Products:** 2013-2014 Nissan Sentra, Versa Sedan and Versa Note  
**Population:** 605,963  
**Problem Description:** The brake pedal may gradually sink when applied very slowly or when the vehicle is stopped with light pressure applied to the brake pedal.

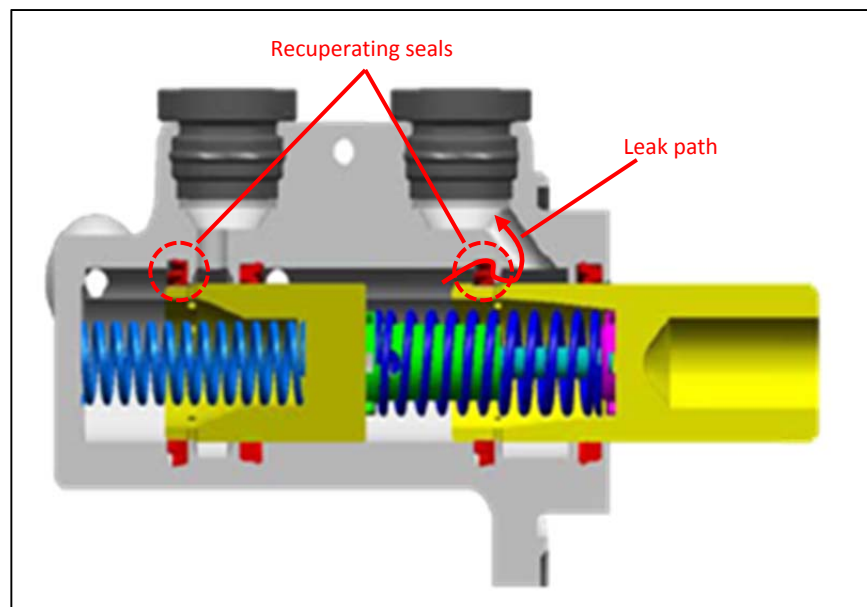
Figure 2. Fixed Seal Master Cylinder, TRW Automotive.

On May 20, 2014, ODI opened PE14-014 based on eight complaints alleging incidents of excessive brake pedal travel in model year (MY) 2013 through 2014 Nissan Sentra, Versa Sedan and Versa Note passenger cars (Figure 1) and information in Early Warning Reporting field reports indicating issues with master cylinder internal seals. In response to an information request letter sent by ODI, Nissan identified a condition with the master cylinder in early production subject vehicles that could result in a slow internal leak past one of the recuperating seals to the brake reservoir when the brake pedal is depressed very slowly or lightly (Figure 2). The subject vehicles are equipped with fixed seal master cylinders supplied by TRW. To address concerns with water hammer noise with the standard seal design, the master cylinders in the early production subject vehicles used AWH (anti-water hammer) seals. The AWH seals are sensitive to contamination from assembly plant cleanliness issues, which can produce the internal leak condition during slow or light brake applies but perform as designed with normal or emergency brake applications. TRW indicated that the risk of contamination interacting with the subject seals is greatest after the evacuation and pressure fill process used to fill the brake system during the manufacturing process (early life issue). TRW developed a new master cylinder seal design (EVO seal) that addresses the noise concern and eliminates the internal leak concern associated with contamination by providing a secondary seal (Figure 3).

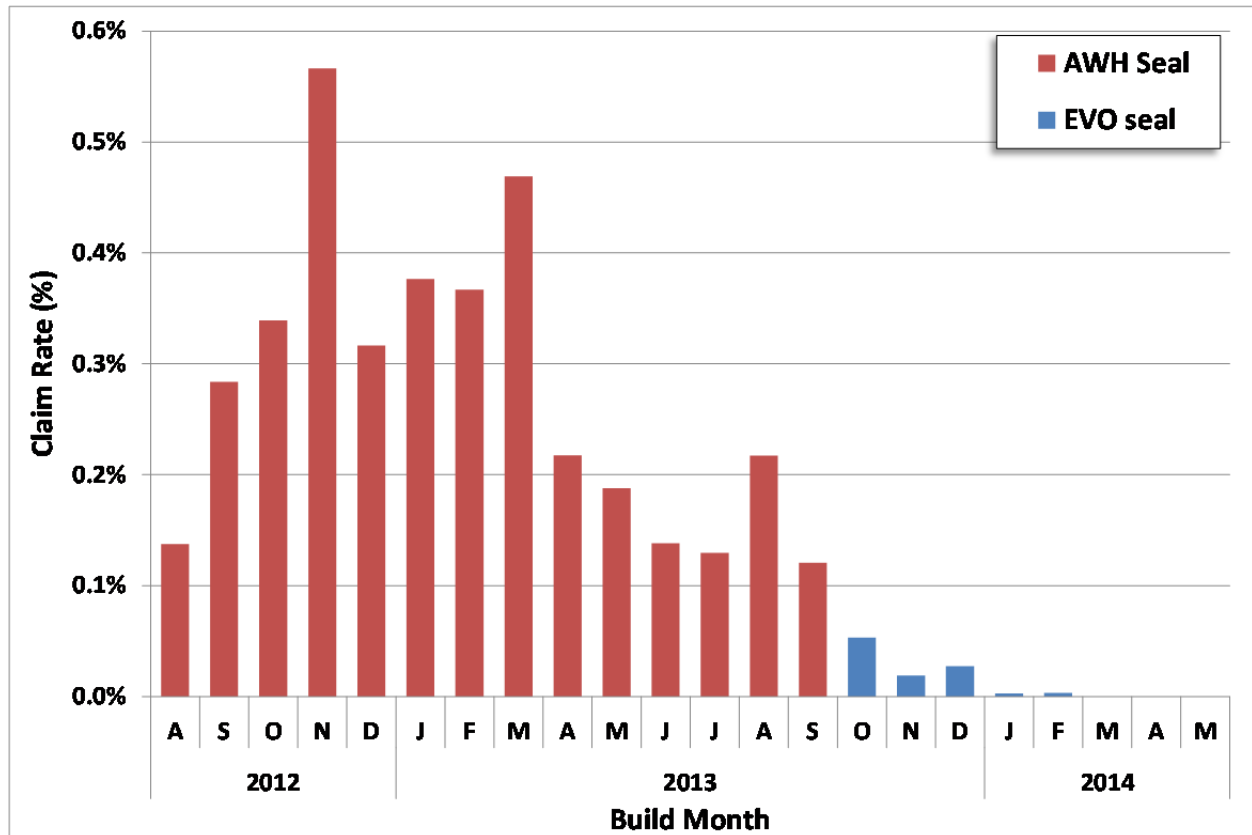
Nissan implemented the new master cylinder design in vehicle production on September 23, 2013. ODI's analysis shows that the master cylinder warranty claim rate is much higher in vehicles produced before the change (Figure 4). Statistical analysis showed that the condition is an early-life problem with relatively low failure rates projected through 100,000 miles and approximately 58 percent of the failures projected to occur by that mileage have already occurred (Table 1). Warranty claims are highest (78% of claims) in vehicles with less than 10,000 miles (Figure 5) and 50 percent of claims involved vehicles with less than 90 days in service (Figure 6).

Figure 4. Subject Vehicle Warranty Claim Rates by Vehicle Month of Build (Nissan IR response data, through 23-May-2014).

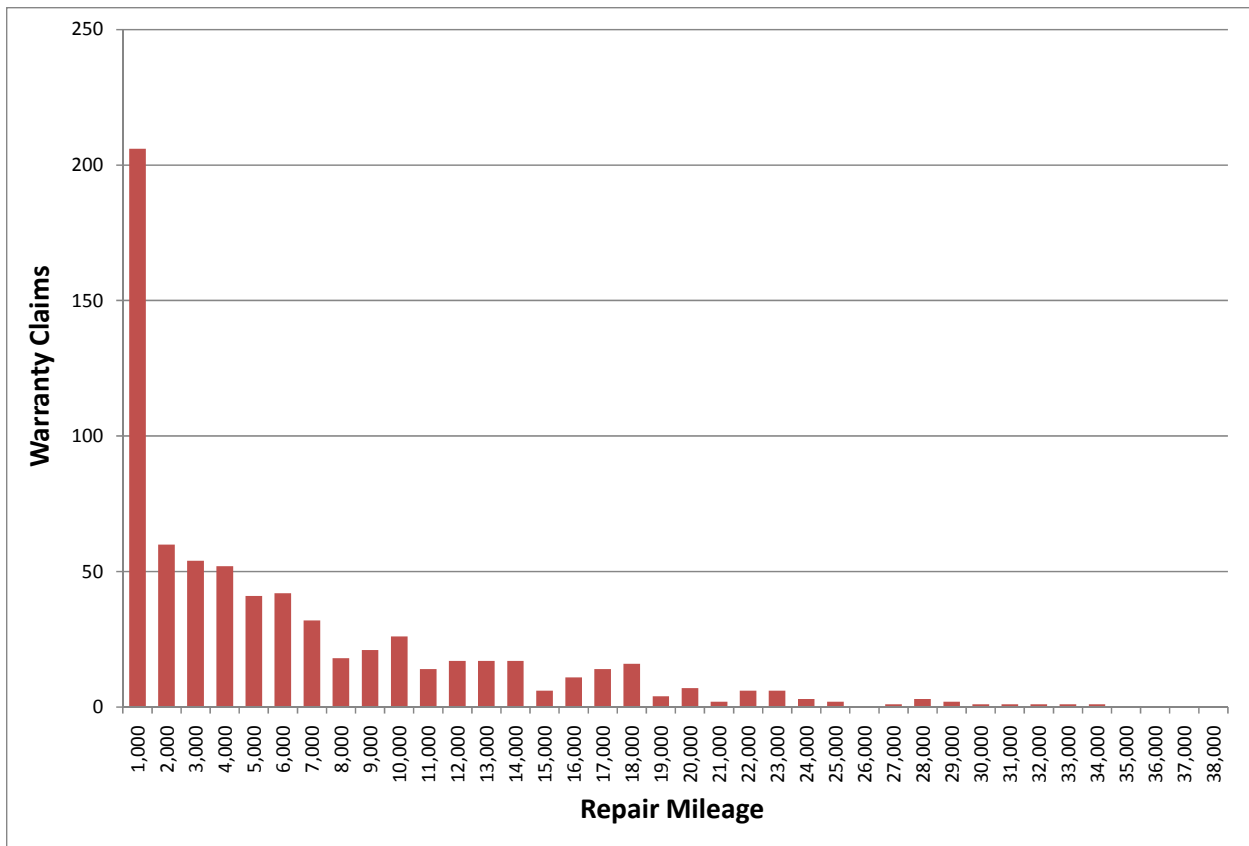
Figure 5. Warranty Claims by Repair Mileage.

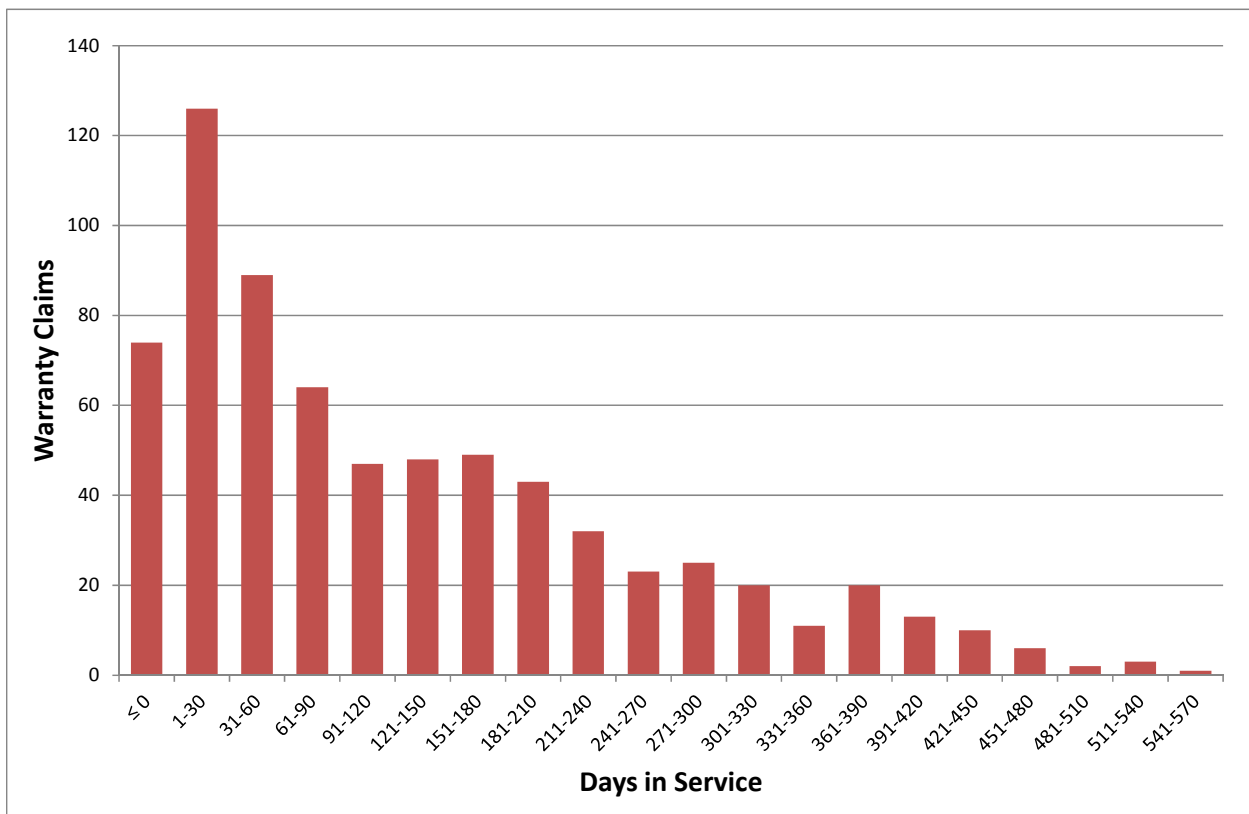
Figure 6. Warranty Claims by Days in Service.

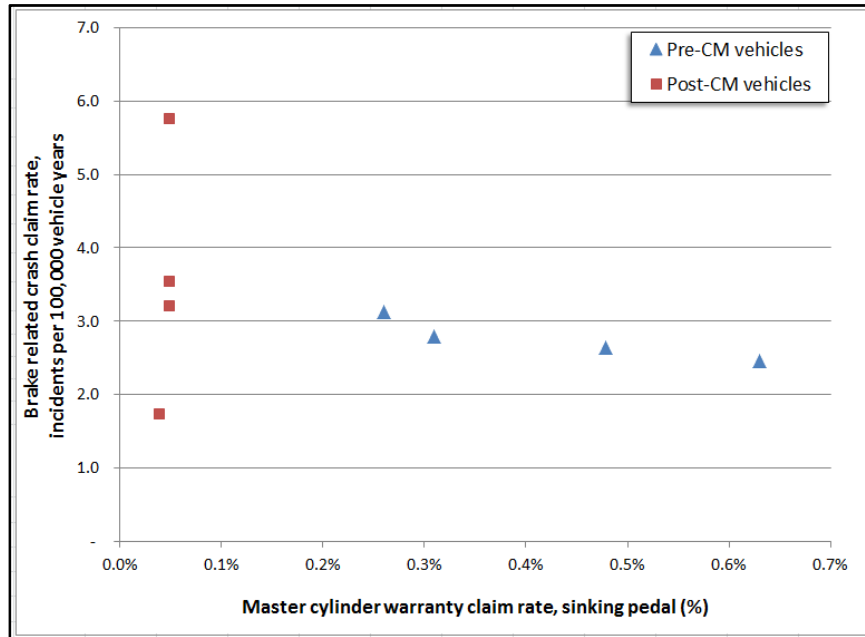
master cylinder was duplicated by post-incident inspection, including one with a different problem than the seal leak issue (a broken plunger). The two crash complaints related to a possible master cylinder concern involved 1 vehicle with the AWH seal and 1 with the EVO seal. Both were minor crashes. The remaining crashes do not appear to be related to any issues with the master cylinder or other brake system fault. In the 4 crashes with Event Data Recorder information available, the data indicated that the brakes were applied too late to avoid the collisions. These include 2 crashes with less than a half second of braking before impact and 2 in which brake applications lasting 1.0 to 2.5 seconds resulted in high decelerations consistent with fully functioning brake systems, but too late to avoid the collision. Overall, the rates of crashes adjusted for vehicle exposure (total vehicle years in service) do not show any correlation to the high warranty rates associated with the AWH seal leak concern (Table 3 & Figure 7).

**Figure 7. Crash rate vs master cylinder warranty claim rate.**
