AQ14-002

FOREST RIVER

ProLo Hatch Rear Support Receiver Replacement Instructions

Forest River, Inc. has decided that a defect which relates to motor vehicle safety exists in certain 2010, 2011, 2012, 2013 Sunseeker, Forester, and Lexington model Class C motorhomes. We believe that you currently have or previously have owned one of these vehicles. For this reason we ask that you arrange for your authorized servicing dealer to correct your vehicle without delay. The service and required parts will be provided to you free of charge.

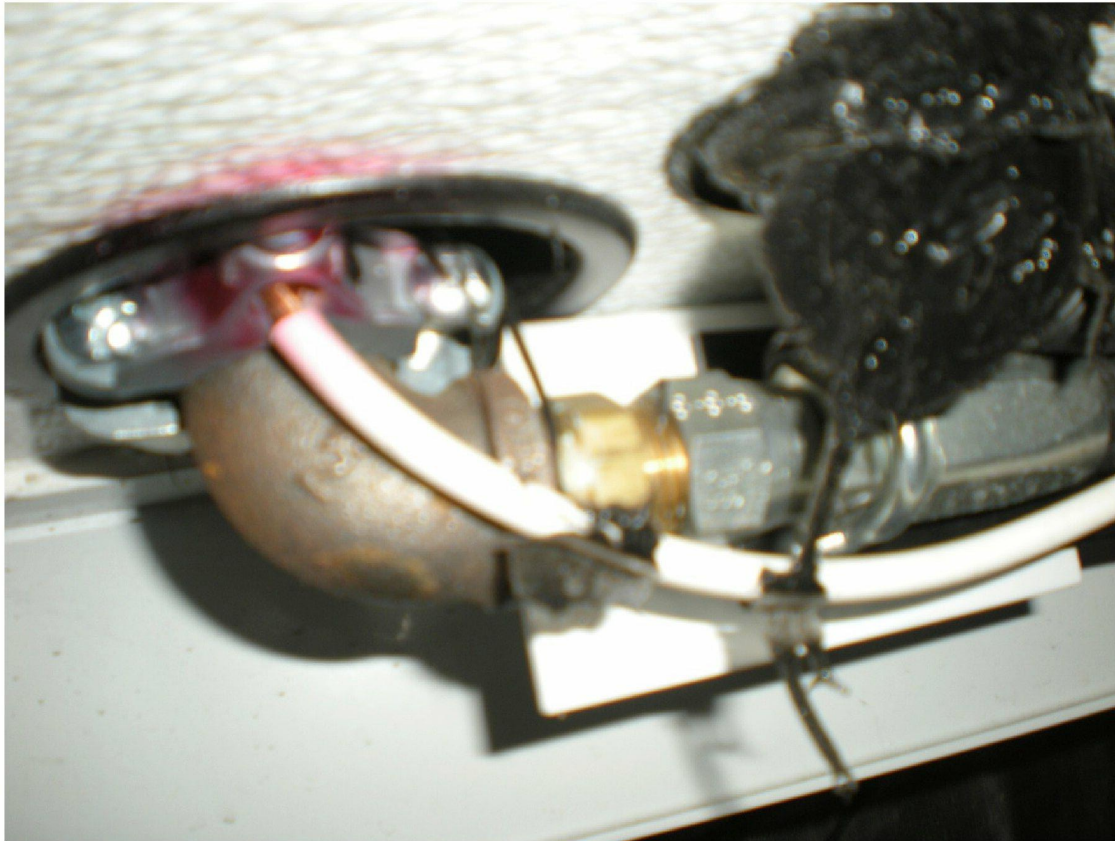
Example A

The issue found in the affected vehicles pertains to a specific bracket that secures the propane delivery system. This bracket is only found under slide out rooms which contain a kitchen range or refrigerator. The bracket may become loose and possibly detach from the slide room floor. **In the even the propane securing bracket detaches it may cause a propane leak resulting in a fire.**

EXTERIOR UNDER SLIDE OUT

- **Start by removing the bracket and U-bolt on the LP line, the grounding bracket, ground wire, and black plastic flex guard. All found under the slide room (Example A). Disconnection of the LP line is not required or necessary.**

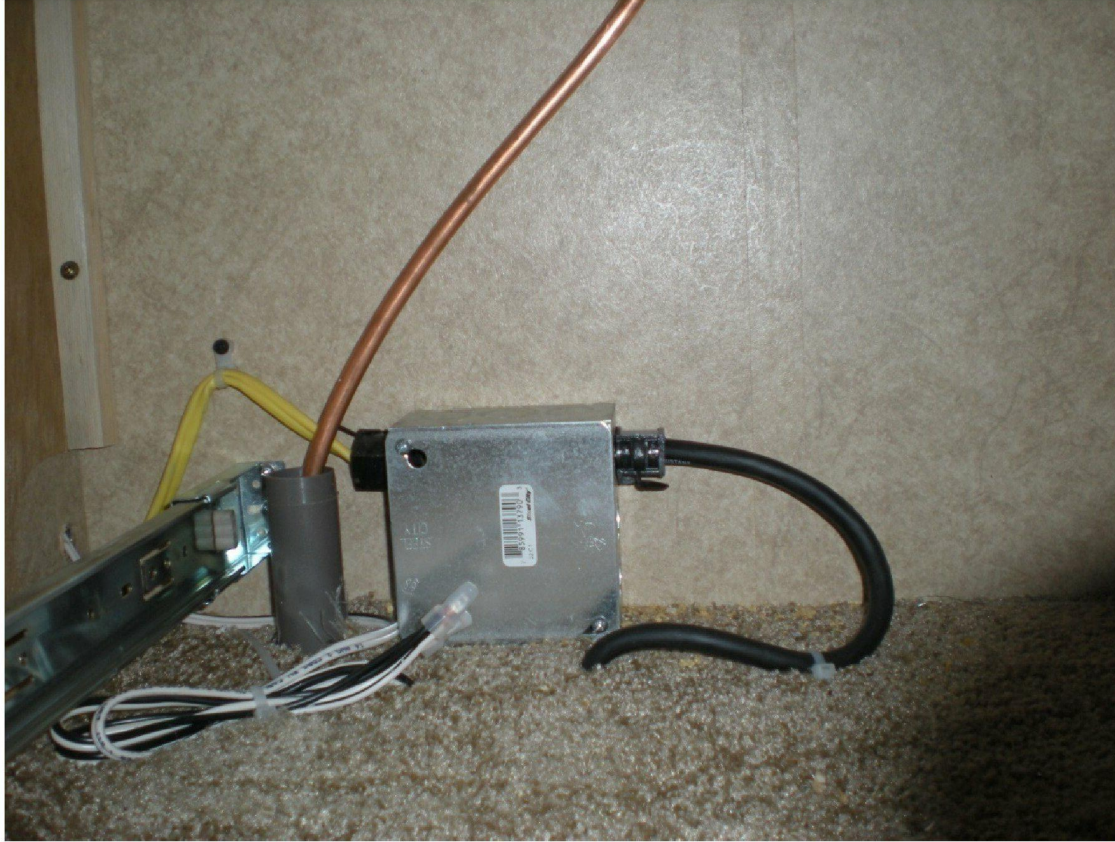
Example B

INTERIOR JUNCTION BOX

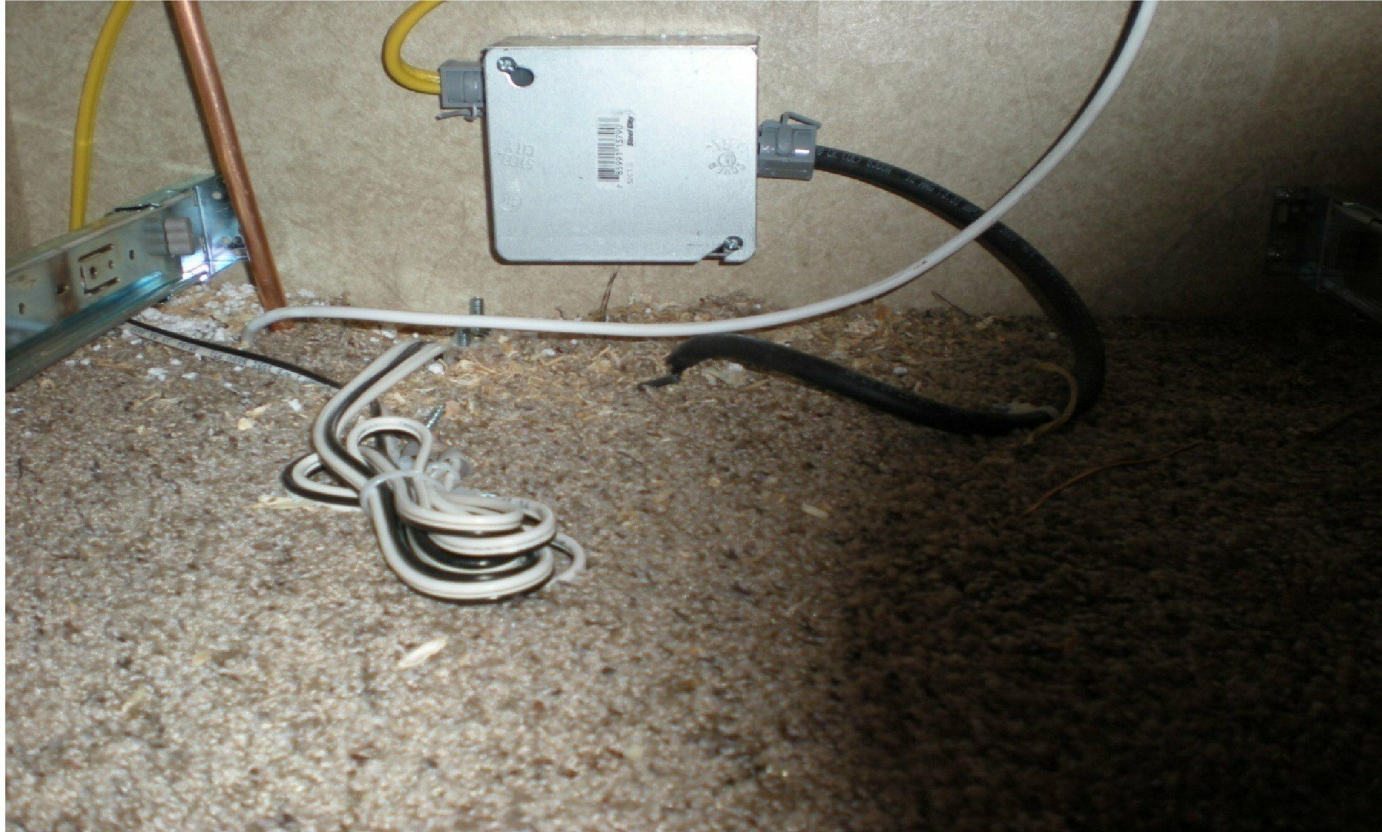
Example C

RAISED JUNCTION BOX

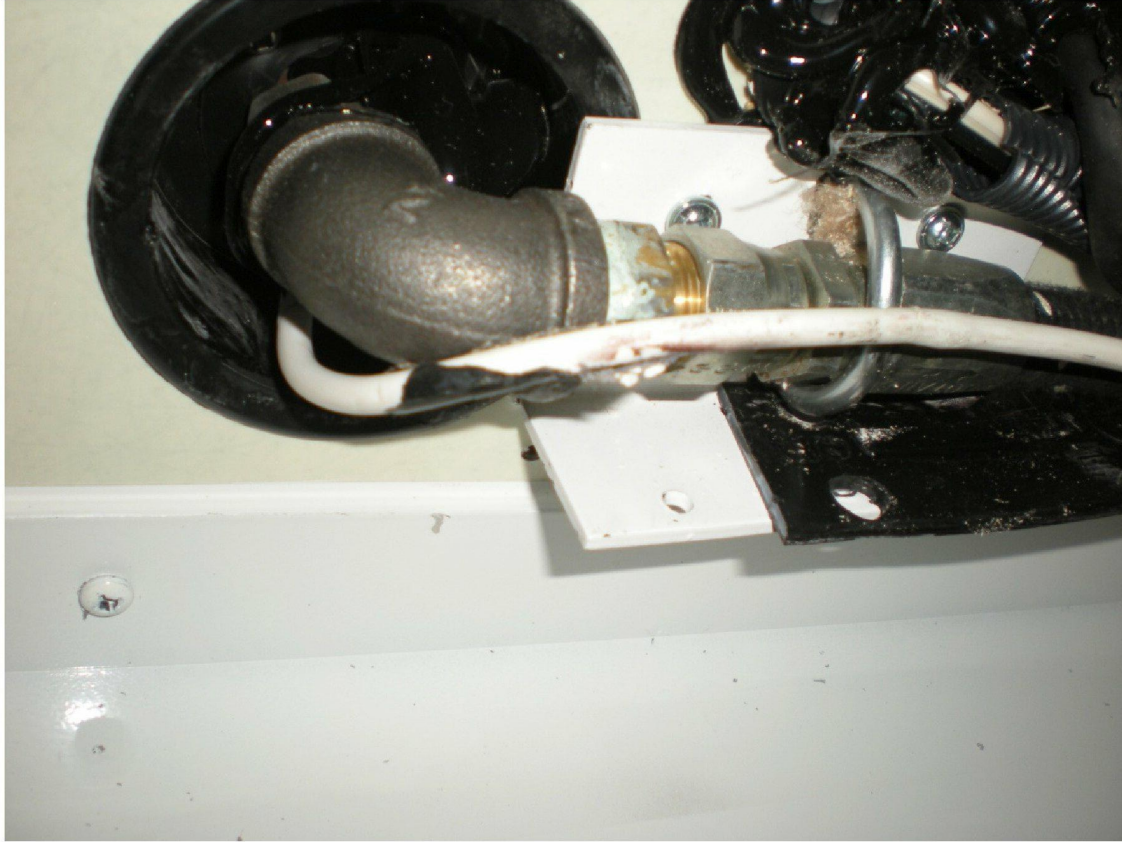
Example D

EXAMPLE OF A COMPLETED REPAIR

- **Secure the U-bolt from under the appliance and replace the drawer. The U-bolt should be tightened enough to secure the LP line, but not tight enough to cause damage to the LP line.**

- **Once the U-bolt is tightened down, the black plastic flex guard may be reattached to the new bracket.**
- **If for any reason a disconnection is made on the LP delivery system, a pressure test must be done after repairs**
