Kia Motors America Field Product Quality Report

Subject/Title: Panoramic Sunroof Shattered

Model Desc: OPTIMA EX

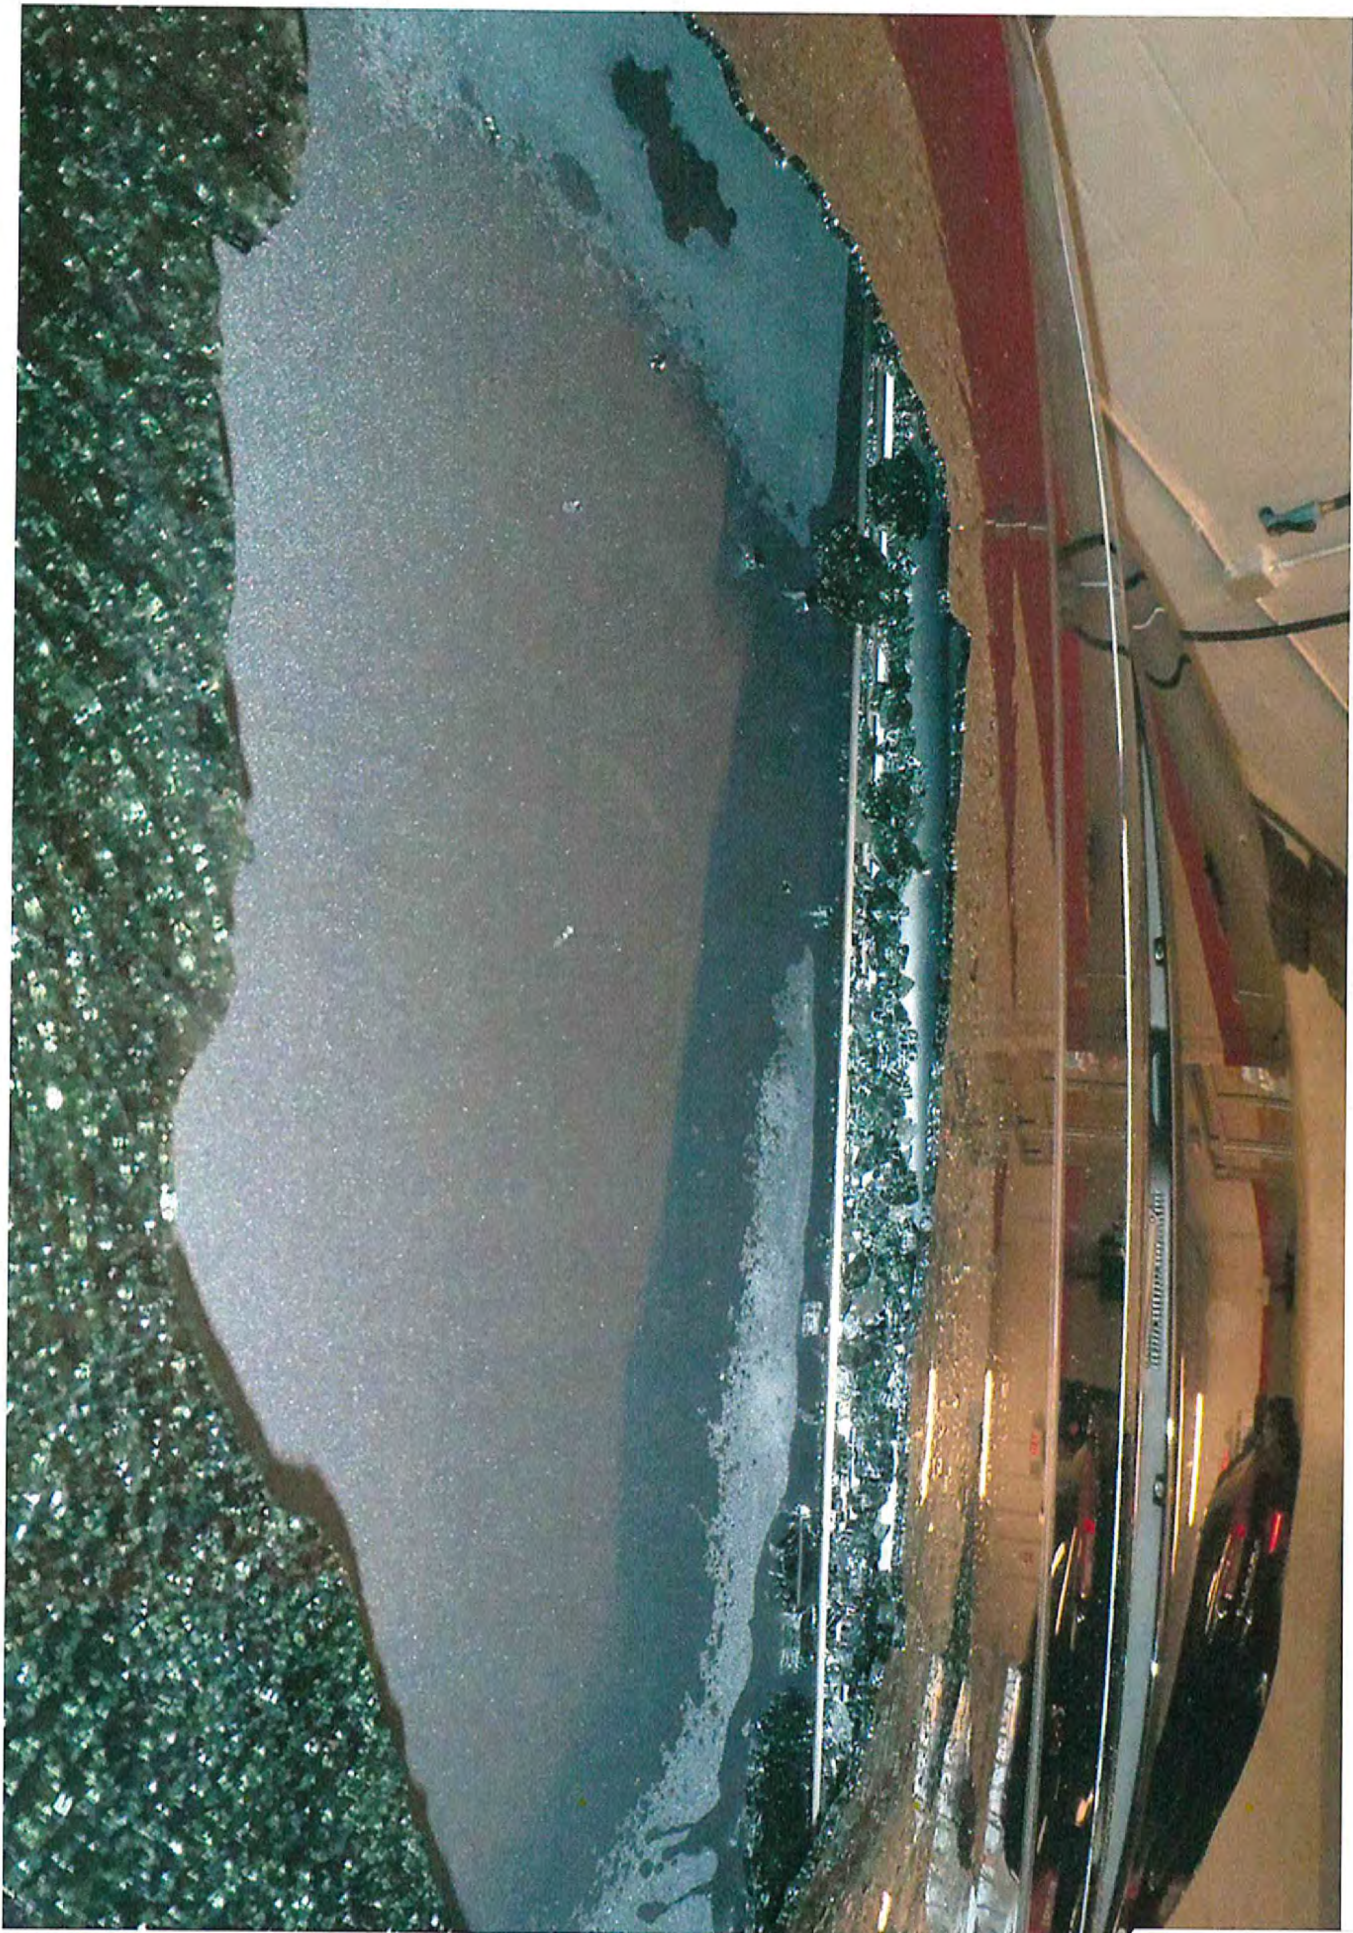
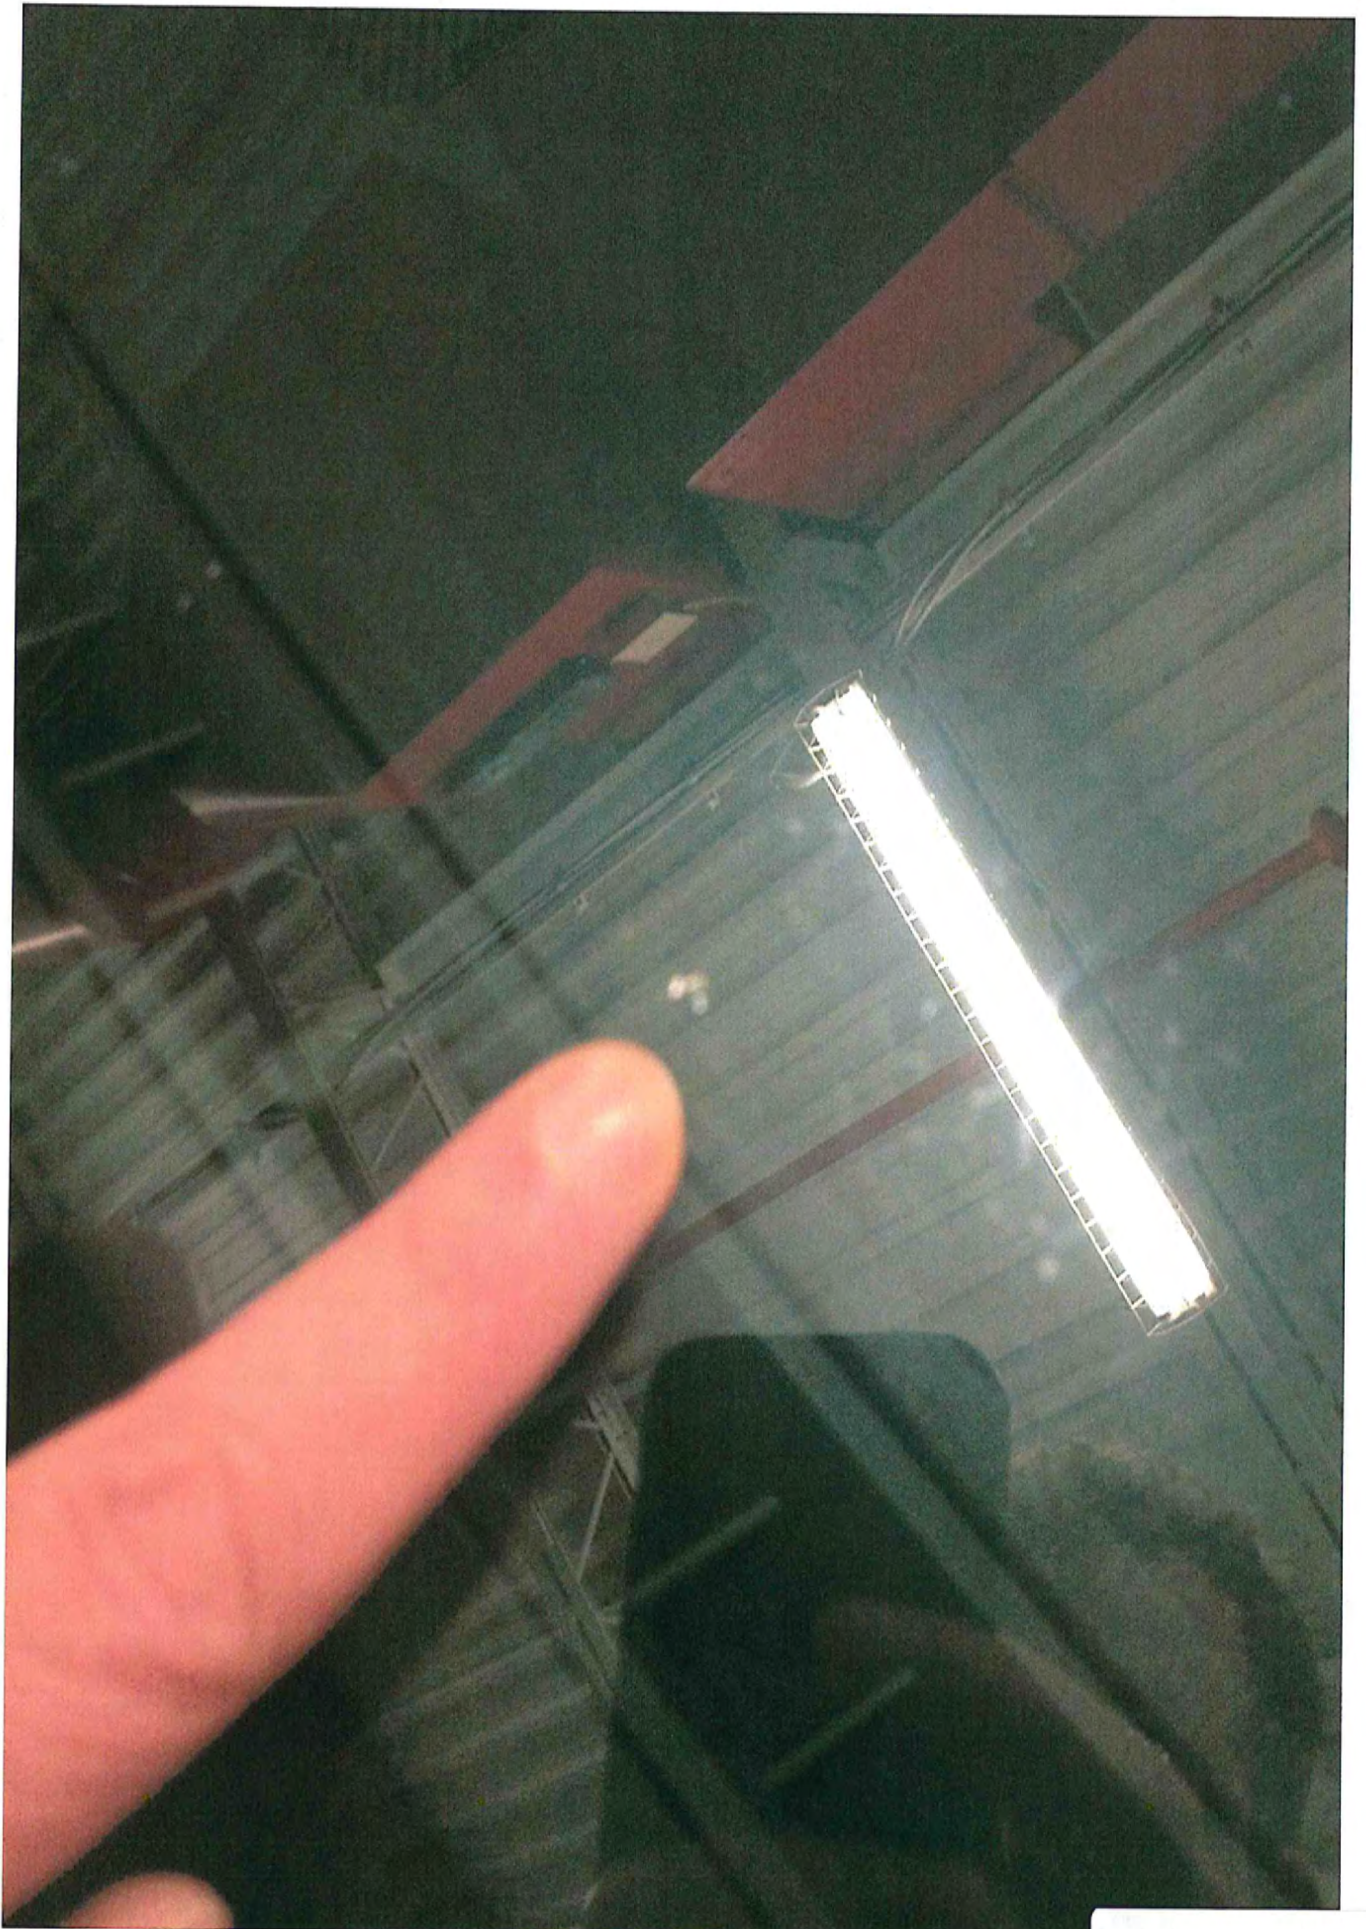
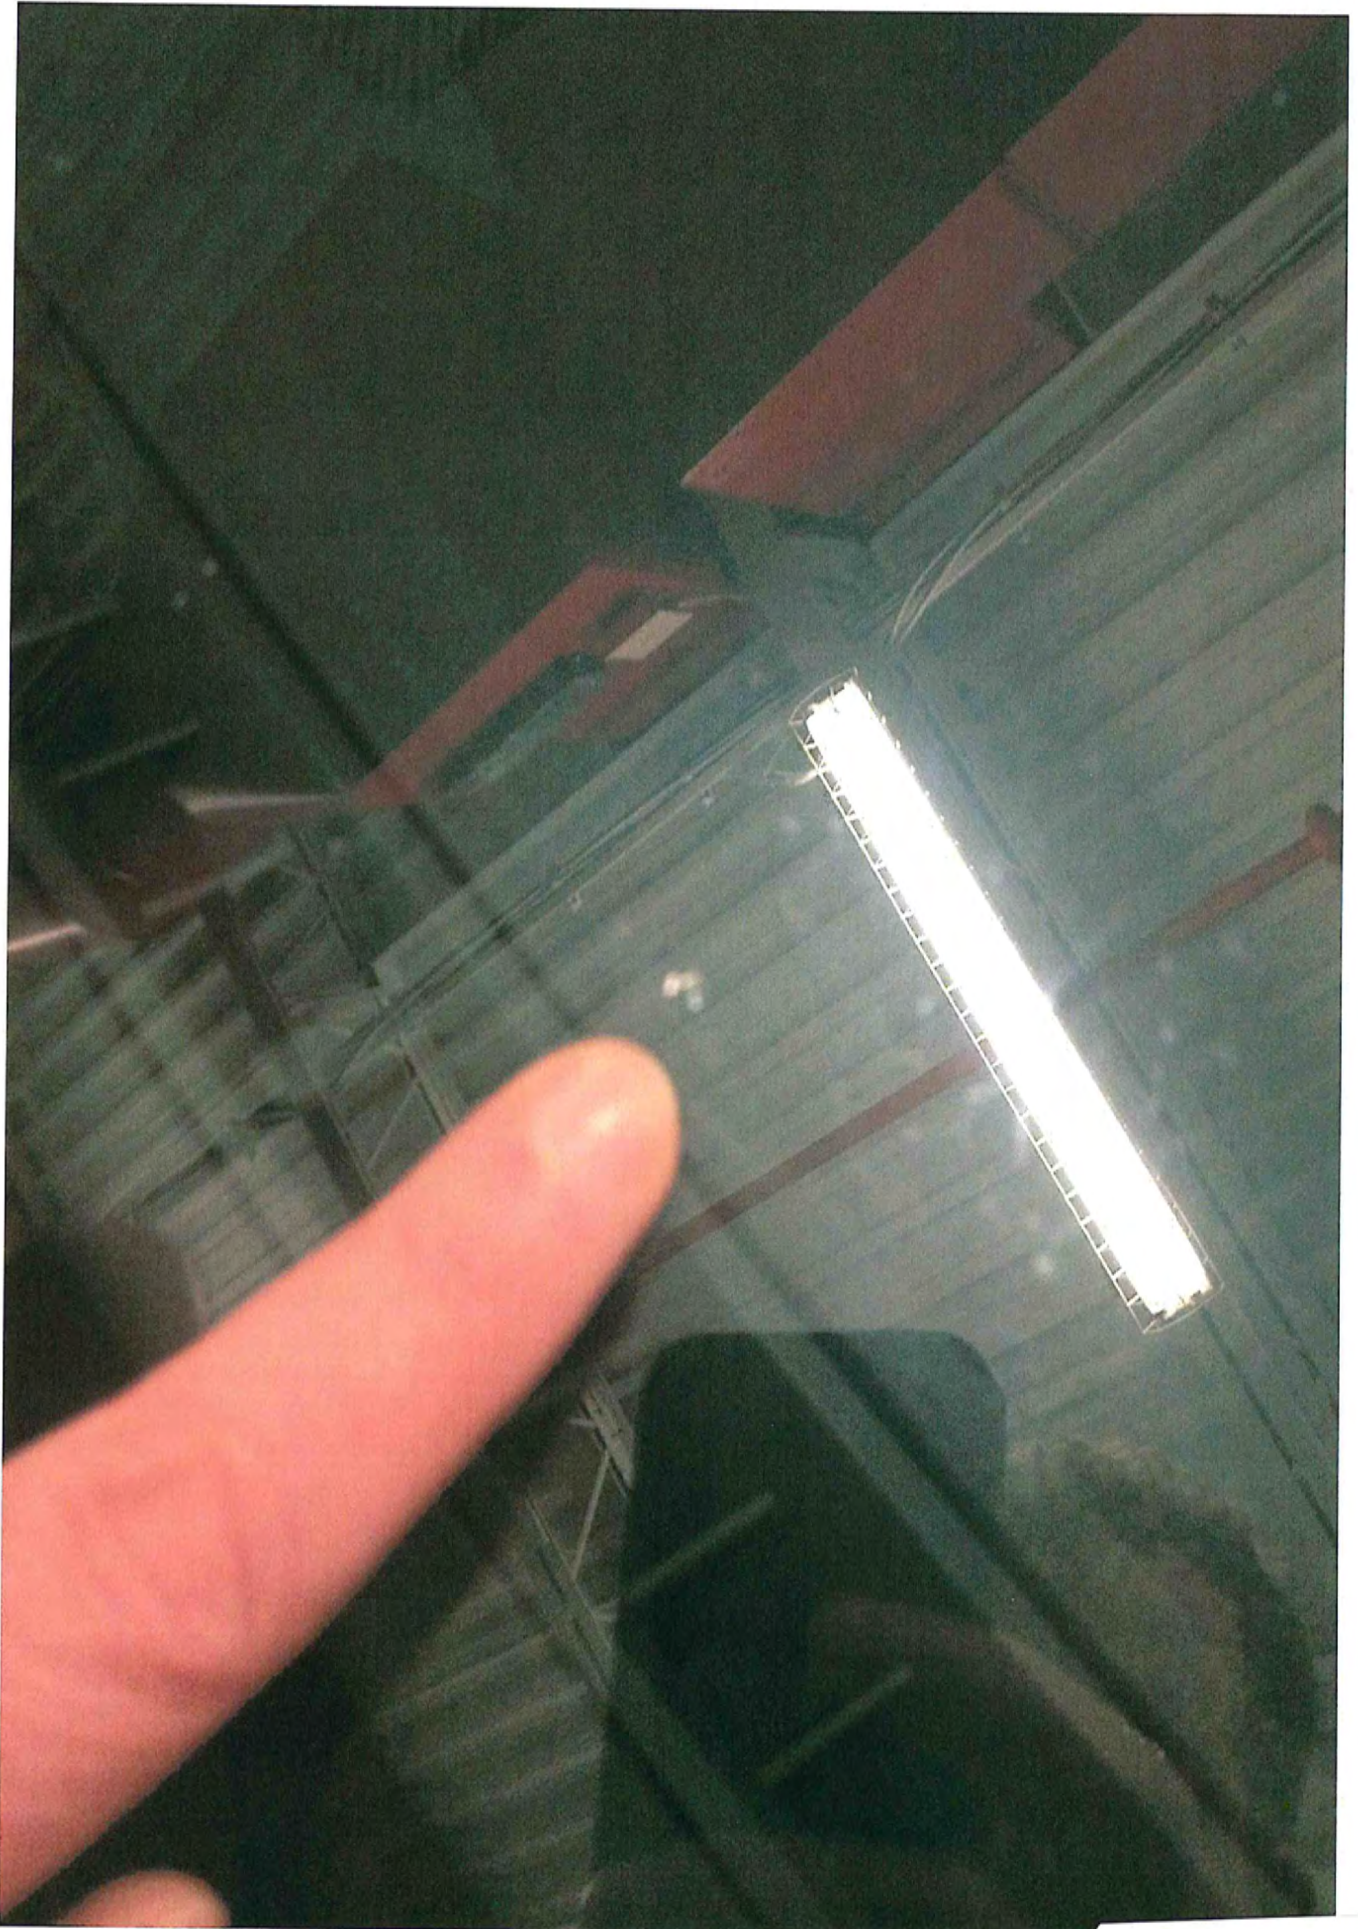
A hole was in the center of the closed glass sunroof panel. (see photo) An outward crack was at the front of the glass that remained in place and cracks were throughout the rest of the panel. A paint chip was found on the hood down to the metal. No rust was on the exposed metal suggesting the chip was recent. A chip was in the windshield was also found. (see photos attached) other small chips in the paint and windshield were noted as well.

Possible roof glass failure due to impact from outside source resulting in weakening of glass integrity. Signs of impact on hood and windshield was found.

No action taken at this time. Results of inspection reported to Platform Engineer and NCA.

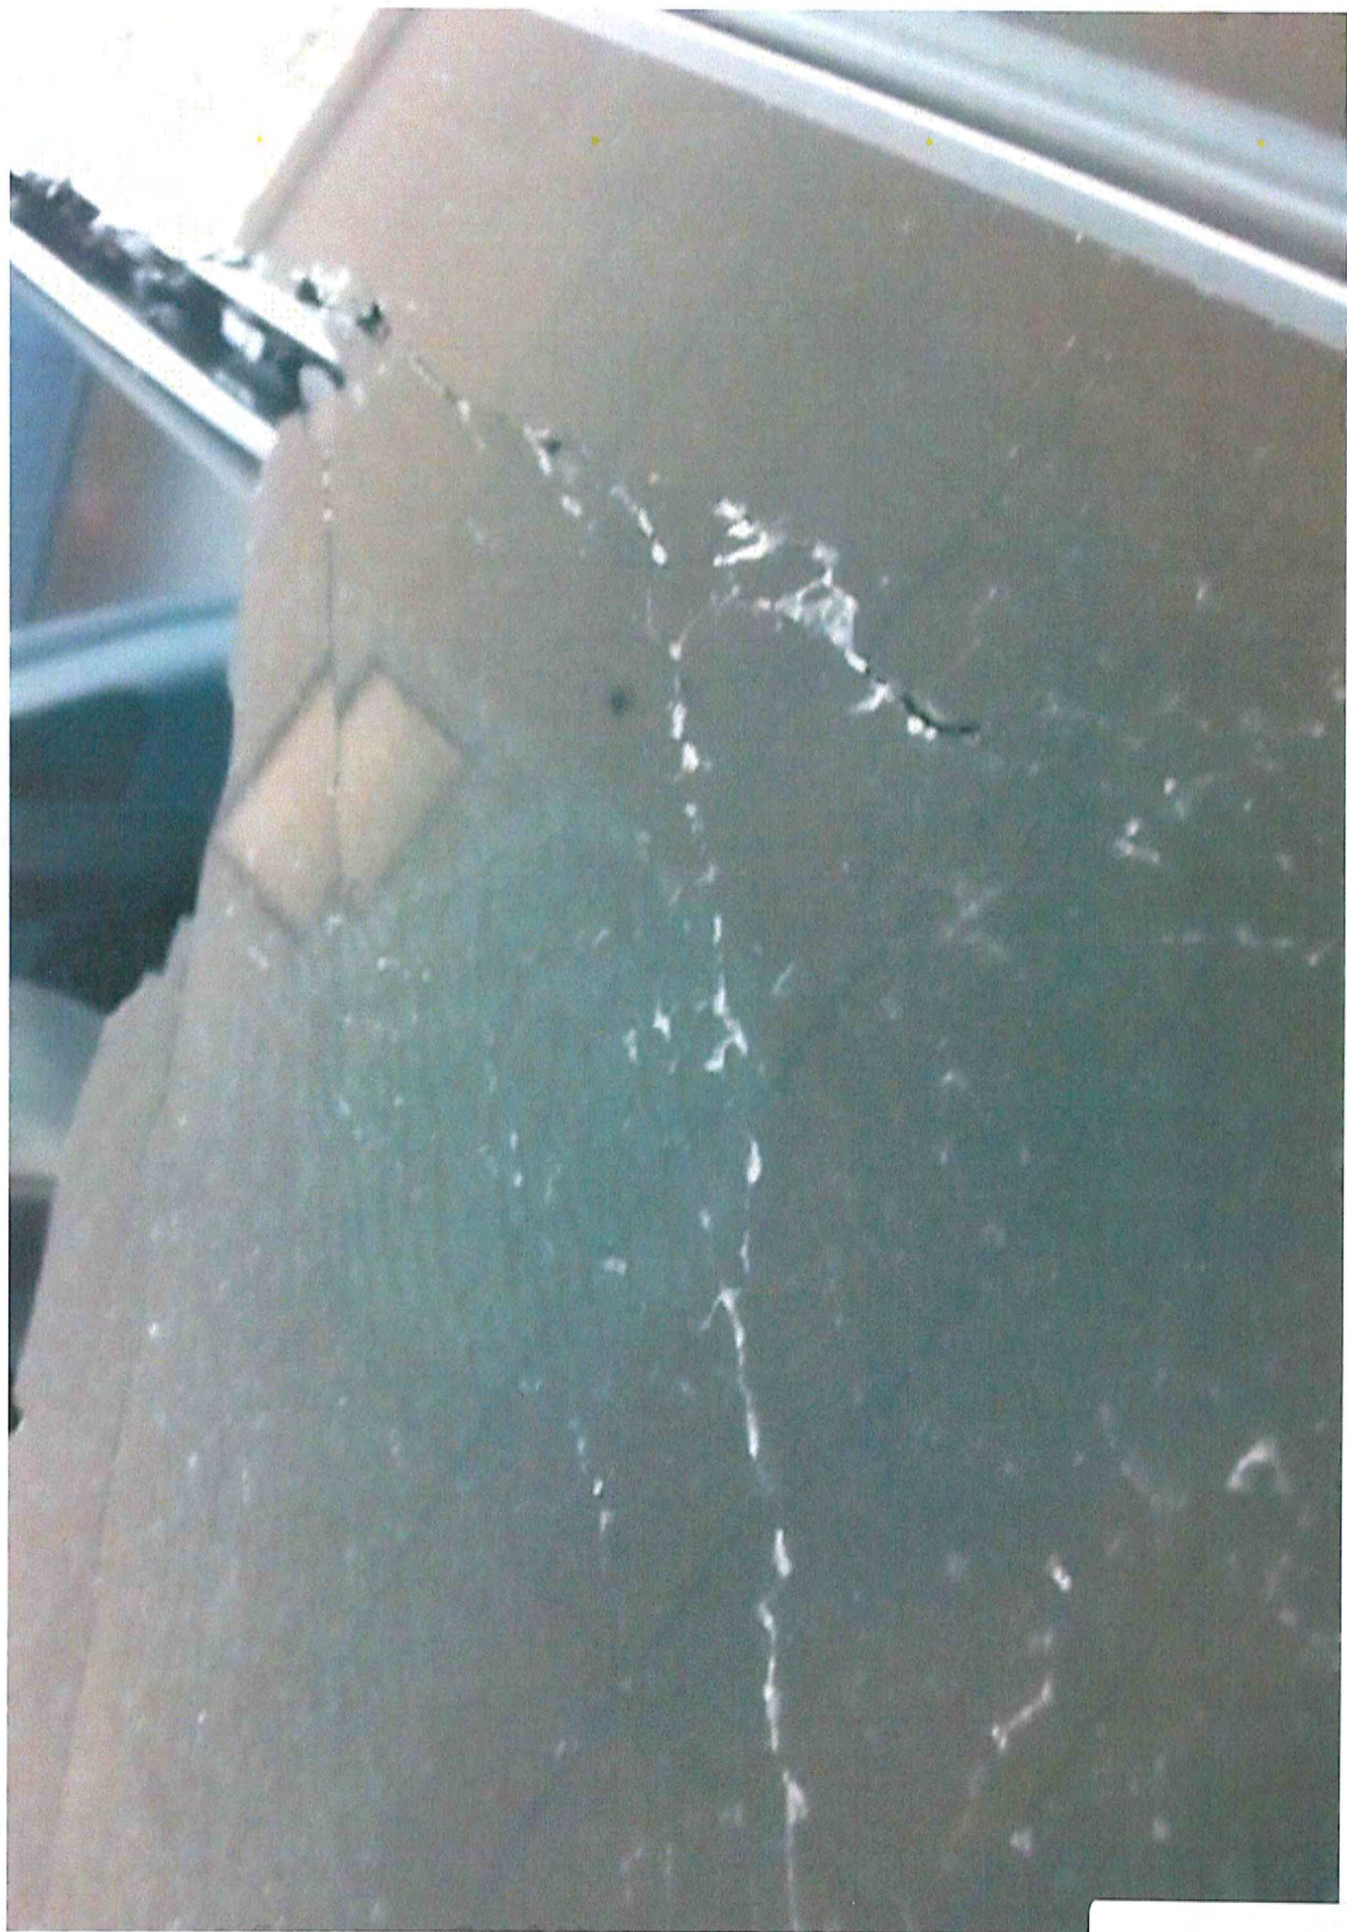
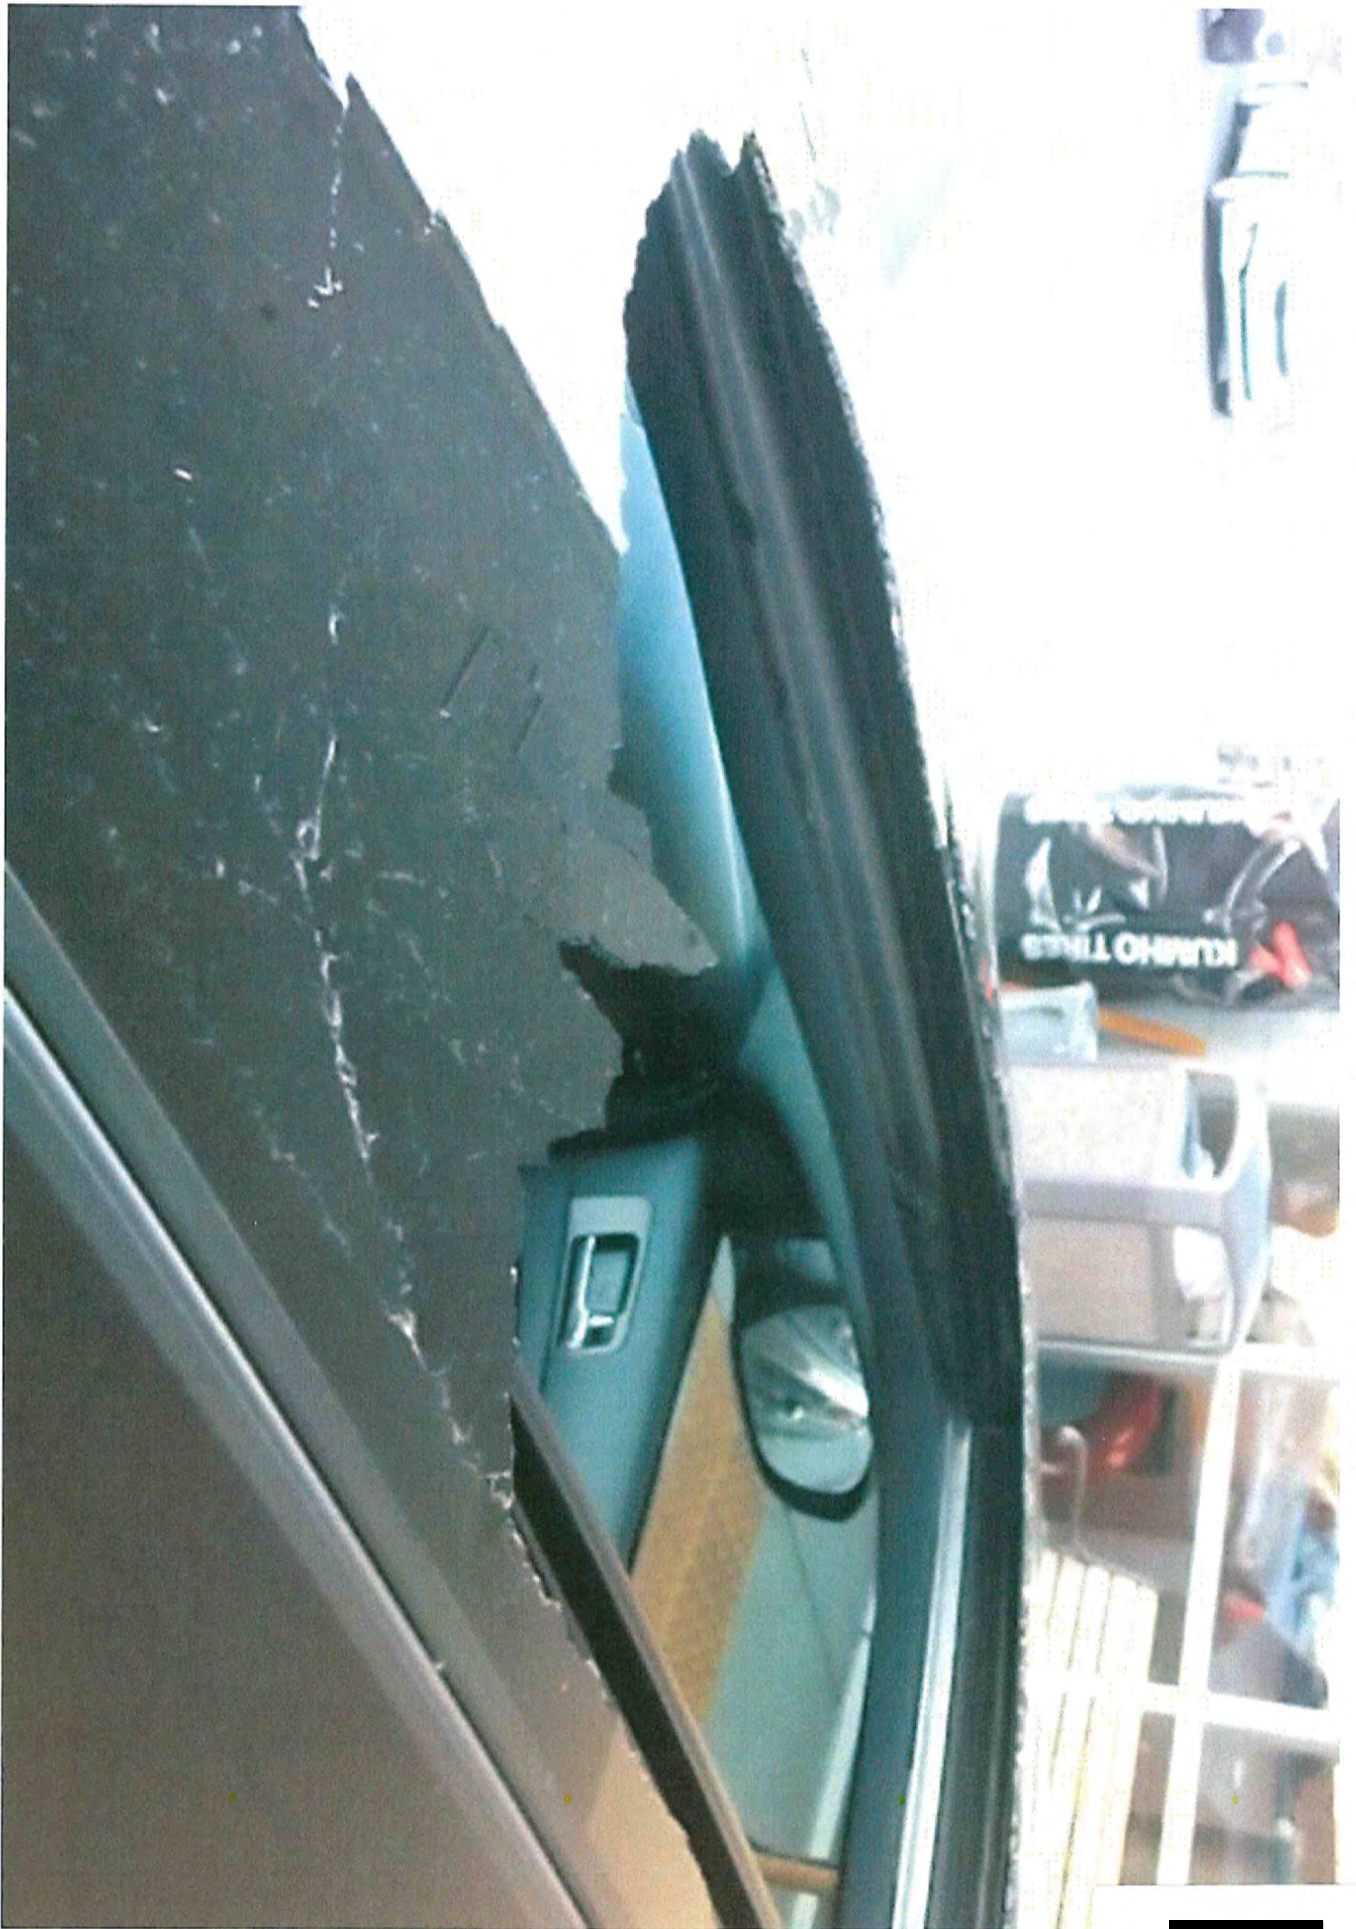
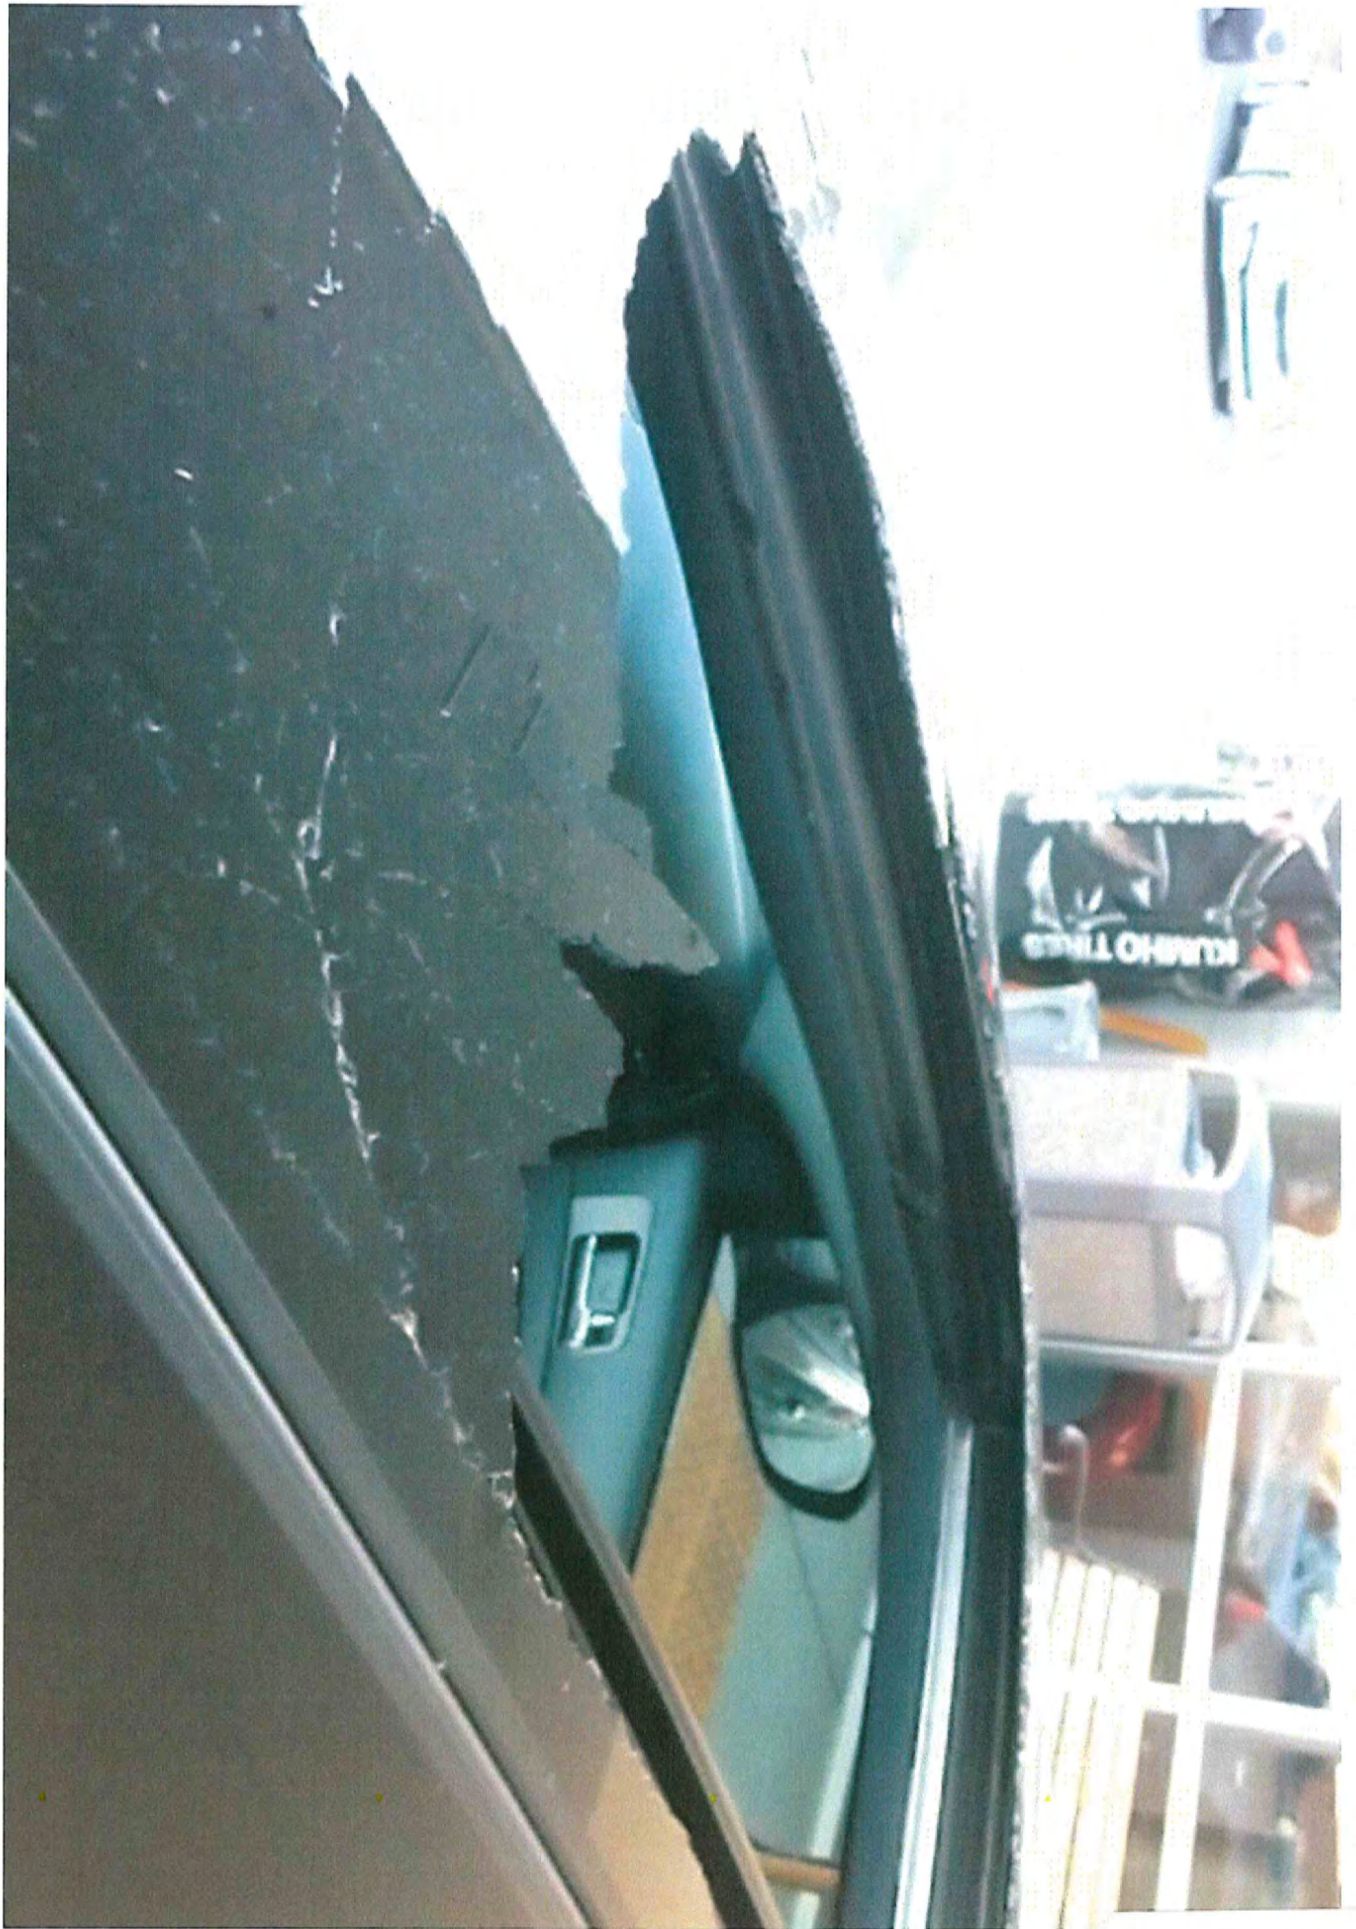
DPSM inspected vehicle and relayed results to FTR. There are no apparent signs of impact causing the sunroof assy to shatter. Normal signs of windshield pitting for driving around the Metro Phoenix Area.

Undetermined

Replace shattered panoramic sunroof glass
