Kia Motors America Field Product Quality Report

Subject/Title: Panoramic Sunroof Shattered

Model Desc: OPTIMA EX

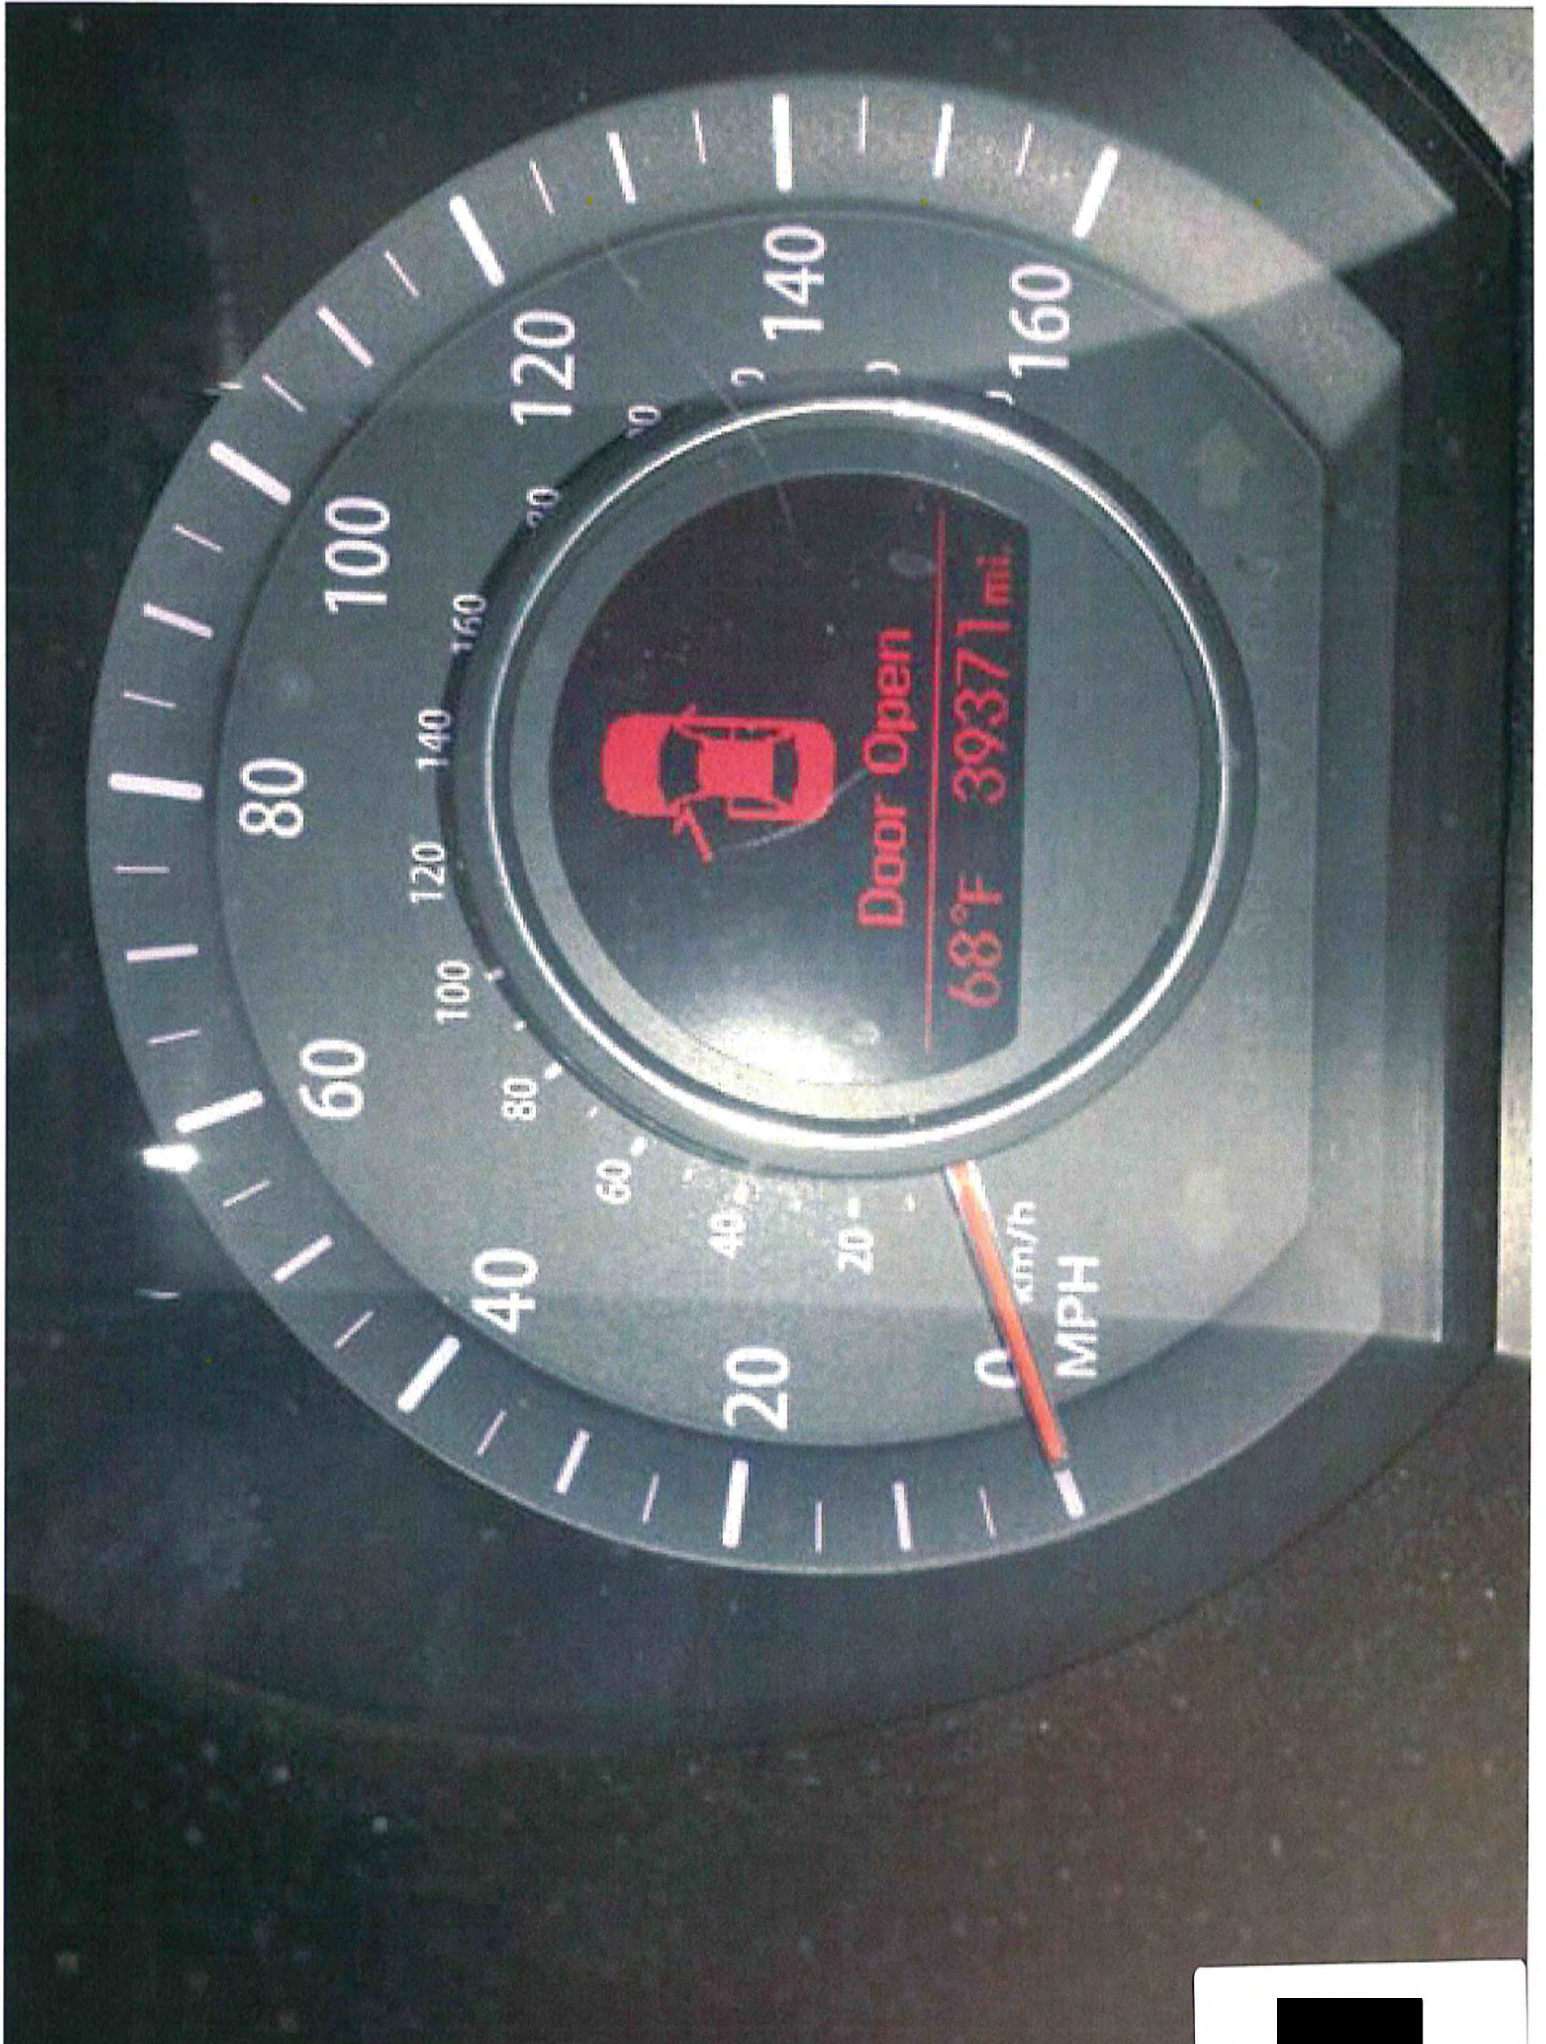
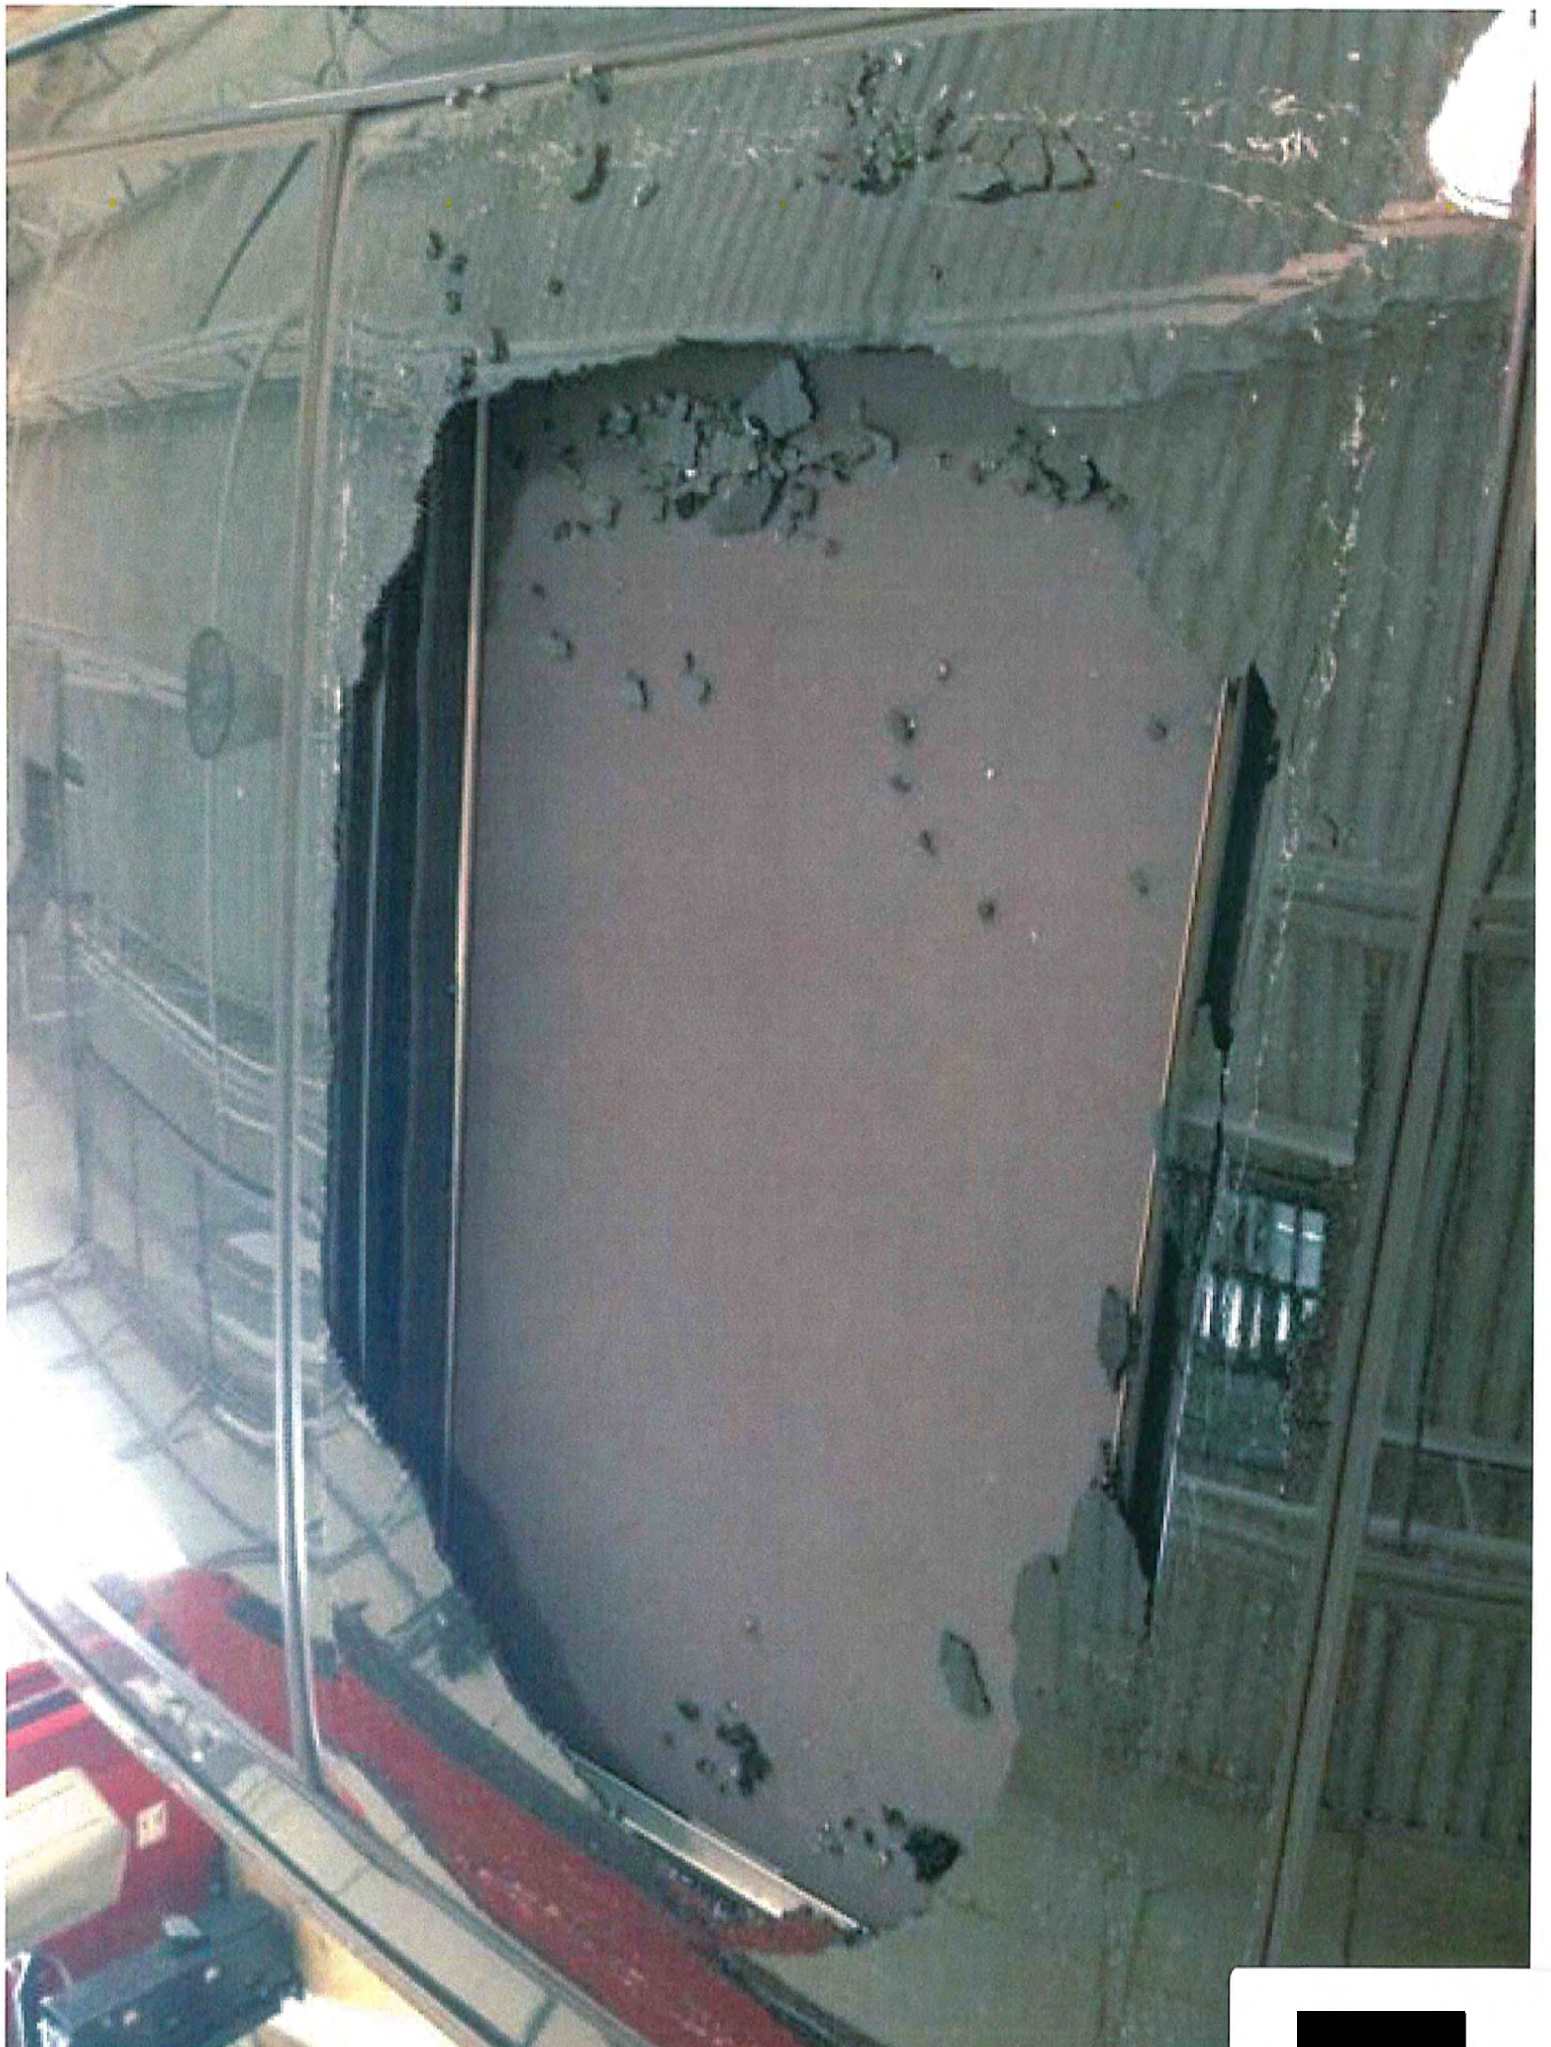
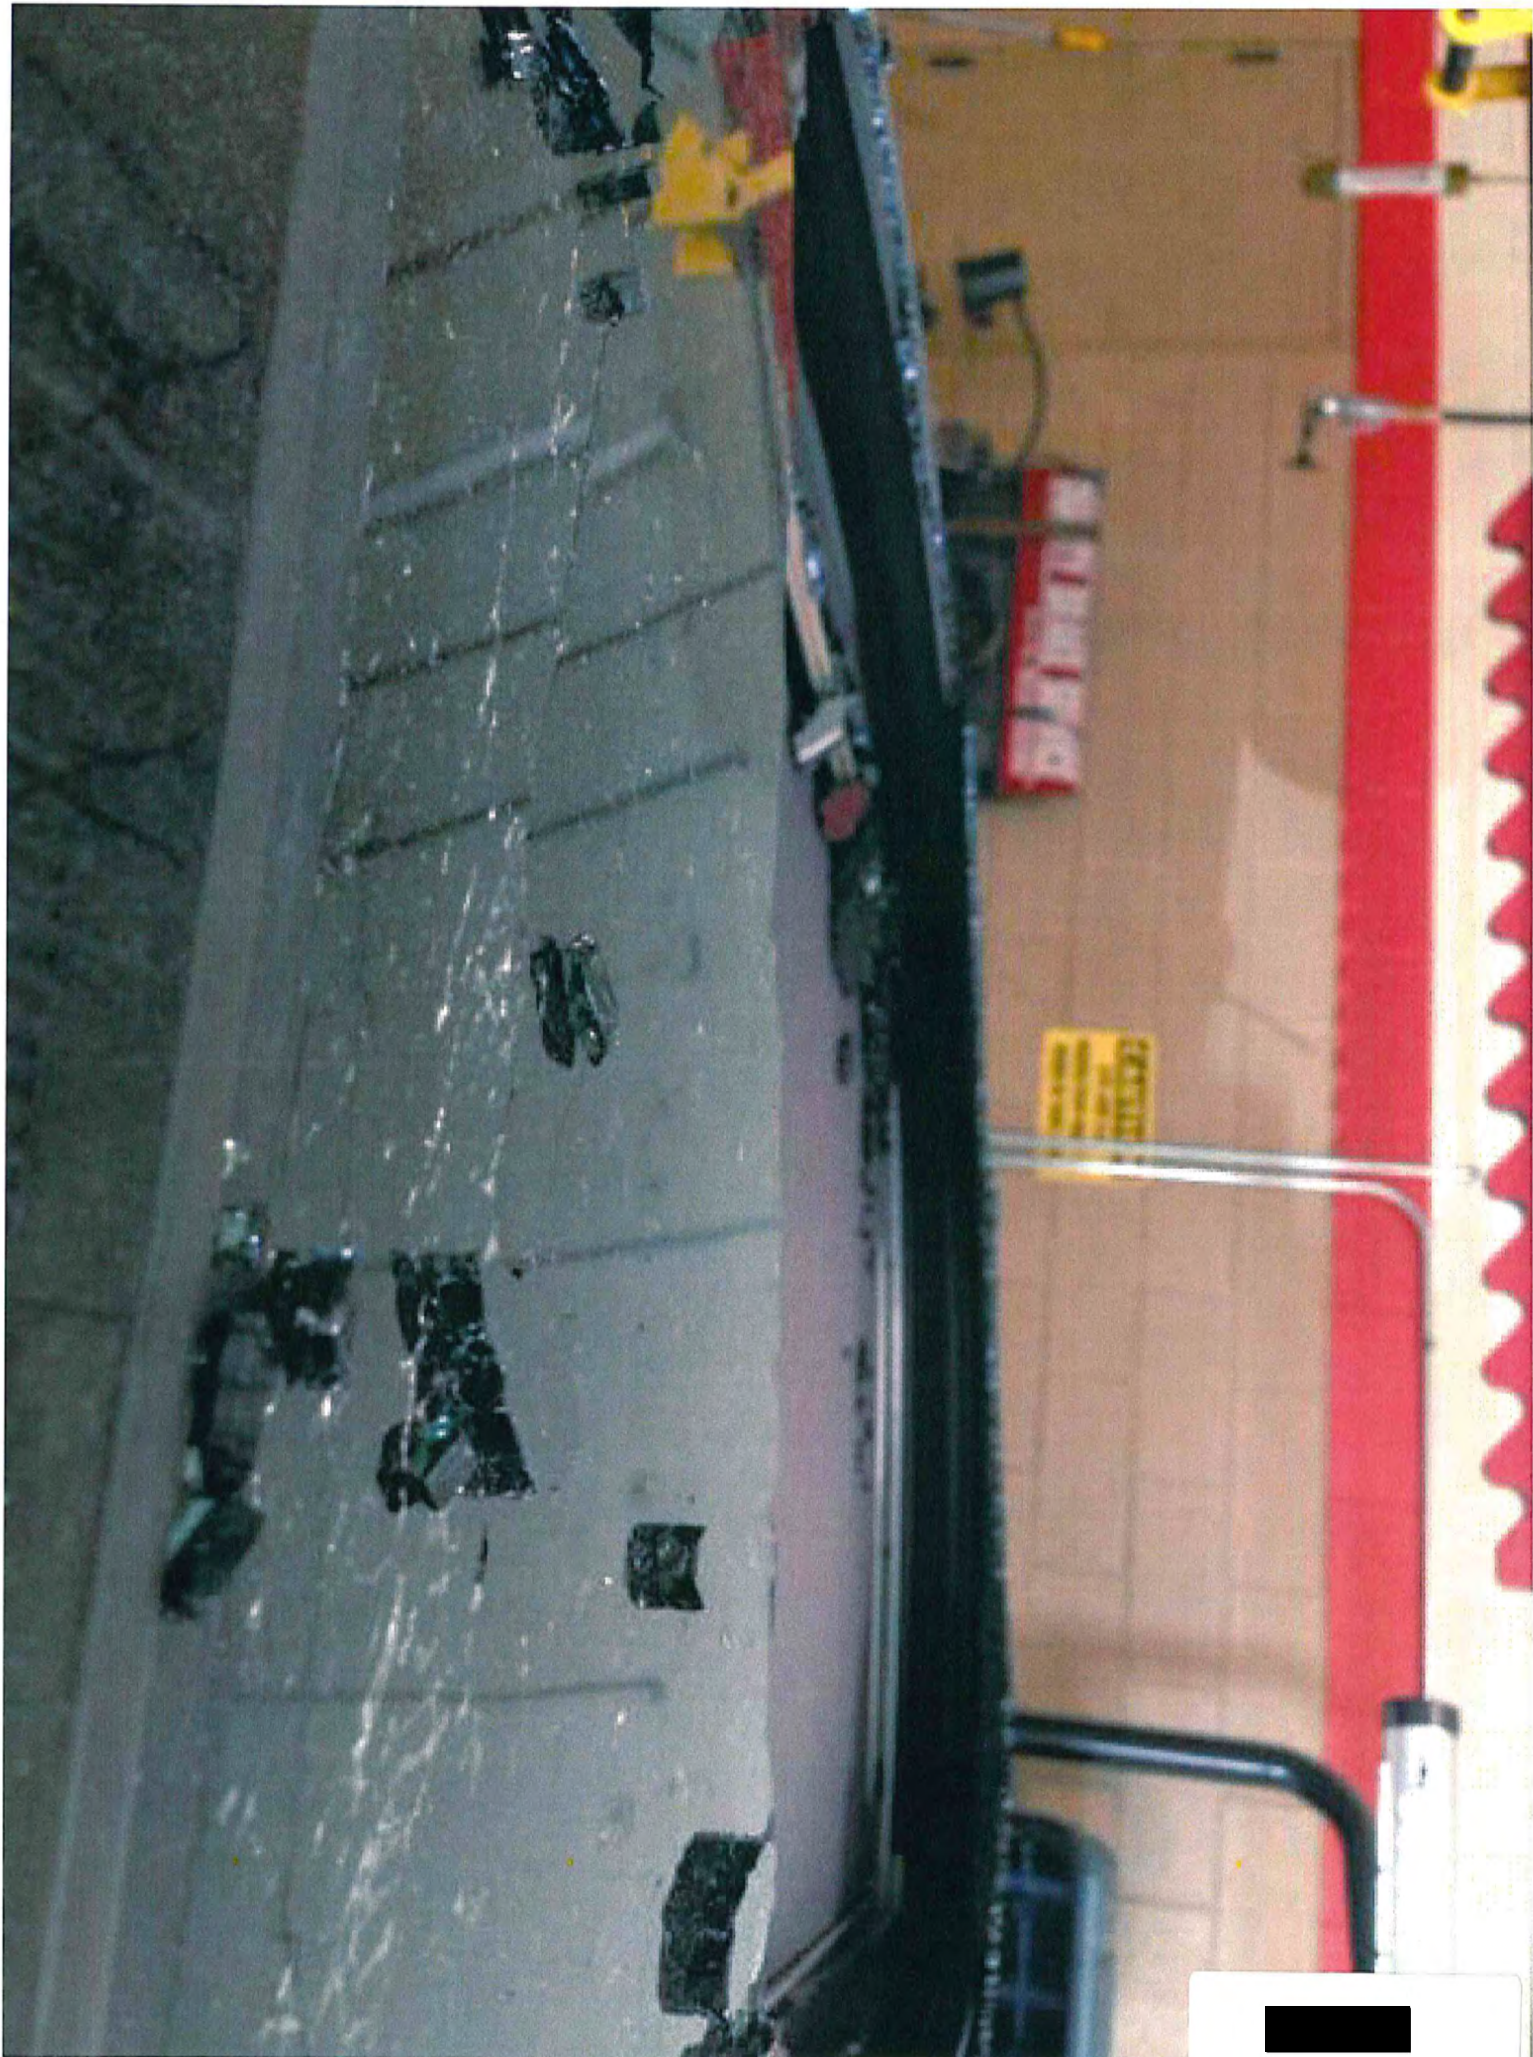
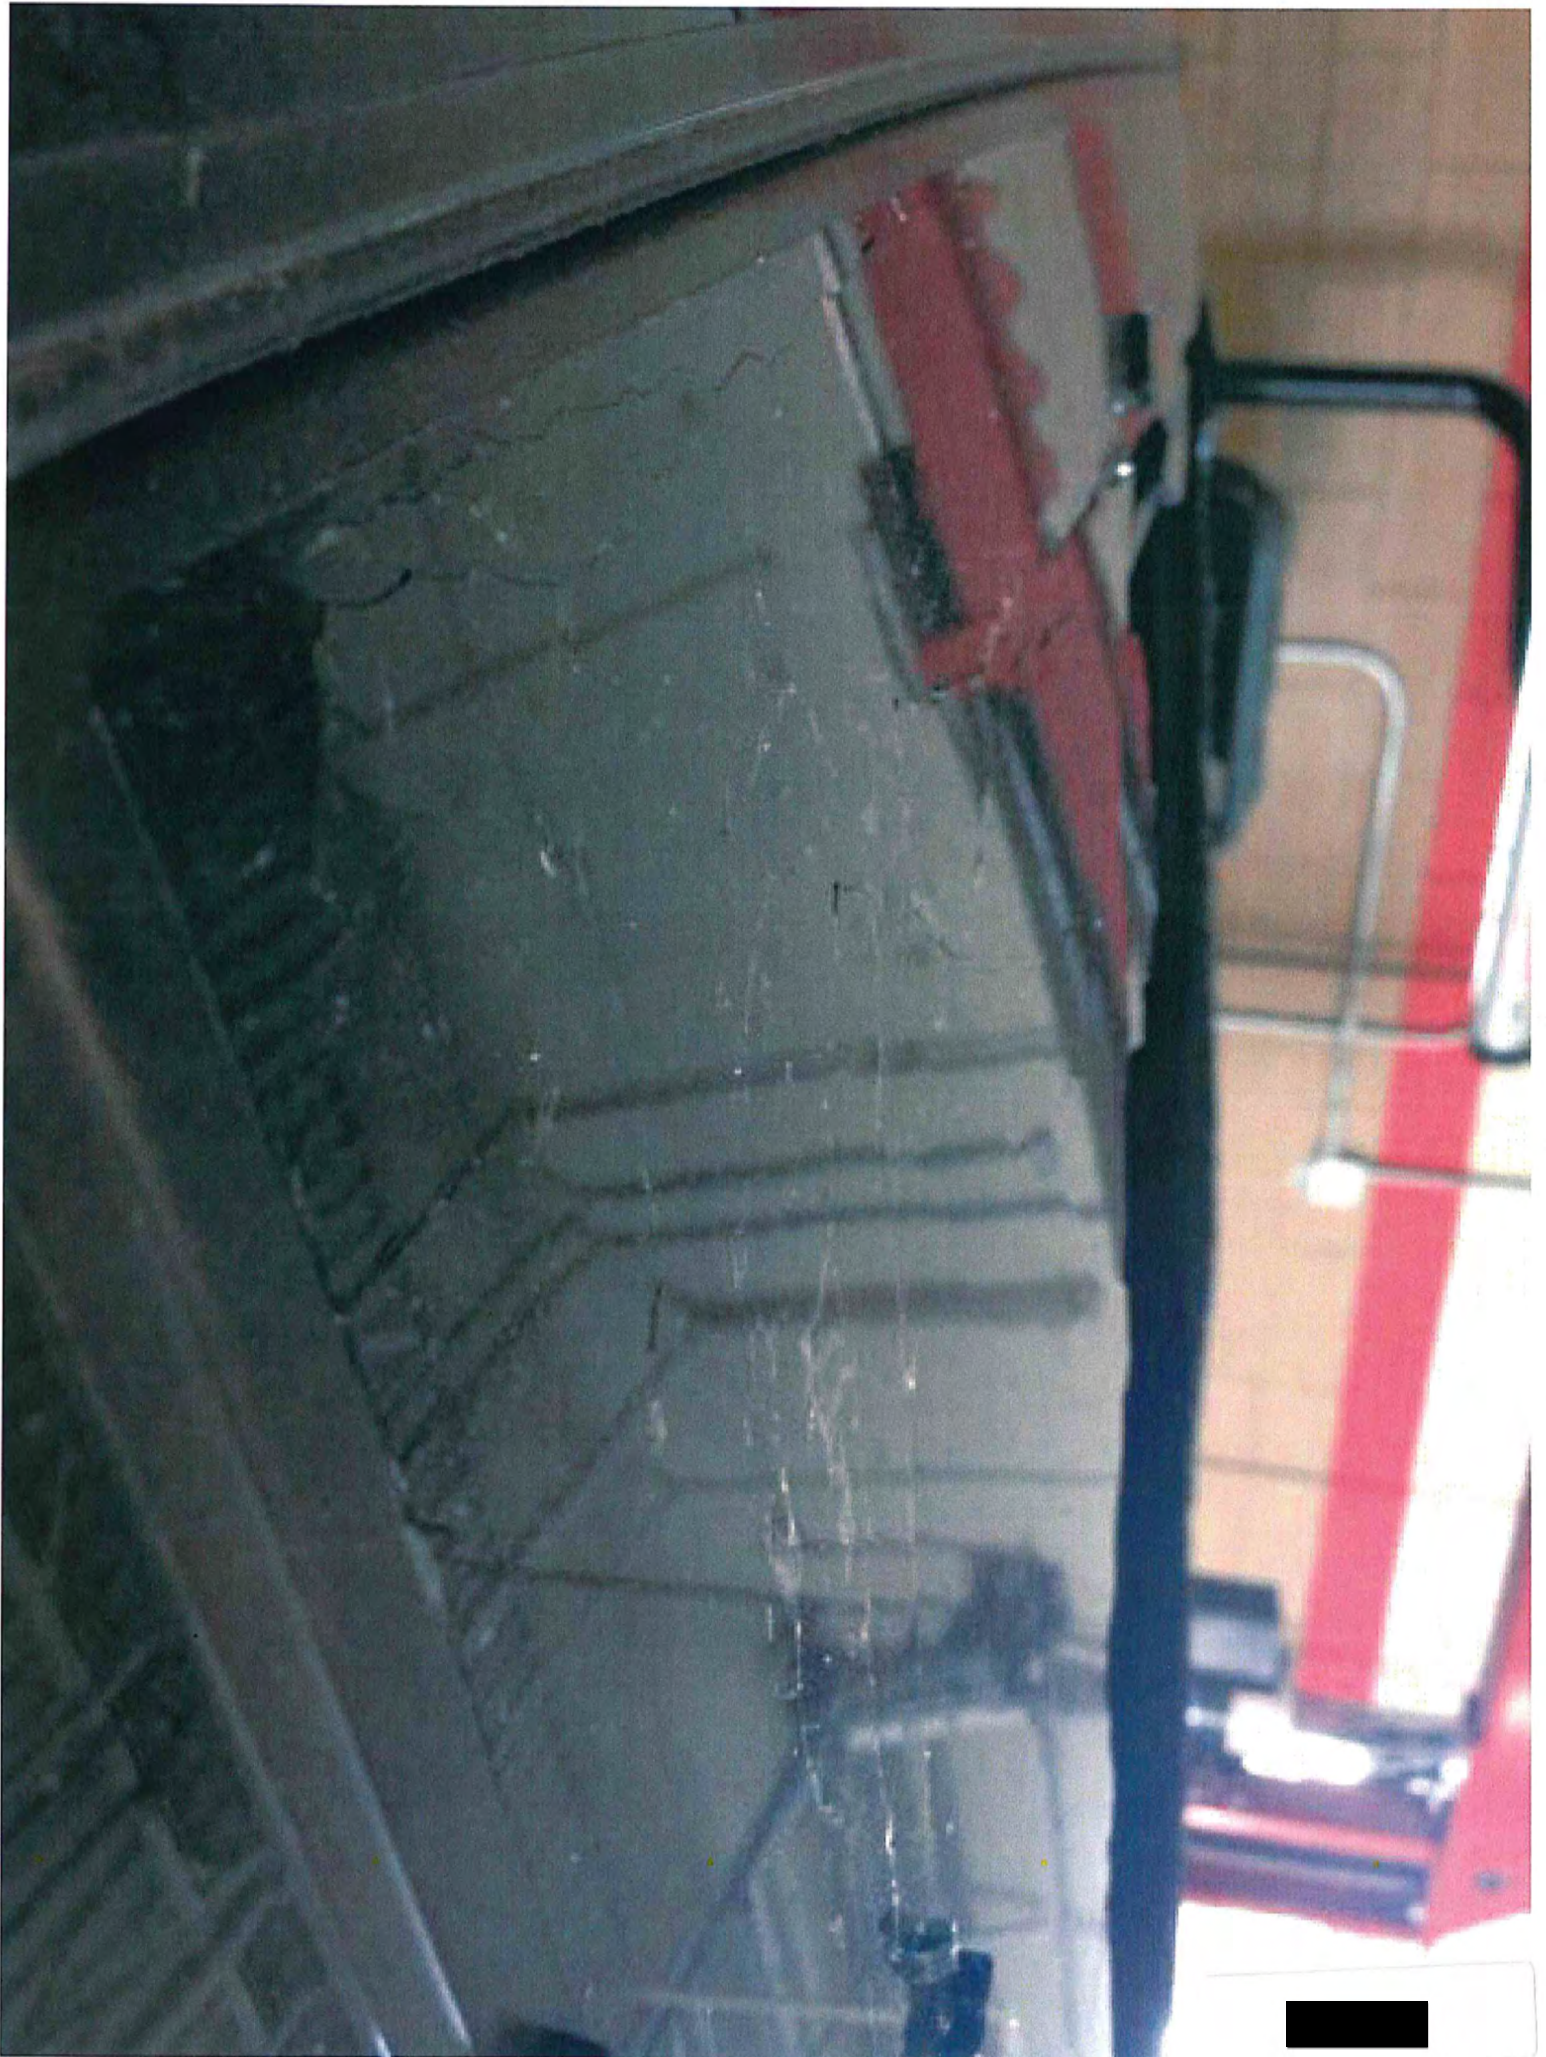
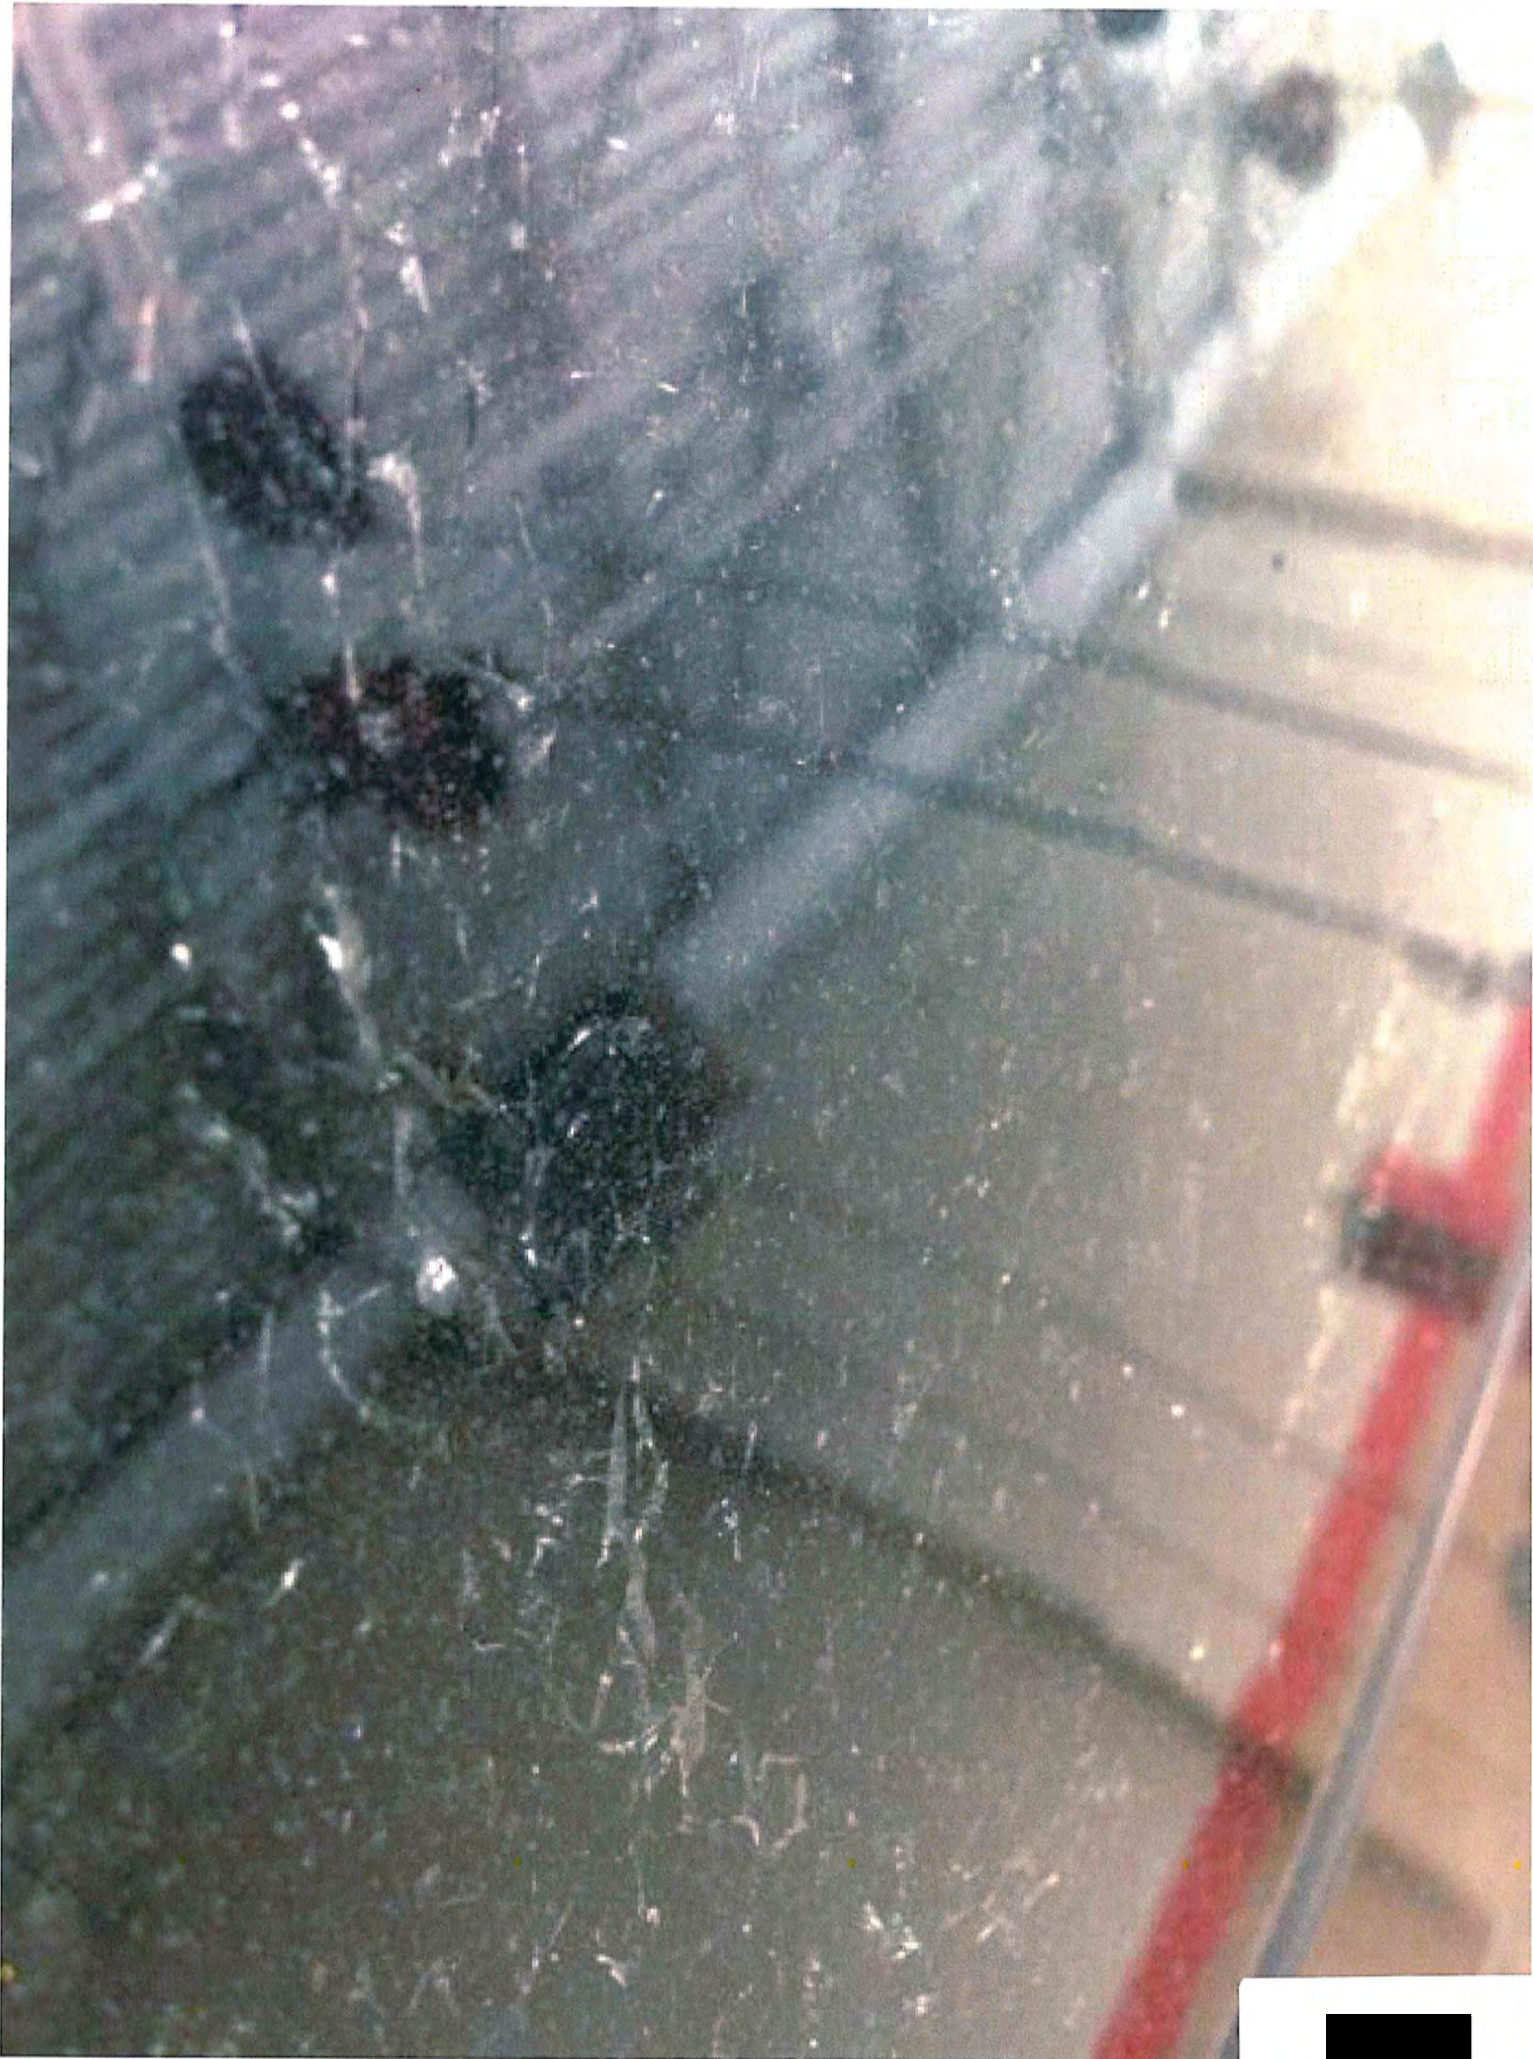
Found no evidence of rock chip in the remaining glass.

Replace the sunroof assy
