Kia Motors America Field Product Quality Report

Subject/Title: Panoramic Sunroof Shattered

Model Desc: OPTIMA EX

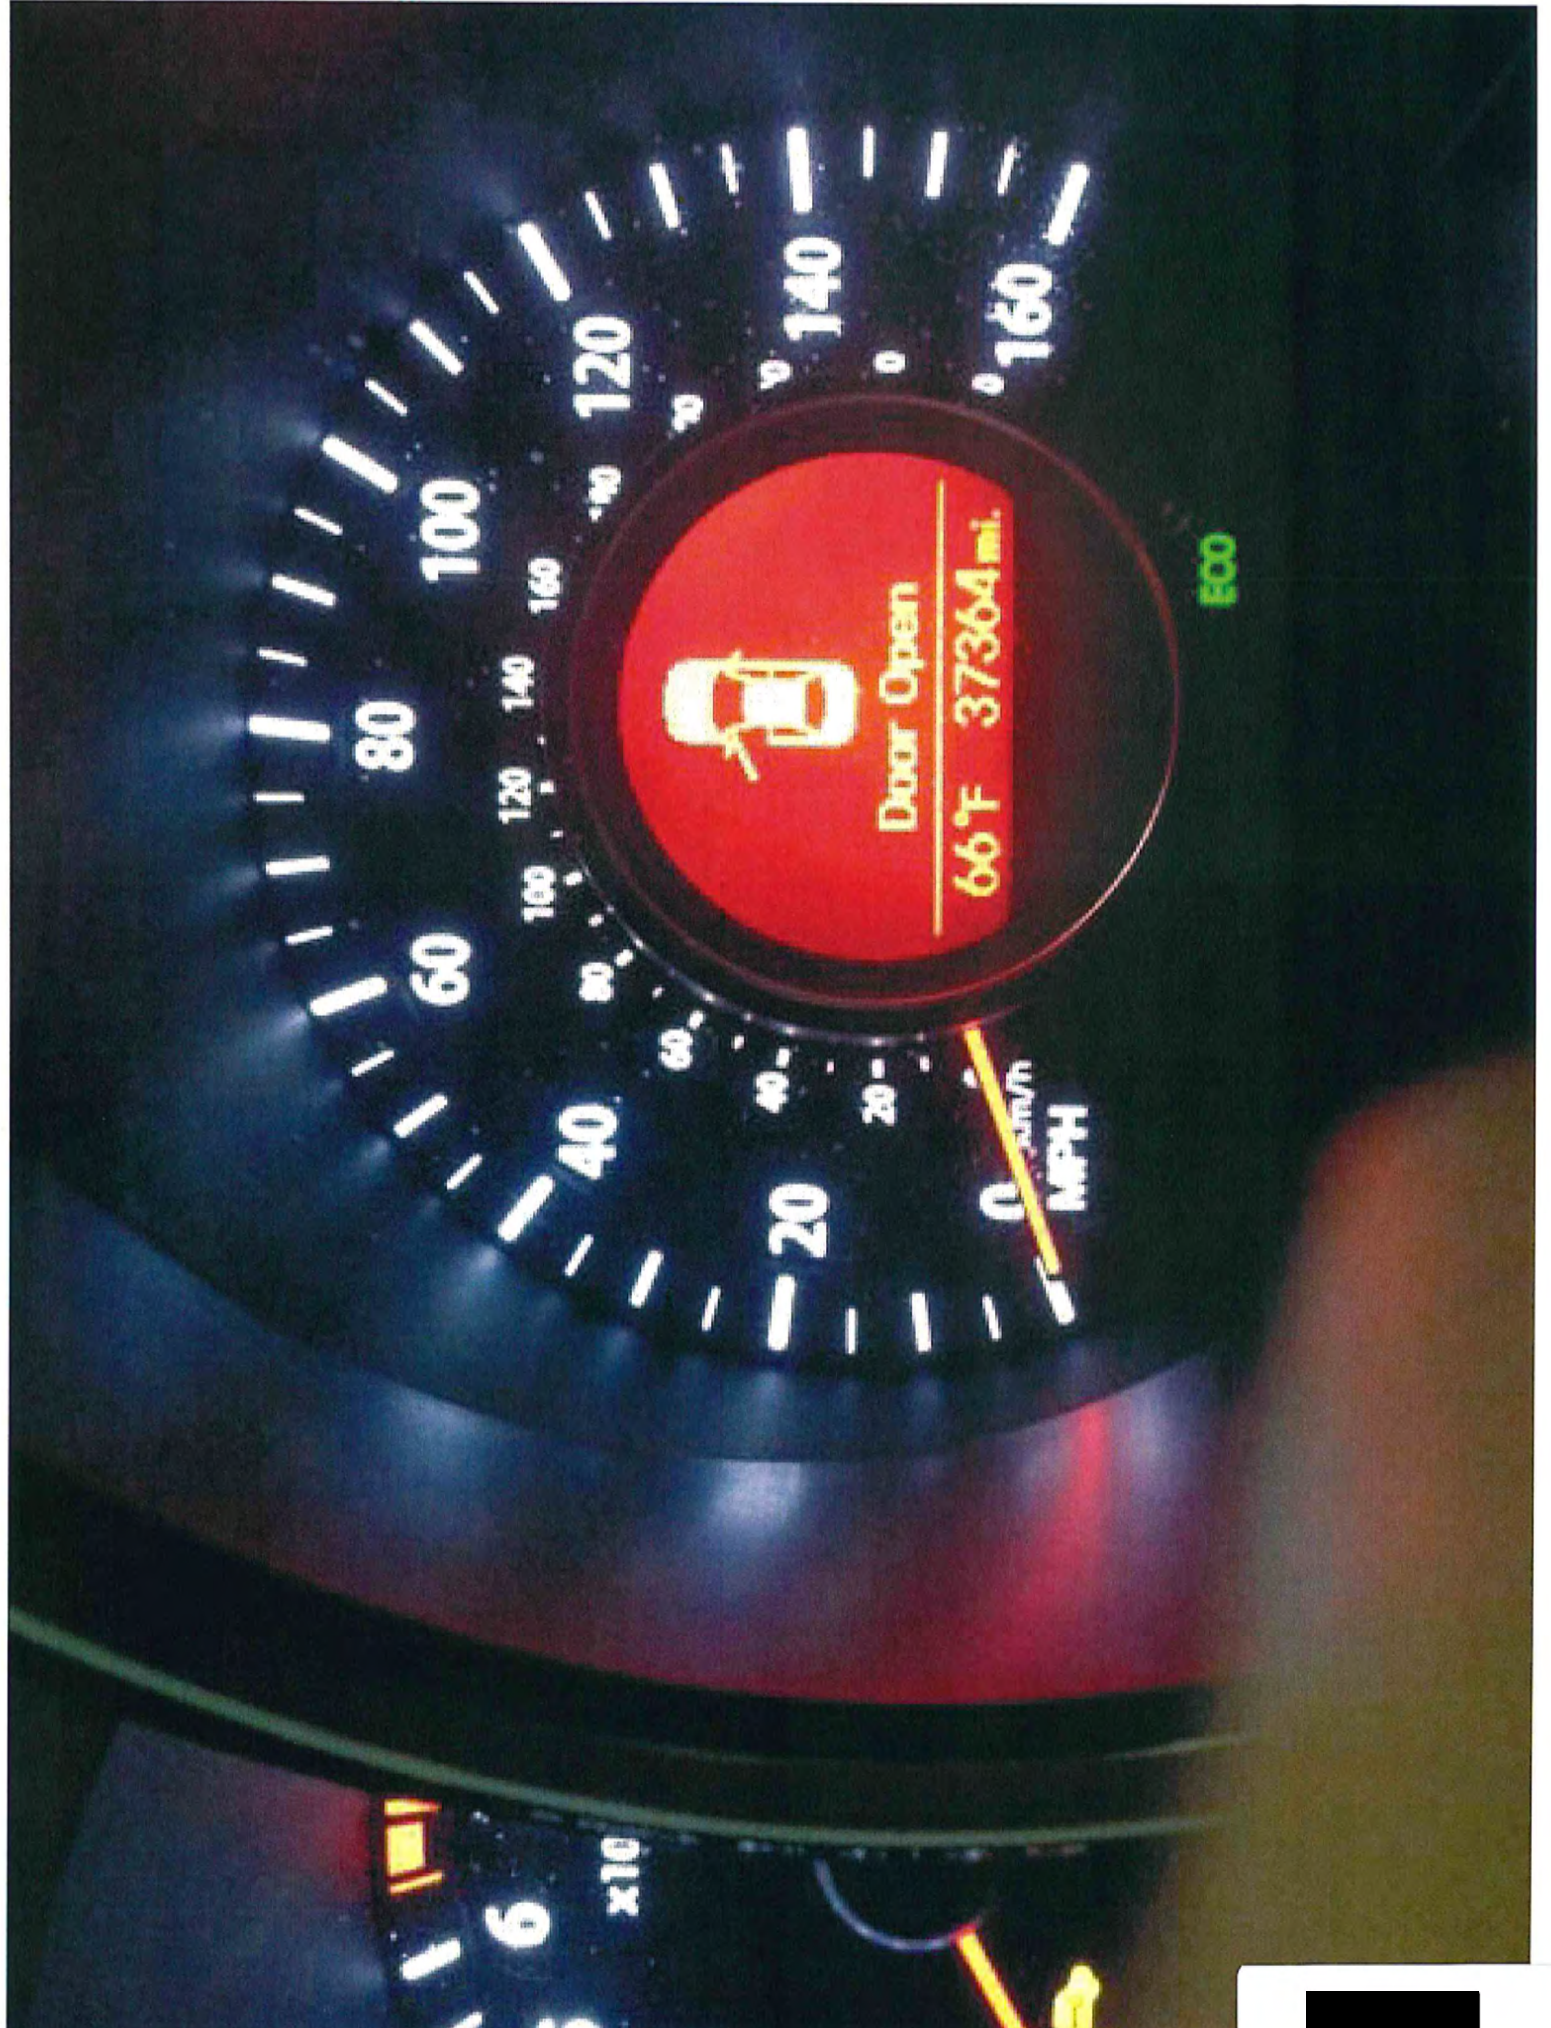
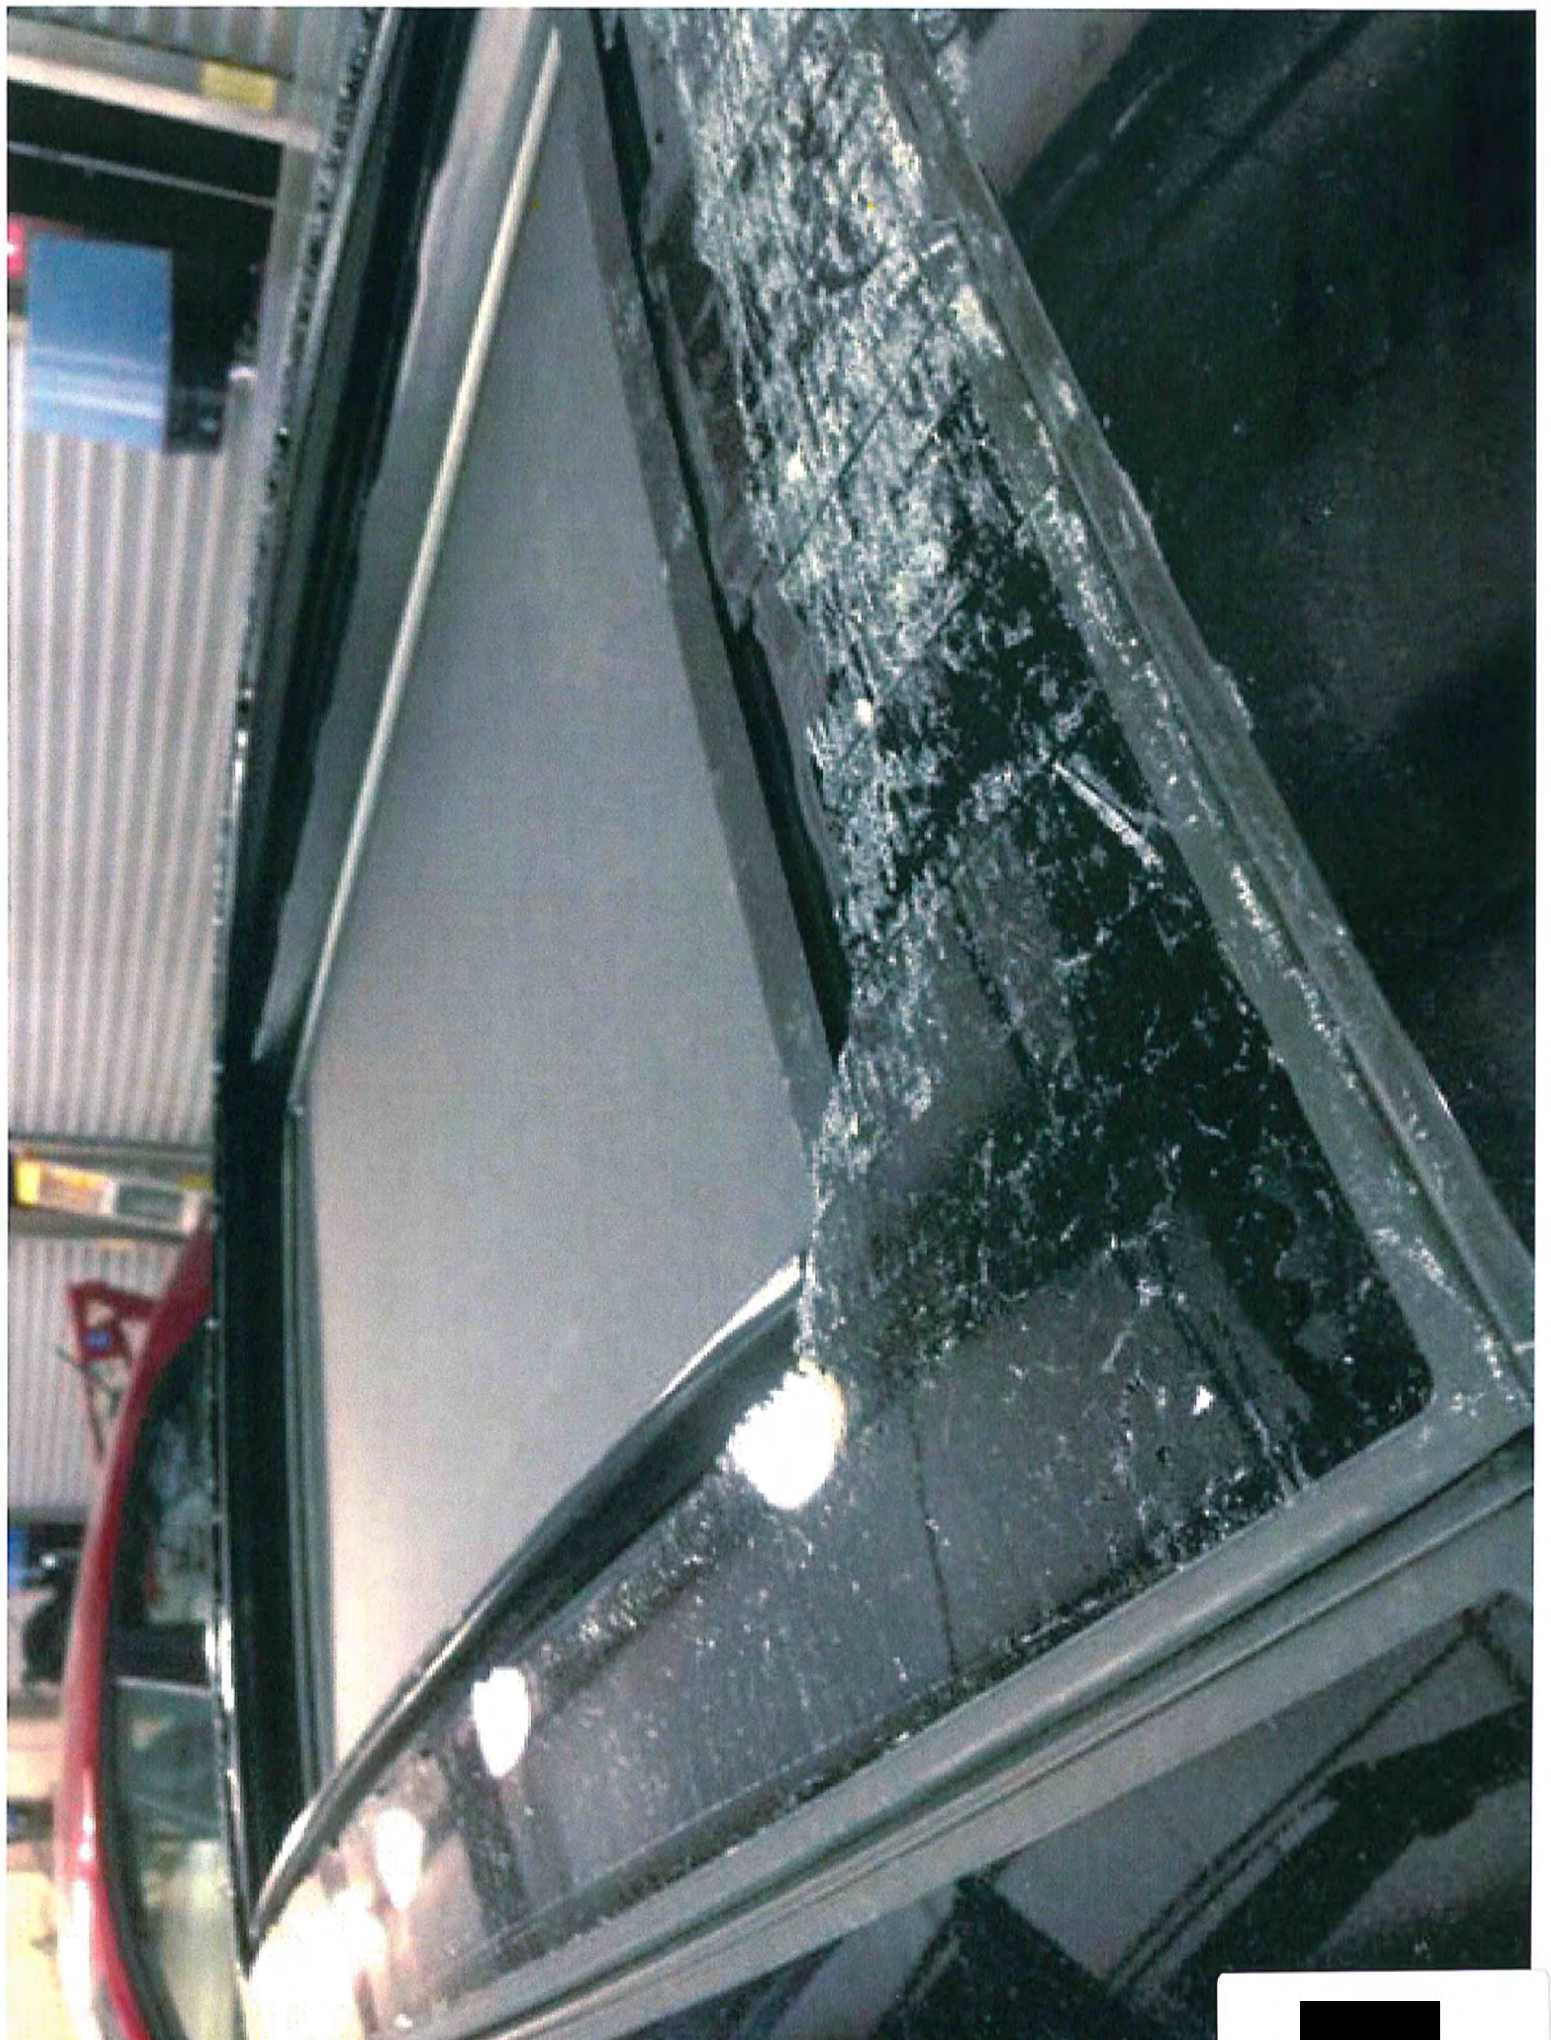
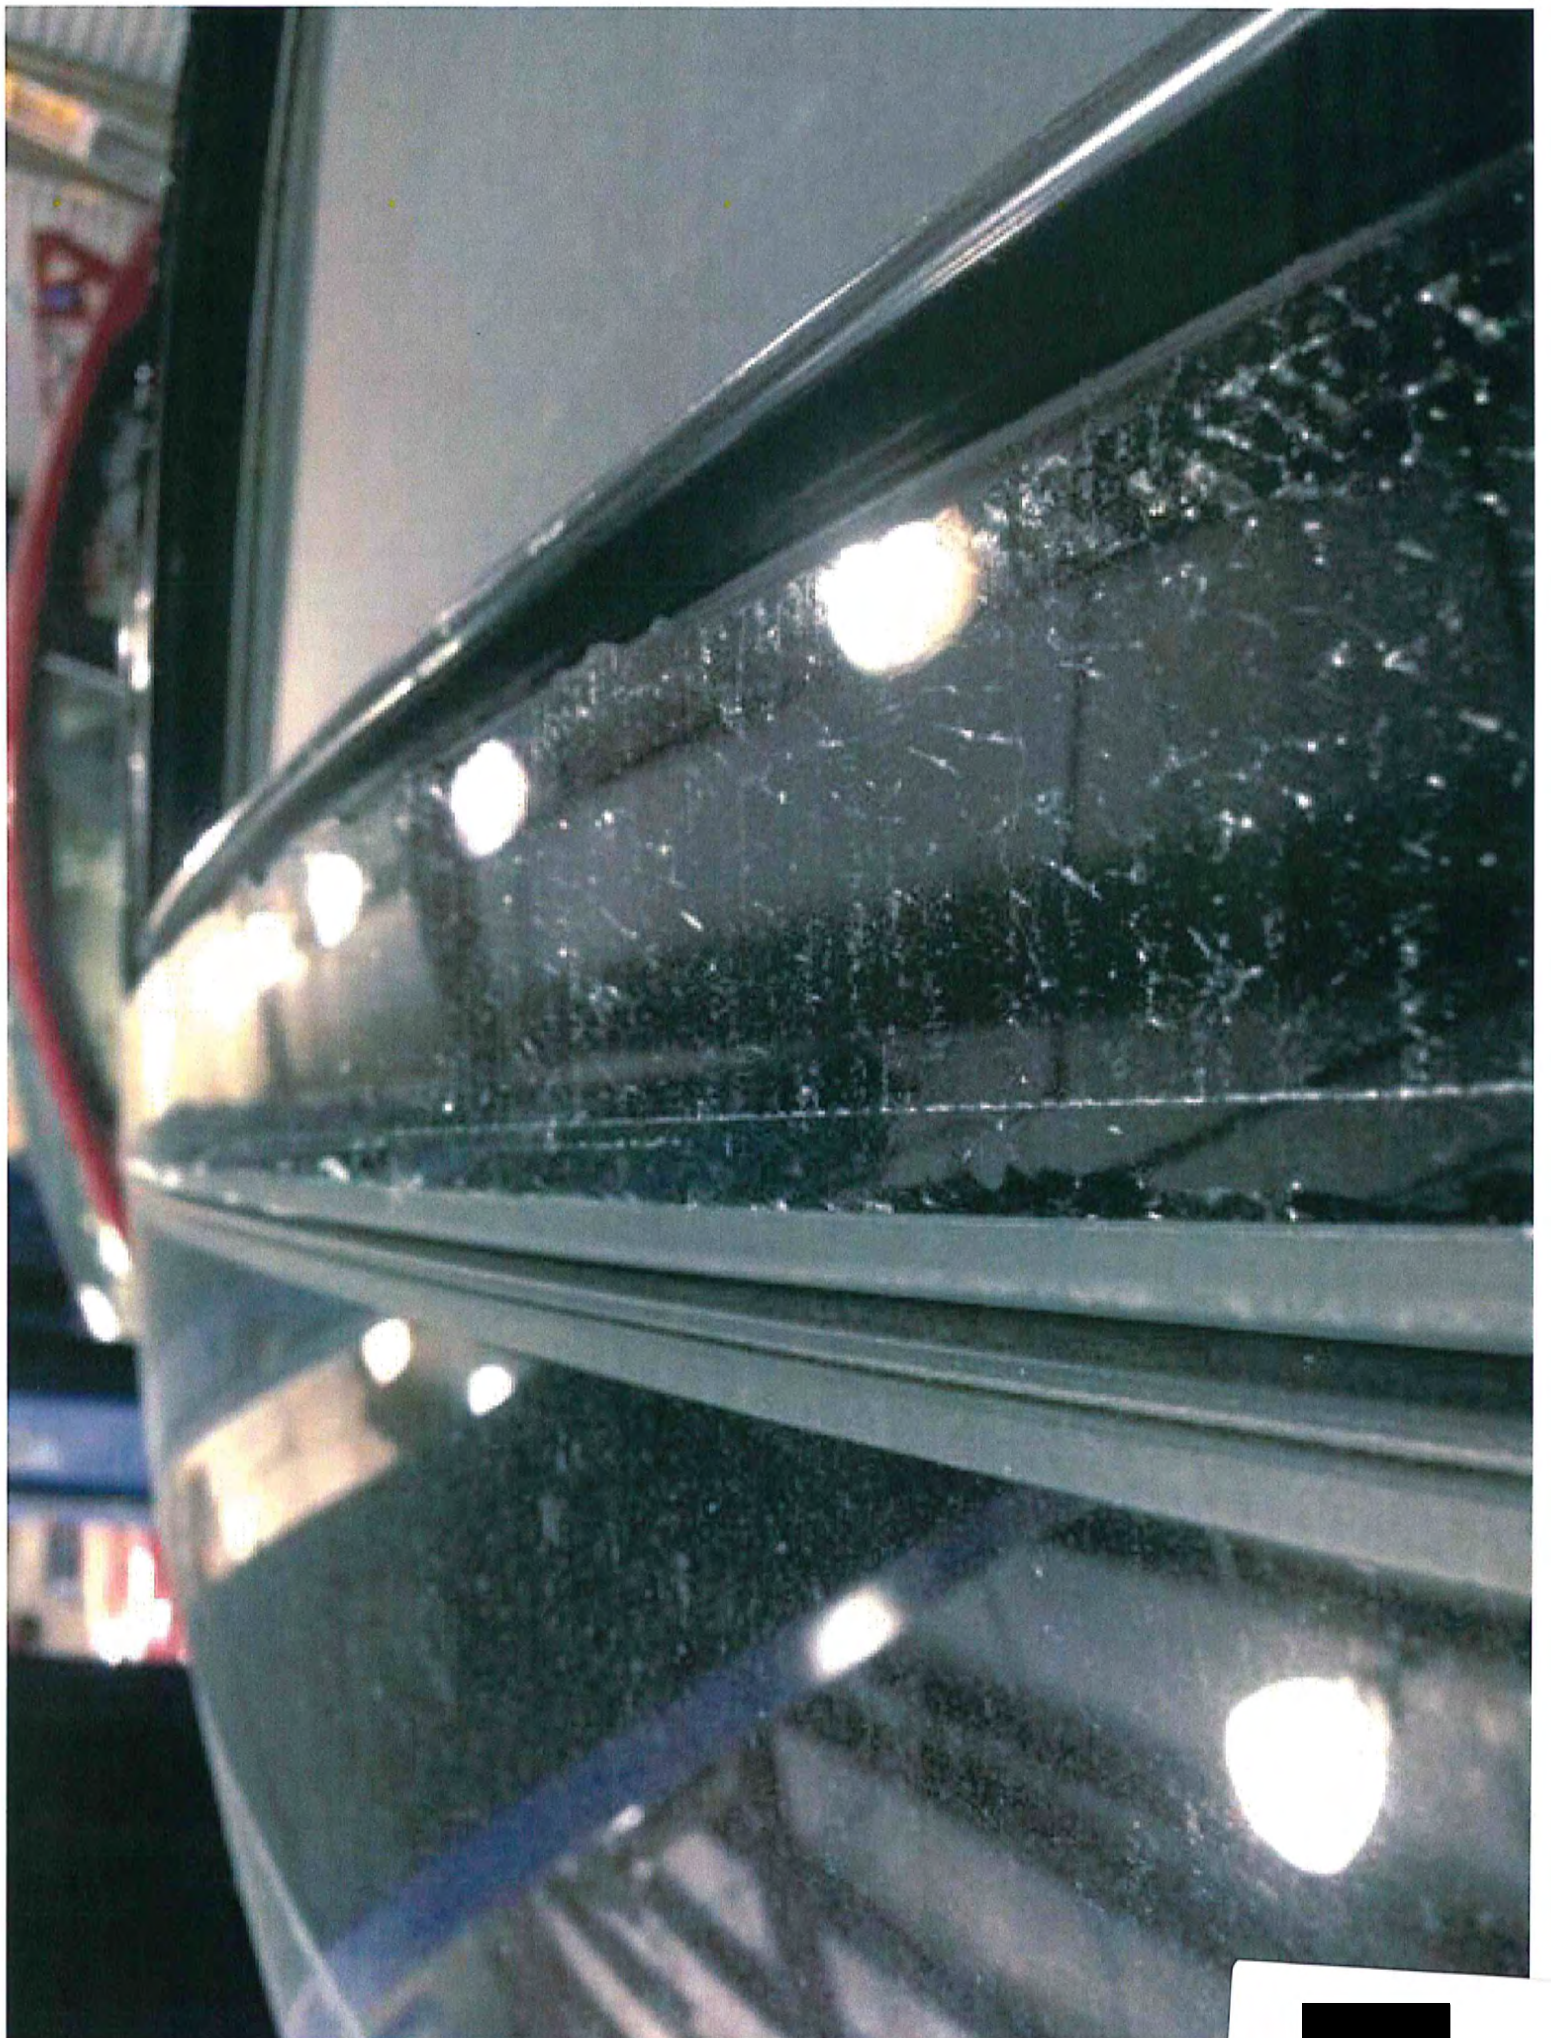
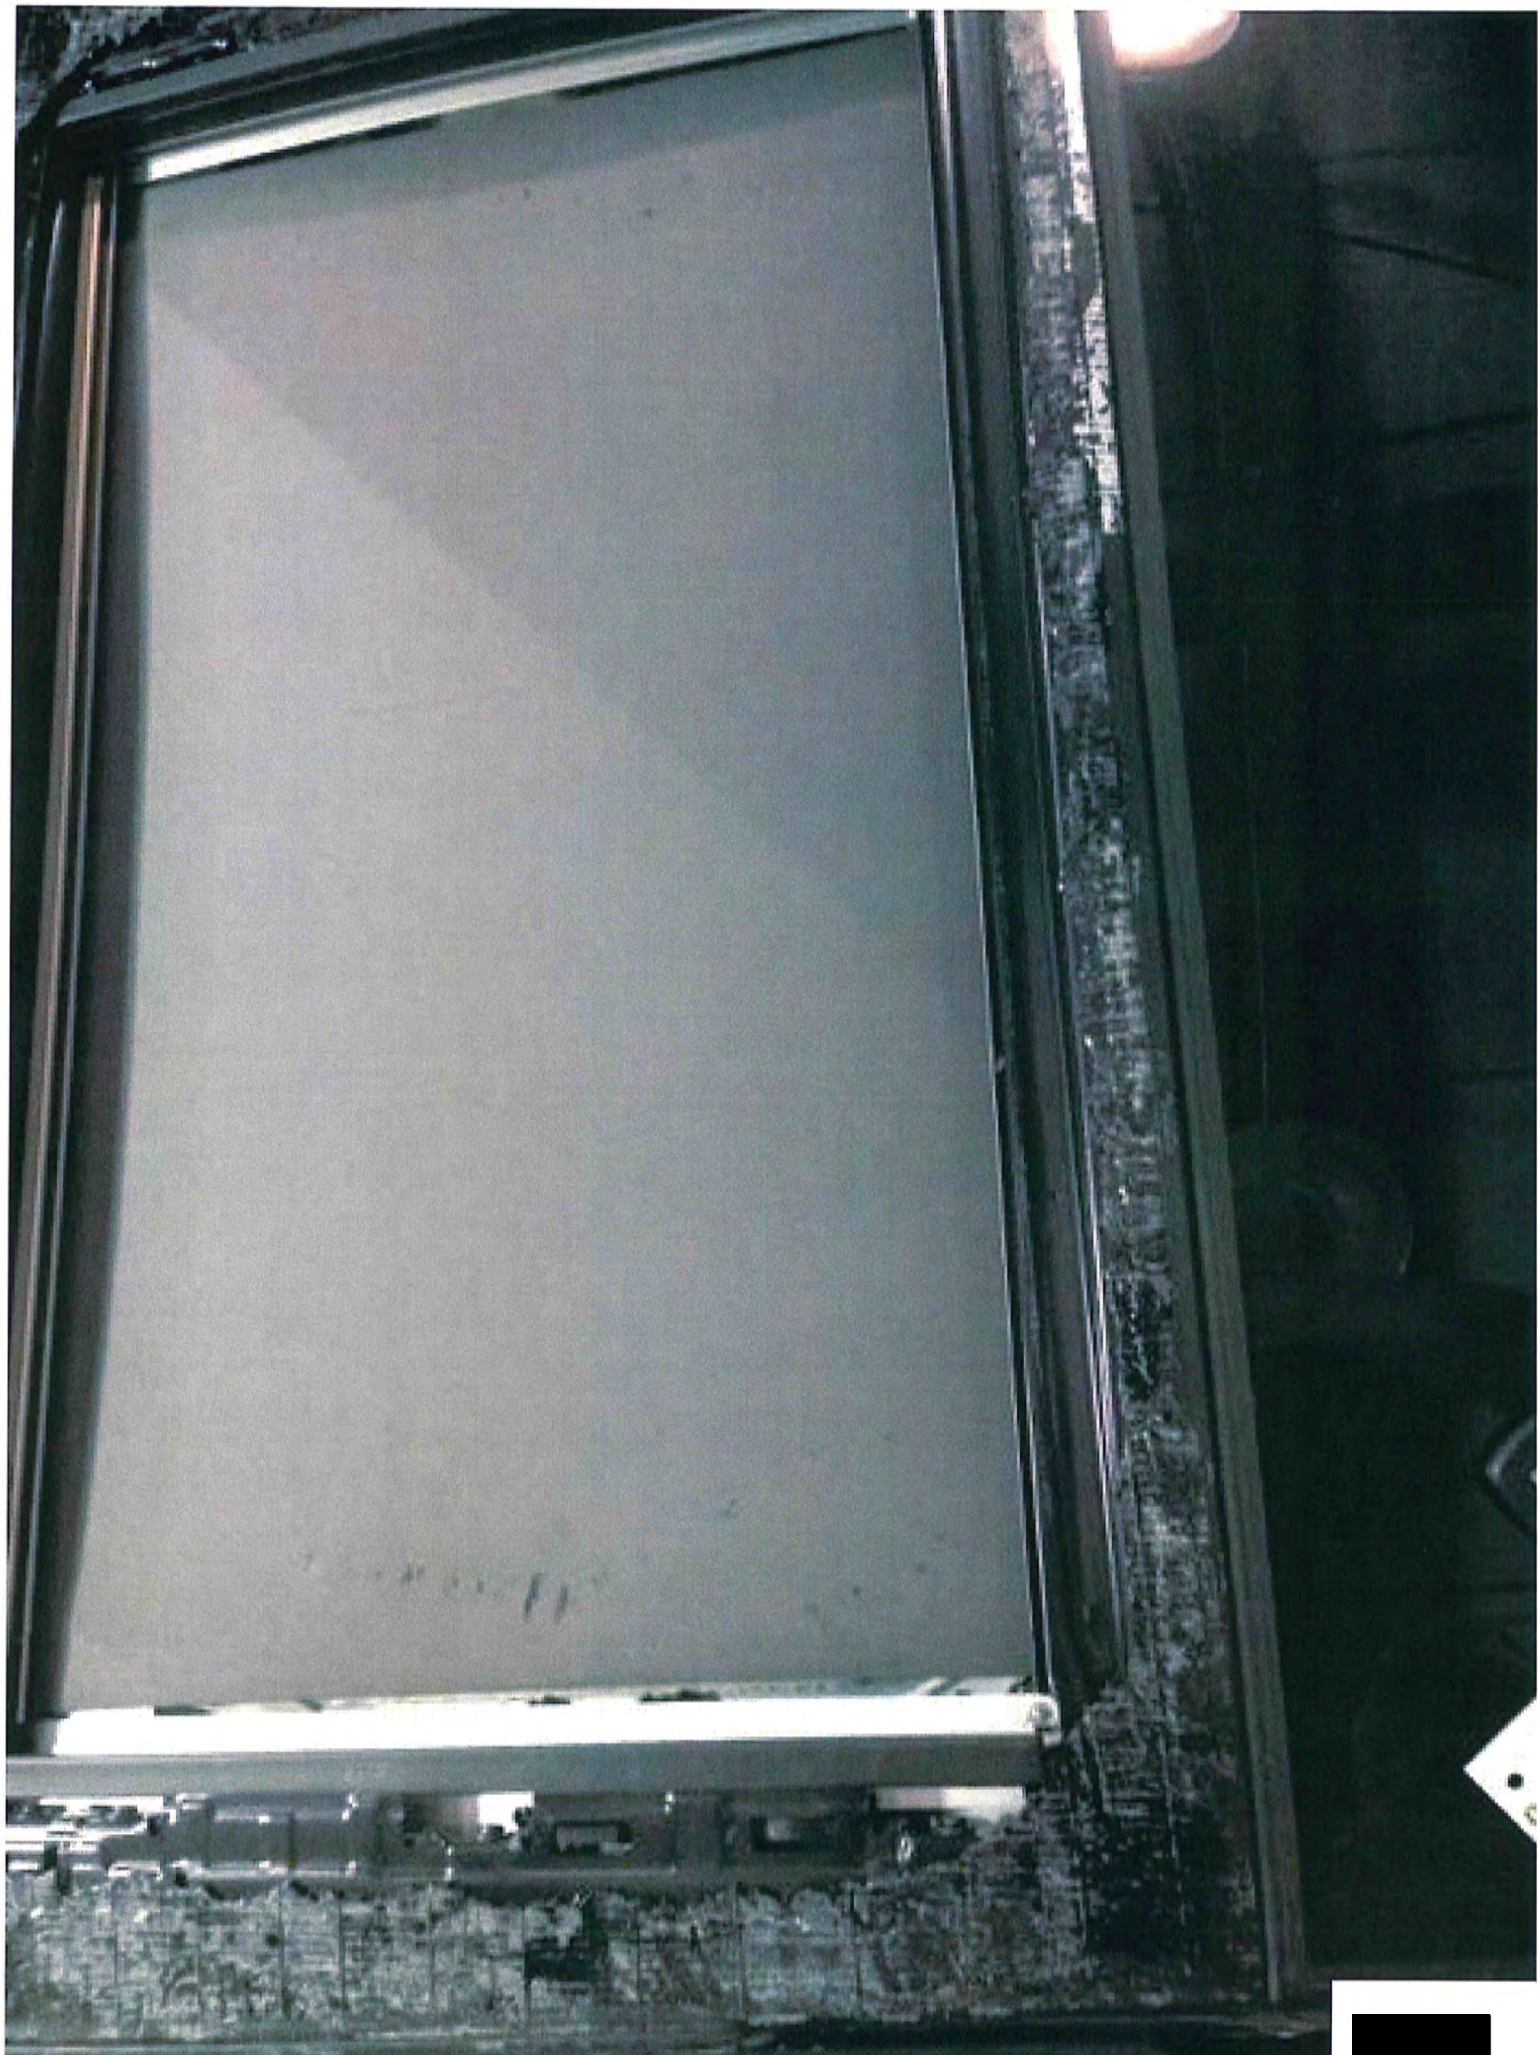
Found no evidence of rock chip. Most of the glass removed by customer.

Replace the sunroof assy.
