Kia Motors America Field Product Quality Report

Subject/Title: Panoramic Sunroof Shattered

Model Desc: OPTIMA EX

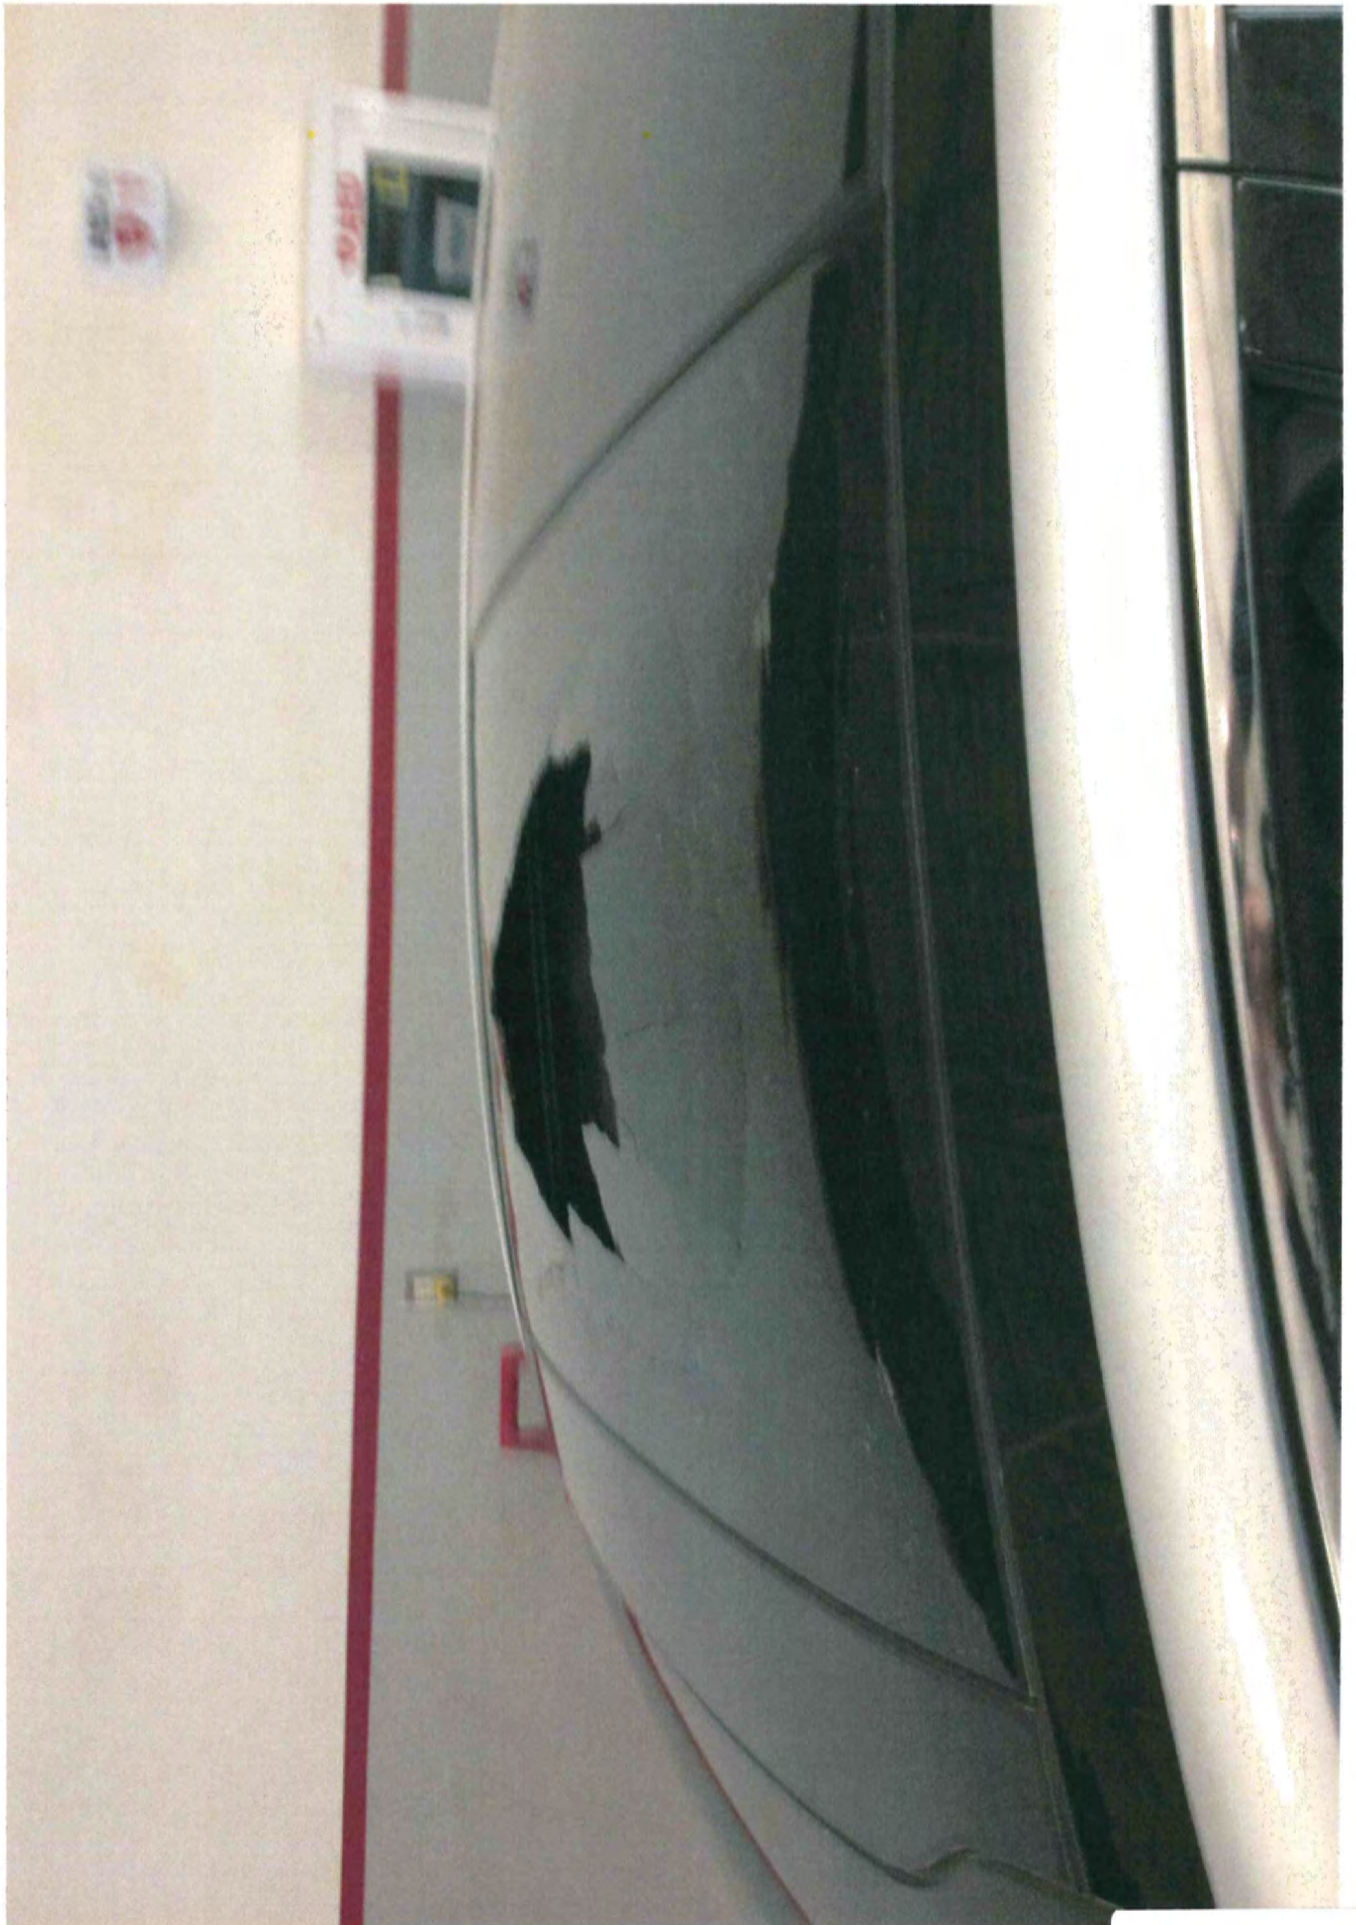
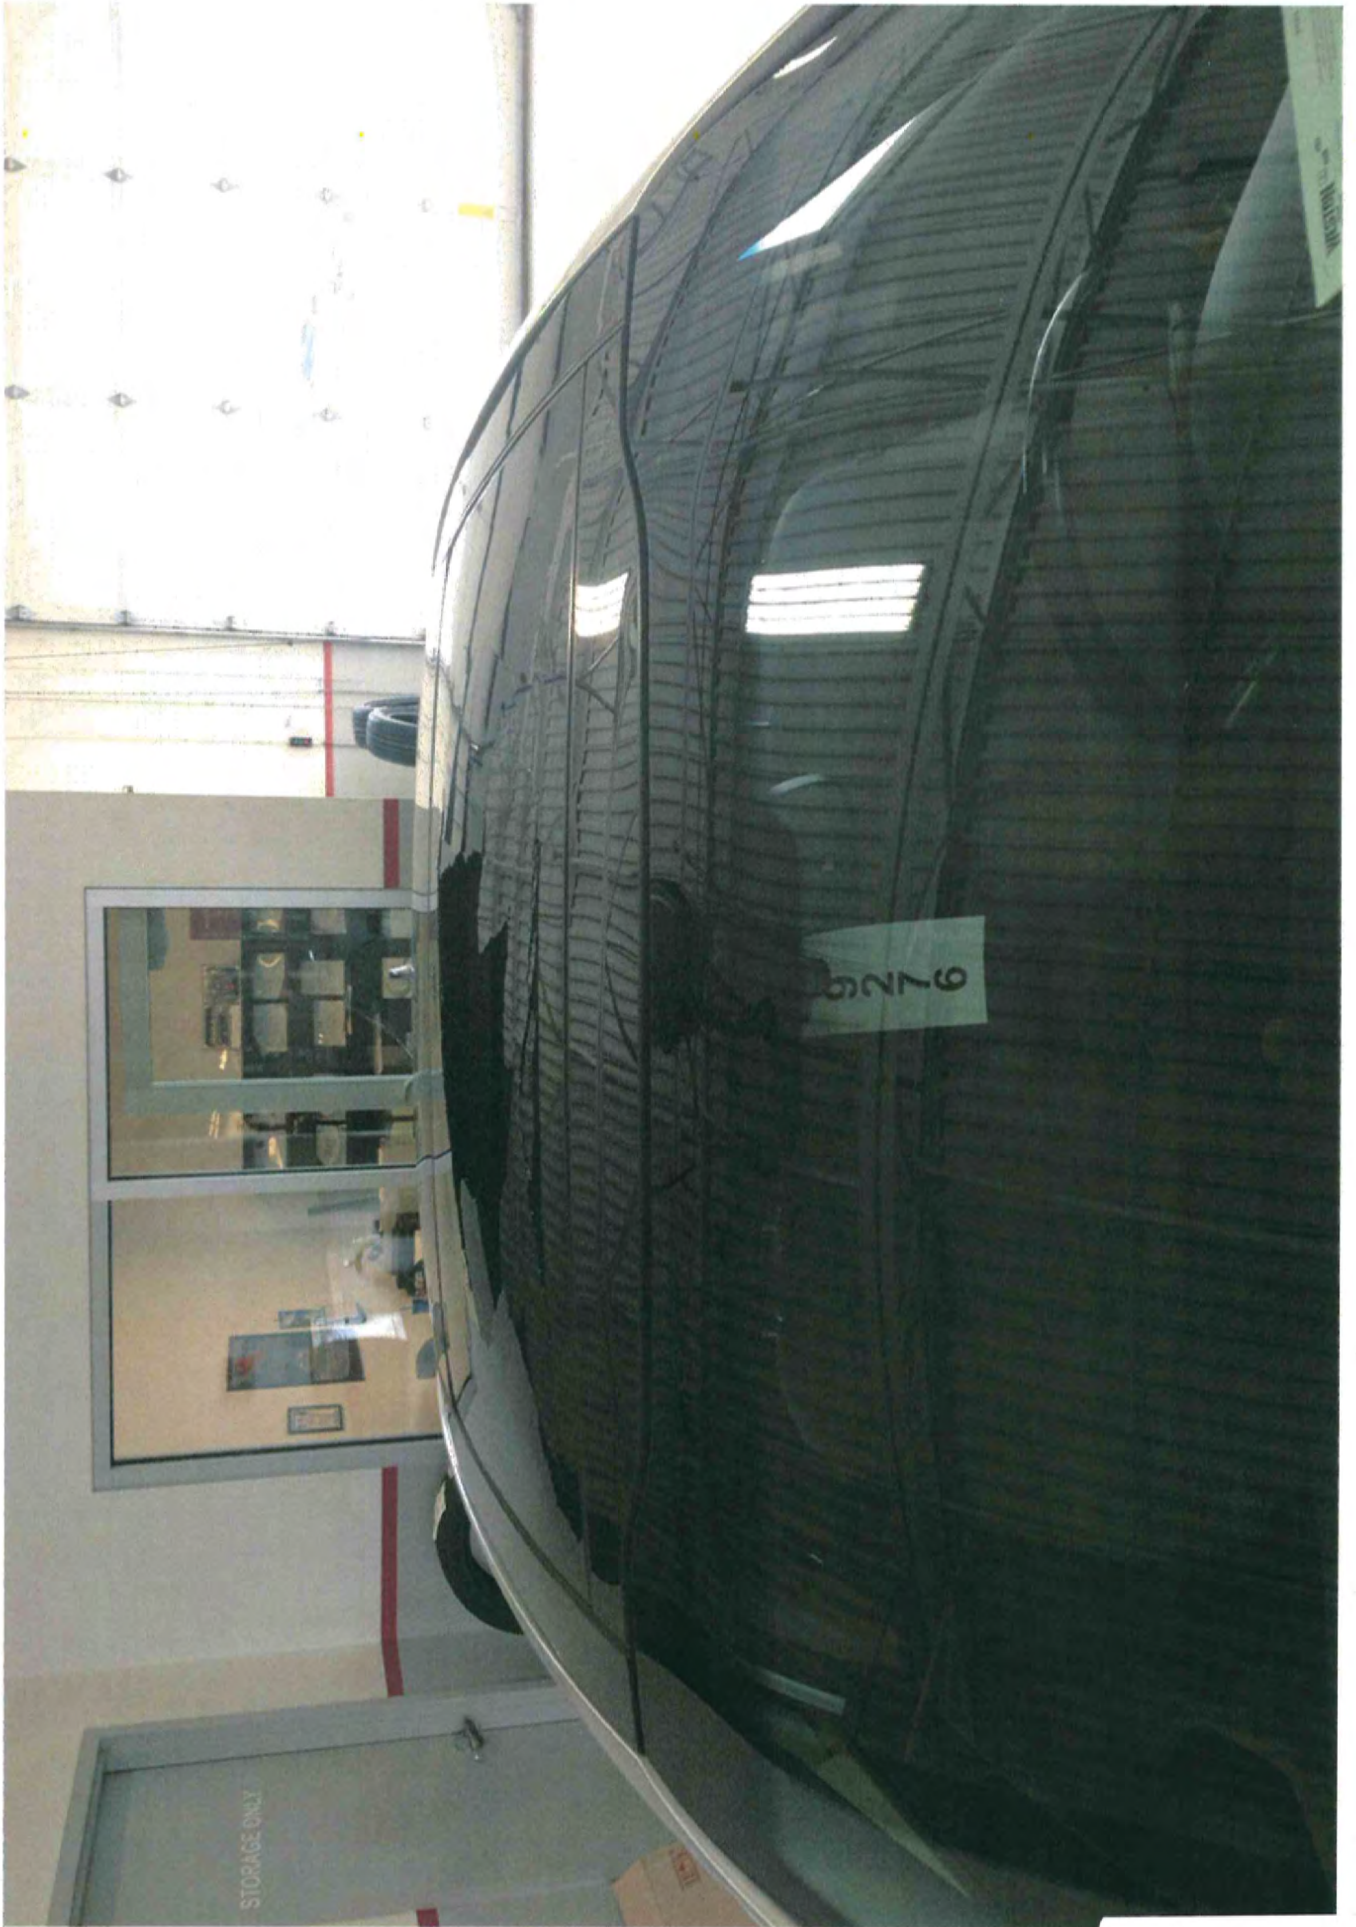
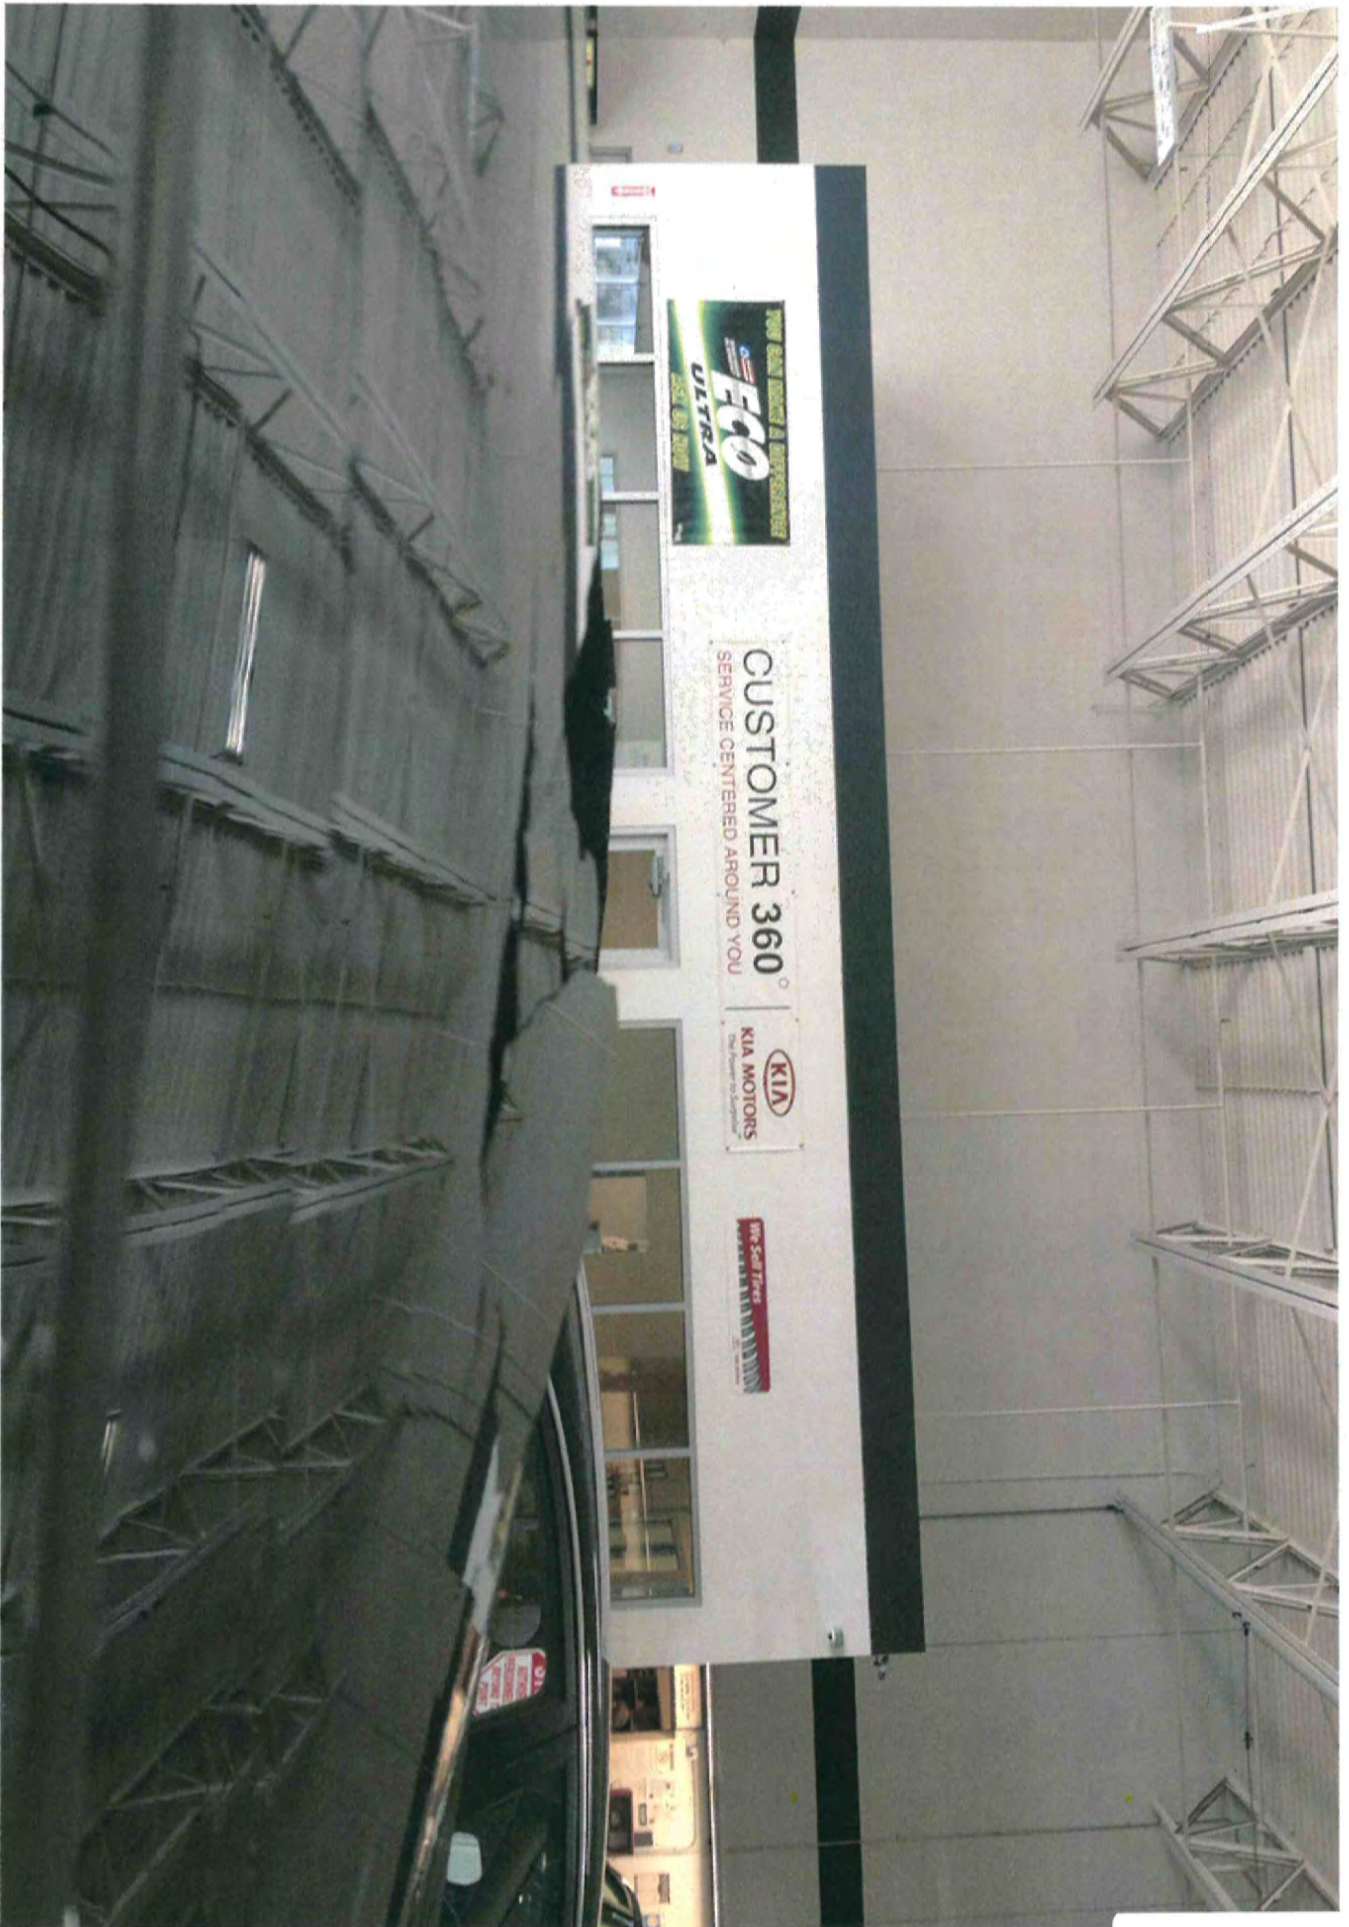
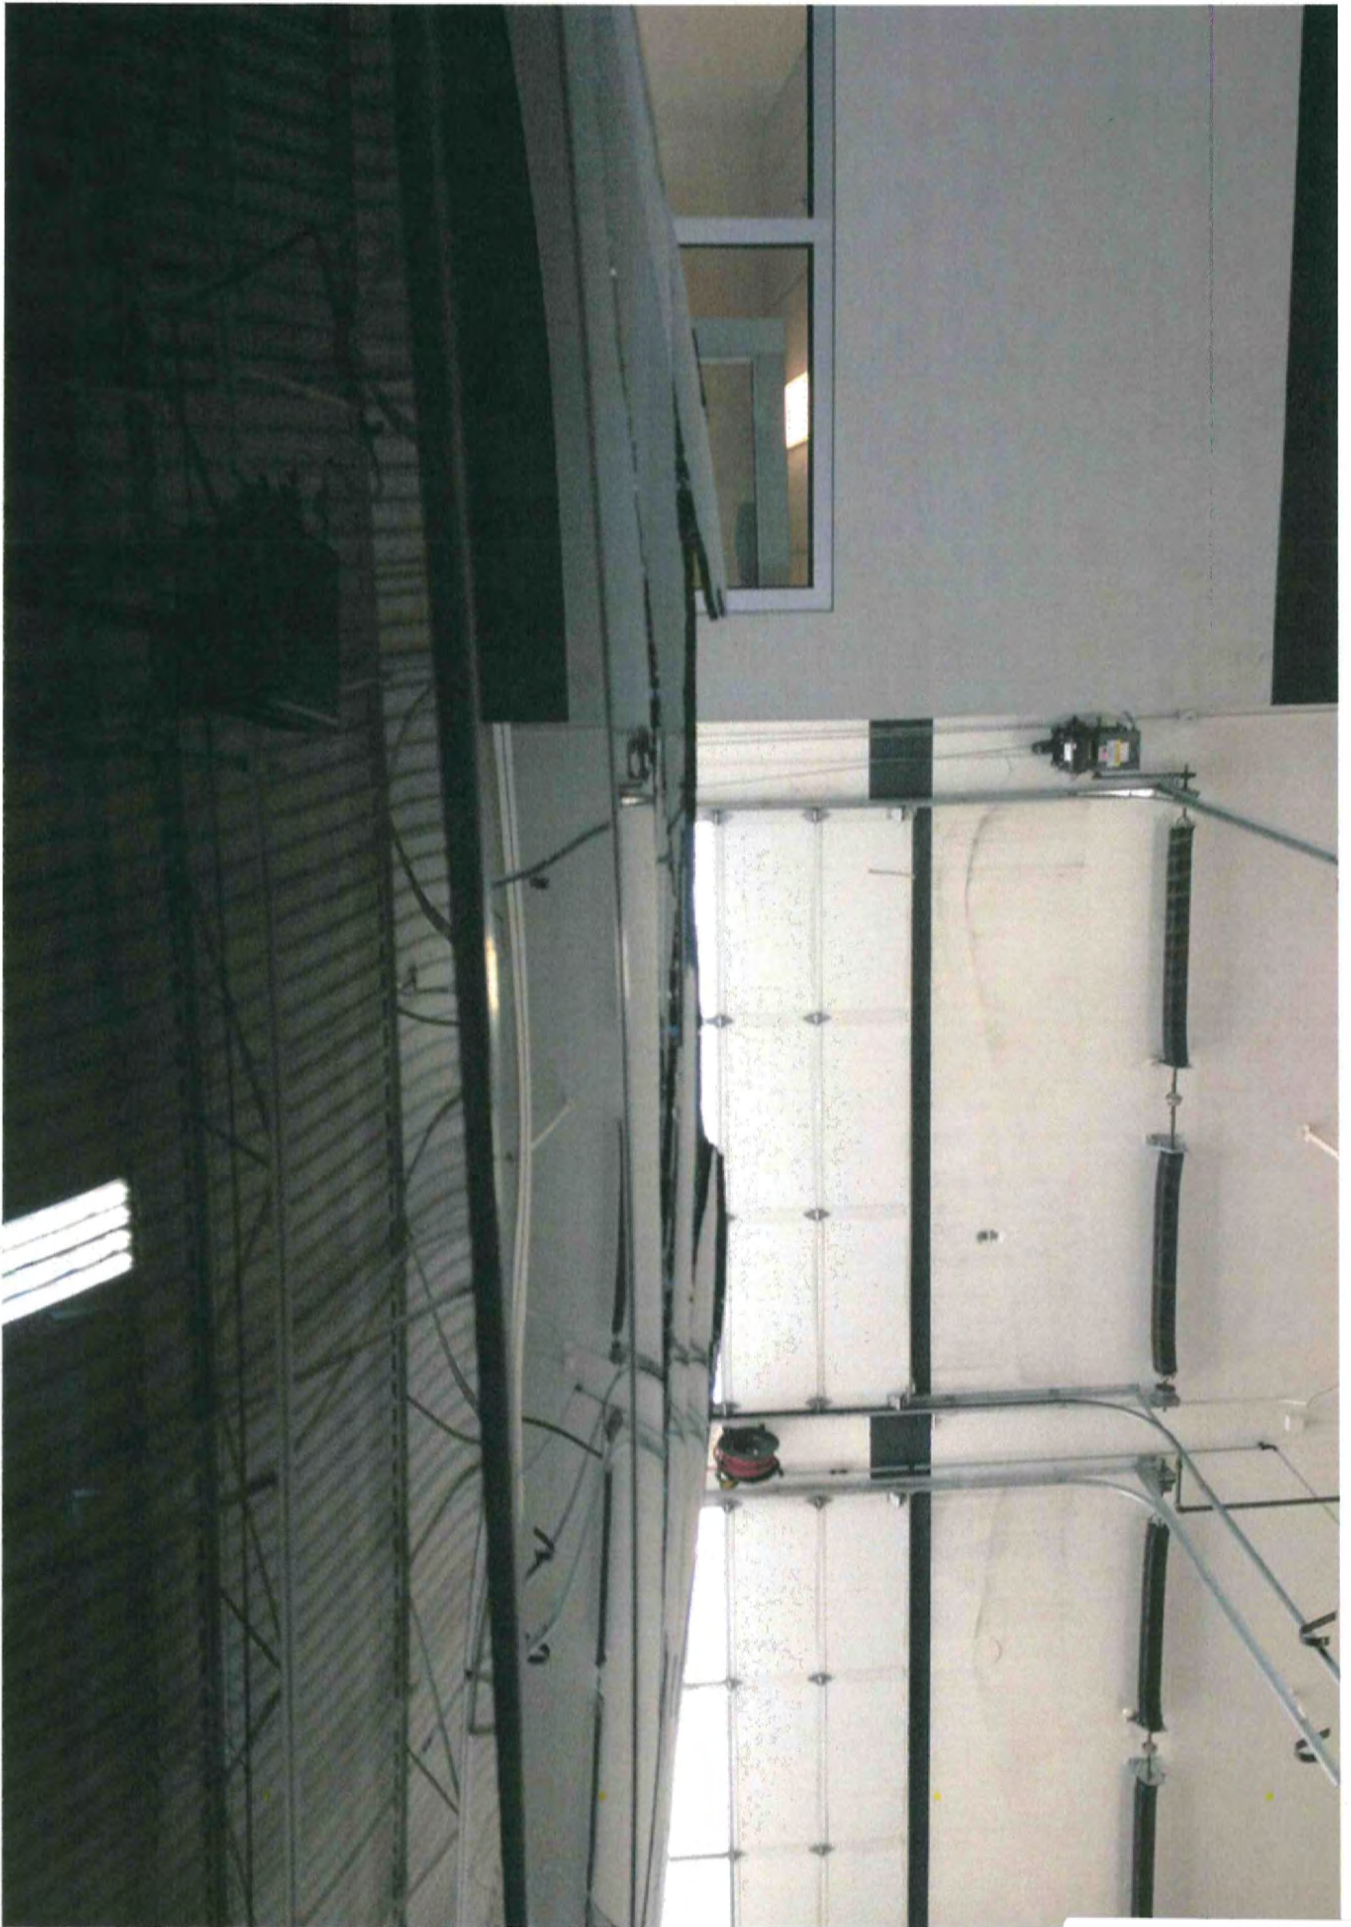
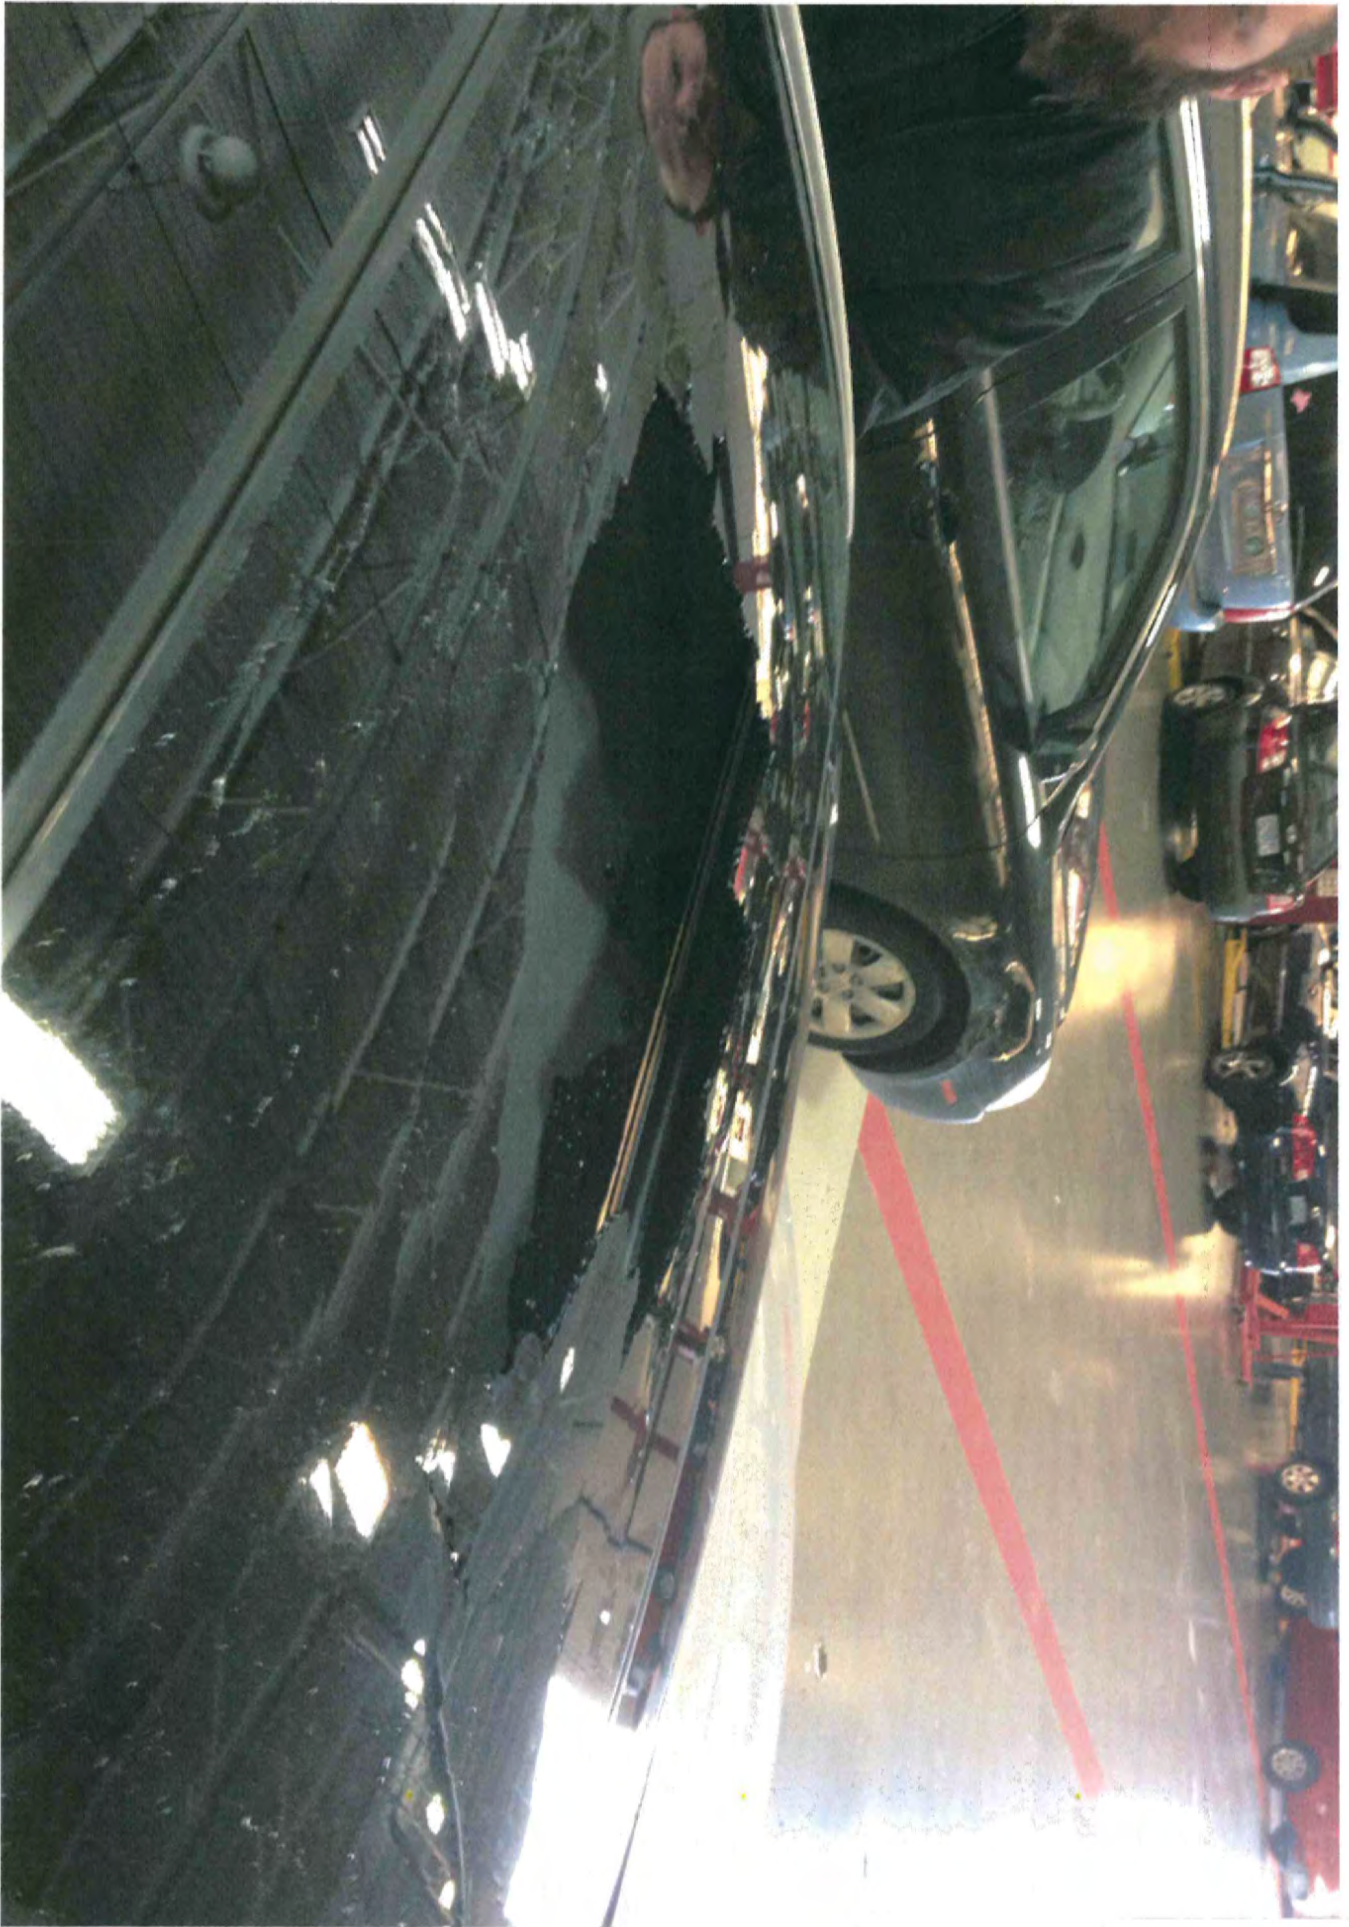
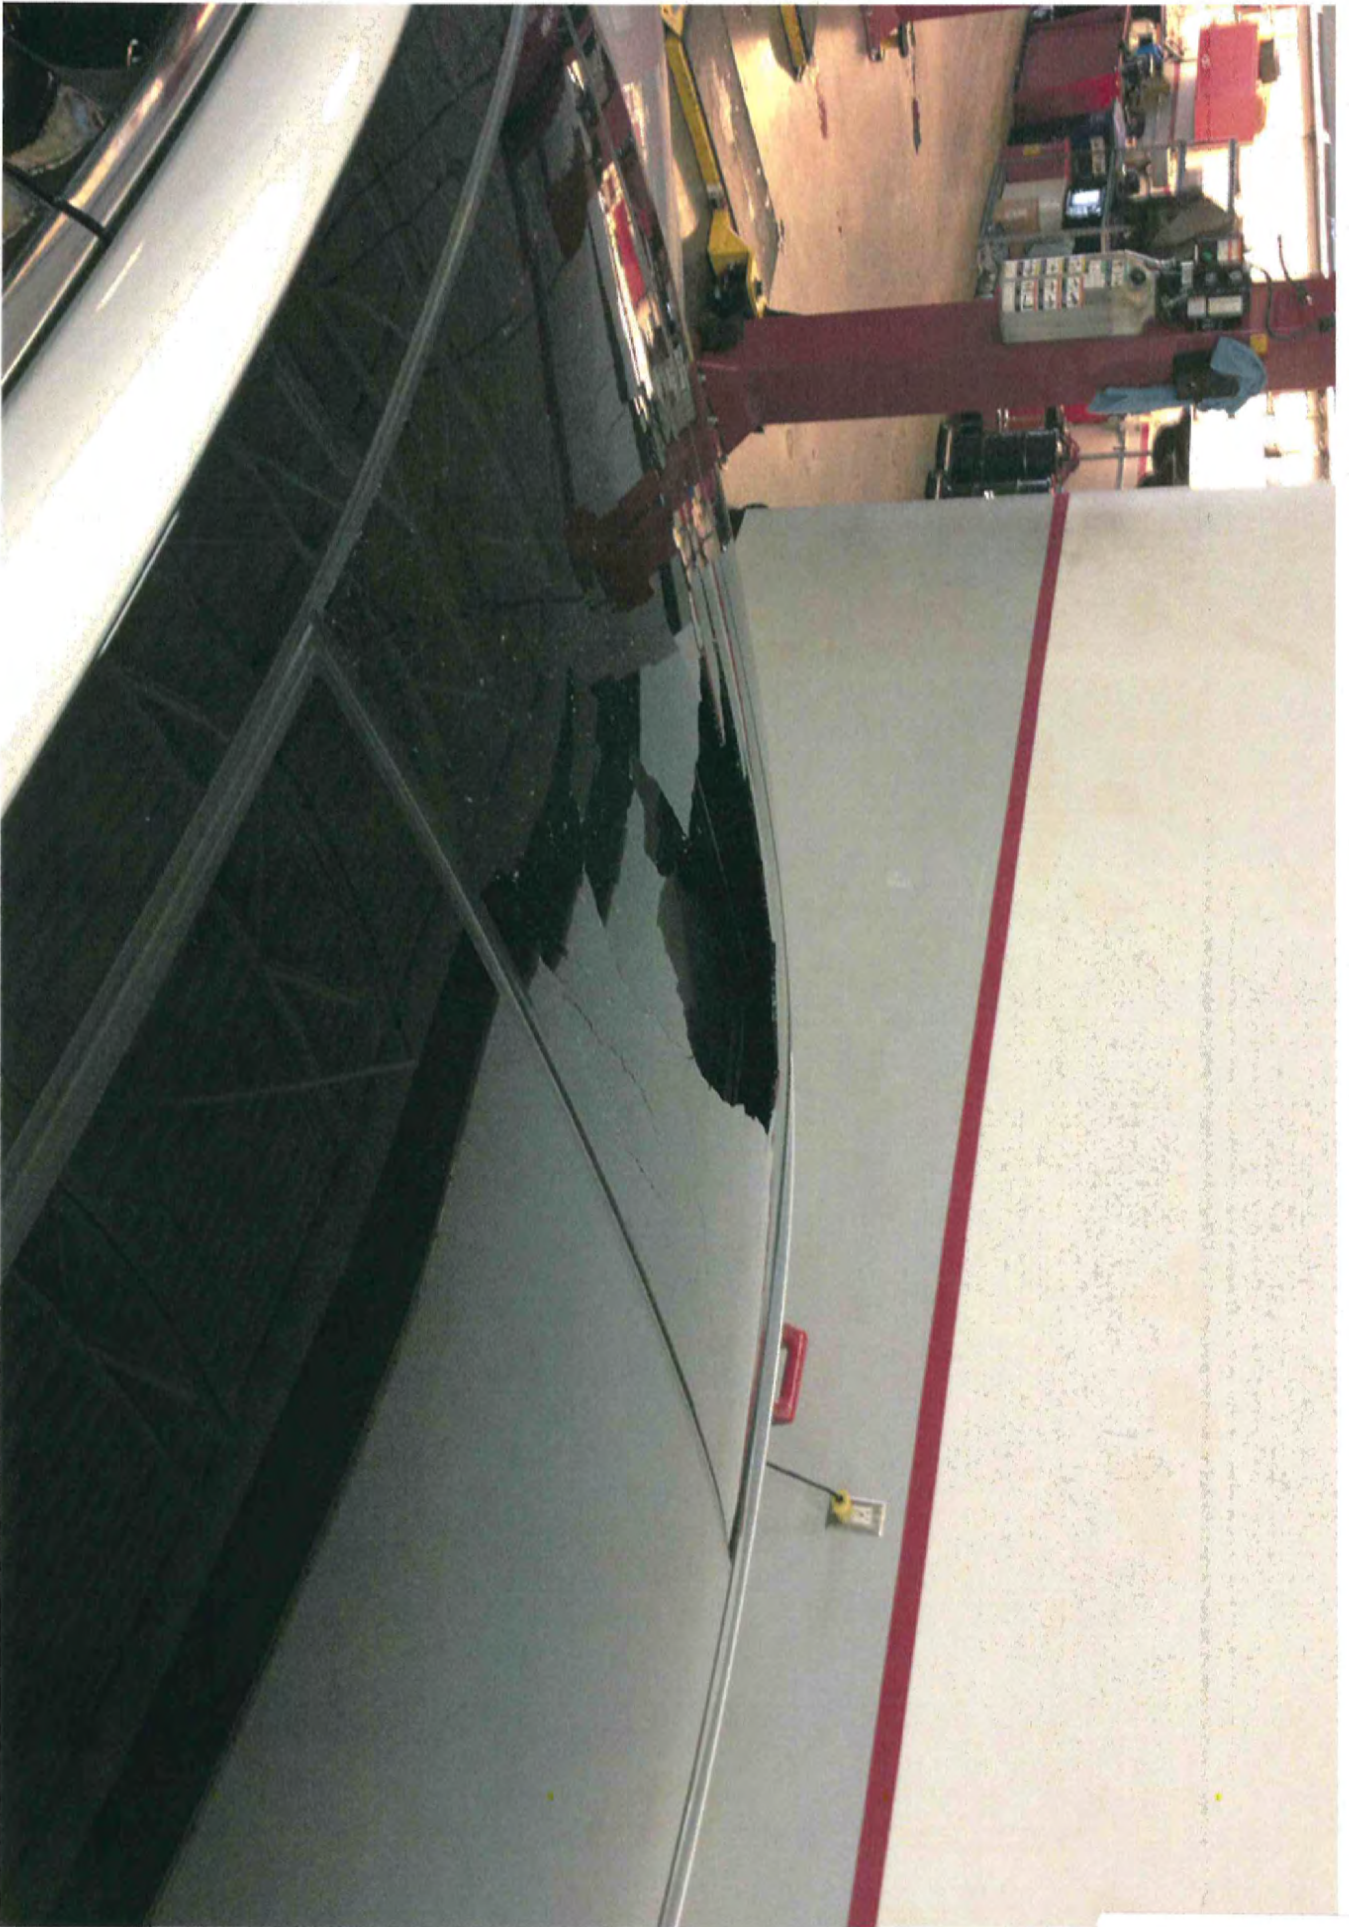
The panoramic shattered outward from vehicle

DPSM investigated vehicle and saw no impact on vehicle or panoramic roof. CA Case Number - K2664531

Replace shattered panoramic glass
