Kia Motors America Field Product Quality Report

Subject/Title: Panoramic Sunroof Shattered

Model Desc: OPTIMA EX

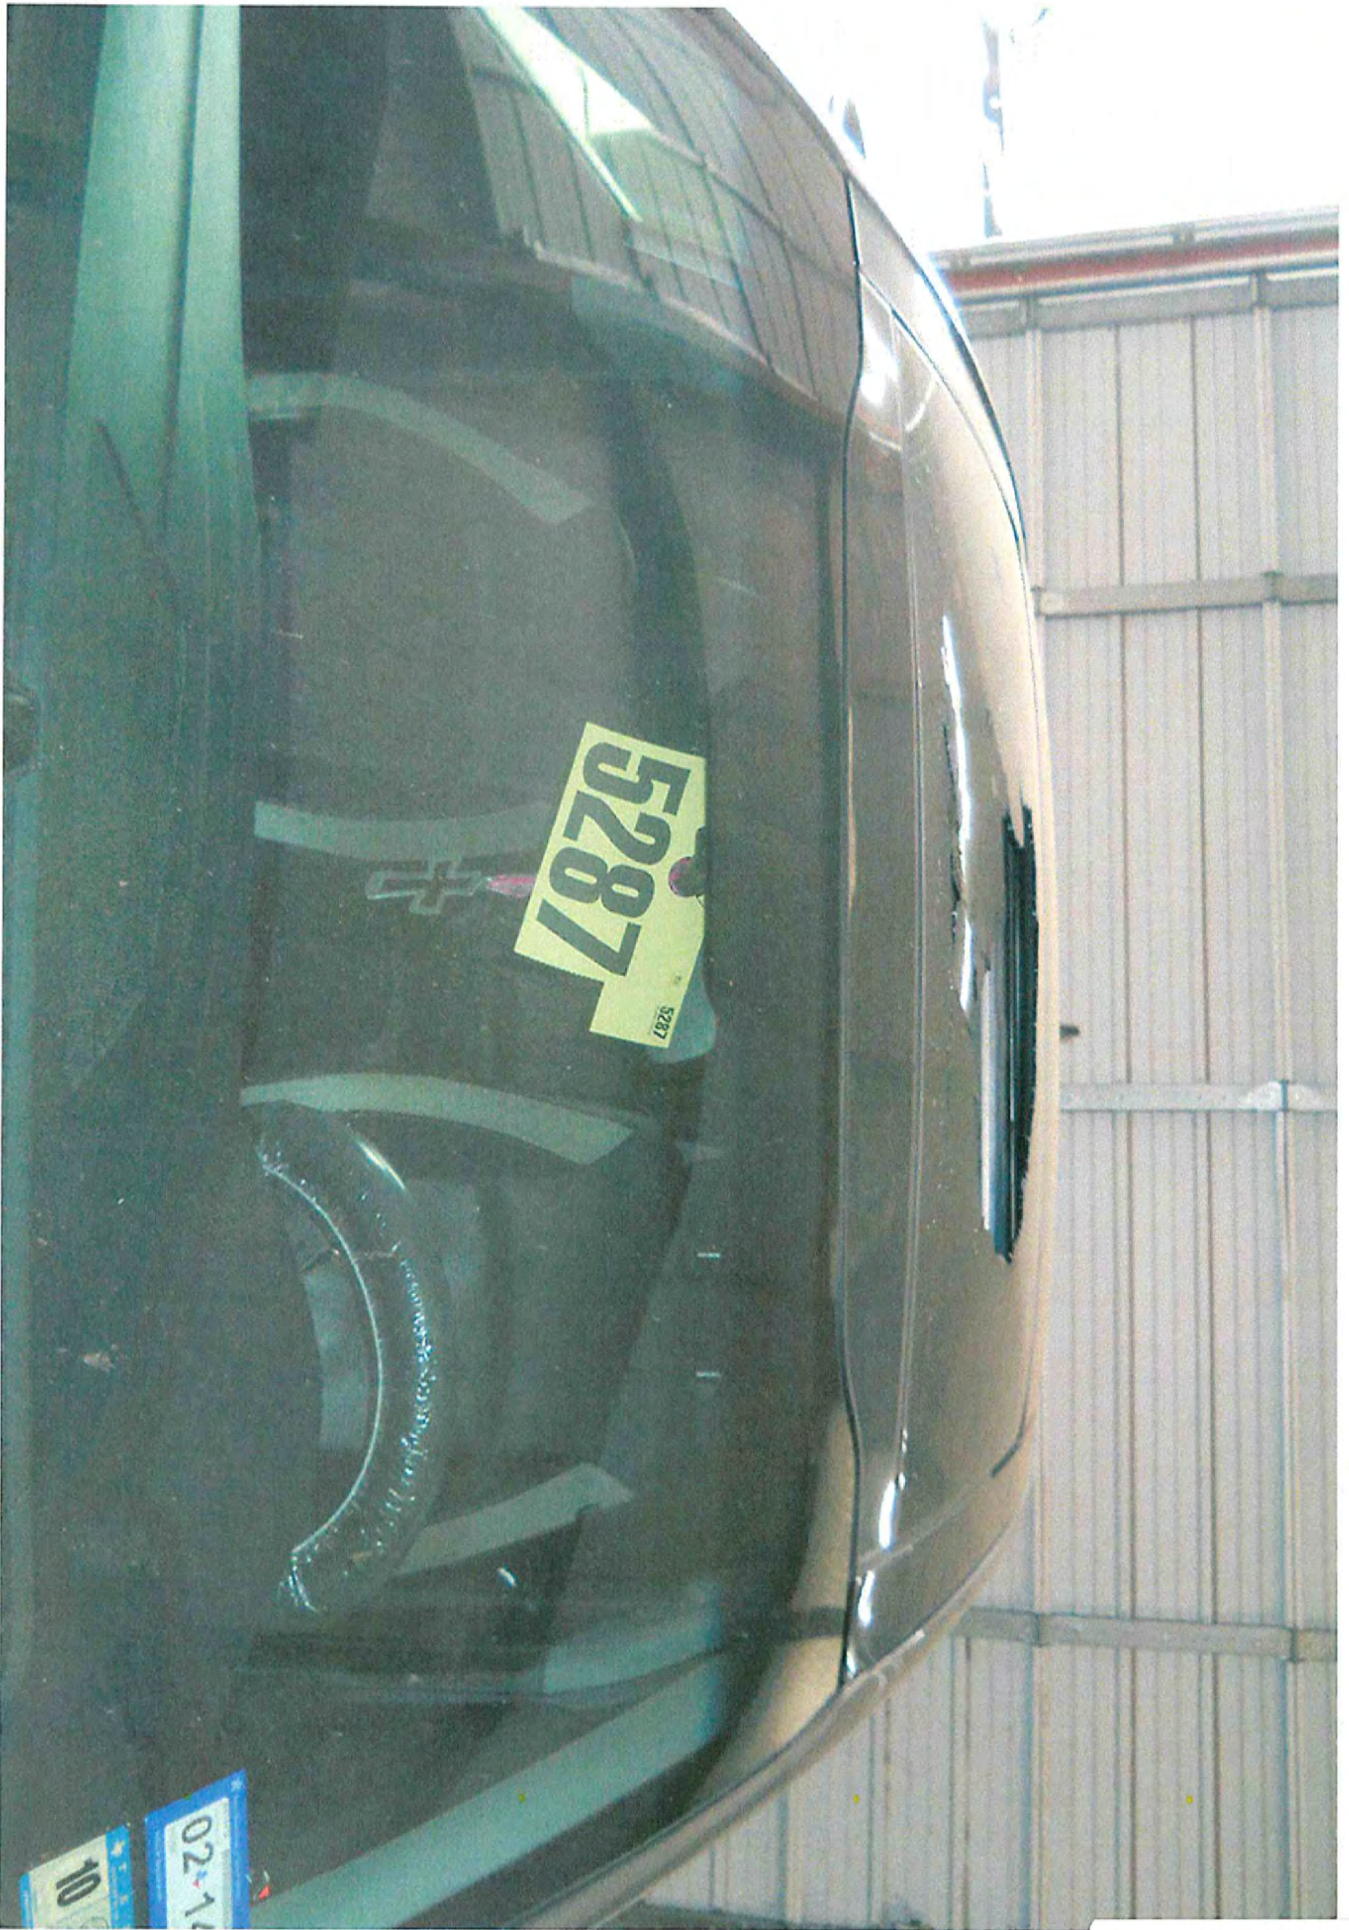
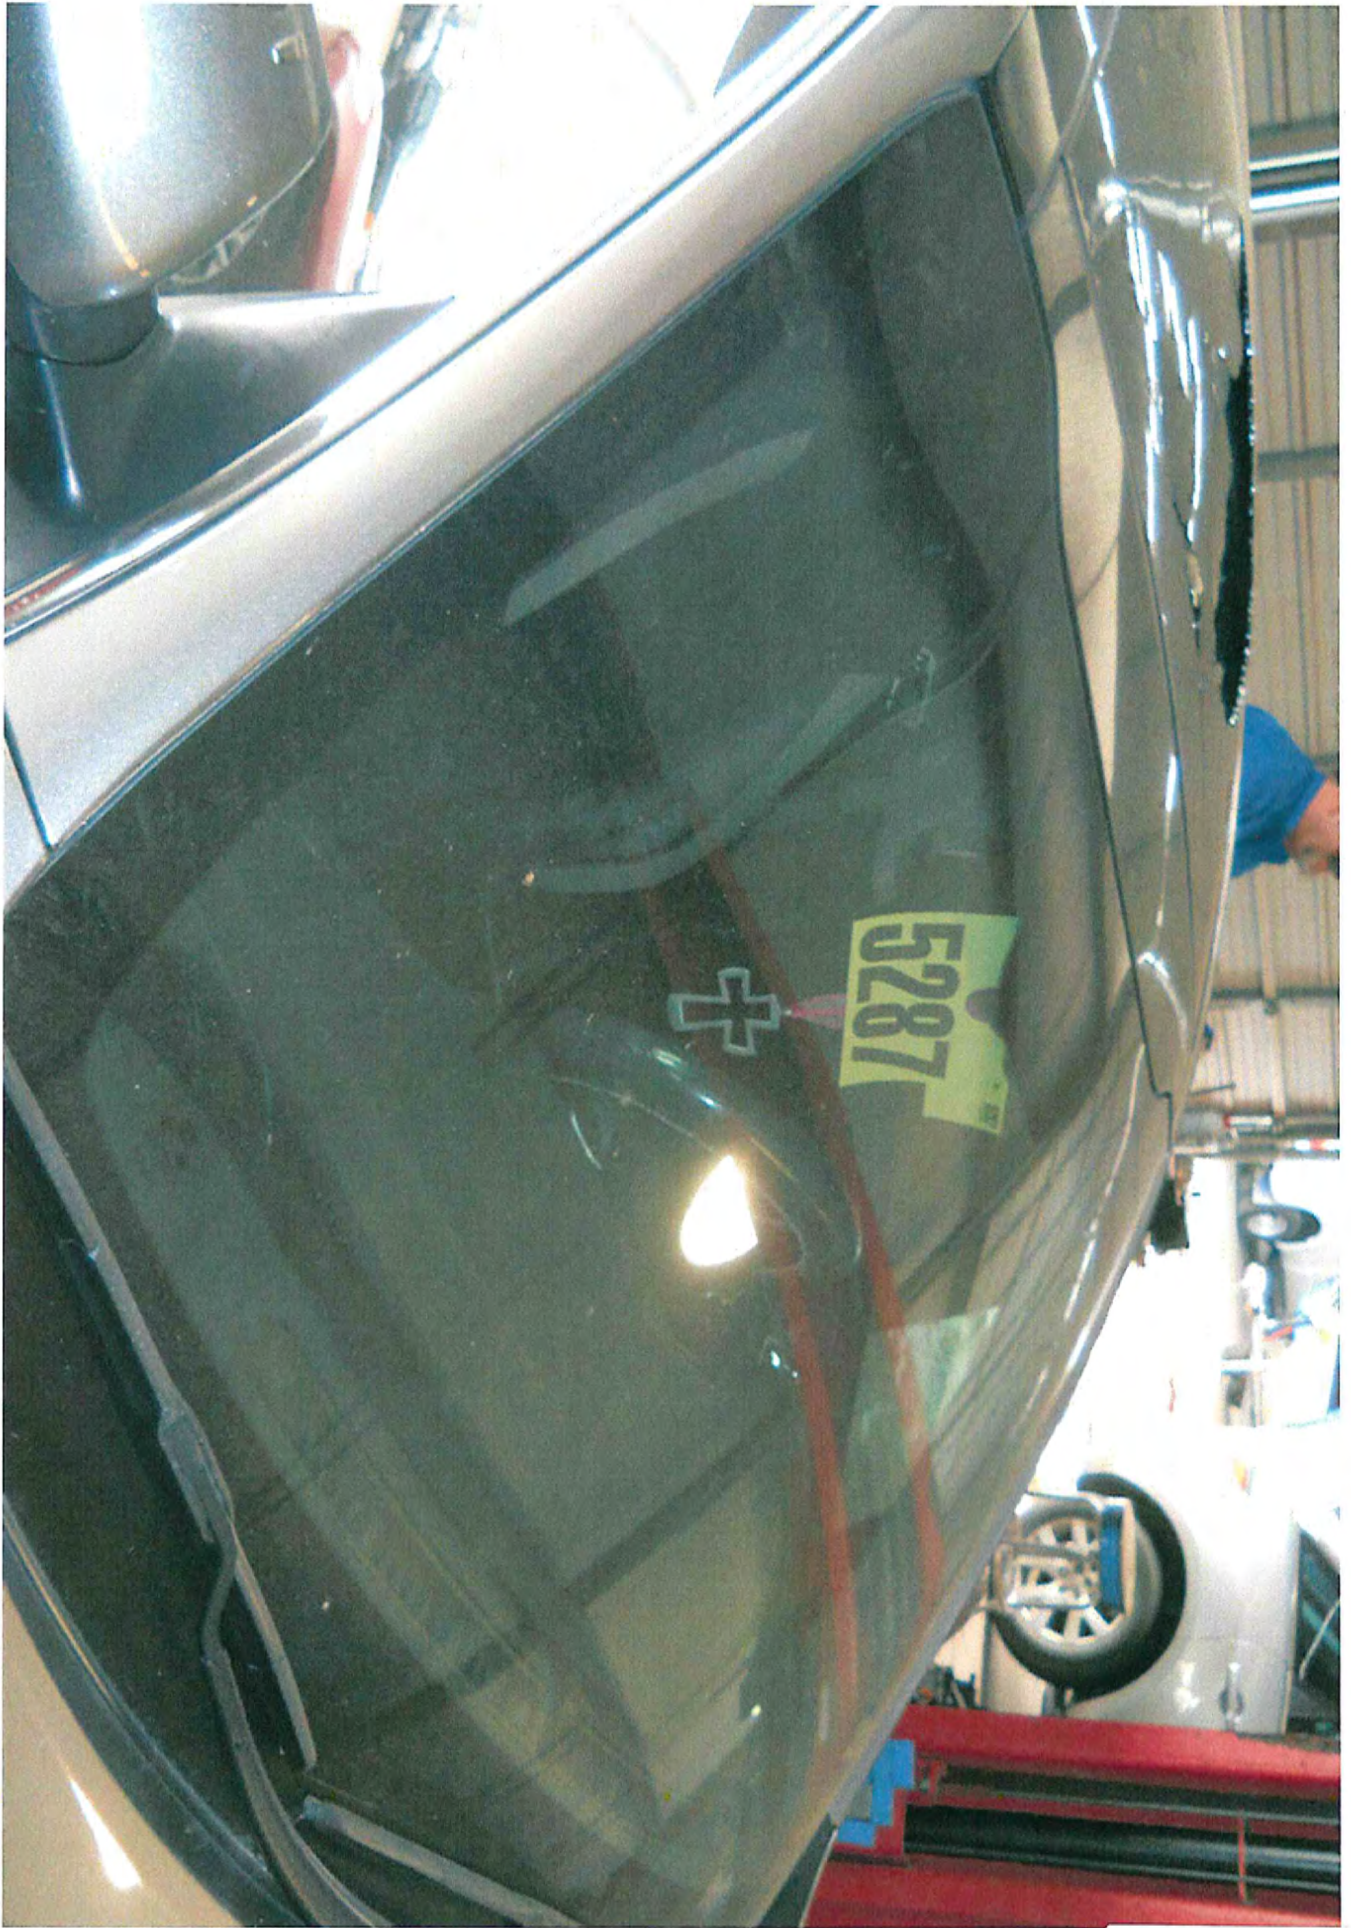
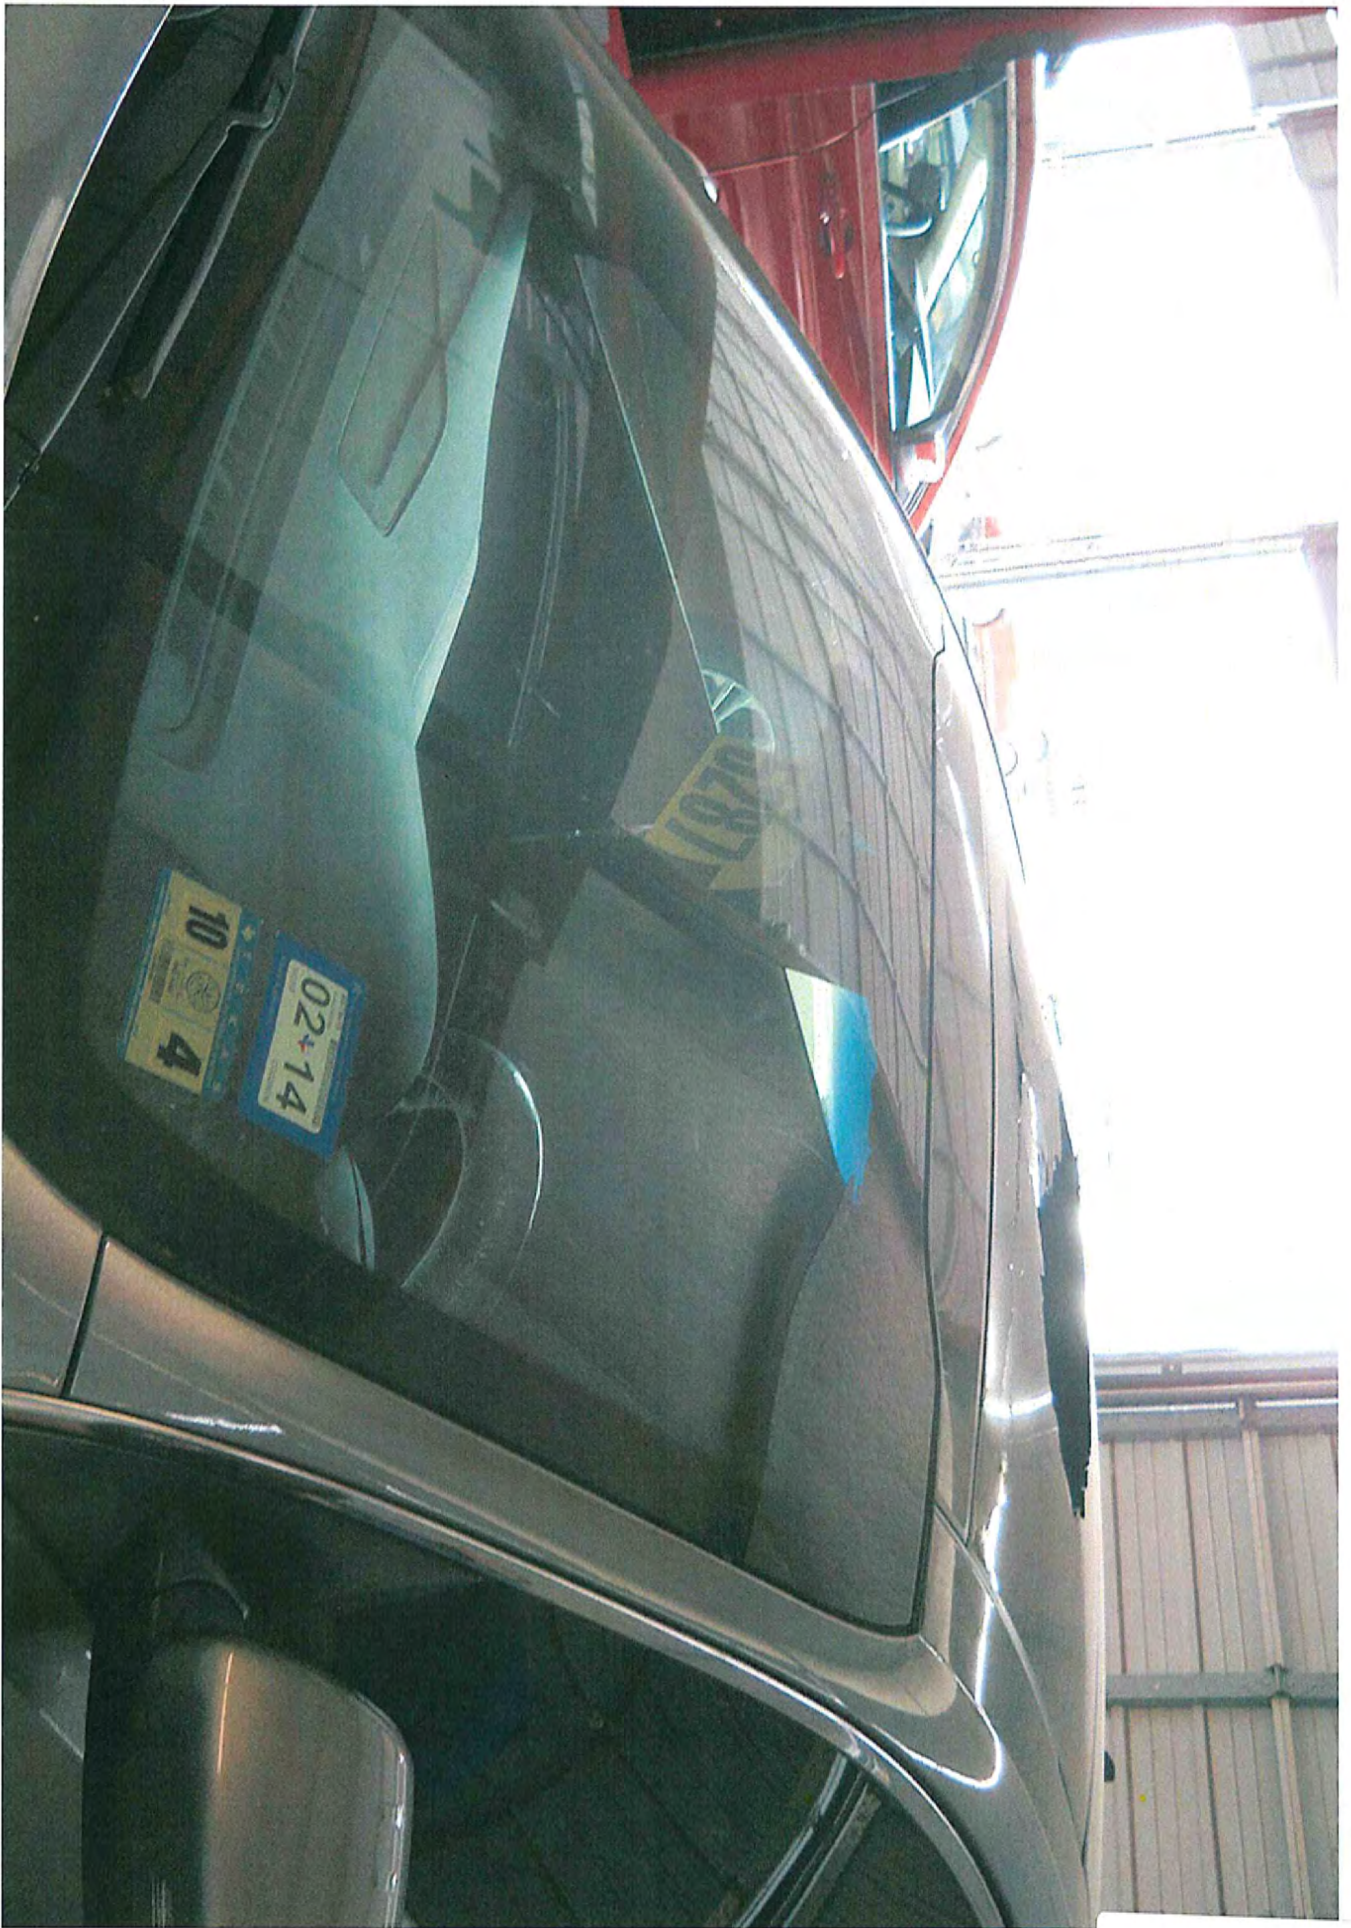
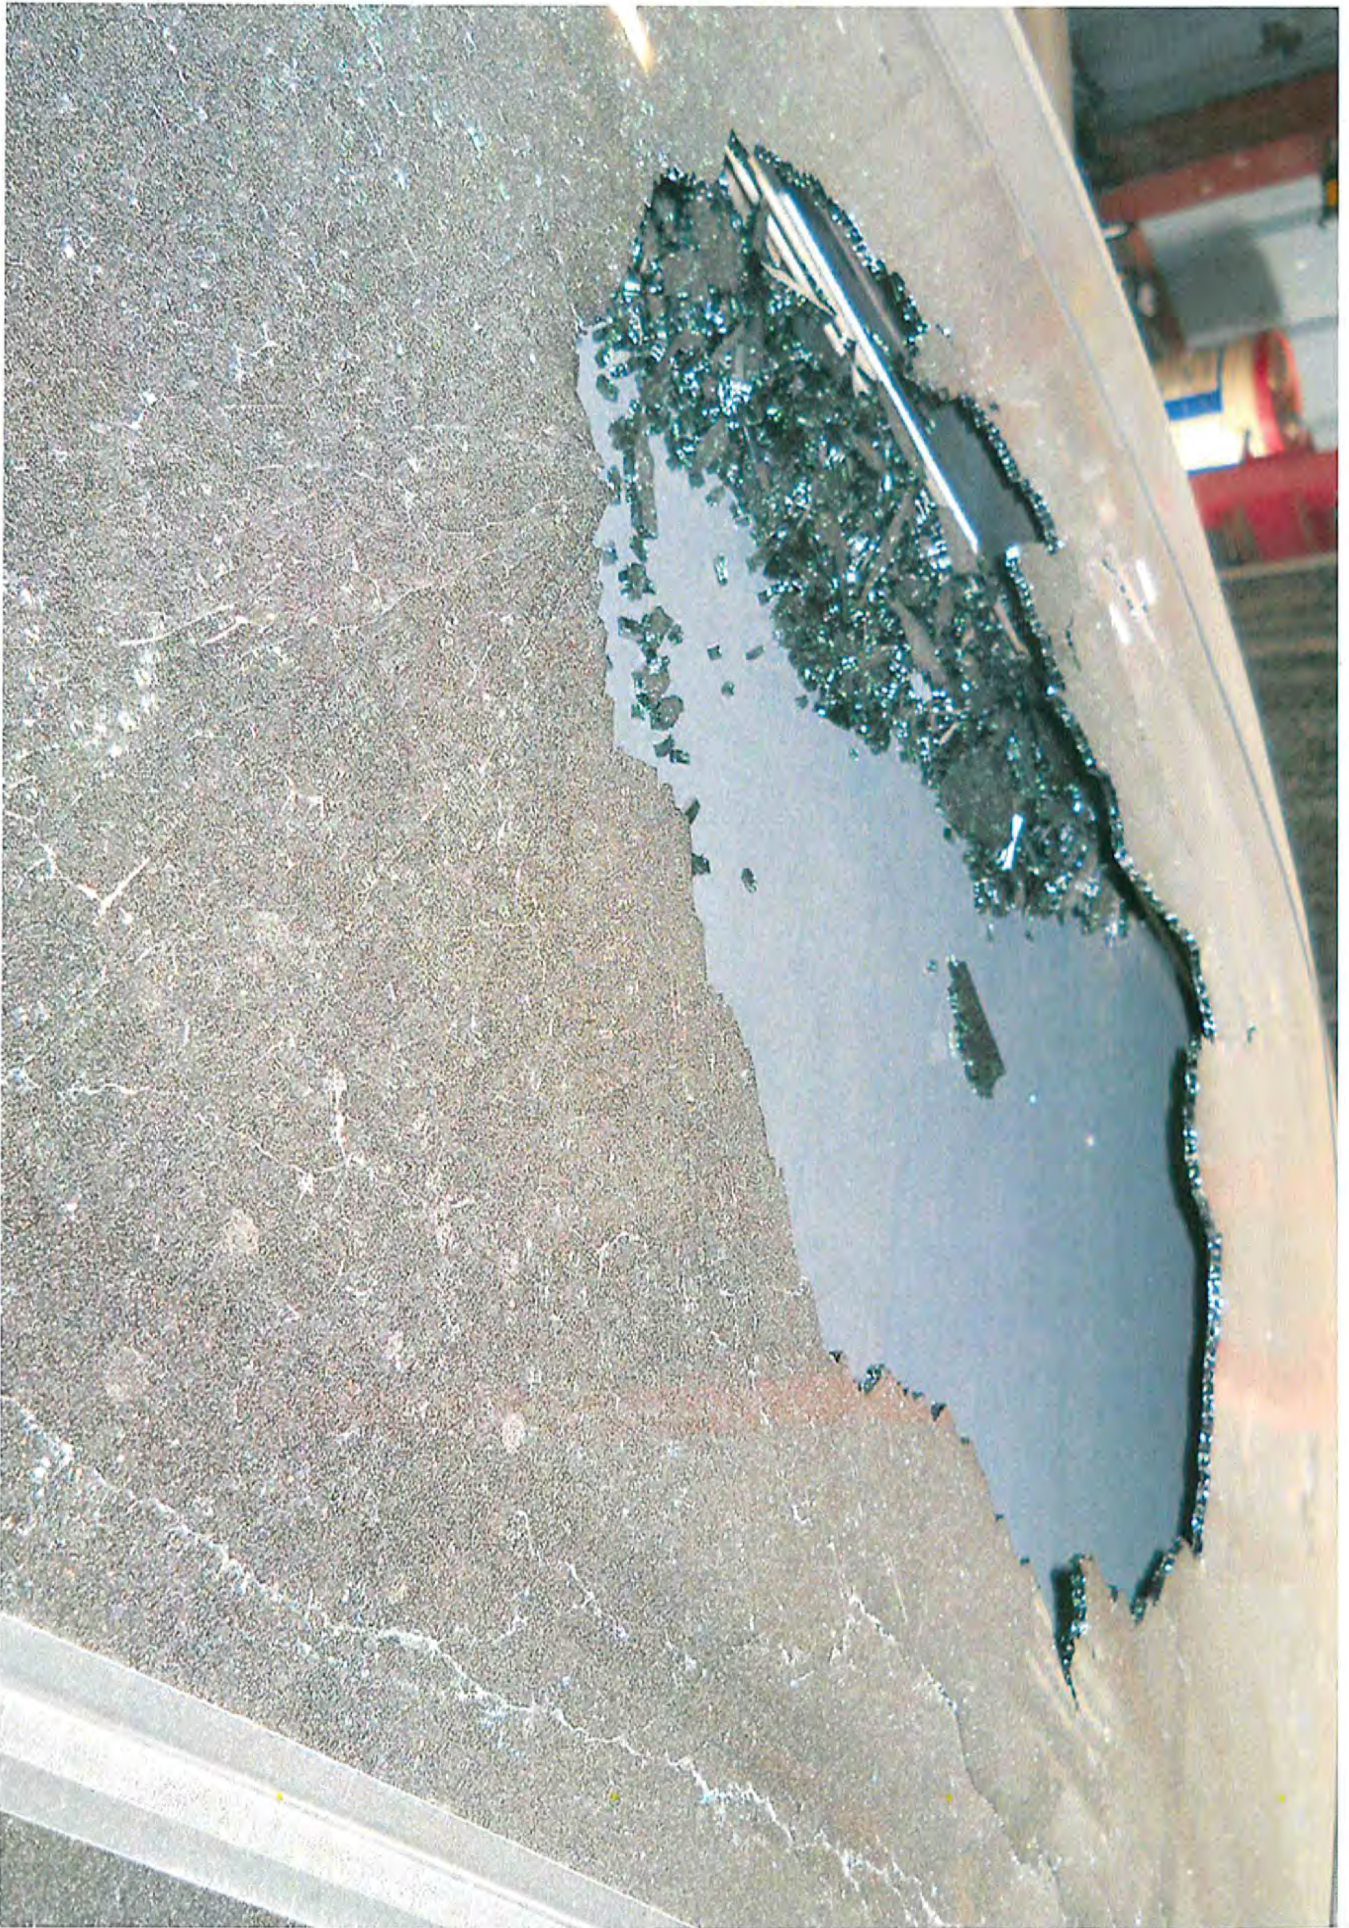
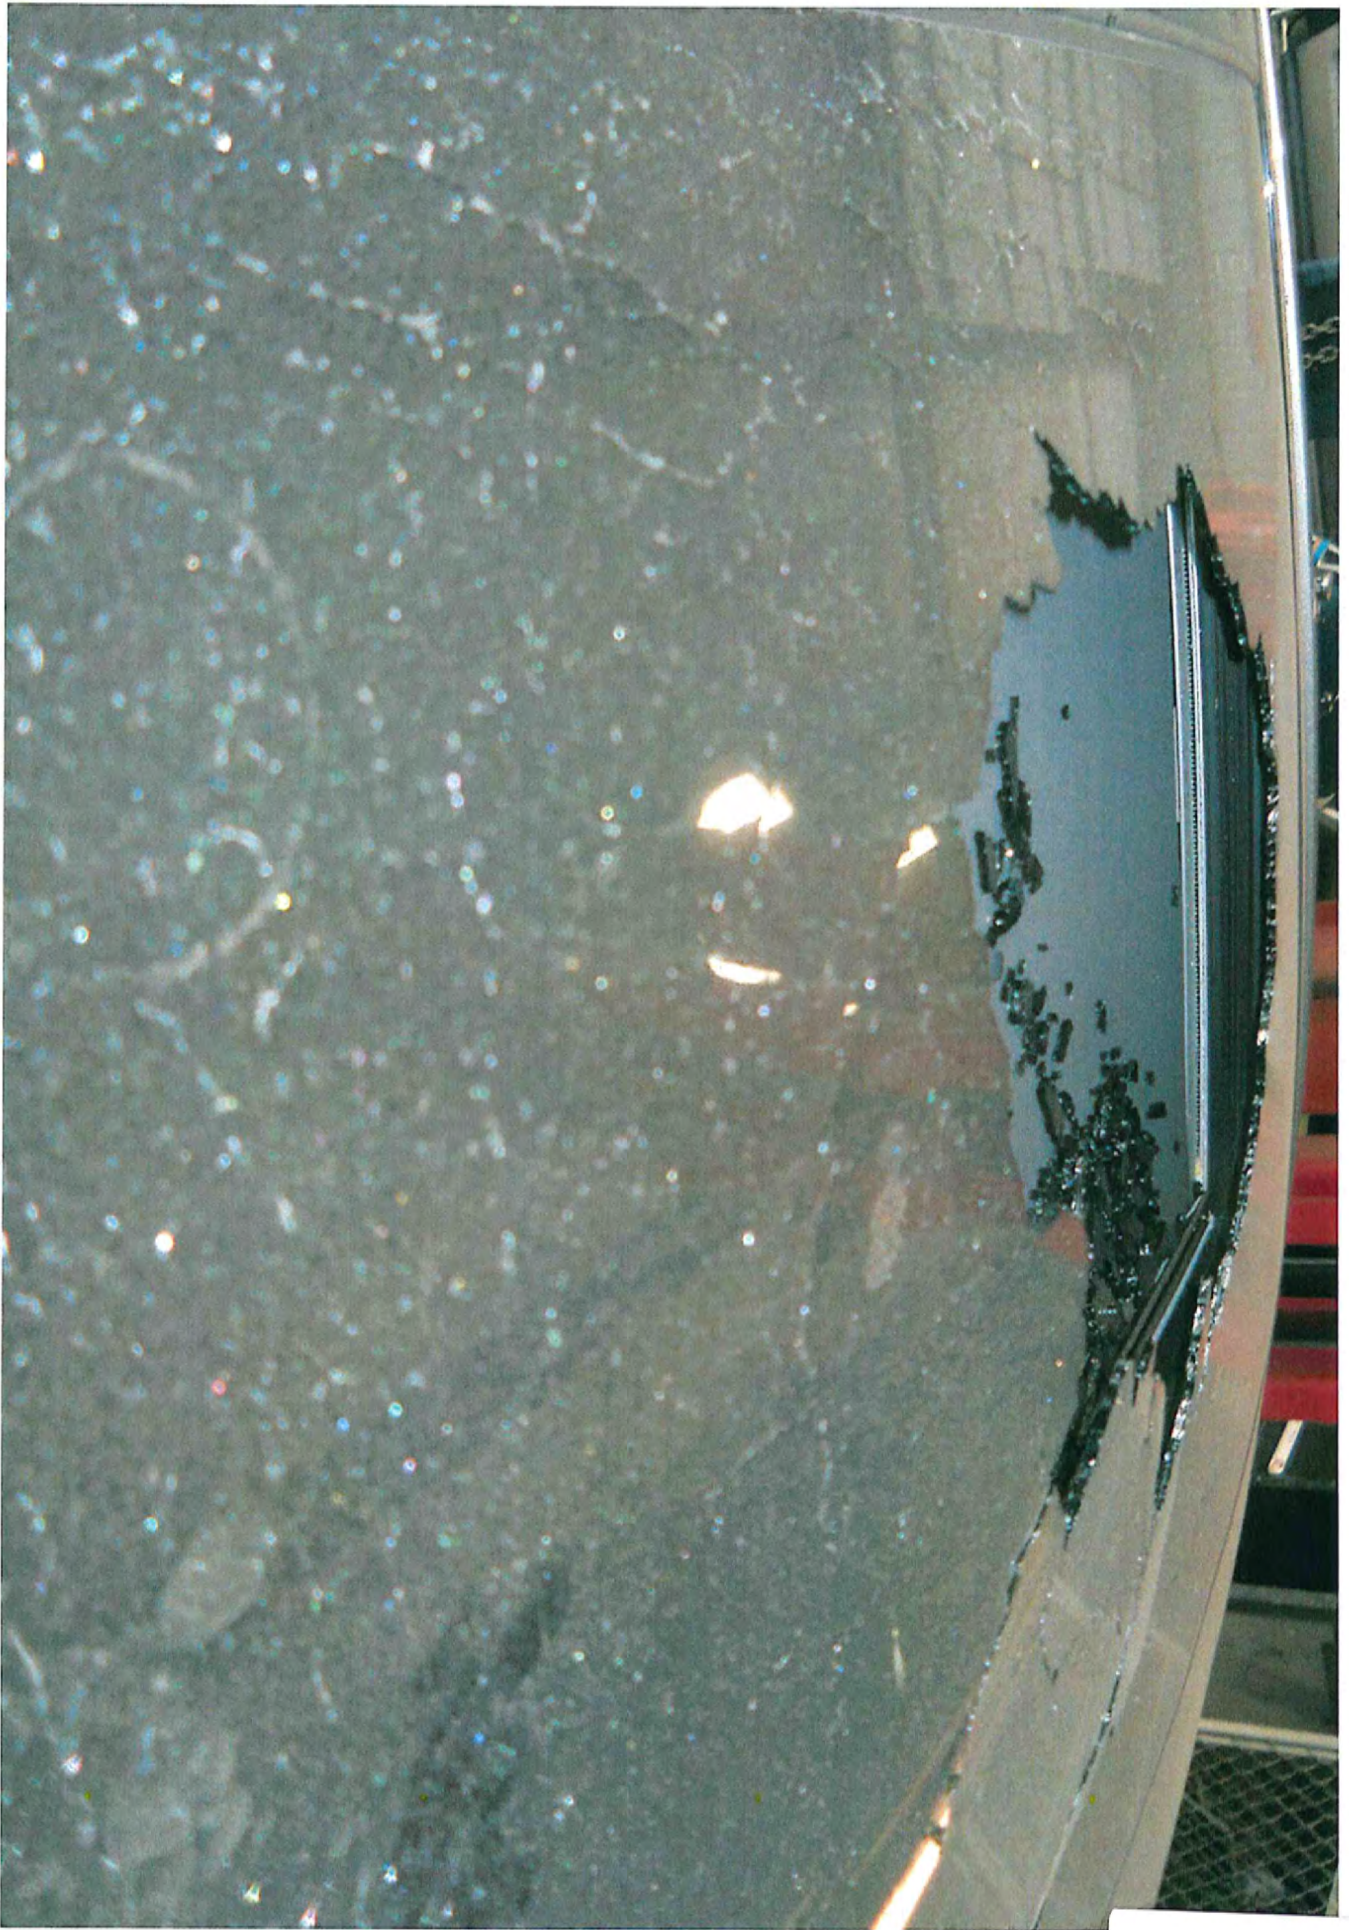
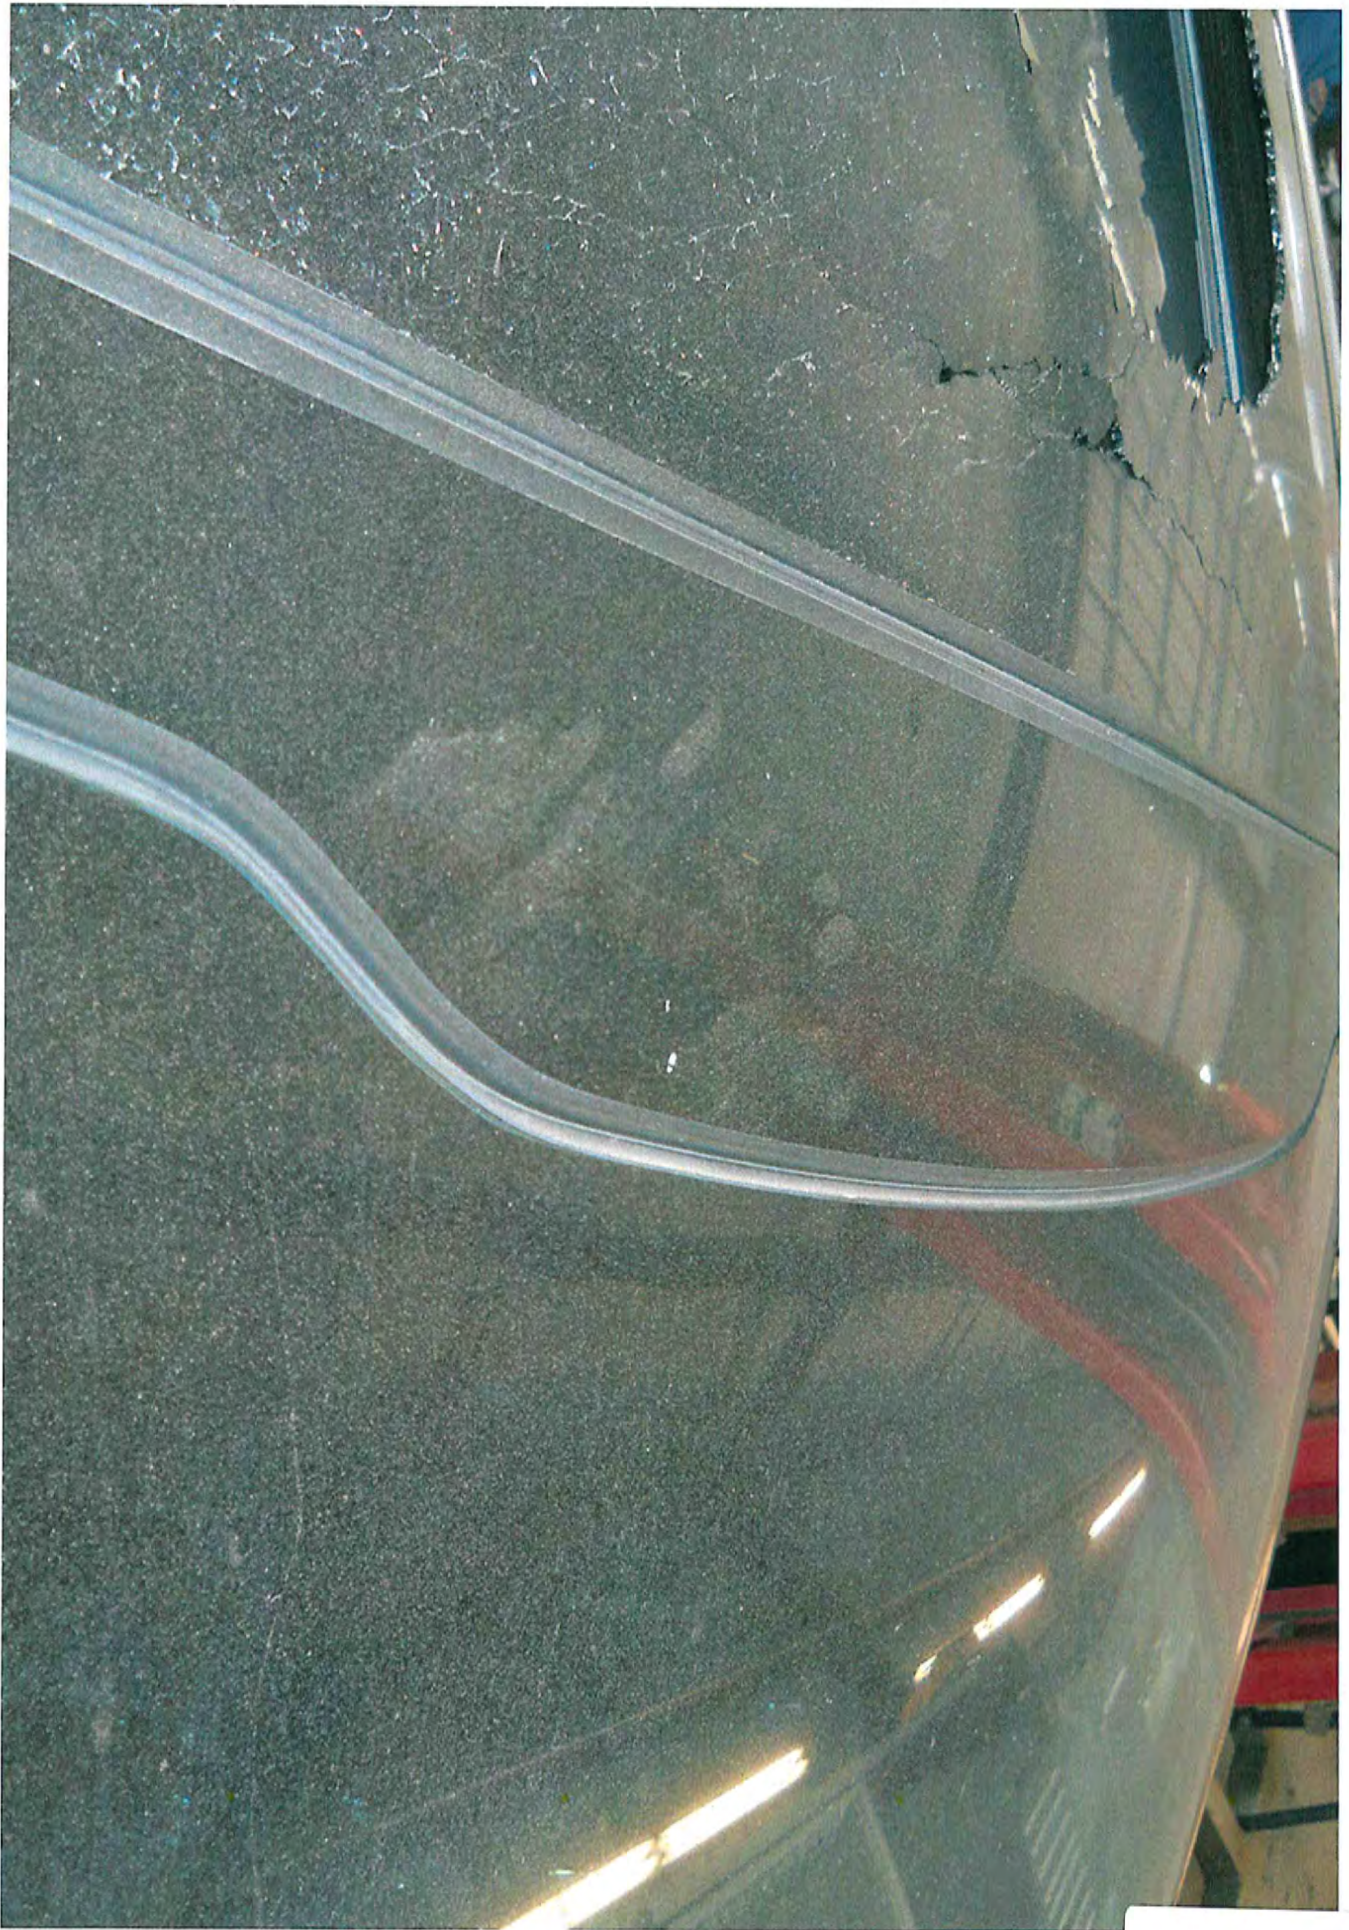
Found no evidence of rock chip.

Replace the sunroof glass
